# Building and Pest Report

## 50 Heath Street Evans Head

| Report/Agreement # | 18112501200782 |
| Inspection Date: | 18 Nov 2025 |

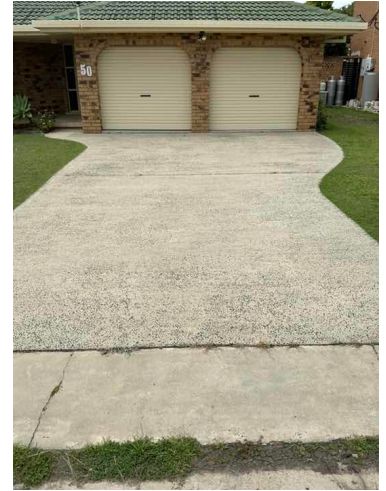
On visual inspection, the general condition of the driveway is serviceable.

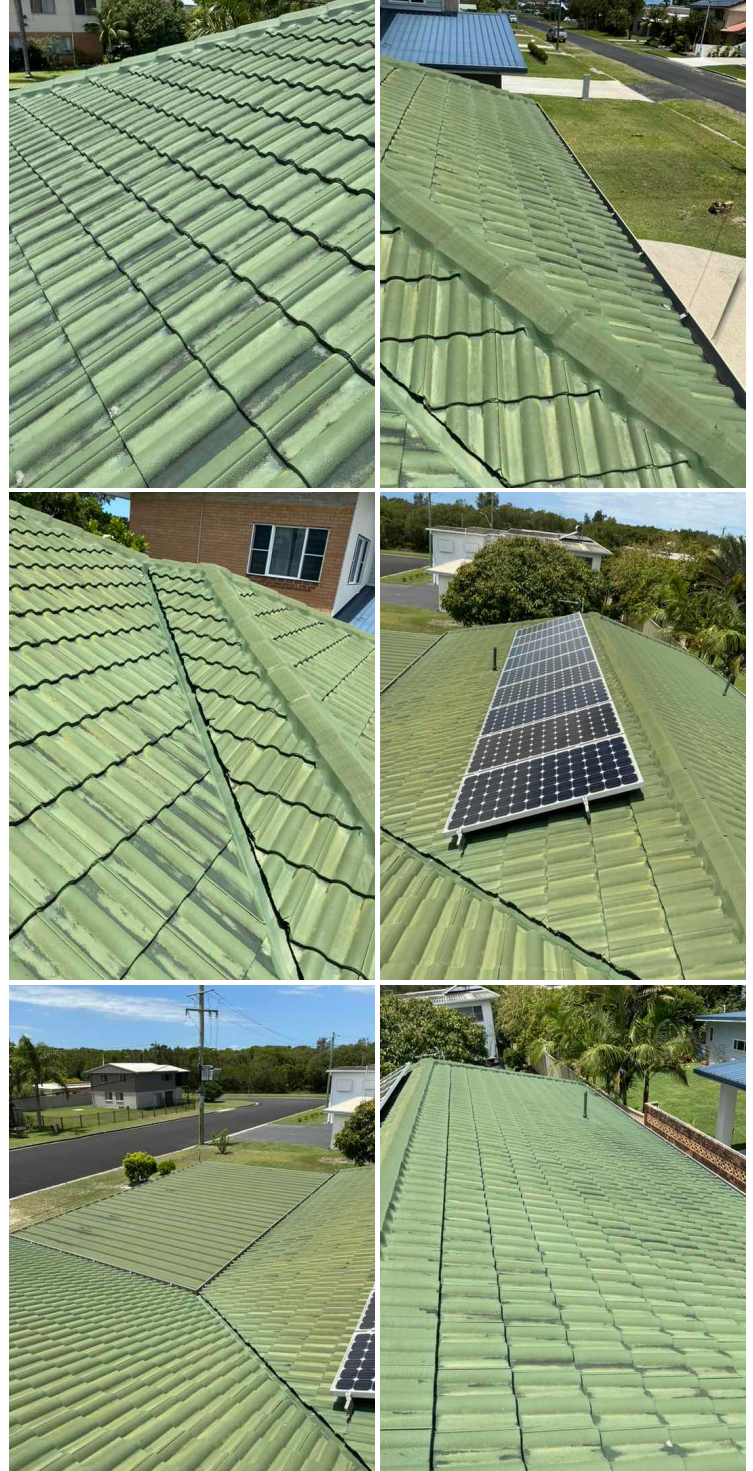
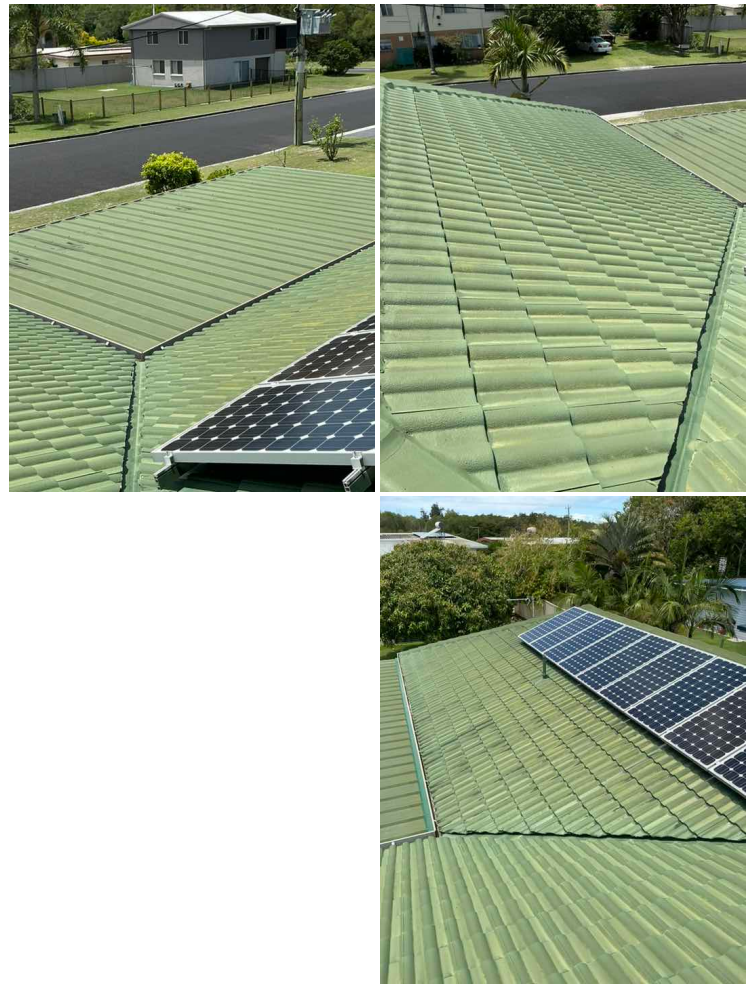
The roof is of concrete tiles.

Of the visible areas, the general condition of the roof is in serviceable condition for the age.

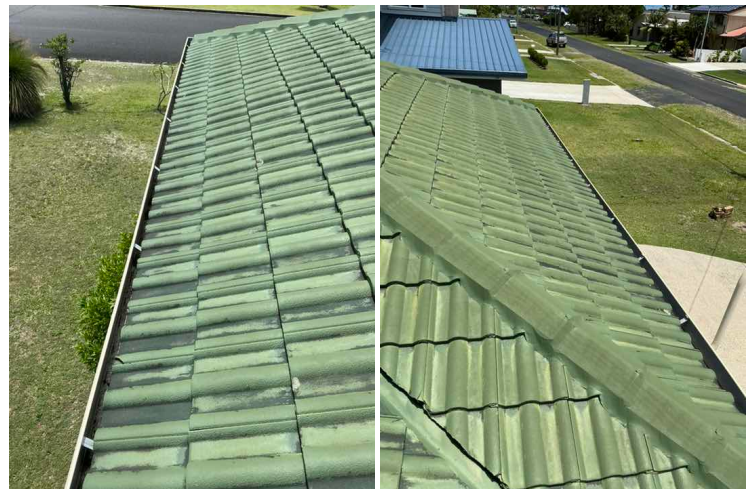
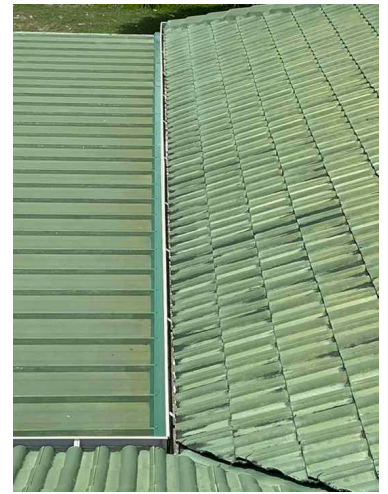
All visible and accessible of the physical nature of the guttering system appears to be in a serviceable condition with no apparent defects at the time of inspection. In the absence of prolonged rain fall efficiency of the guttering can not be assessed and you may find that further investigation or repairs maybe required. Note: Periodic maintenance checks should be carried out for rust penetrations and leaks.

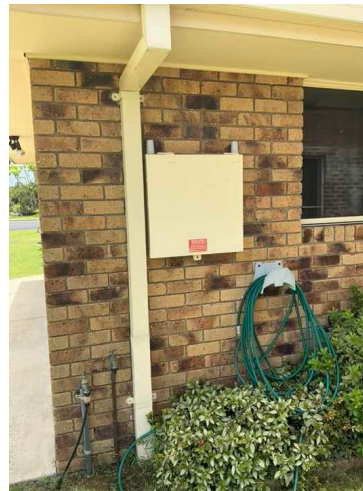
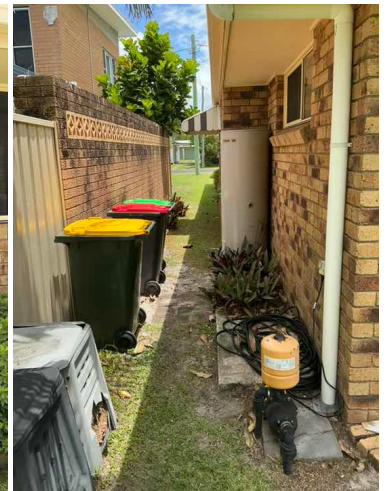
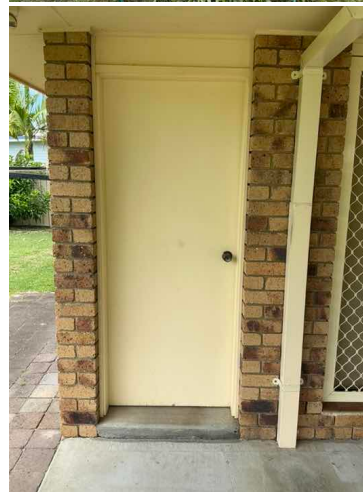
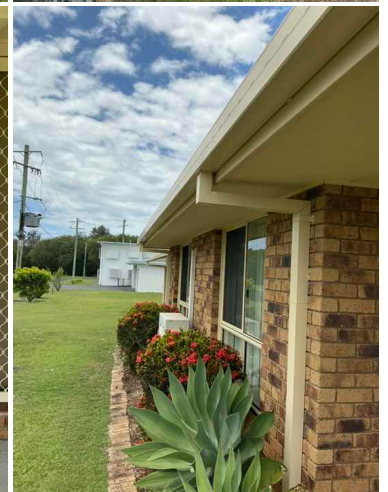
On visual inspection no apparent defects were noted to the down pipes and are considered serviceable, however no comment can be made with regard to blockages or connections to stormwater or functionality in the absence of rain. Note: Periodic maintenance checks should be carried out for rust penetrations and leaks.

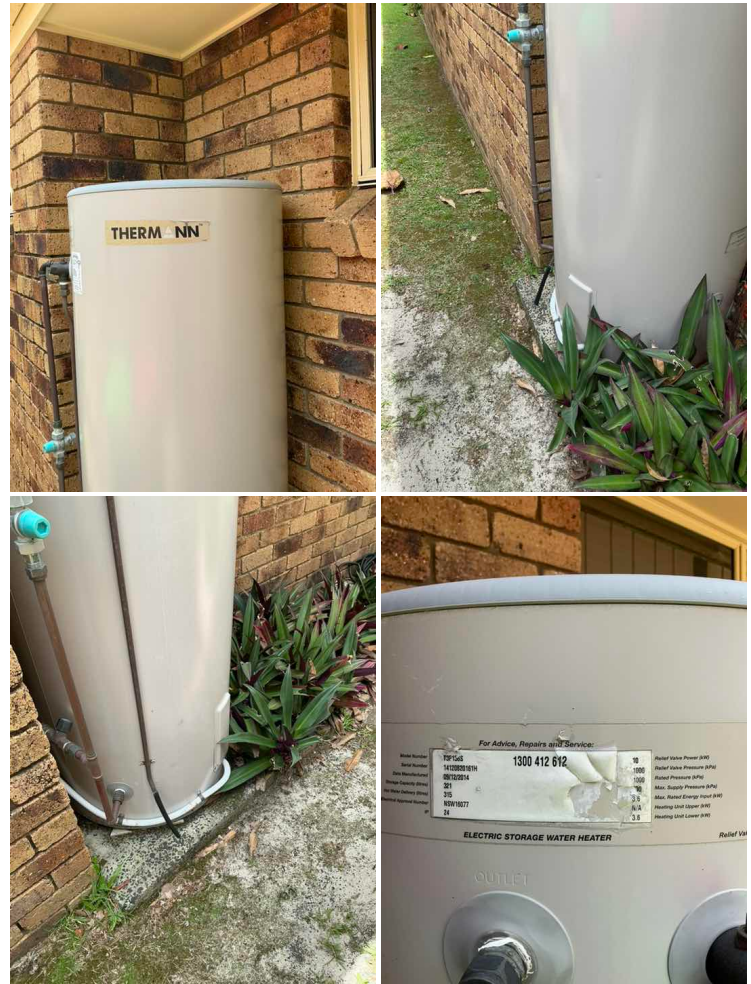
The hot water system appears to be in a serviceable condition. No specific tests other than running the hot water from a tap was carried out. No determination has been made as to the suitability or adequacy of the hot water system in relation to capacity or otherwise.

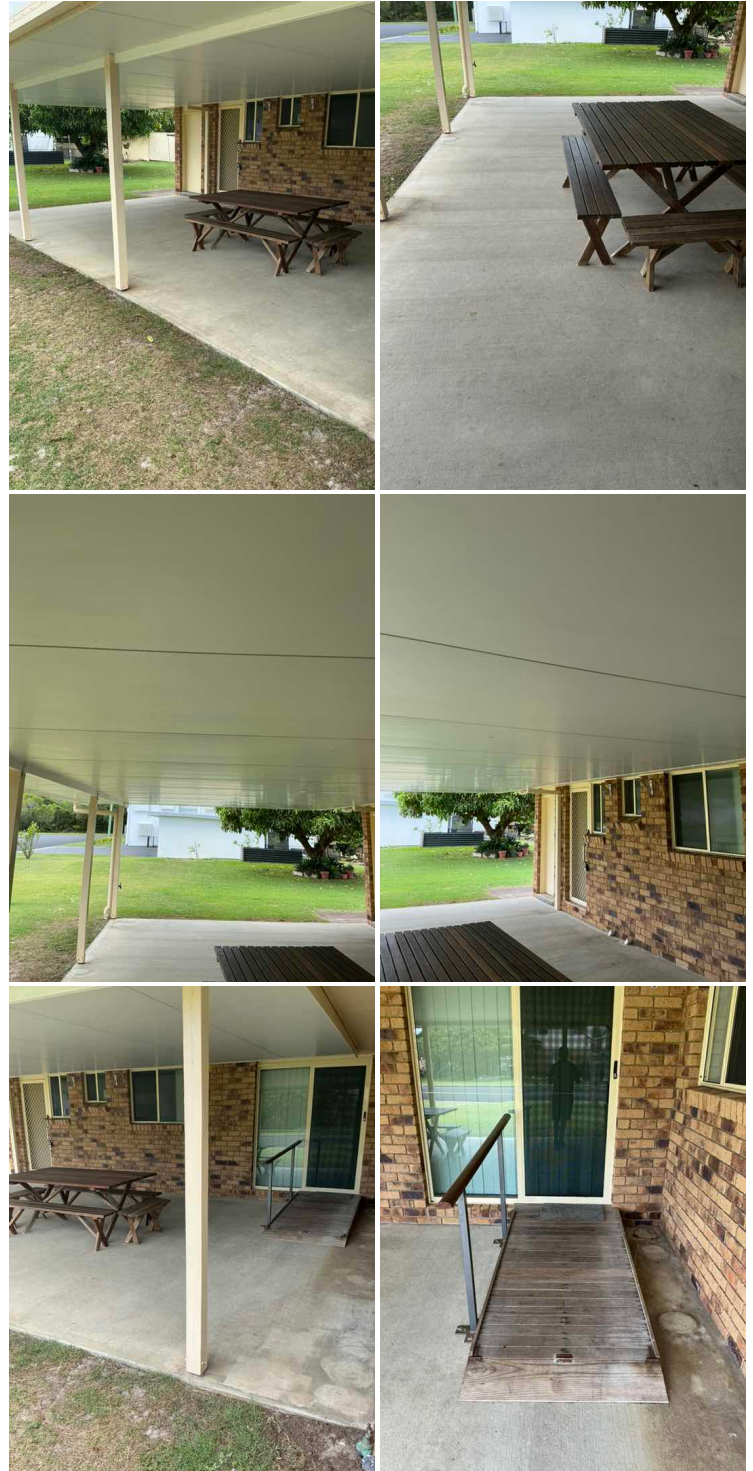
Visible sections of the Alfresco area are serviceable or in reasonable or condition for the age of this dwelling.

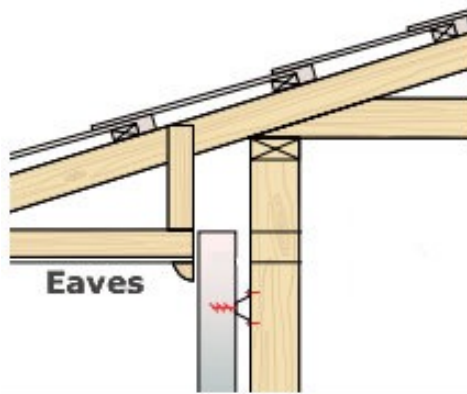
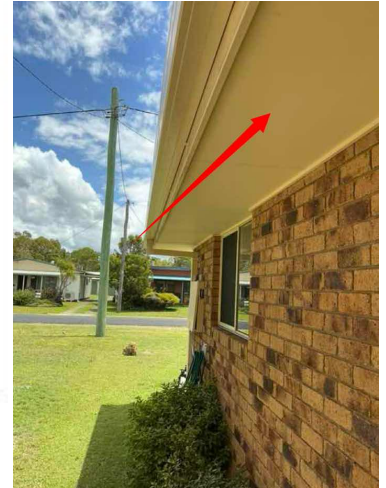
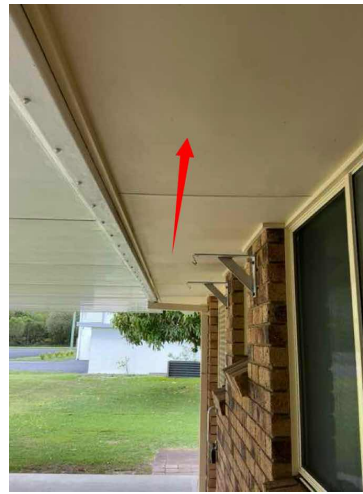
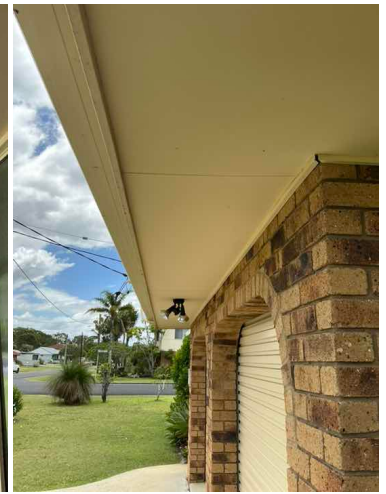
The soffit lining (eaves) are in a serviceable condition with no notable defects.

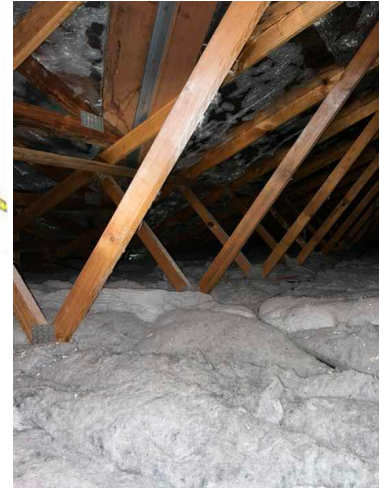
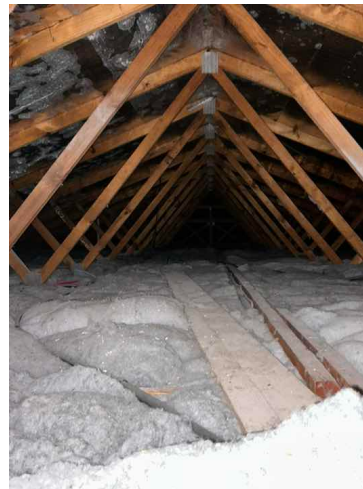
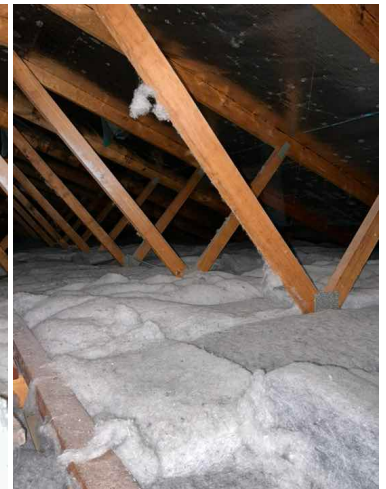
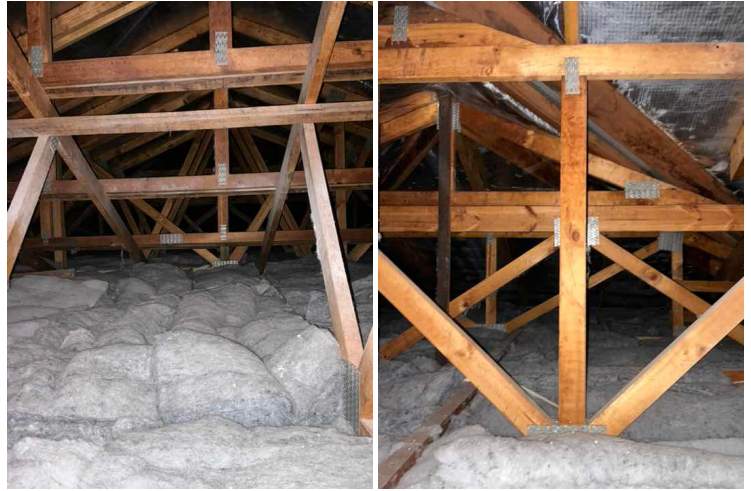
There is insulation present in the roof space/void. This is preventing a full inspection of ceiling joists from being undertaken. It is strongly recommended that full access be gained as it could be harbouring timber pest activity, damage or defects.

Viewed from out side due to restricted entry. No comment can be made regarding condition

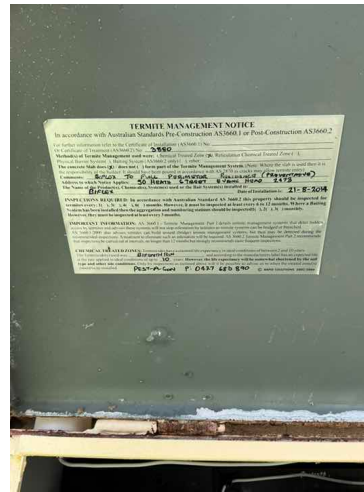
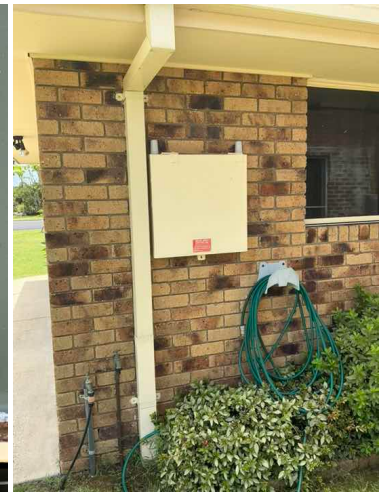
Yes, Drill Holes (Chemical Treatment) were located at the property.

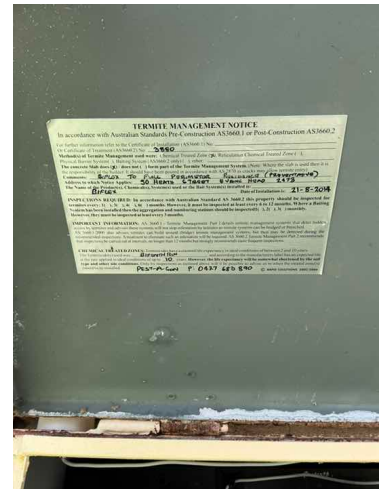
Yes, a durable notice was found in the meter-box during the inspection.

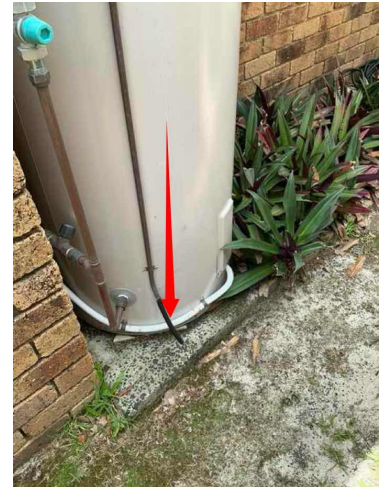
Yes. The hot water overflow does not drain to the perimeter of the building.
