Building and Pest Report

2/62 Gibbon St Lennox Head

Pest And Building Inspection

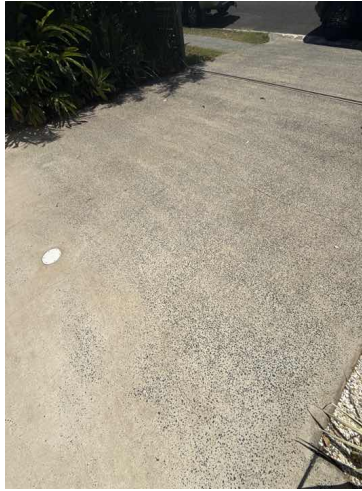
Driveway Condition

On visual inspection, the general condition of the driveway is serviceable.

Common cracks were observed on the driveway. Whilst these cracks appeared to be typical at the time of inspection, we strongly recommend you monitor these cracks and if worsening occurs contact a concreter for further advice.

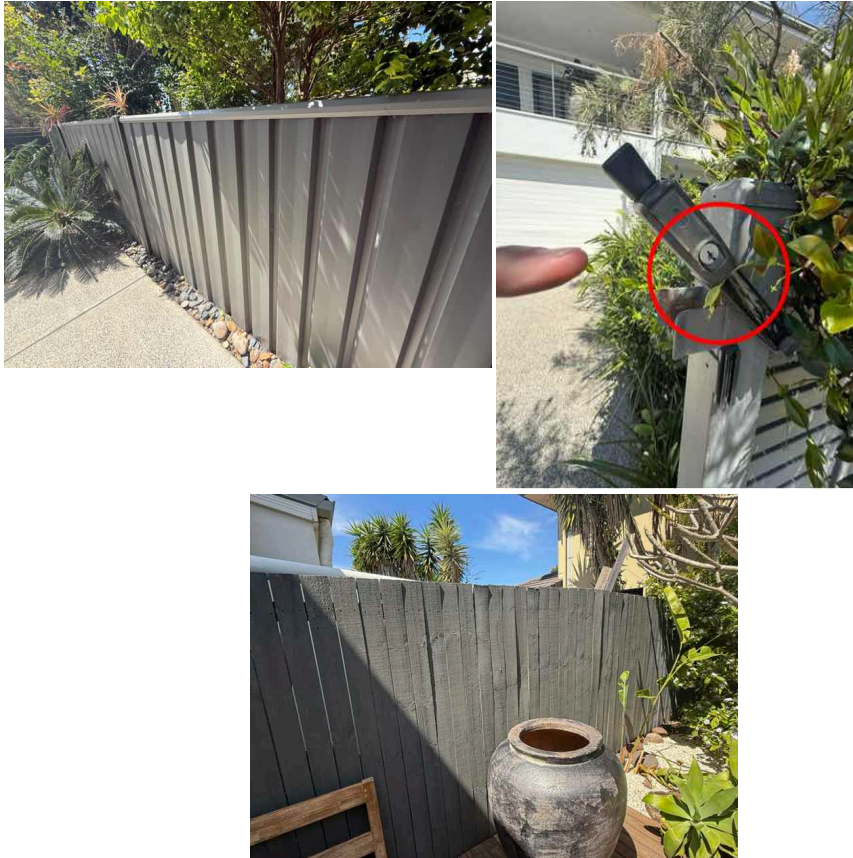
Fences & Gates

Of the visible areas, the general condition of the fences and gates is serviceable for the age of dwelling.

General age to fence components. General upkeep and maintenance required. A qualified fencing contractor should be engaged for repairs.

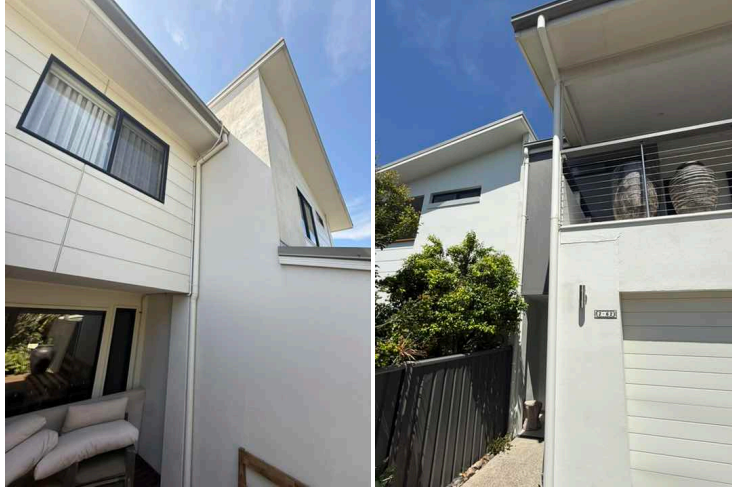
On visual inspection no apparent defects were noted to the down pipes and are considered serviceable, however no comment can be made with regard to blockages or connections to stormwater or functionality in the absence of rain. Note: Periodic maintenance checks should be carried out for rust penetrations and leaks.

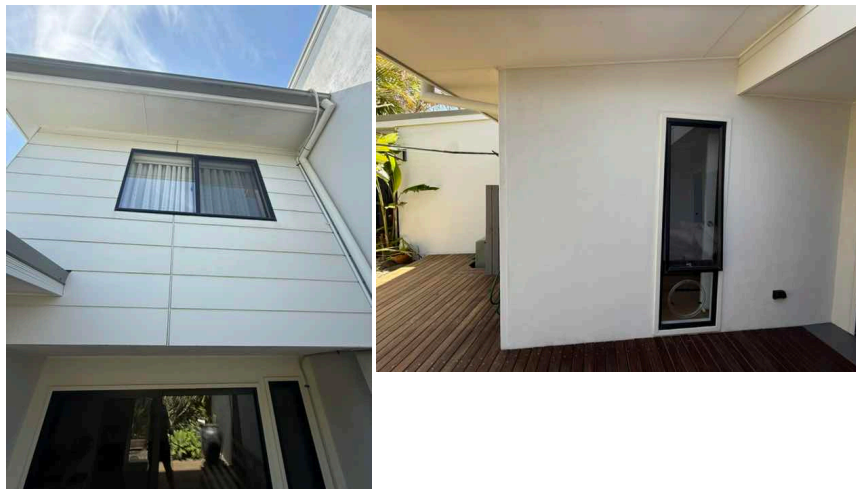
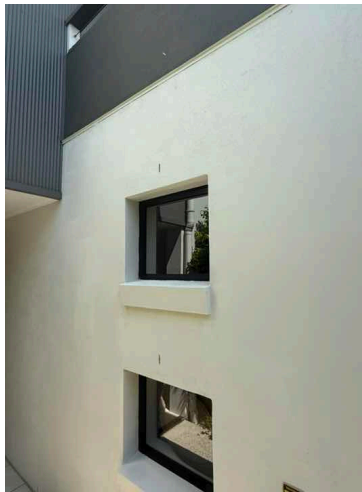
Condition

On visual inspection, the general condition of the exterior walls is serviceable for the age.

There appears to have been some settlement in the building which has caused some cracking to the walls. These cracks are categorized as 0 to 2. This can also cause some doors to bind or be out of square. In the inspectors opinion these cracks are due to settlement, usually due to ground movement and subsequent movement to building materials can be expected. Any cracks should be monitored and if cracks increase in size, further investigation should be carried out by a structural engineer.

For clarification on the category of cracks please refer to Cracking of Building Elements in Section 2D of the Terms and Conditions contained in this report.

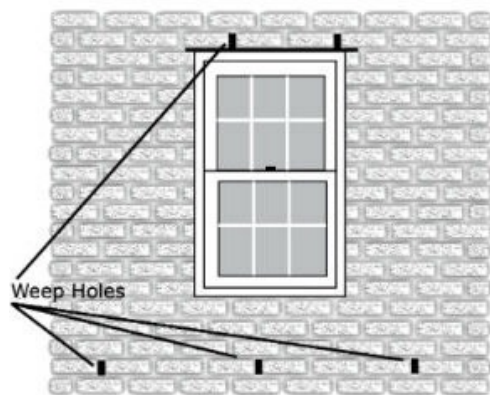
Weep Holes and Ventilation

The weep holes are unobstructed .

Vents are covered by decks. Sub floor vents should be exposed and allowing free flowing air.

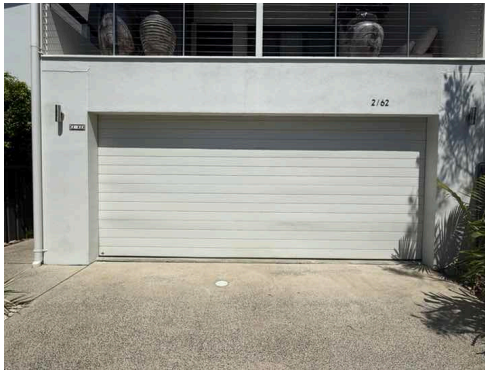
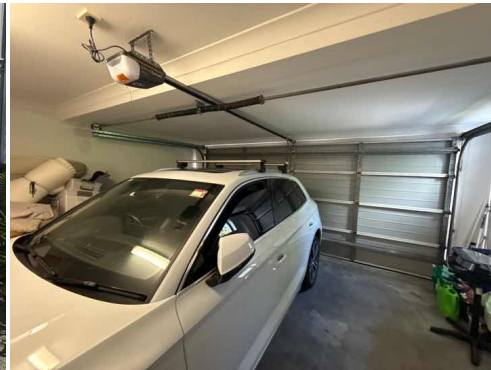
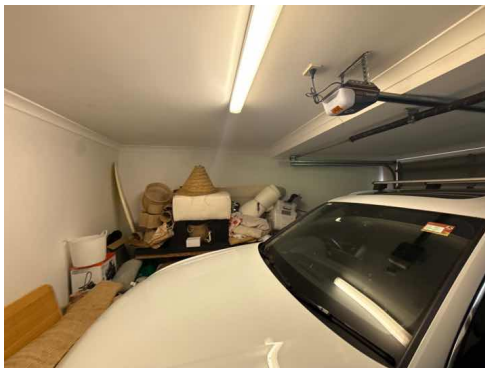
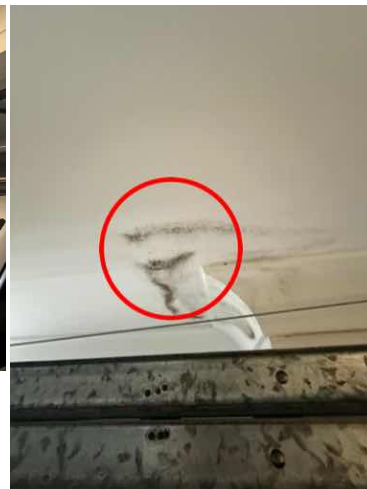
Stored items restricted a full and thorough inspection of this area. Defects may exist in the obstructed and inaccessible areas. It is strongly recommended that full access be granted to enable a thorough inspection as there may be timber pest activity, damage or defects. Note: Where vehicles and storage has restricted a full inspection it is advised that this area be cleared so a full and unobstructed inspection can be carried out.

From the visible and accessible areas, the garage appears to be in a serviceable condition for the age of the property with no notable structural defects sighted.

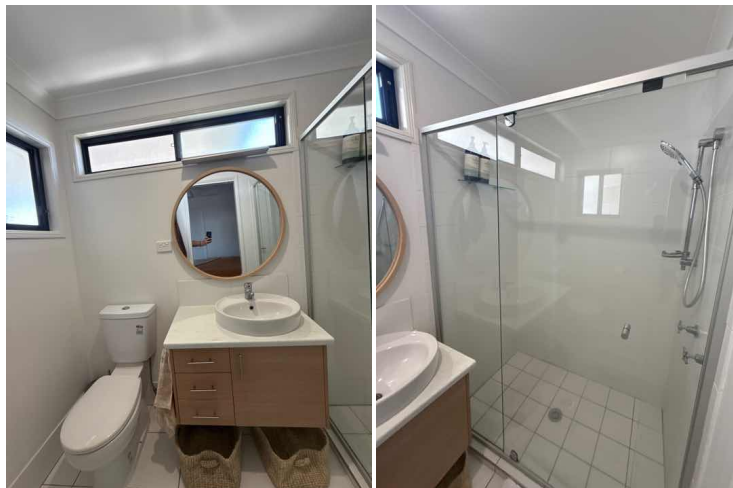
Of the visible areas, the general condition of this bathroom is serviceable or in reasonable condition for age of dwelling.

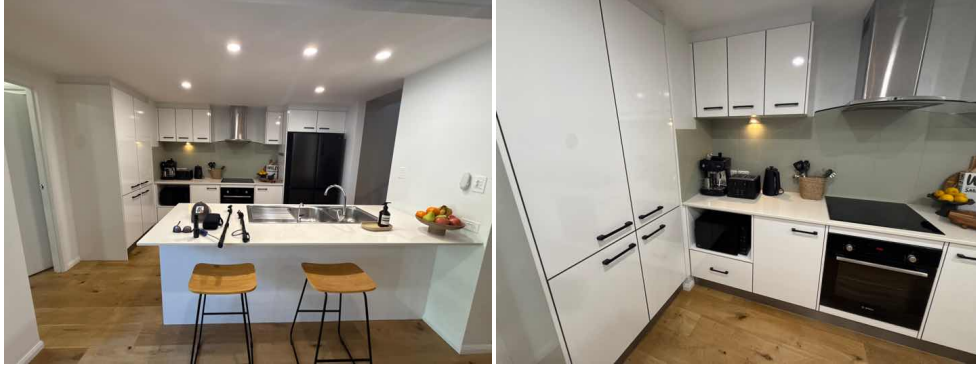
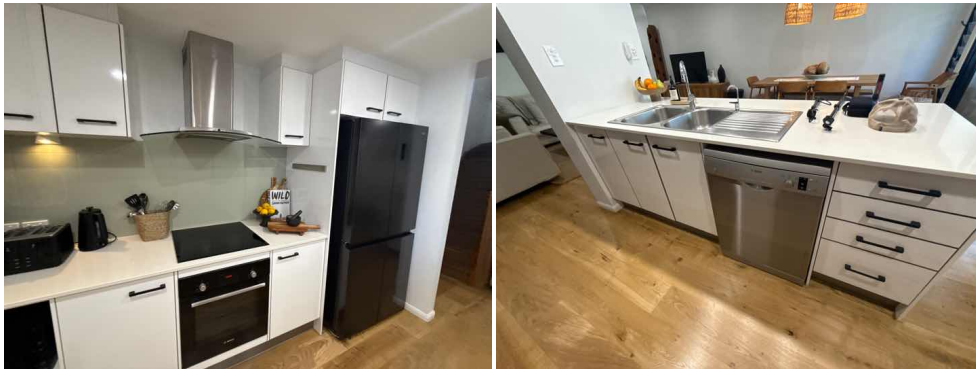
Of the visible areas, the general condition of the kitchen and pantry is serviceable or in reasonable condition for age of dwelling.

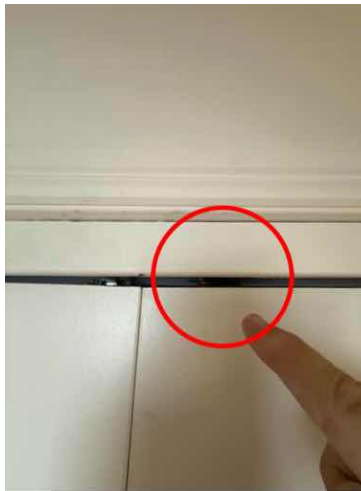
Doors

Loose bi-fold runner
