PEST AND BUILDING PRE-PURCHASE REPORTS

BUILDING & PEST INSPECTIONS

2/27 Matilda Street
Lennox Head

BPI - INSPECTION REPORT

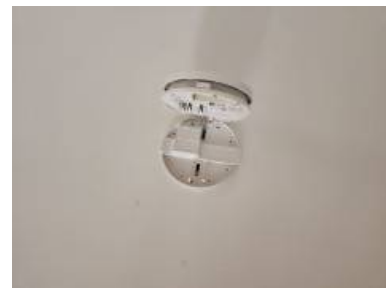
Present - Hall, Bed 1 (new backup battery required)

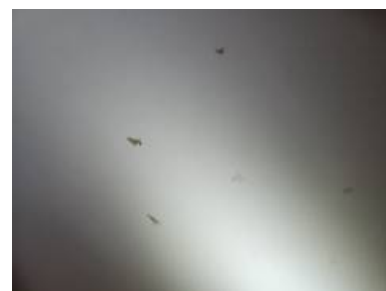
Cracking / Sagging / Defective Lining

Some minor damage to ceiling sheeting requires touching up / repair / repainting.

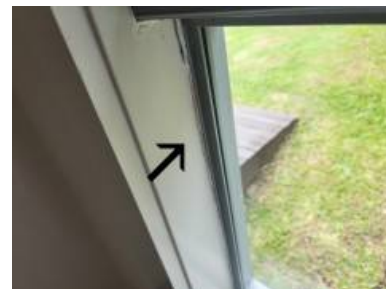
Putty / Water Staining

Some window reveals require touching up / repainting to master bedroom.

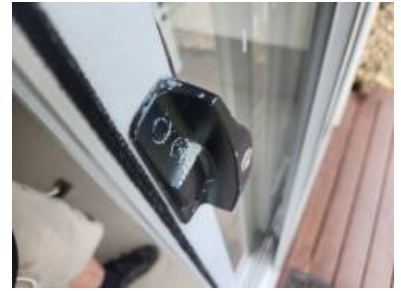
Door Hardware

Signs of corrosion to laundry door handle.

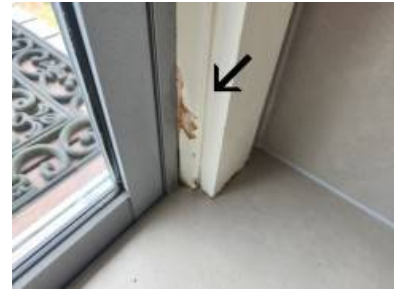
Door Frames

Evidence of weather damage to the base of the timber door frame requires repair / repainting to laundry door.

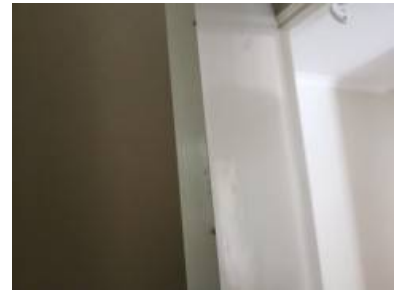
Doors

Paintwork to some doors requires touching up / repainting.

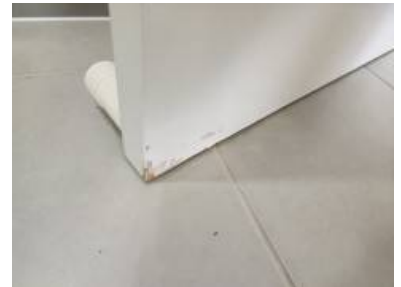
Signs of past water penetration to Ensuite door base.

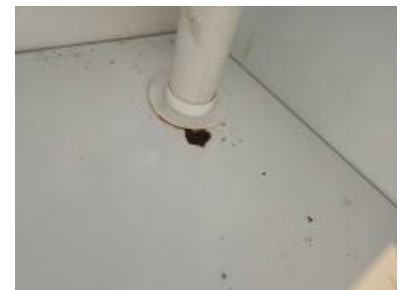
Damage

Laundry tub cabinet shows signs of rust and requires repair / painting with Killrust or better.

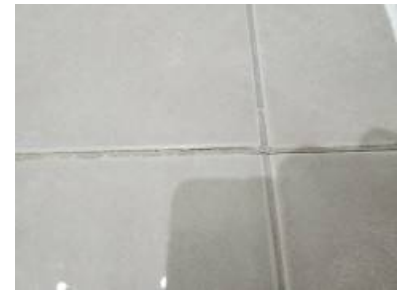
Tiles

Minor crack to grout join to shower floor needs regrouting or sealing.

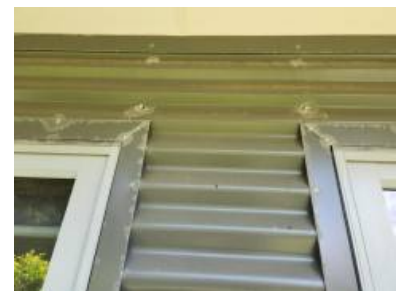
Some colourbond cladding and flashings are showing signs of corrosion to master bedroom.

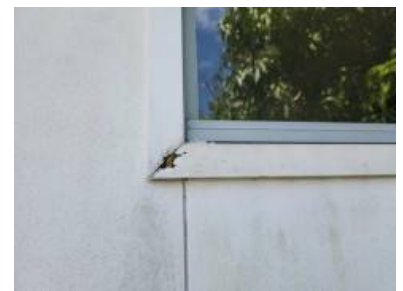
Some architraves are showing signs of wood rot to bathroom window.

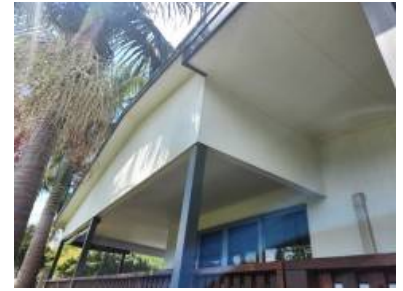
The external paintwork / finish to the external surfaces and timberwork is generally satisfactory. There are some sections / areas that require touching up / repainting.

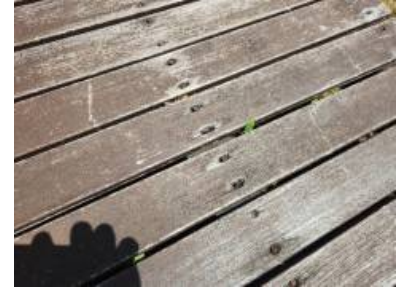
Some verandah decking timbers show signs of weather damage / decay and require repair / refixing / resealing to entrance ramp.

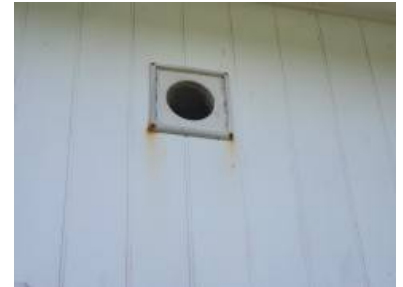
Kitchen vent needs replacing.

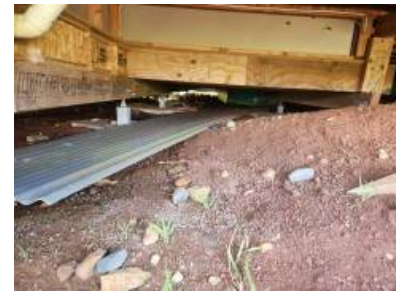
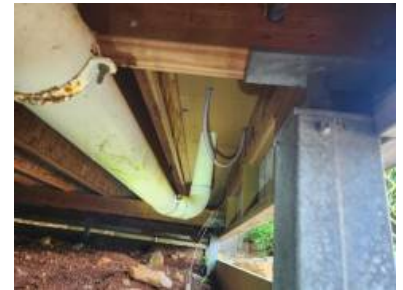
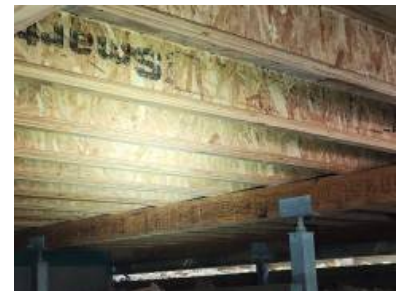
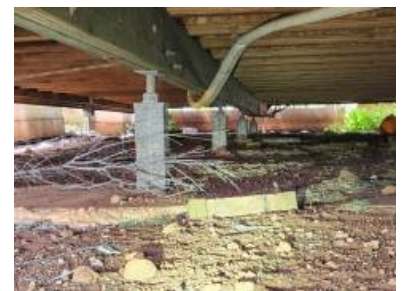
Debris

Remove old building materials.

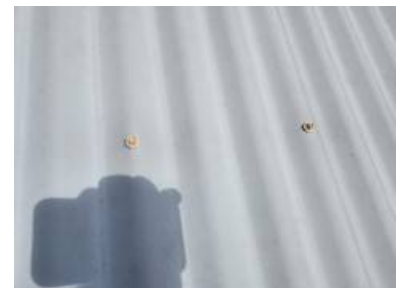
The sheet roofing and flashings are in reasonably good condition. Some roofing screws show signs of rust and require replacement.

Some roofing screws show signs of rust and require replacement.

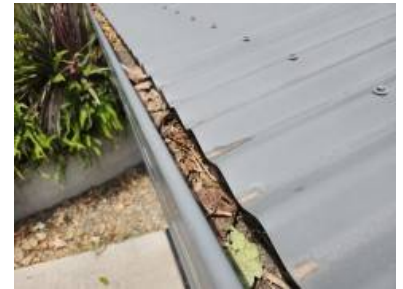
Some sections of guttering are full of debris and require cleaning. Failure to do so may allow water to become blocked and back flow into the roof void causing water damage.

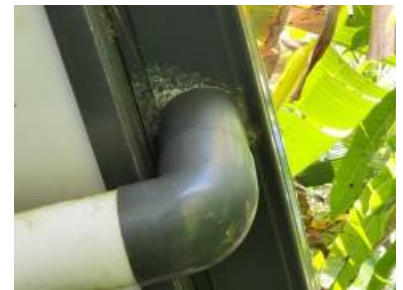
Some gutters have rust beginning around down pipe joins, I recommend repairing with kill rust.

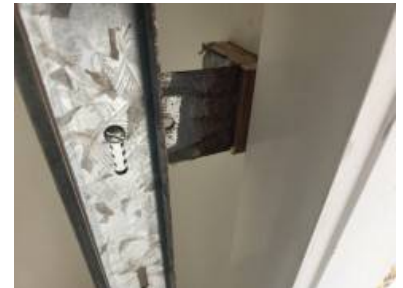
Condition:
Rust beginning to garage door brackets.

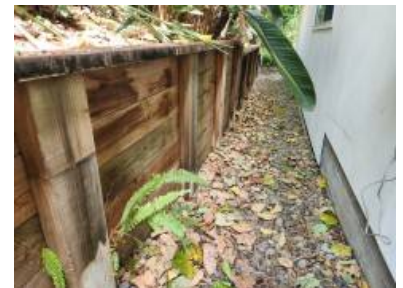
Condition:
The timber retaining wall shows evidence of movement.

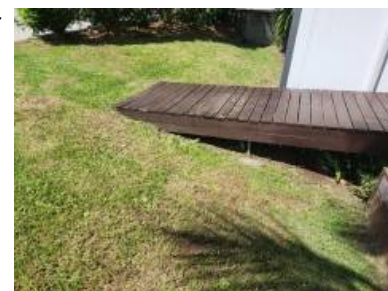
- Some external timbers to the Building are in contact with the ground / soil. Timber to ground contact may allow concealed termite entry / attack. The situation should be modified so that timber to soil contact does not occur (by creating a 75mm visual barrier) or have them treated with termiticide
