Building and Pest Report

1/4 Pinnacle Row Lennox Head

Report/Agreement #	170625114555506
Inspection Date:	17 Jun 2025
Inspection Time:	11:45 am

Pest And Building Inspection

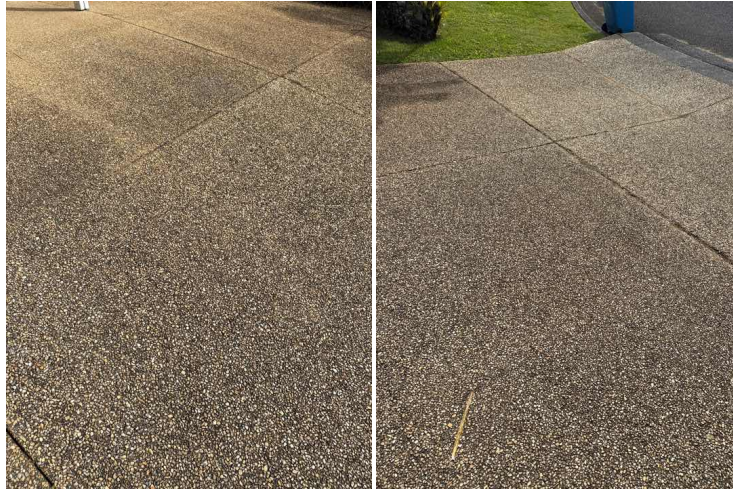
On visual inspection, the general condition of the driveway is serviceable.

Common cracks were observed on the driveway. Whilst these cracks appeared to be typical at the time of inspection, we strongly recommend you monitor these cracks and if worsening occurs contact a concreter for further advice.

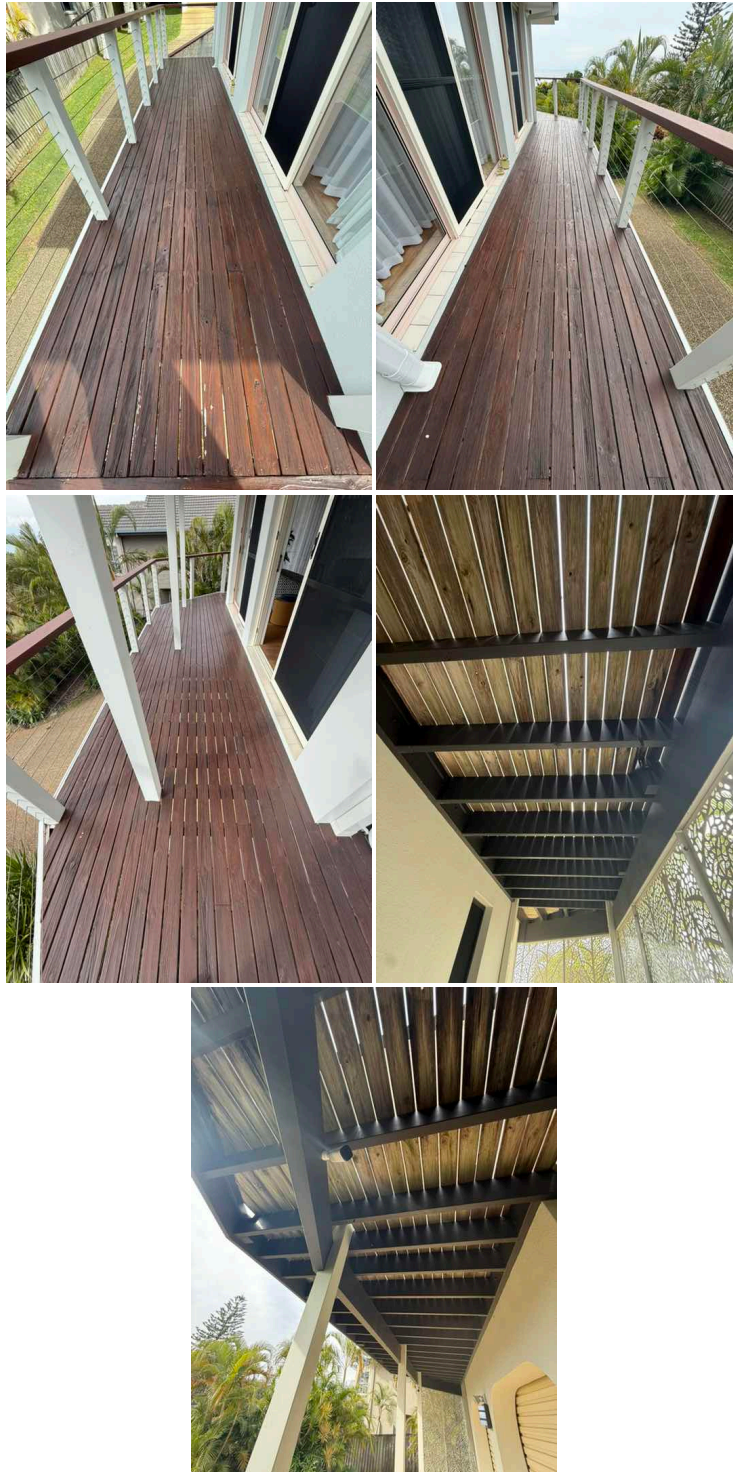
Of areas visible, minor defects and/or maintenance issues were visible. These will require assessment and subsequent repairs by a licensed tradesperson. Please read below for details. Please note that the inspector believes these to be of a minor nature relative to the age of the dwelling and or lack of proper and continual maintenance. Others, including other inspectors may differ in their opinions.

Decking board surfaces are weathered. We recommend cleaning and maintenance as needed.

Balustrade rail height- should be 1 m in height from deck/balcony/patio floor. In some circumstances this regulation was non-existent dependent on the age of the dwelling and technically there is no requirement to rectify. Recommendations: We strongly advise you rectify to comply for safety concerns.

Upon visual inspection, loose wires were observed on the balustrade, posing a safety hazard. Immediate action is required to secure the wires to prevent potential injury. It is recommended that a licensed electrician or contractor be engaged to properly fasten and conceal the wires, ensuring compliance with safety standards and maintaining the structural integrity of the balustrade.

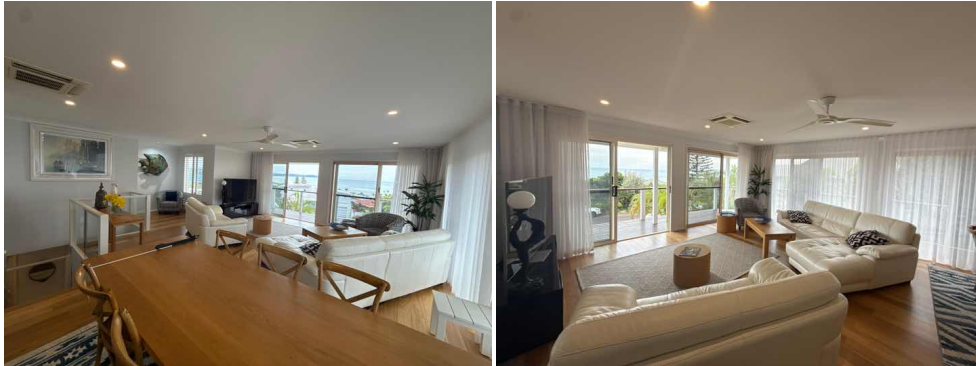
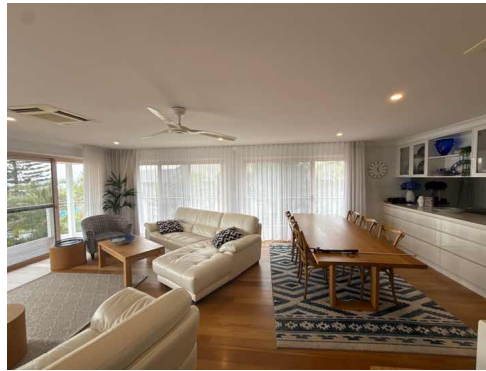
Ceiling stains - Moisture readings obtained. In the absence of rain It's difficult to ascertain with certainty the location of the leak. A qualified roofer/roofing plumber should be engaged for advice and recommendations. All water damaged plaster should be replaced.

Ceiling stains - No moisture readings obtained. These may have been repaired however you will need to monitor after a prolonged period of rainfall. If leaking persists, a qualified plumber should be engaged for advice and recommendations. All water damaged plaster should be replaced.

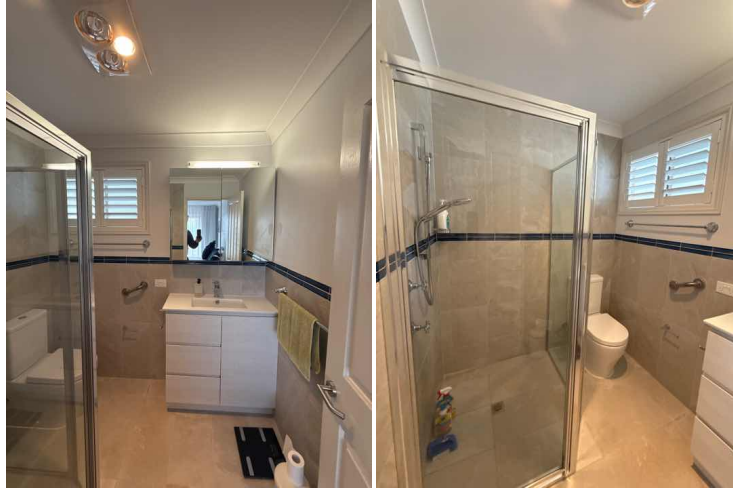
Door stop should be fitted - Wall damage from door handle impacting wall lining has occurred.
Recommendations: A qualified carpenter should be engaged for advice and recommendations.

Cornice separation. I recommend you contact a licensed plasterer for repairs.

Settlement Cracks Noted . These are typical and generally patch and paint will suffice, however Monitoring these cracks advised for 12 months and if become wider or longer, you will need to contact a structural engineers to assess.

The shower screen door requires adjustment, maintenance or repair to operate properly.

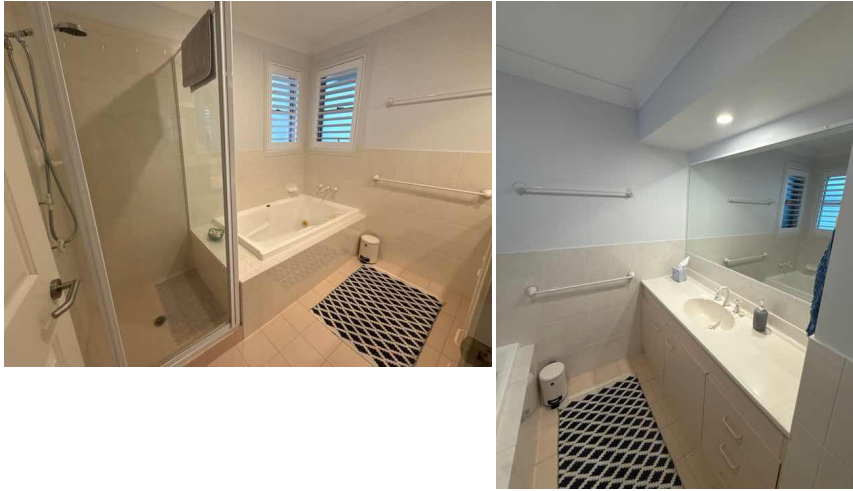
Cornice separation. I recommend you contact a licensed plasterer for repairs.

The shower screen door requires adjustment, maintenance or repair to operate properly.

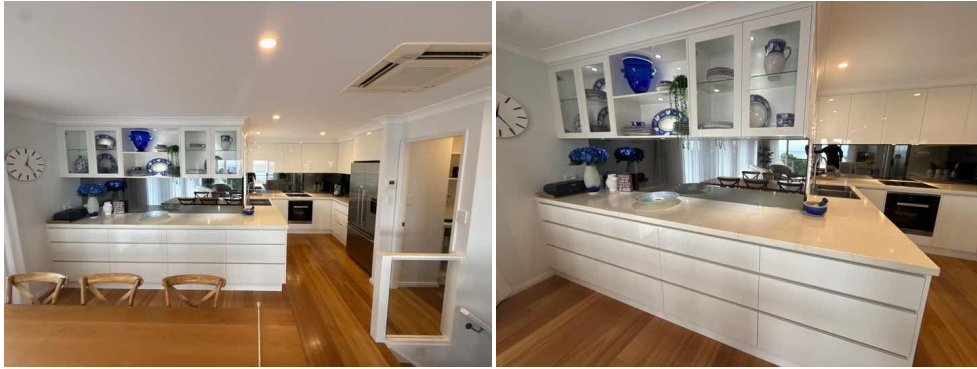
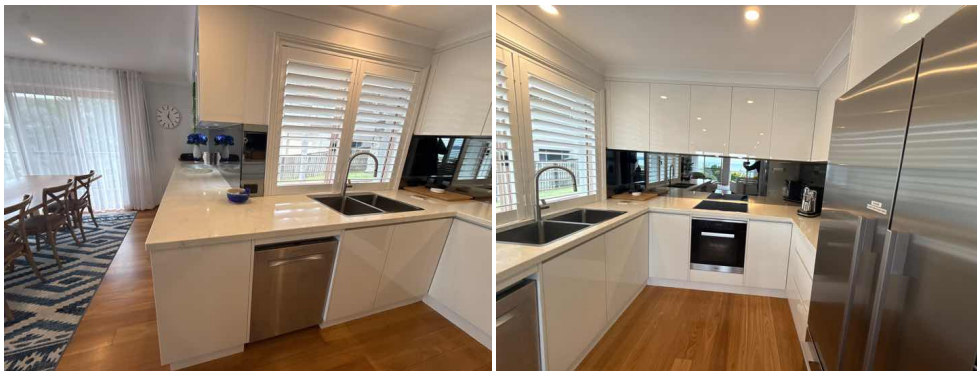
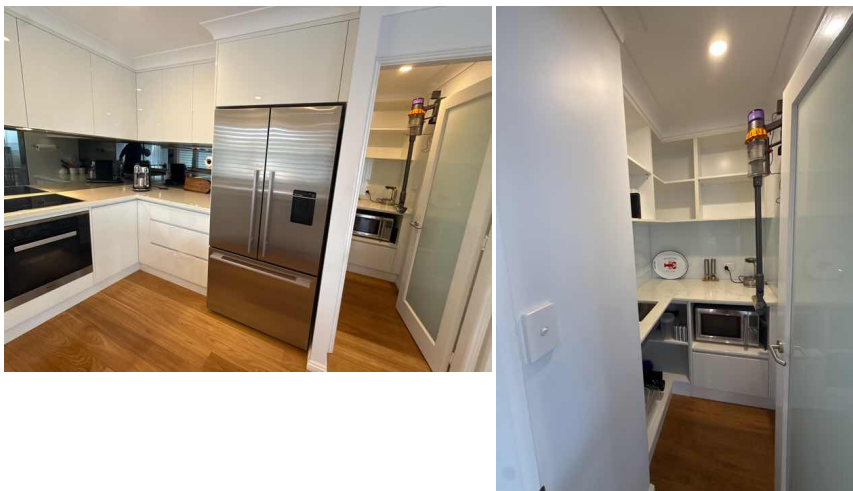
Cornice separation. I recommend you contact a licensed painter for repairs.

Ceiling stains - No moisture readings obtained from same. Recommendations: These may have been repaired, however, you will need to monitor after a prolonged period of rainfall - If leaking persists, a qualified plumber should be engaged for advice and recommendations. Essentially, it is preferable to have all water damaged plaster replaced by a qualified plasterer due to potential detachment or collapse.

Adjustment to cabinet doors required, in some instance hinges may need to be replaced.
