Building and Pest Report

3 Waterford Pde Skennars Head

Report/Agreement #	121125085905131
Inspection Date:	12 Nov 2025
Inspection Time:	08:59 am

Pest And Building Inspection

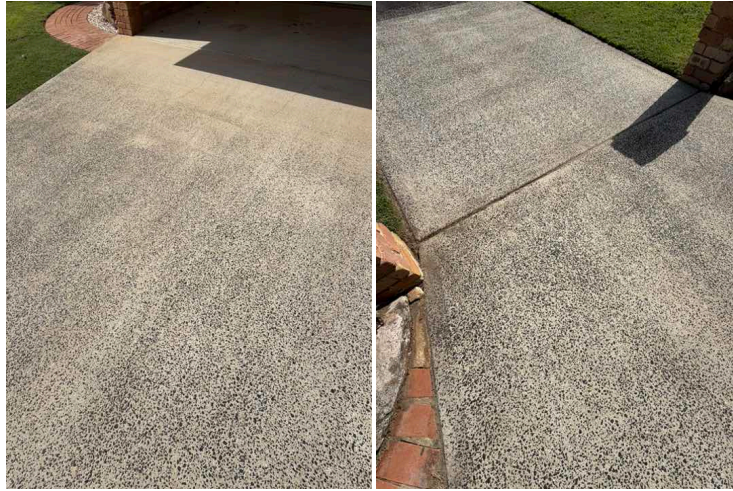
Common cracks were observed on the driveway. Whilst these cracks appeared to be typical at the time of inspection, we strongly recommend you monitor these cracks and if worsening occurs contact a concreter for further advice.

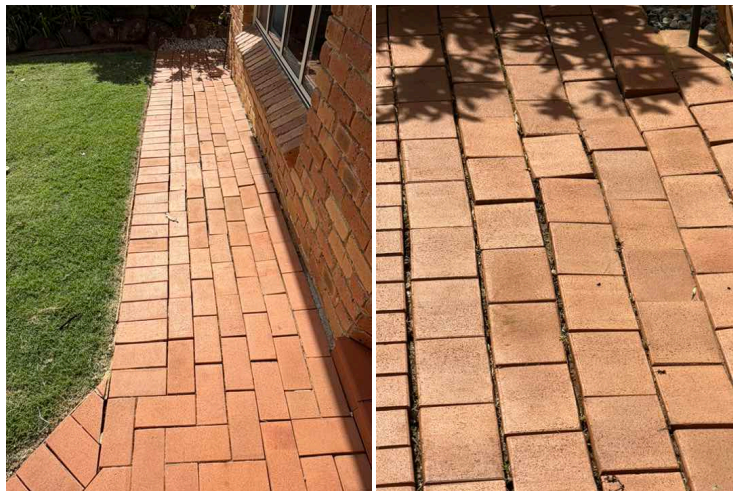
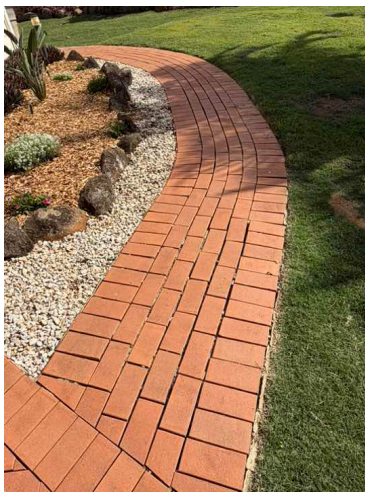
Surface raised and settled in some areas. This can cause water ponding. Relaying recommended.

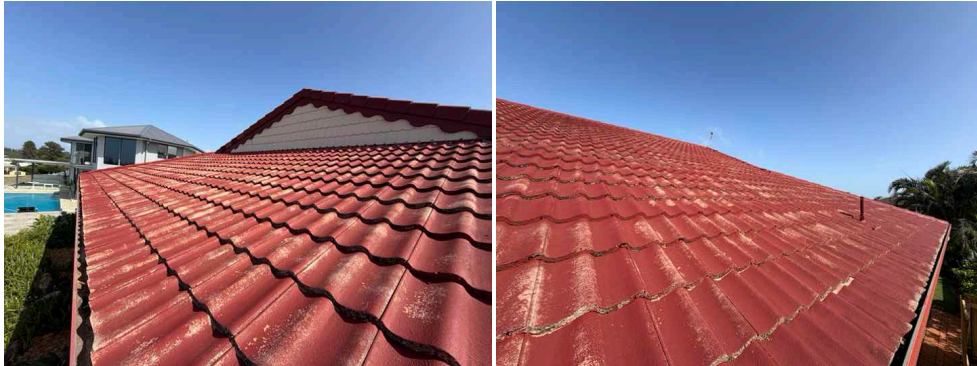
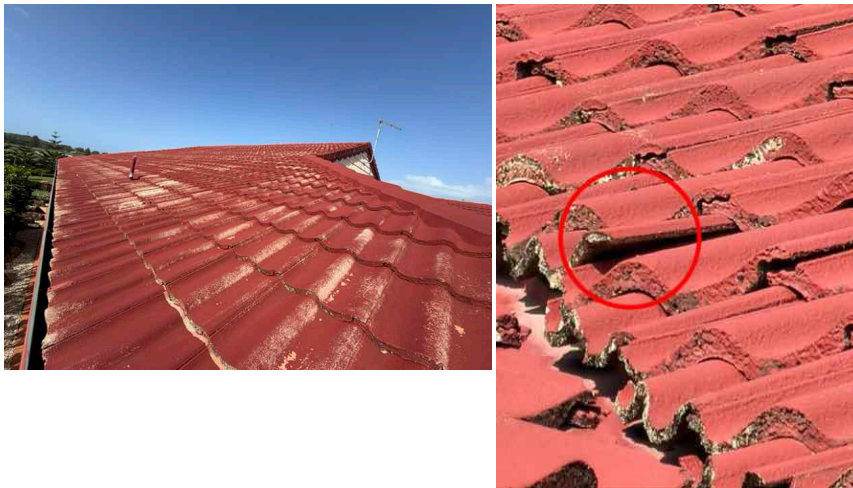
Deterioration & ageing evident. I recommend you contact a roof restorer to clean, seal, and repoint the mortar.

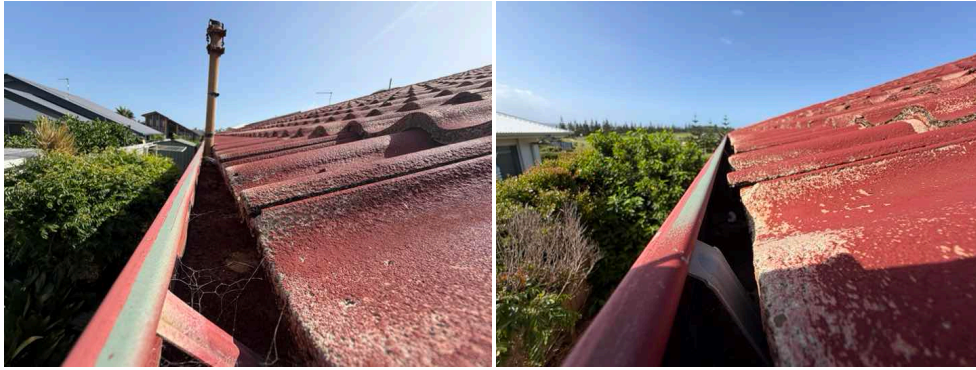
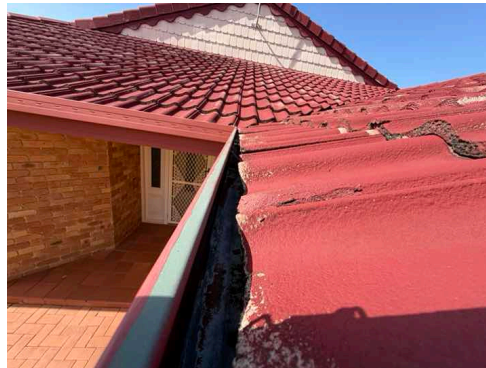
Gutter surface rust in sections- the rust is yet to penetrate and repairs/sealing may be an option. A qualified roof plumber should be engaged for advice and recommendations.

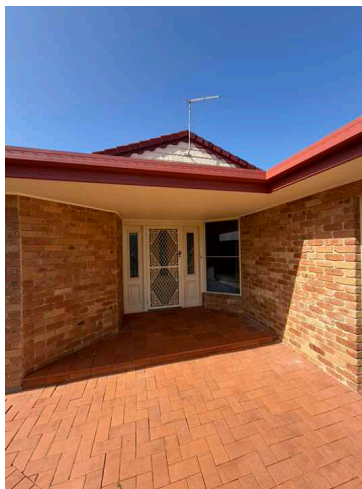
Upon visual inspection, the screen door was found to have loose screws, compromising its stability and function. It is recommended to tighten or replace the screws to ensure the door operates smoothly and securely. If the frame is damaged, consider reinforcing it or replacing the affected sections. Engage a licensed tradesperson to assess and perform necessary repairs to restore the door's integrity.

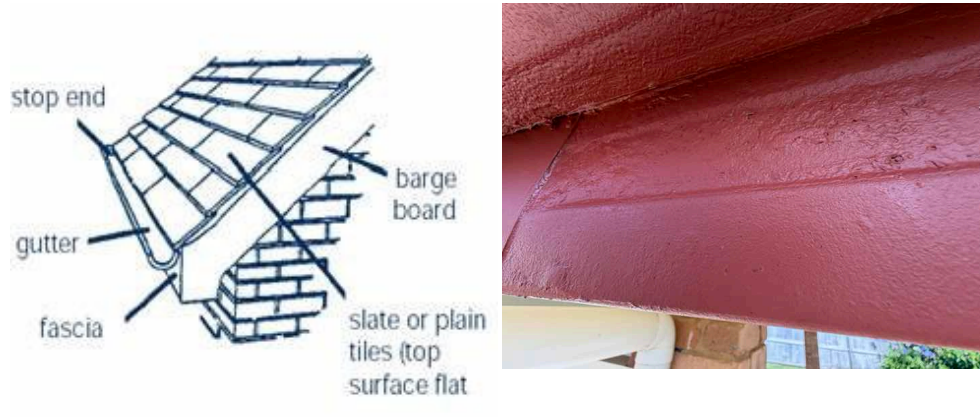
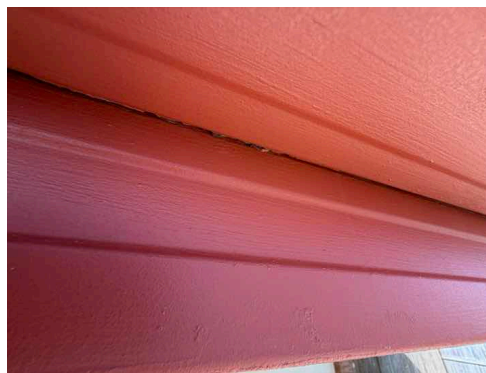
Minor deterioration & ageing evident. Recommendations: Maintenance works, general upkeep should be carried out.

Upon visual inspection, surface rust was observed on metal components. This corrosion may lead to structural weakening if not addressed. It is recommended to clean the affected areas using a wire brush, apply a rust converter, and repaint with a rust-inhibitive primer and topcoat. A suitably licensed or qualified tradesperson should perform these repairs to ensure proper treatment and prevent further deterioration.

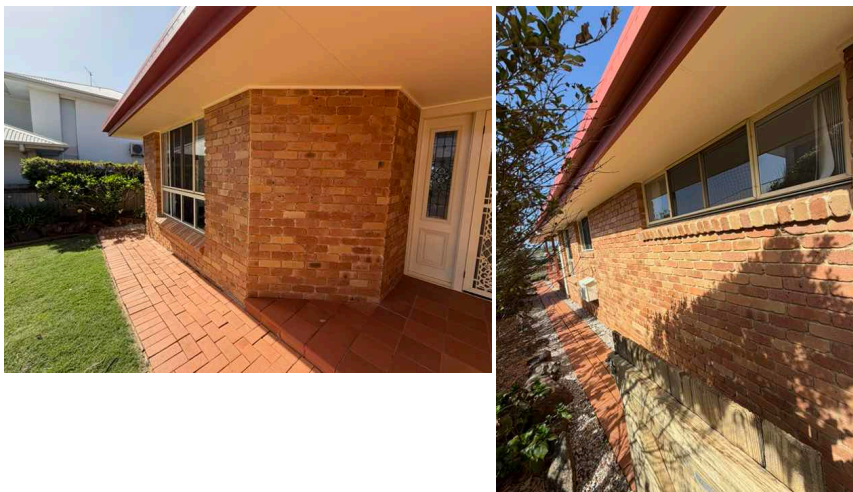
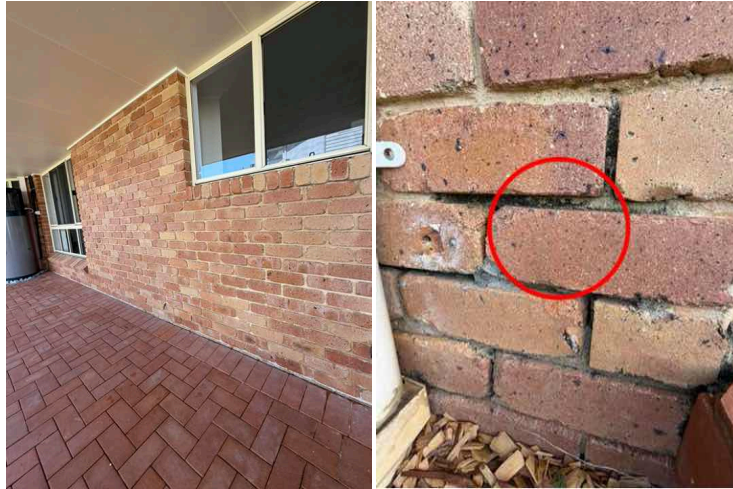
There appears to have been some settlement in the building which has caused some cracking to the walls. These cracks are categorized as 0 to 2. This can also cause some doors to bind or be out of square. In the inspectors opinion these cracks are due to settlement, usually due to ground movement and subsequent movement to building materials can be expected. Any cracks should be monitored and if cracks increase in size, further investigation should be carried out by a structural engineer.

Mortar erosion between the brickwork is eroded. Contact a qualified bricklayer for repairs.

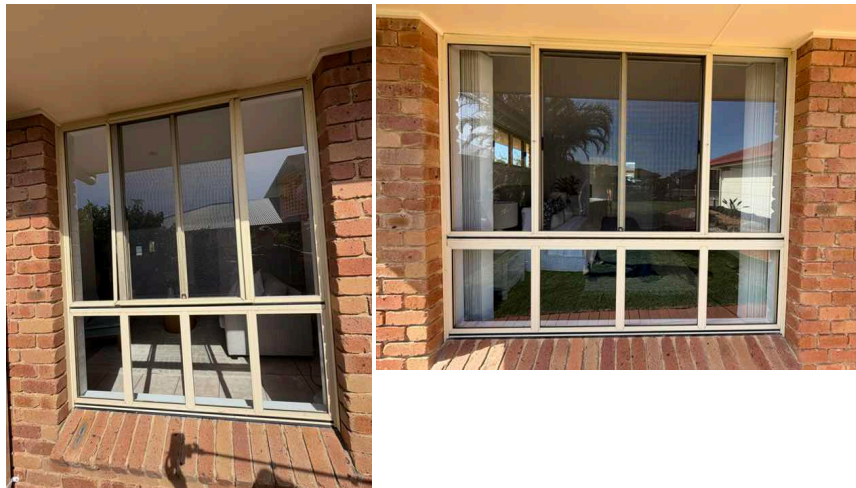
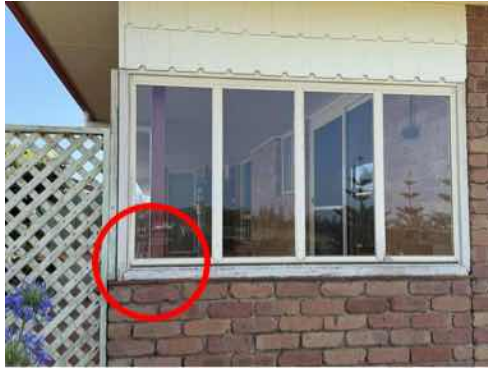
General age/damage has occurred to window components. Recommendations: Restoration work recommended. A qualified carpenter should be engaged for advice and recommendations.

Sections of the external windows have paint deterioration. Engage a qualified painter for repairs.

Minor Timber fungal decay is evident in sections of the window framework - Some areas should be replaced. A qualified carpenter should be engaged for advice and recommendations.

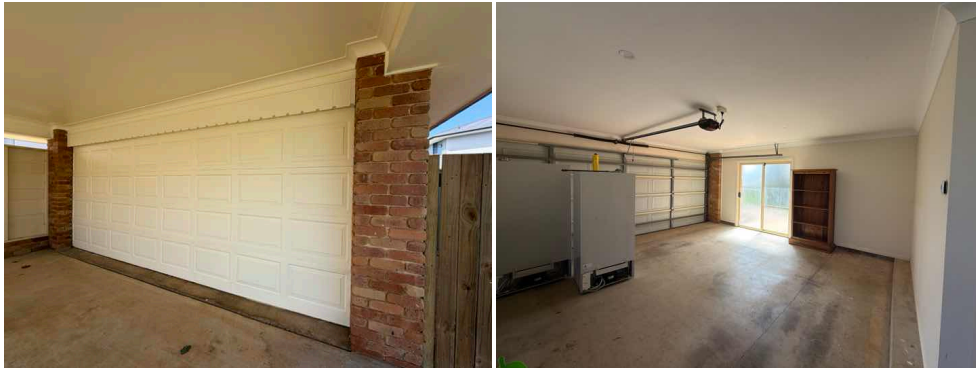
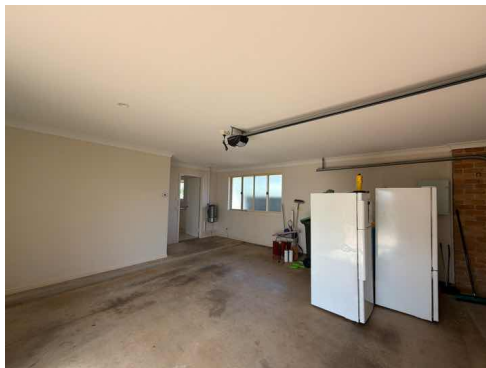
Minor hairline slab cracks - Note. Whilst these cracks appeared to be minor at the time of inspection, we strongly recommend you monitor these cracks and if worsening occurs contact a qualified concreter for further advice.

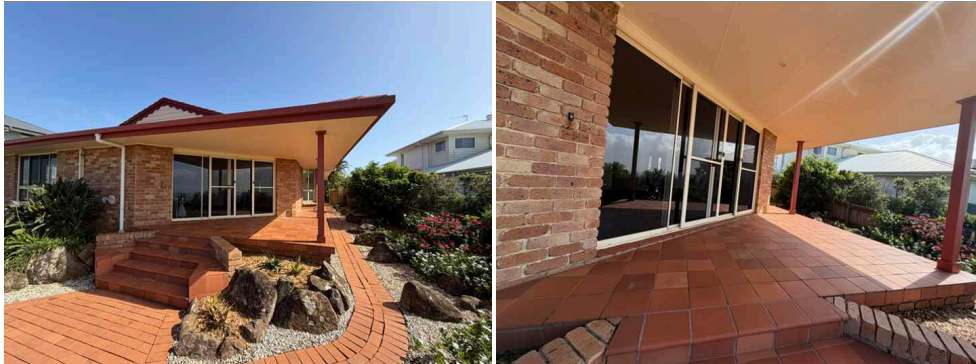
Tiles are drummy and loose. This needs to be fixed by a qualified tiler to eliminate any water penetration issues.

Tile grout deterioration. A qualified tiler should be engaged for advice and recommendations. Grout deterioration may cause leaking and water penetration.

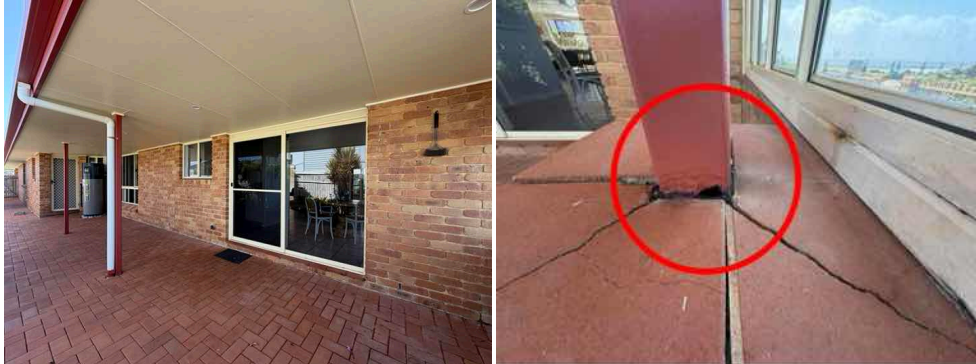
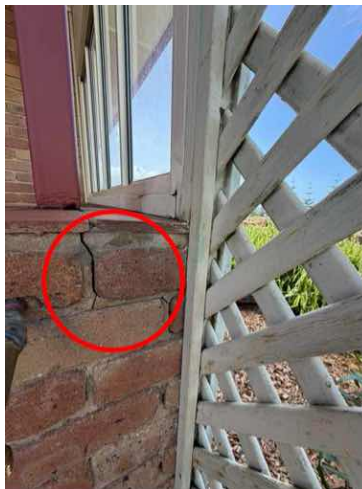
Upon visual inspection, a crack was observed in the brick pier, indicating potential structural issues. It is recommended to engage a licensed mason or structural engineer to assess the severity of the damage. Repairs may involve repointing the mortar joints, reinforcing the pier, or replacing damaged bricks to ensure stability and prevent further deterioration. Regular monitoring is advised to ensure long-term integrity.

Upon visual inspection, rust was observed on the steel post, indicating potential structural compromise. Immediate action is recommended to prevent further deterioration. A licensed tradesperson should remove rust using appropriate tools, apply a rust-inhibiting primer, and repaint the post with weather-resistant paint. Regular maintenance checks should be scheduled to ensure ongoing integrity and safety of the structure.

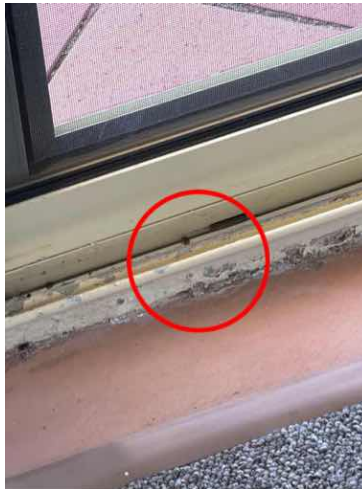
Rear door / frame deterioration - General age/damage has occurred to door frame, face or components.

Recommendations: A qualified carpenter should be engaged for advice and recommendations.

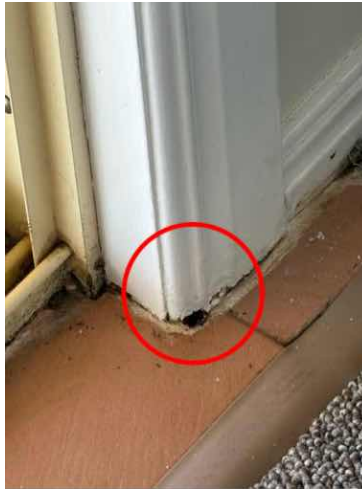
Upon visual inspection, wood rot was identified on the skirting. This decay compromises structural integrity and may lead to further deterioration if not addressed. It is recommended to remove and replace the affected skirting sections with treated timber. Ensure proper sealing and ventilation to prevent future moisture buildup. Regular maintenance checks are advised to monitor and mitigate potential recurrence.

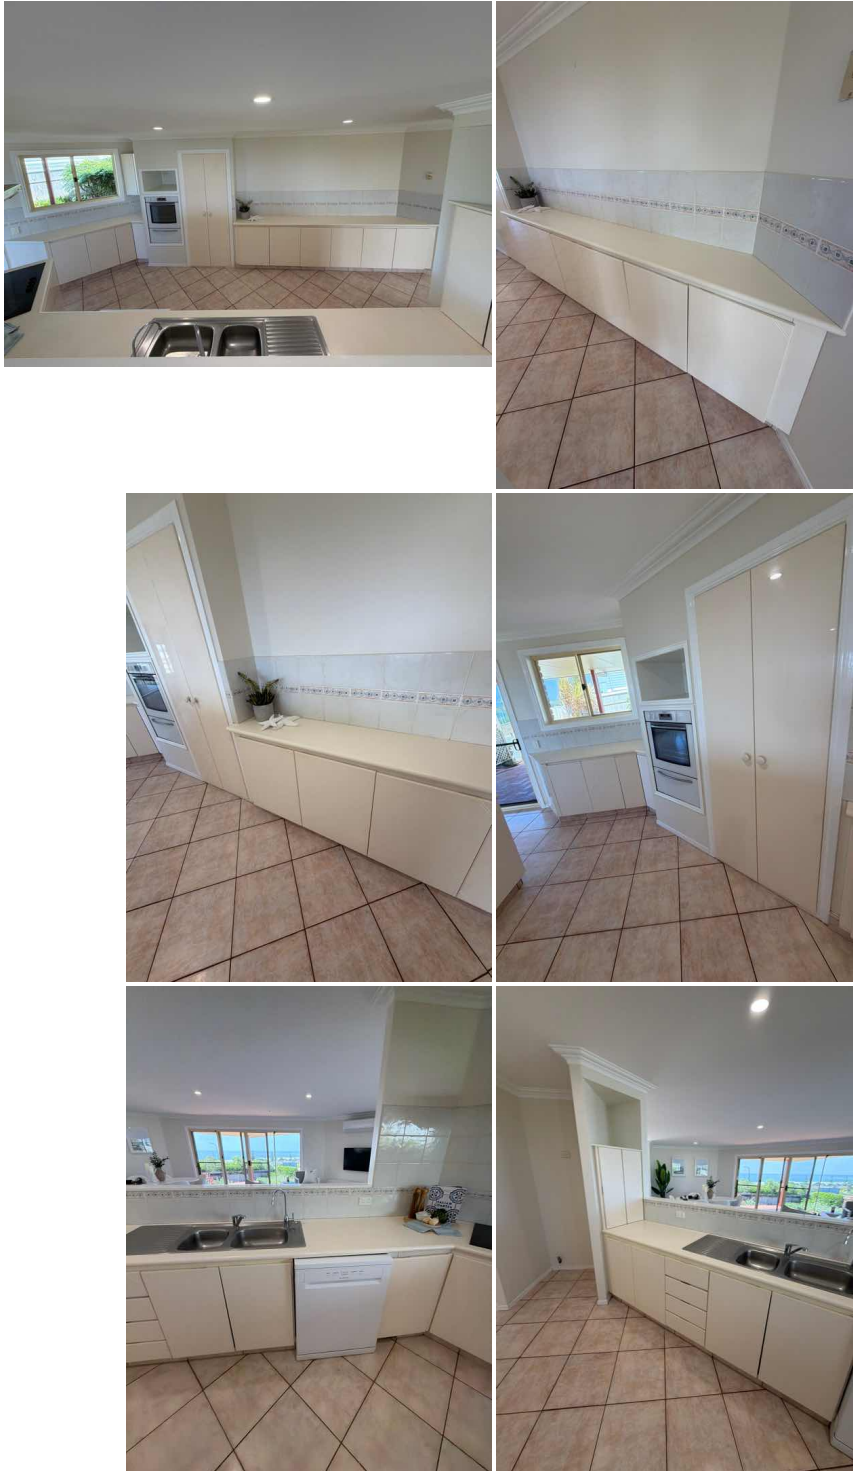
Minor cracks floor tiles. A qualified tiler should be engaged for repairs.

Drummy tiles noted. This needs to be repaired at the earliest as this has the potential to lead to many related issues such as damp, water ingress to other areas and cracked tiles. Contact a qualified tiler for repairs and recommendation.

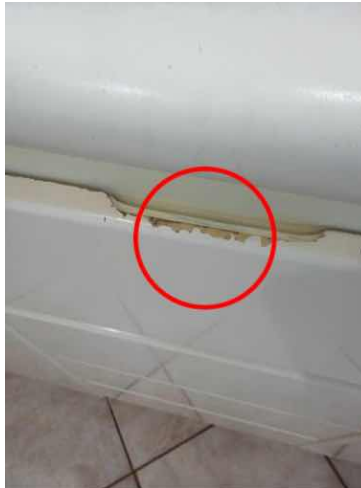
Adjustment to cabinet doors required, in some instance hinges may need to be replaced.

Damage was noted to the cabinets, contact a joinery company for repairs

Apply flexible sealant to cabinet/wall junction for a clean finish.

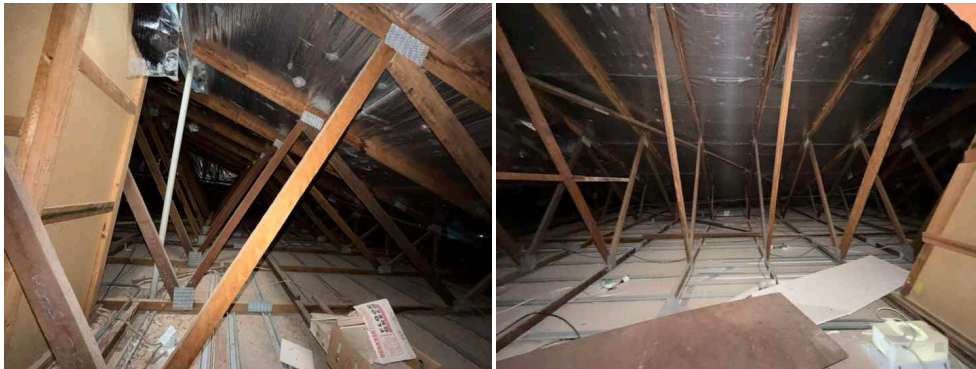
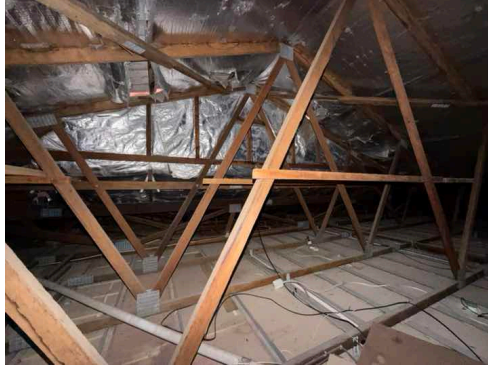
No insulation installed. Recommendations: Engage insulation contractor to assess.

Sarking deteriorated/ damaged / aged in some sections. A qualified roofing contractor should be engaged for advice and recommendations.
