# Building and Pest Report

## 1/17 Stewart Street Lennox Head

Report/Agreement #	080725101832555
Inspection Date:	08 Jul 2025
Inspection Time:	10:18 am

### Pest And Building Inspection

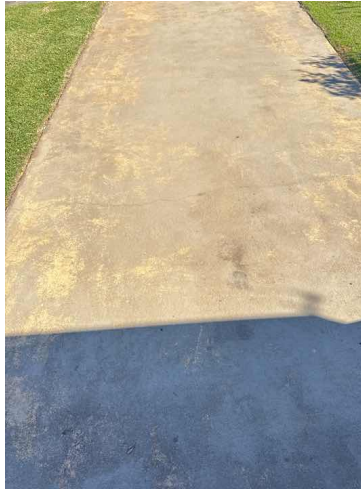
On visual inspection, the general condition of the driveway is serviceable.

Common cracks were observed on the driveway. Whilst these cracks appeared to be typical at the time of inspection, we strongly recommend you monitor these cracks and if worsening occurs contact a concreter for further advice.

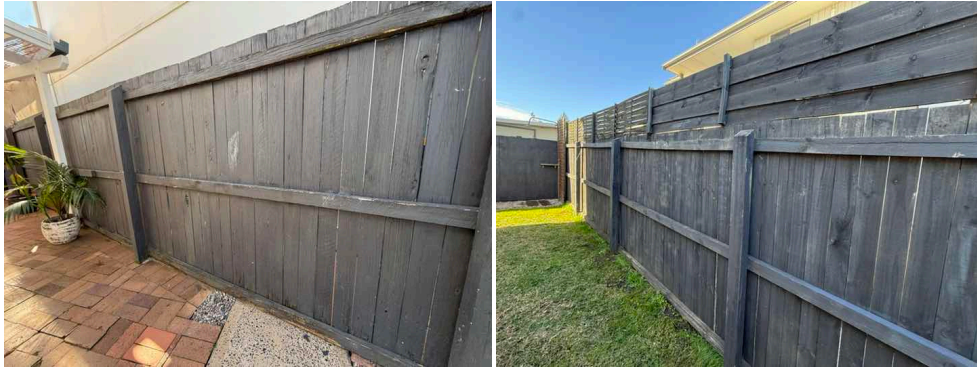
Of the visible areas, the general condition of the fences and gates is serviceable for the age of dwelling.

General age to fence components. General upkeep and maintenance required. A qualified fencing contractor should be engaged for repairs.

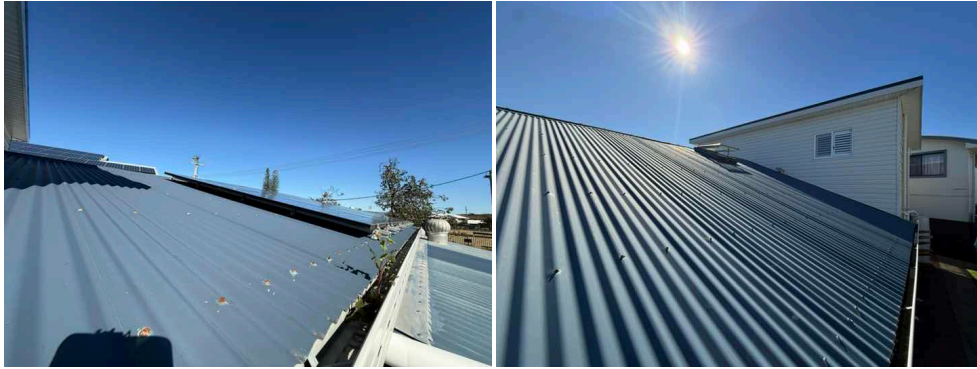
Of the visible areas, the general condition of the roof is in serviceable condition for the age.

Note: In the absence of rainfall there is no guarantee that the roof won't leak.

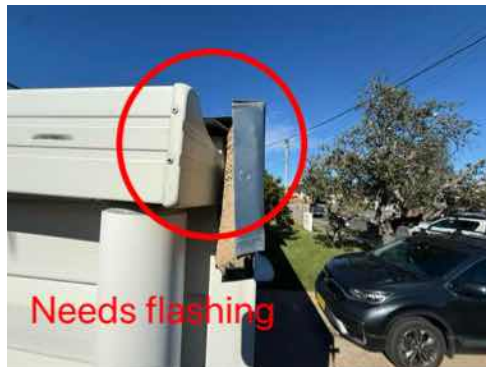
Visible section of The roof cladding appeared in a serviceable condition for the age of this dwelling. Annual maintenance inspection recommended.

Corrosion noted to the screw fixings of the metal roof. Have these checked and replaced by qualified roofing contractor.

The flashing appears to be serviceable.

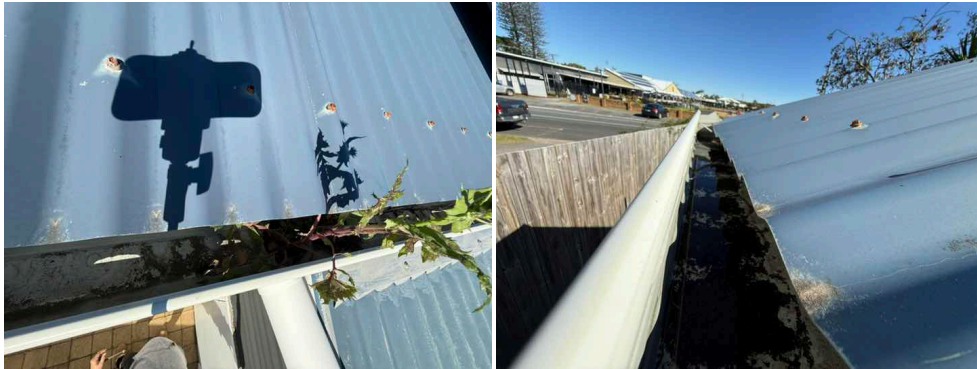
All visible and accessible of the physical nature of the guttering system appears to be in a serviceable condition with no apparent defects at the time of inspection. In the absence of prolonged rain fall efficiency of the guttering can not be assessed and you may find that further investigation or repairs maybe required. Note: Periodic maintenance checks should be carried out for rust penetrations and leaks.

Debris in guttering areas- this requires cleaning out to prevent blocking of downpipes and leaking into eaves and fascia. Have gutters cleaned and assessed by a plumber for adequate fall. Regularly clean to prevent ponding. Ponding water will contribute to rust.

Gutter ponding - This can relate to poor fall, inadequate down pipes, gutter or debris build up. If debris presence has been noted above clean same out and re-assess for any ponding. If clean guttering is ponding it can be a blocked down pipe or the guttering fall is inadequate. A qualified roof plumber should be engaged for advice and recommendations.

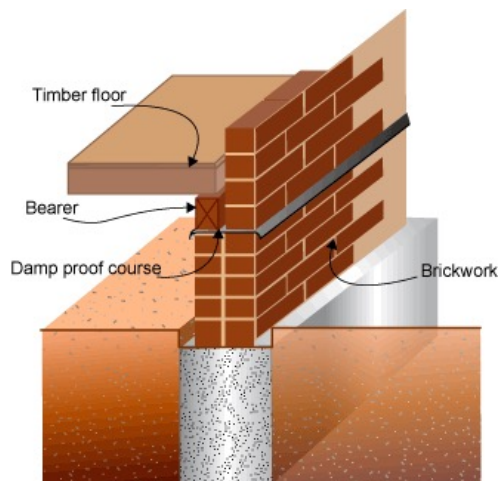
A damp proof course is not visible or could not be visually identified. This may cause rising damp issues. Contact a specialist in this field to further investigate and make recommendation.

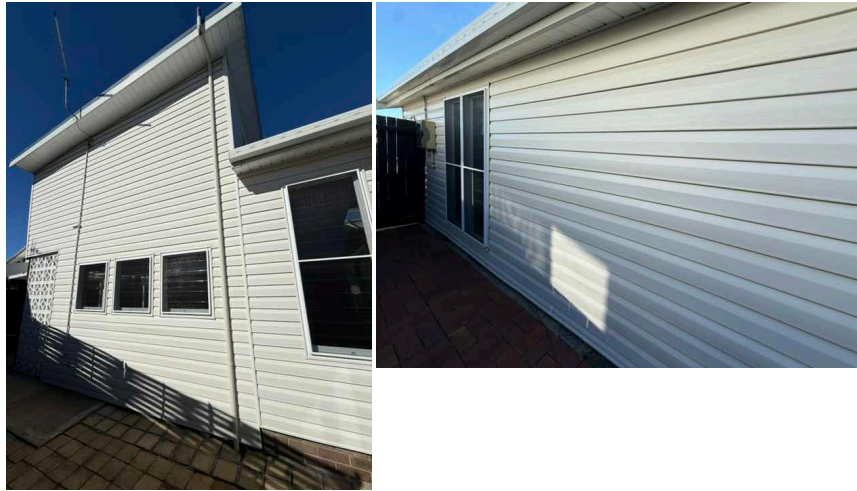
On visual inspection, the general condition of the exterior walls is serviceable for the age.

External cladding is in contact with the ground. This is a conducive condition for moisture penetration causing decay and/or concealed termite entry. Contact a licensed builder for recommendations.

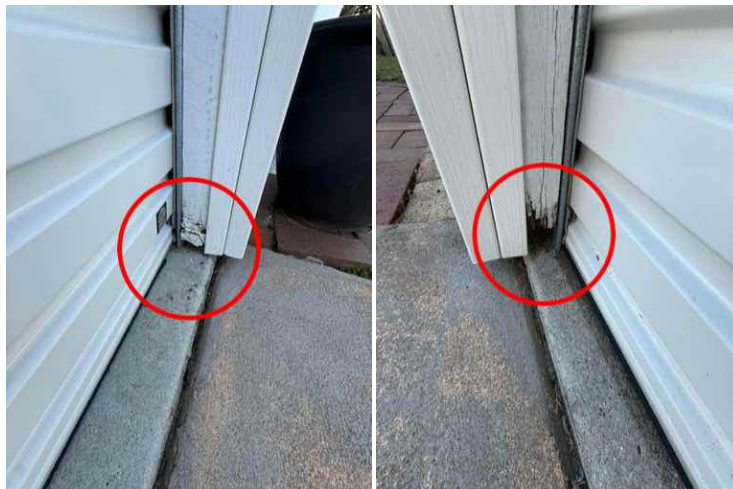
Damp damage to door/frame - It appear water has damaged areas of the door. I am not able to ascertain if this is still occurring and this can only be ascertained during heavy rainfall periods. Contact a qualified carpenter for repairs.

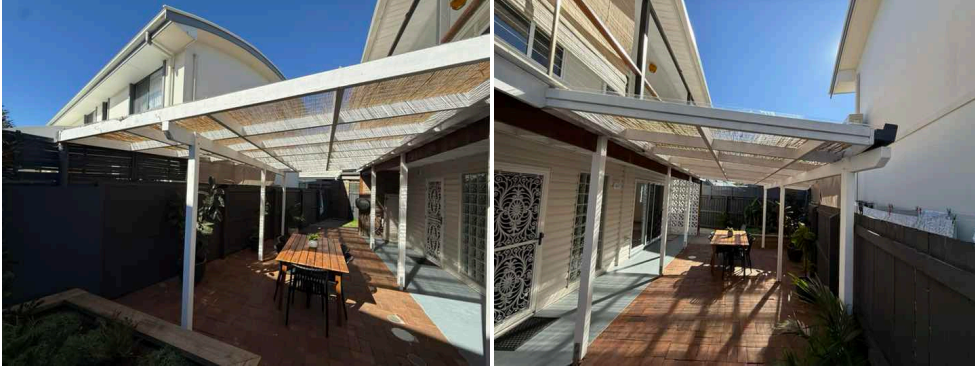
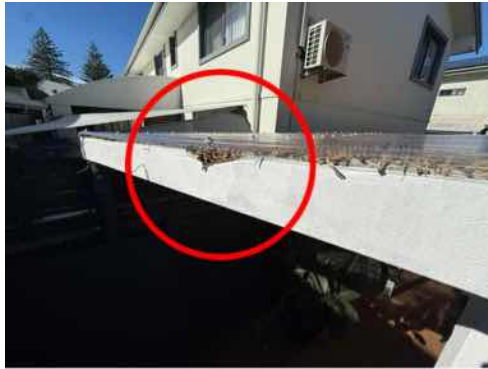
Timber fungal decay in the framework is visible. A qualified carpenter should be engaged for advice and recommendations.

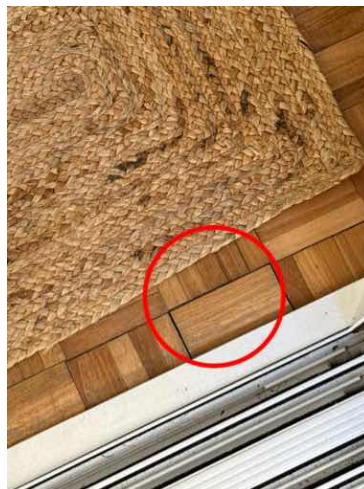
Upon visual inspection, the timber flooring was found to be loose, posing potential safety hazards. It is recommended to engage a licensed tradesperson to assess and secure the flooring. Repairs may involve re-nailing or replacing affected boards to ensure stability. Regular maintenance checks should be scheduled to prevent future issues and maintain the integrity of the flooring.

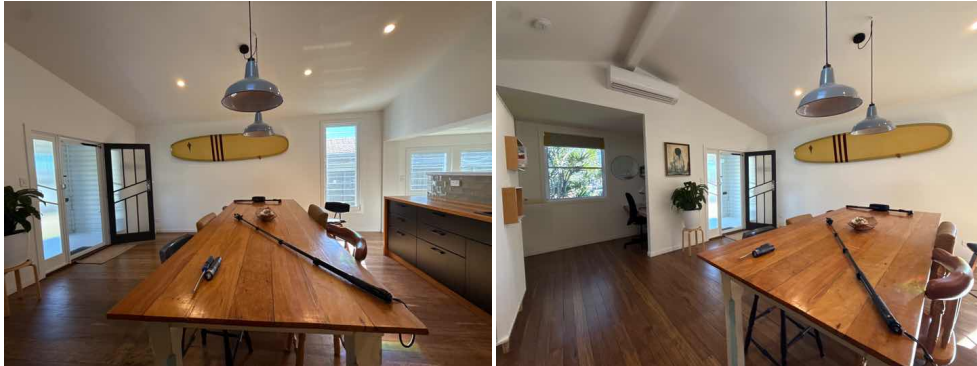
Settlement Cracks Noted. These are typical and generally patch and paint will suffice, however we recommend you monitor these cracks and if they become wider or longer, you will need to contact a structural engineers to assess.

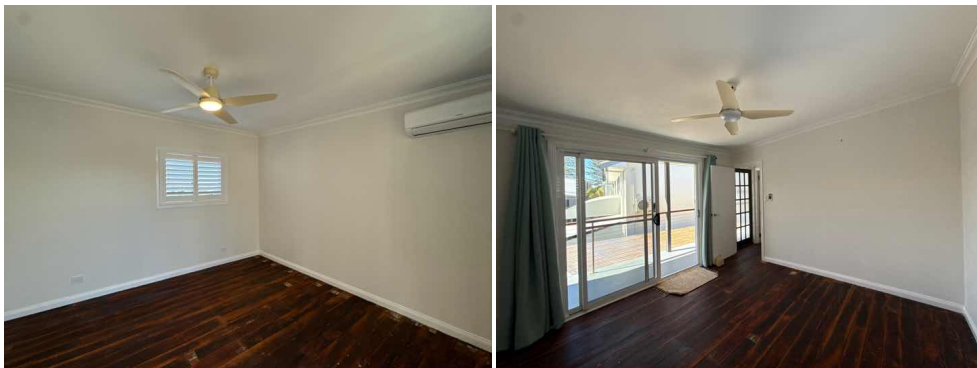
Upon visual inspection, the external sliding door lock is malfunctioning due to misalignment and wear. The locking mechanism is stiff and does not engage smoothly. Recommend hiring a licensed locksmith to realign the door, lubricate the lock, and replace any worn components to ensure proper function and security. Regular maintenance checks are advised to prevent future issues.

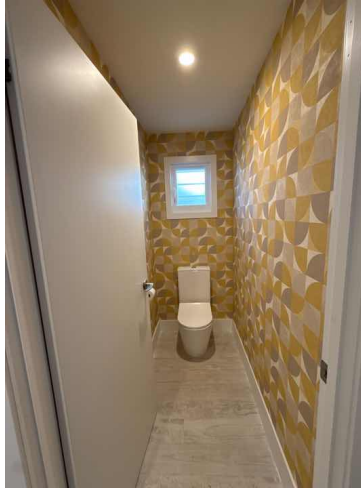
No exhaust fan is installed - Recommend having one installed.

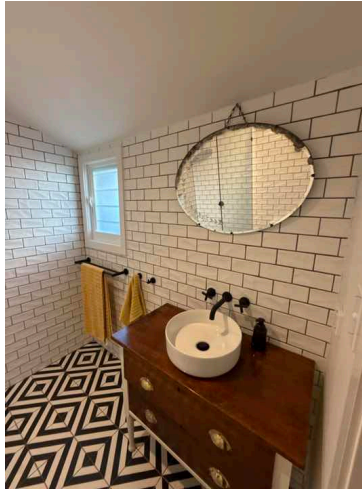
Settlement Cracks Noted . These are typical and generally patch and paint will suffice, however Monitoring these cracks advised for 12 months and if become wider or longer, you will need to contact a structural engineers to assess.

Silicone sealant has been applied to the interface of the floor and walls in the bathroom in an apparent attempt to prevent water penetration to surrounding areas. This method of repair can only be considered to be temporary. Further waterproofing may be necessary.

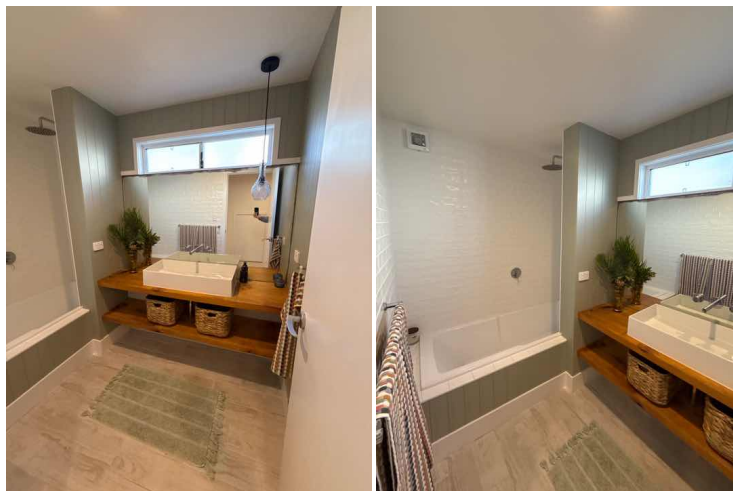
The vanity mirror is desilvering at edges. Replacement recommended.

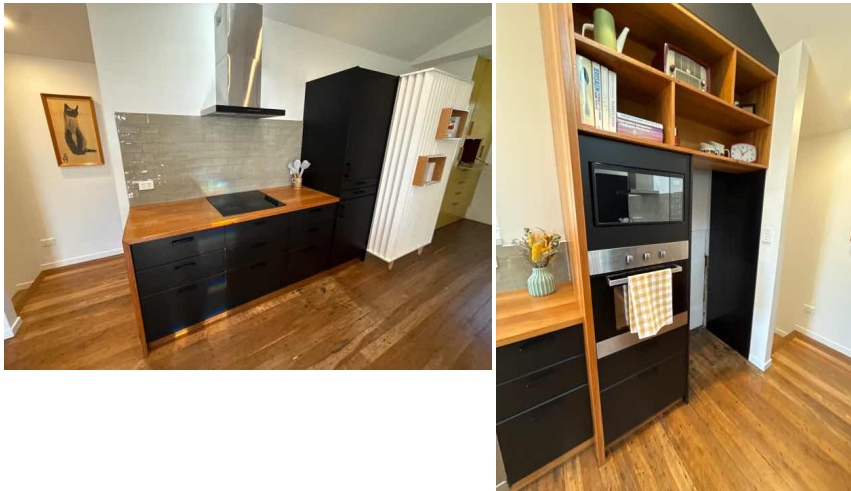
Minor cornice cracks - Minor cornice cracks visible. Recommendations: I recommend you contact a licensed plasterer for further advice and recommendations.

Ceiling stains - No moisture readings obtained from same. Recommendations: These may have been repaired, however, you will need to monitor after a prolonged period of rainfall - If leaking persists, a qualified plumber should be engaged for advice and recommendations. Essentially, it is preferable to have all water damaged plaster replaced by a qualified plasterer due to potential detachment or collapse.

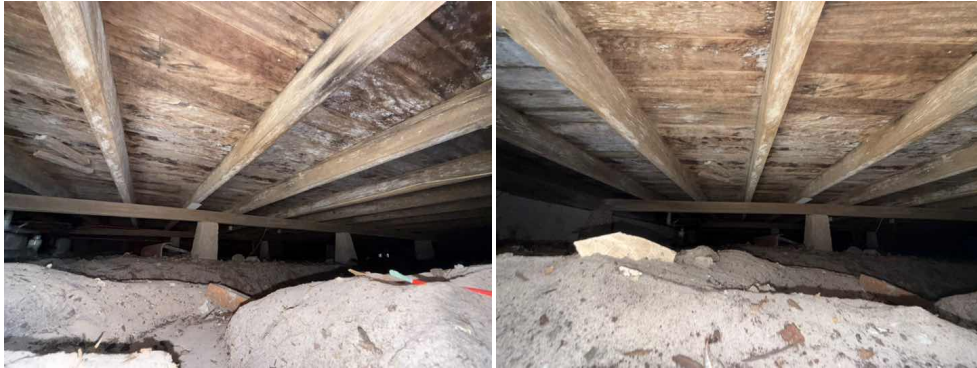
Subfloor ventilation appeared to be limited. This may be conducive to timber decay. Improvement to the ventilation is recommended. Contact a licensed builder for advise and rectification.
