Building and Pest Report

8 Morton Way Skennars Head

Report/Agreement #	140125125742127
Inspection Date:	14 Jan 2025
Inspection Time:	12:57 pm

Pest And Building Inspection

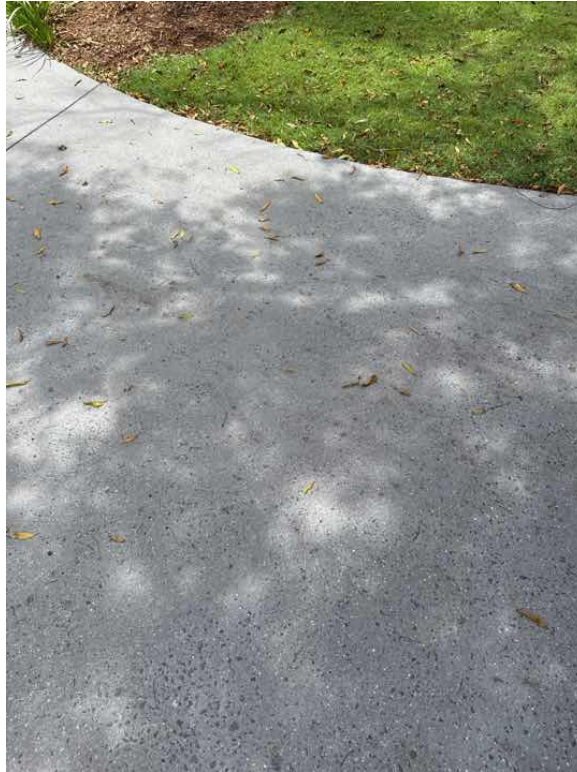
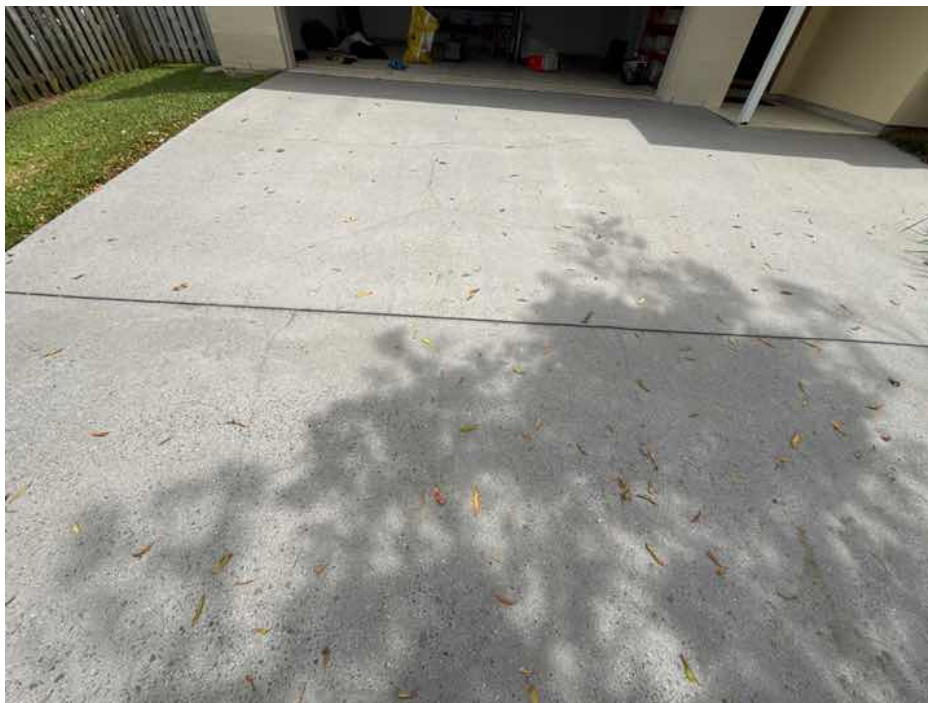
Common cracks were observed on the driveway. Whilst these cracks appeared to be typical at the time of inspection, we strongly recommend you monitor these cracks and if worsening occurs contact a concreter for further advice.

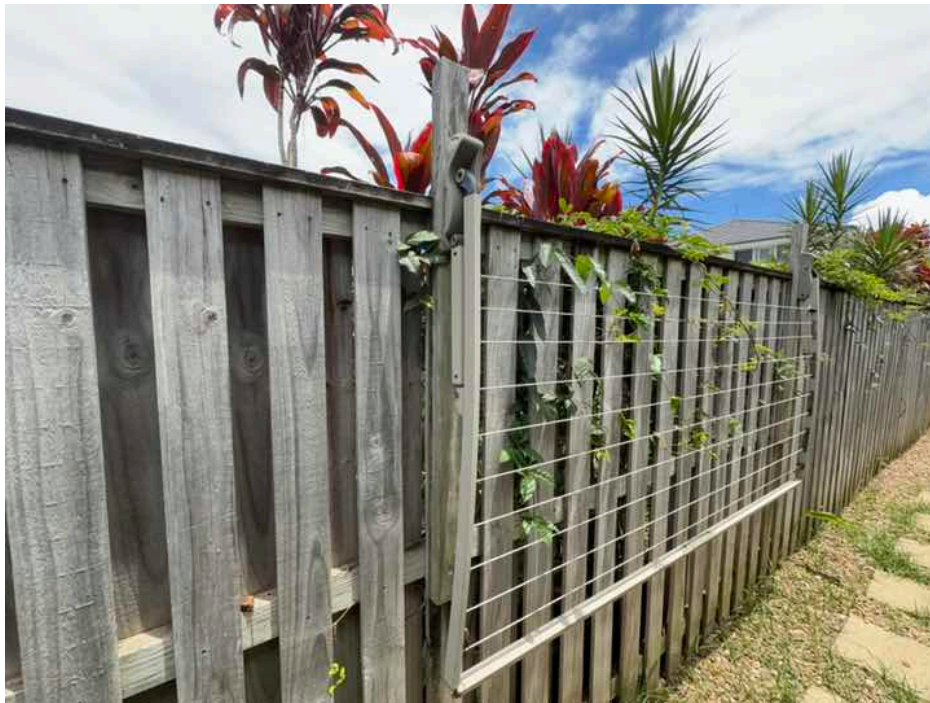
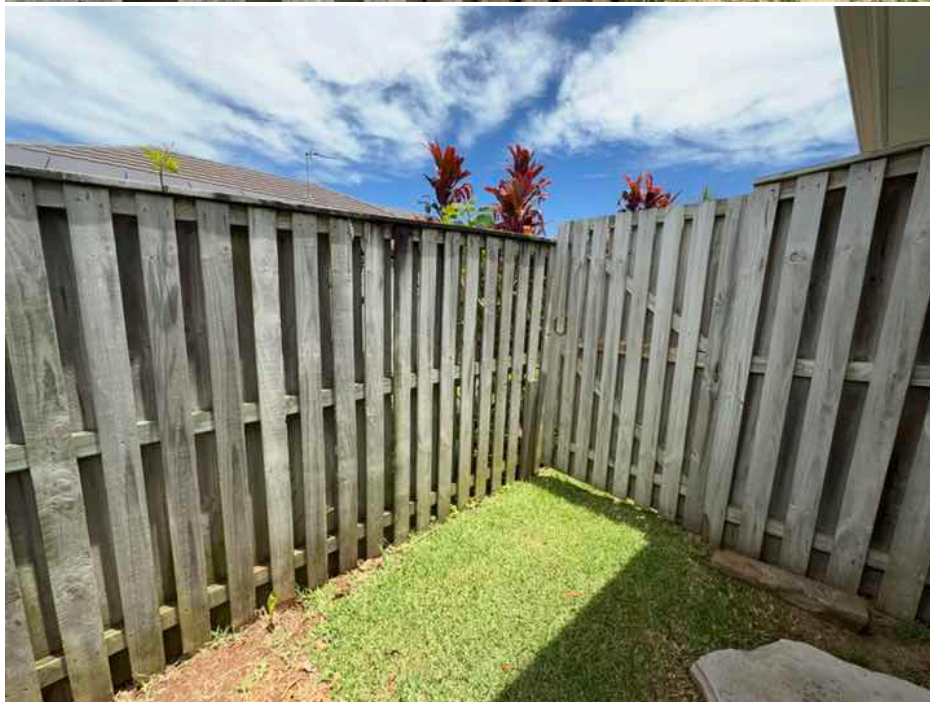
The gate does not latch. Have repaired by a qualified fencer.

Fence rot/leaning. Repairs are required by a fencing contractor to avoid unsafe conditions.

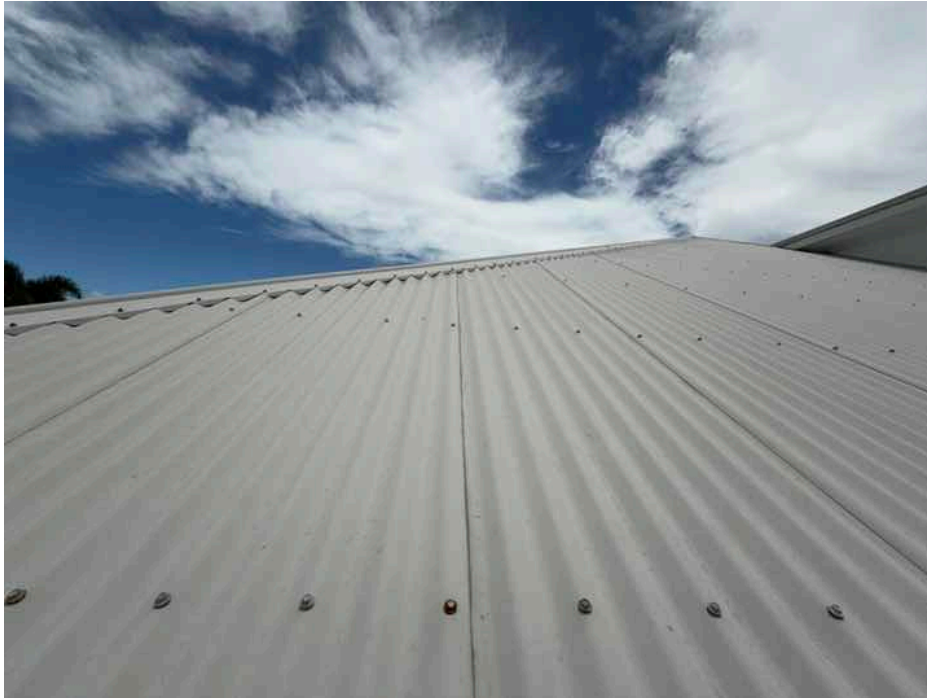
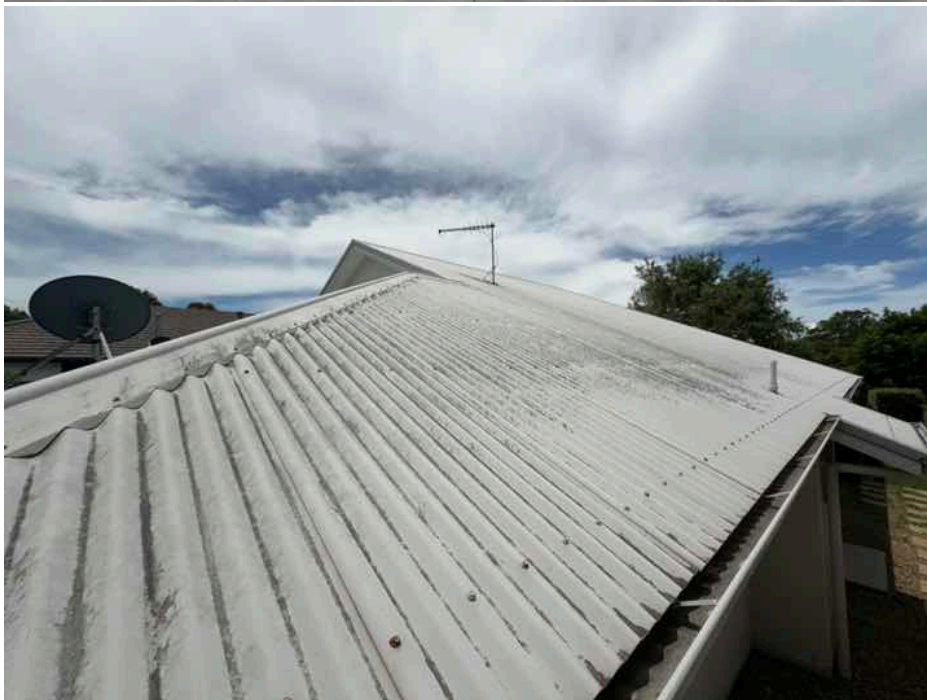
Corrosion noted to the screw fixings of the metal roof. Have these checked and replaced by qualified roofing contractor.

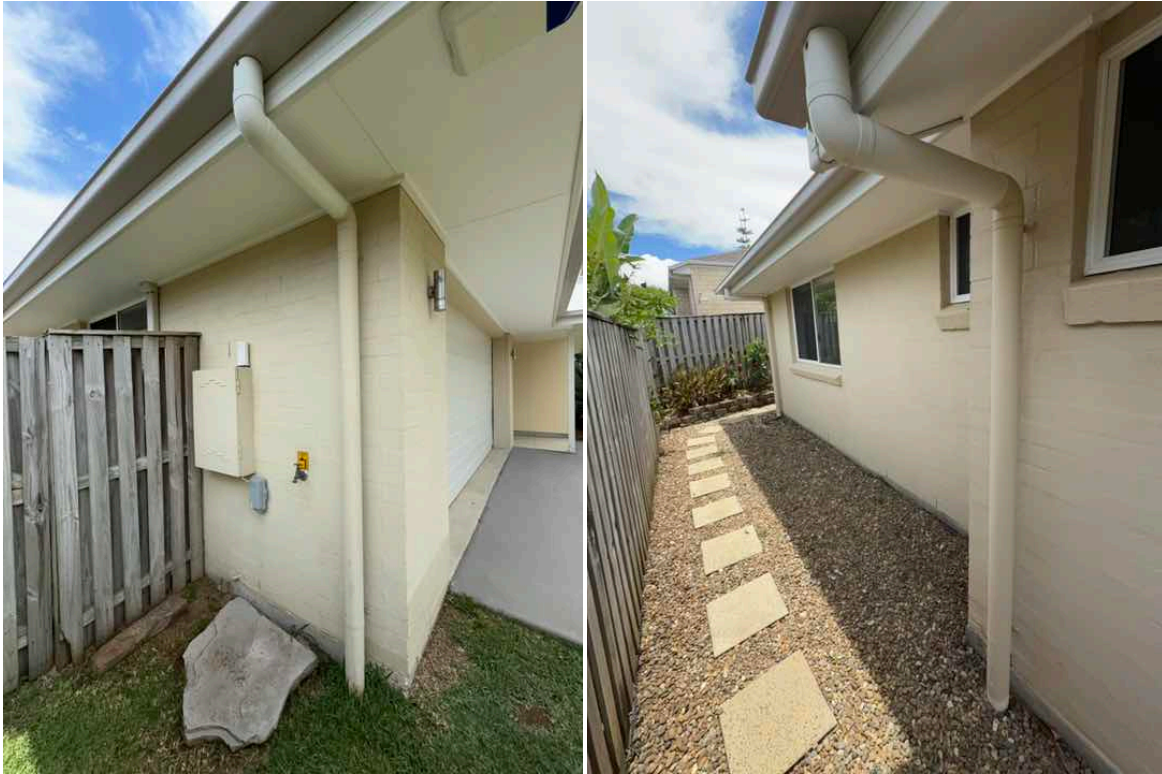
Rusty brackets

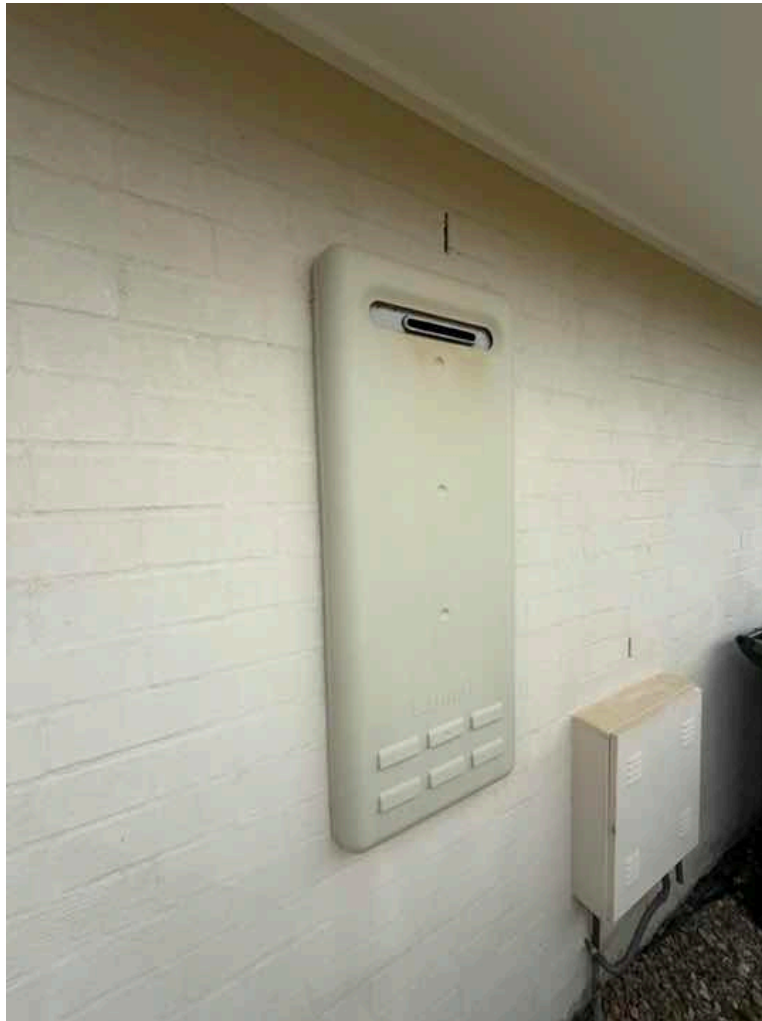
General rust deterioration was observed on the hot water unit casing. We recommend you replace the unit.

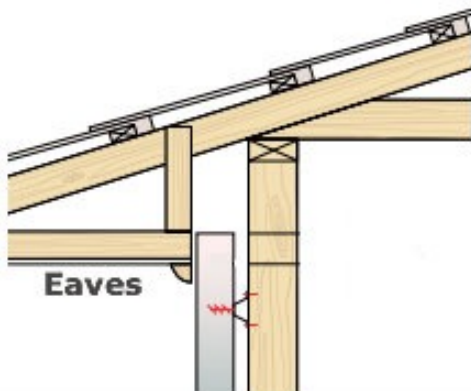
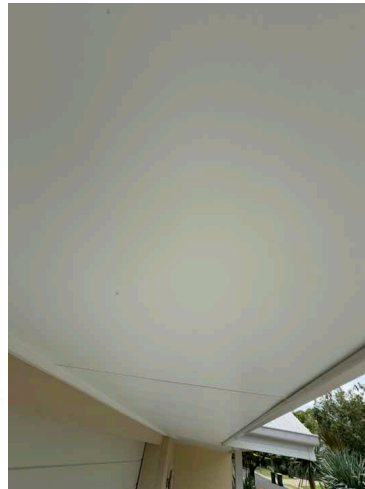
Loose quad timber

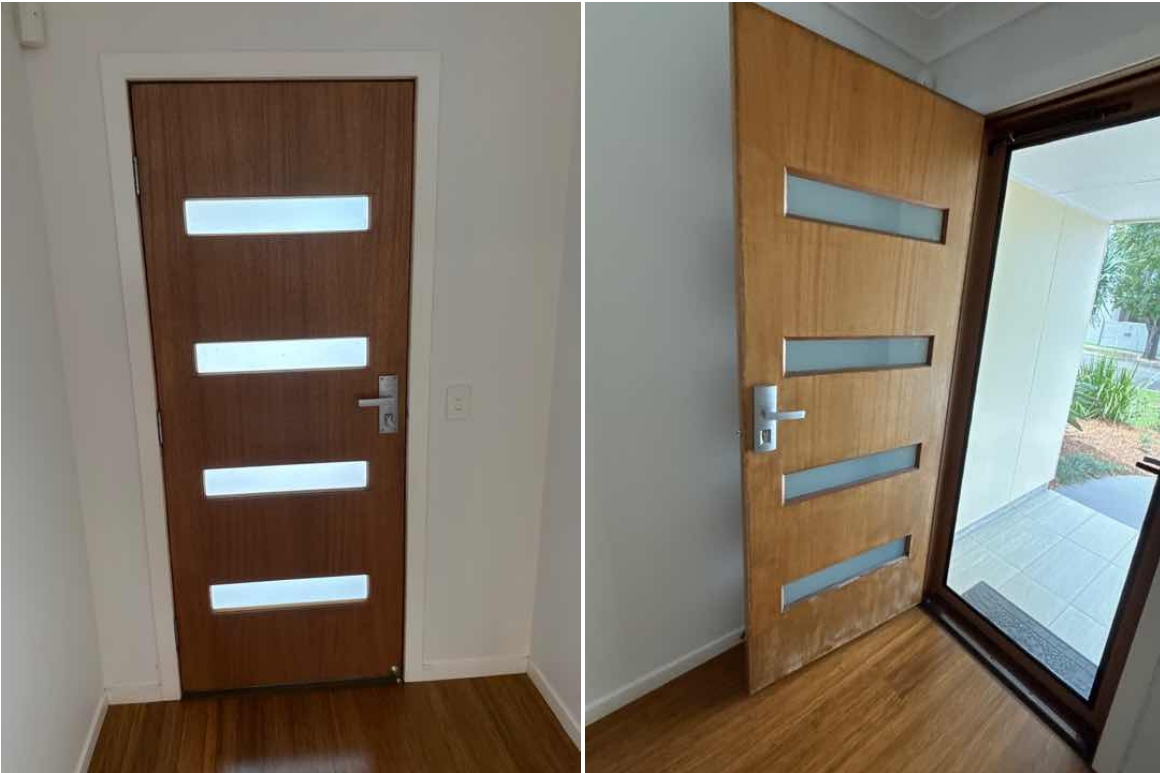
Weathered

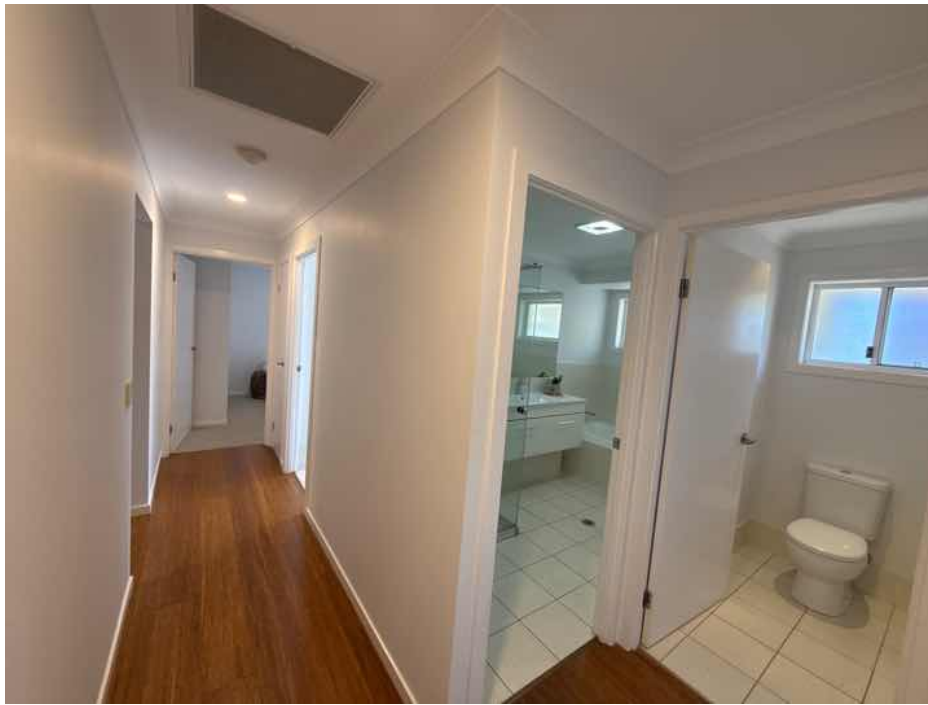
Impact damage noted. Contact a qualified painter for repairs.

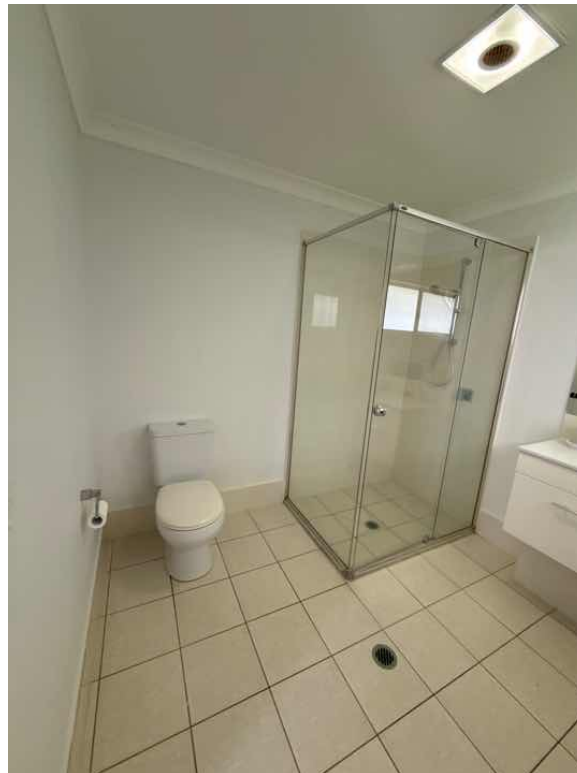
Cracked tile/s noted. This can cause extensive floor and floor frame damage and is conducive to termite infestation if water is leaking through the cavity. A qualified tiler should be engaged for advice and recommendations.

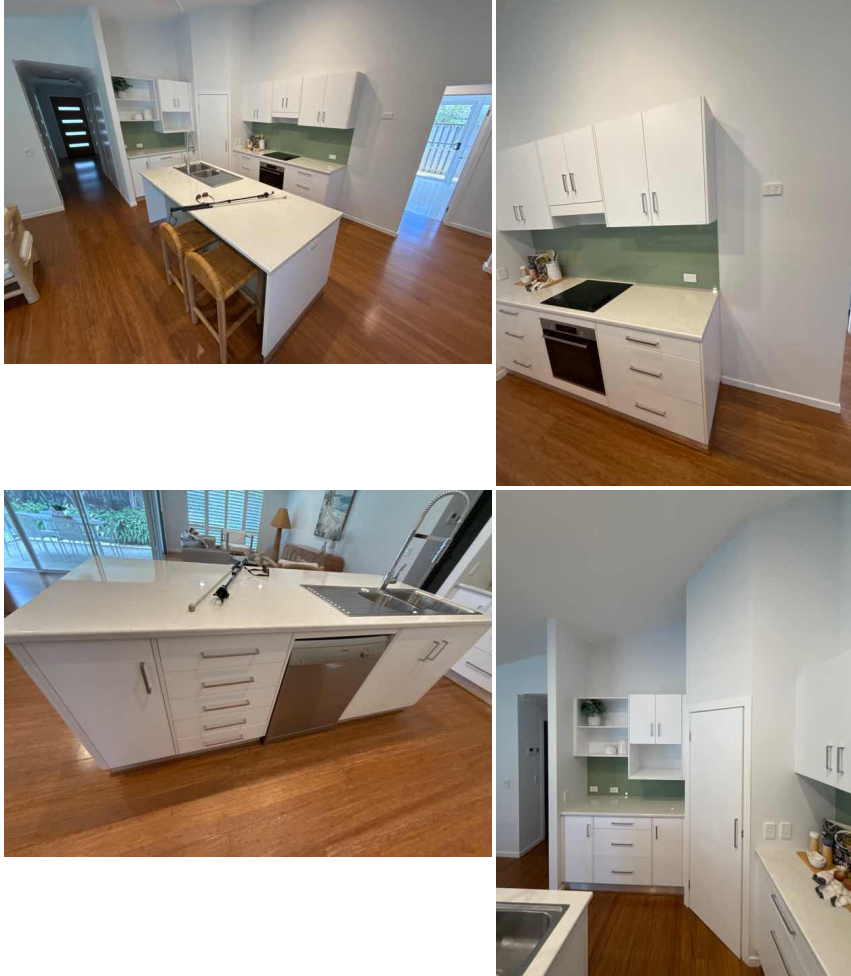
Adjustment to cabinet doors required, in some instance hinges may need to be replaced.
