# Building and Pest Report

## 42 Seaside Ave Skennars Head

| Inspection Date: | 16 Oct 2025 |

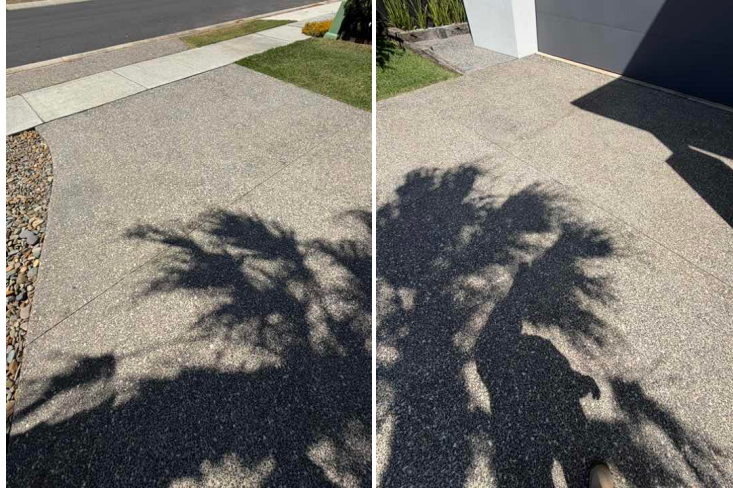
On visual inspection, the general condition of the driveway is serviceable.

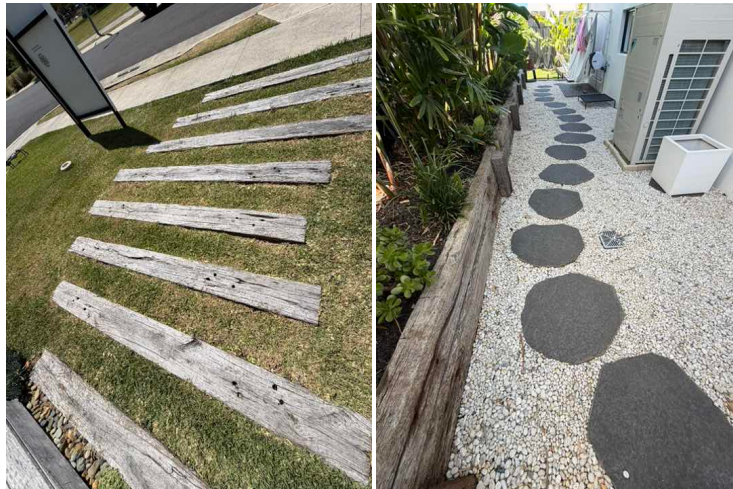
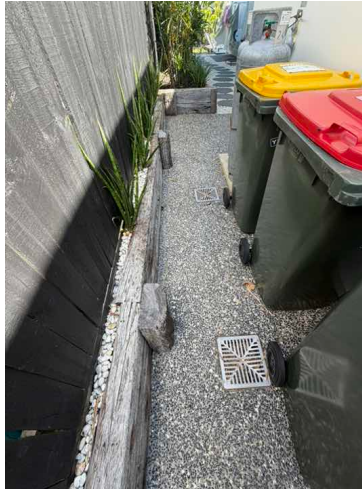
The paths around the home are in a serviceable condition for the age of this dwelling with no major defects visible.

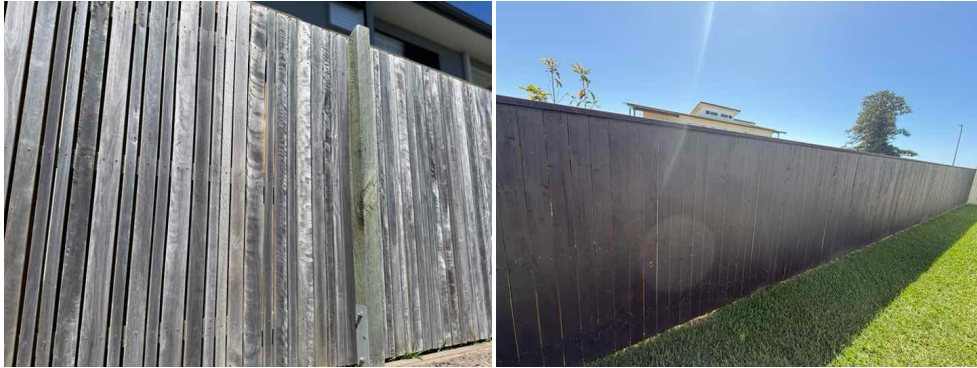
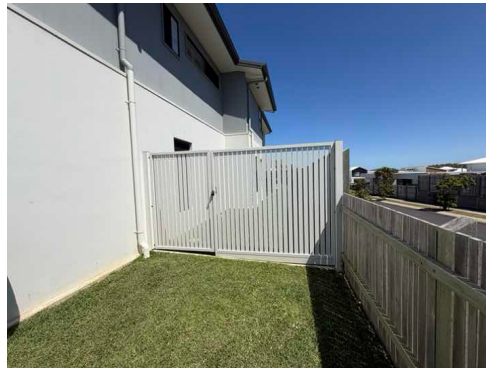
Of the visible areas, the general condition of the fences and gates is serviceable for the age of dwelling.

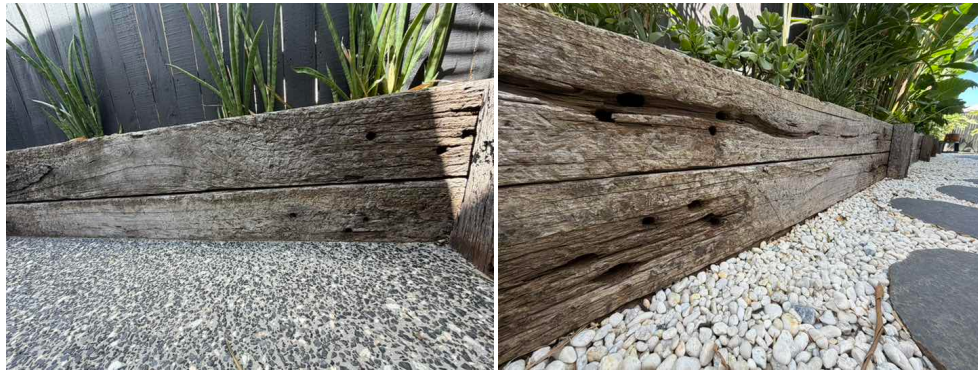
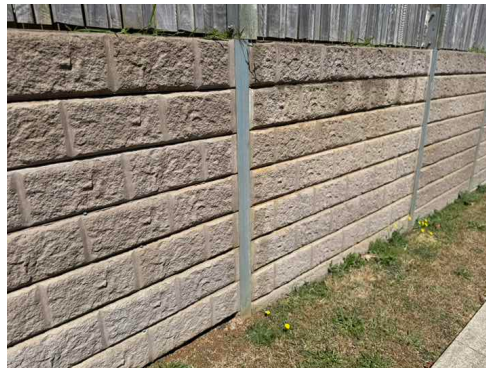
Of the visible areas, the general condition is serviceable or in reasonable condition for age of dwelling.

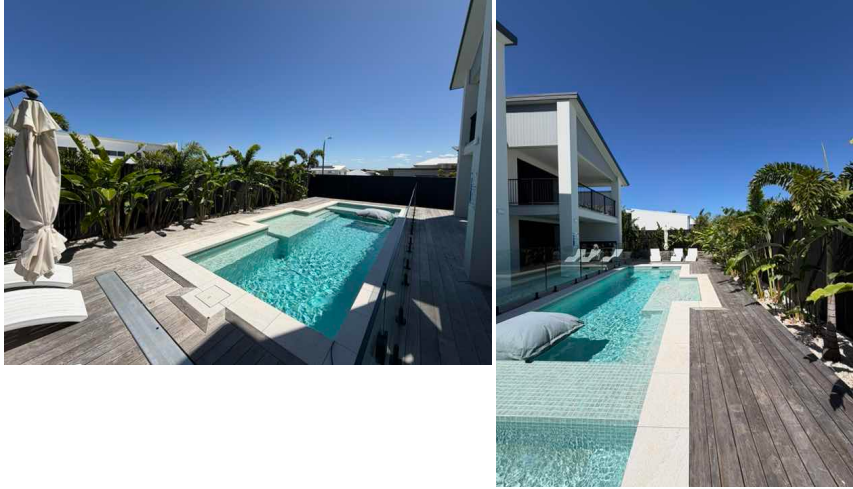
Pool fence and signage were sighted.

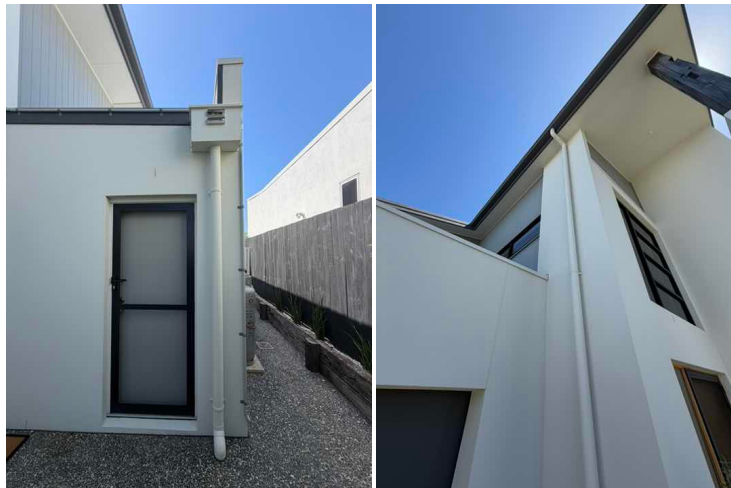
On visual inspection no apparent defects were noted to the down pipes and are considered serviceable, however no comment can be made with regard to blockages or connections to stormwater or functionality in the absence of rain. Note: Periodic maintenance checks should be carried out for rust penetrations and leaks.

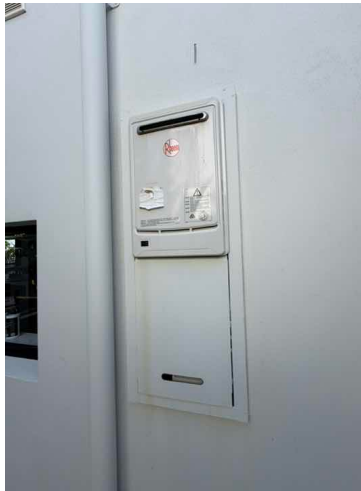
The make of the hot water unit is rheem.

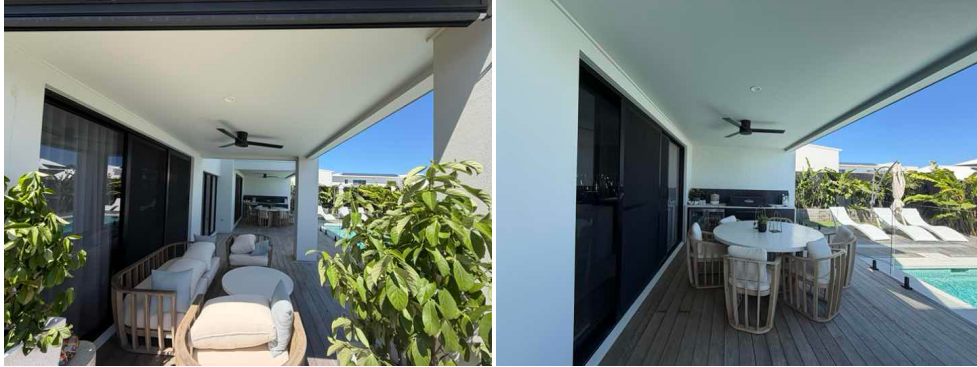
Visible sections of the Alfresco area are serviceable or in reasonable or condition for the age of this dwelling.

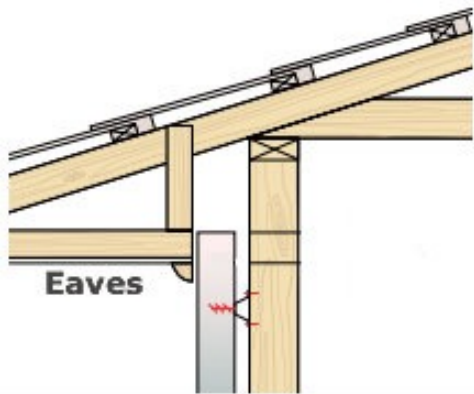
The soffit lining (eaves) are in a serviceable condition with no notable defects.

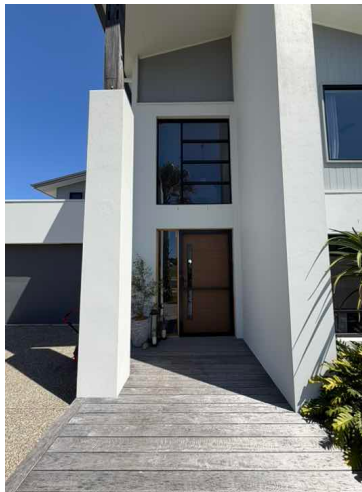
The entry porch serviceable or in reasonable or condition for the age of this dwelling.

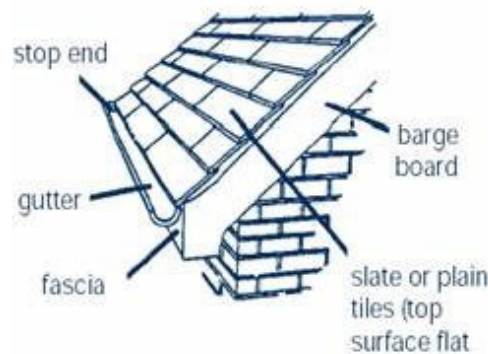
On visual inspection, the general condition of the fascia/barge boards is serviceable.

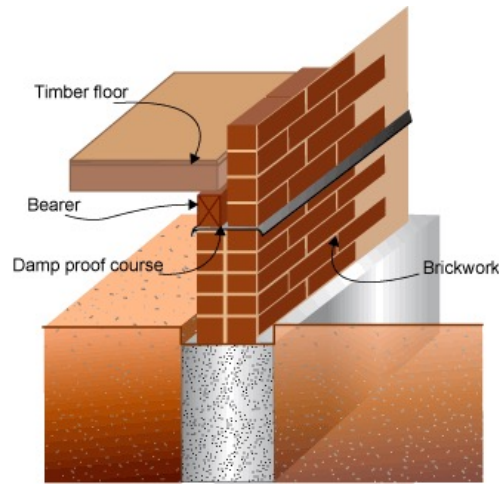
A damp proof course (DPC) was noted.

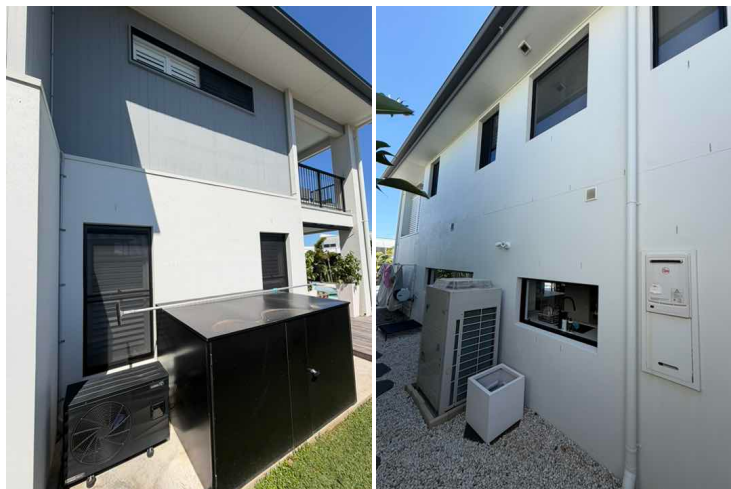
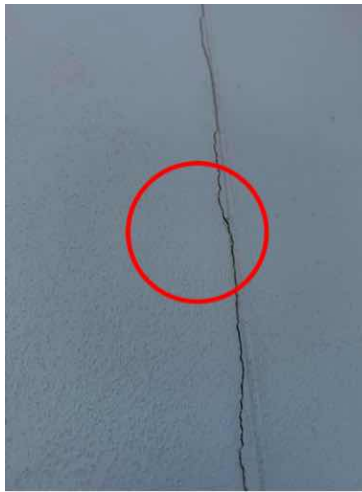
On visual inspection, the general condition of the exterior walls is serviceable for the age.

There appears to have been some settlement in the building which has caused some cracking to the walls. These crack are catergorized as 0 to 2. This can also cause some doors to bind or be out of square. In the inspectors opinion these cracks are due to settlement, usually due to ground movement and subsequent movement to building materials can be expected. Any cracks should be monitored and if cracks increase in size, further investigation should be carried out by a structural engineer.

Settlement cracks - Recommendations: Monitoring advised. If widening subsequently occurs it will require assessing by a structural engineer.

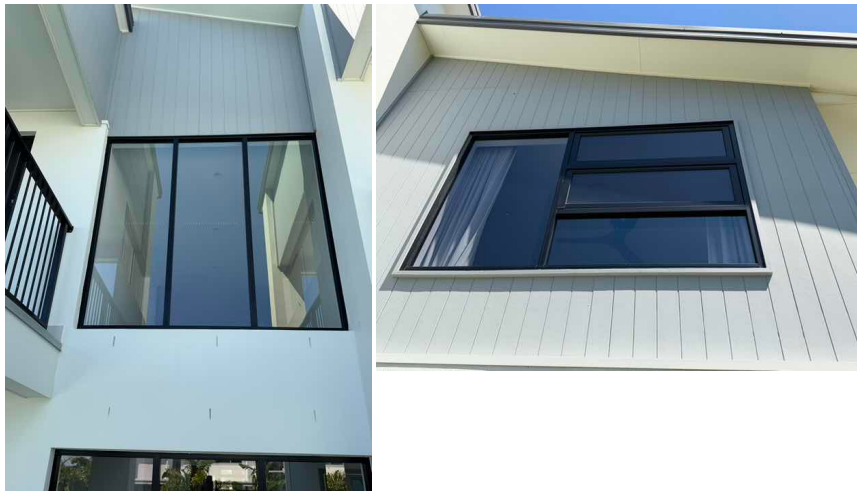
On visual inspection, the general condition of the windows is serviceable for the age.

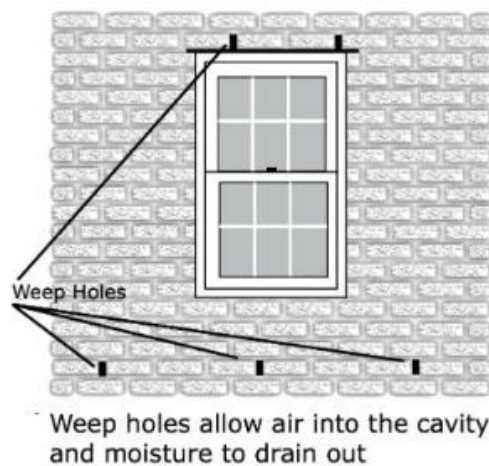
The weep holes are unobstructed .

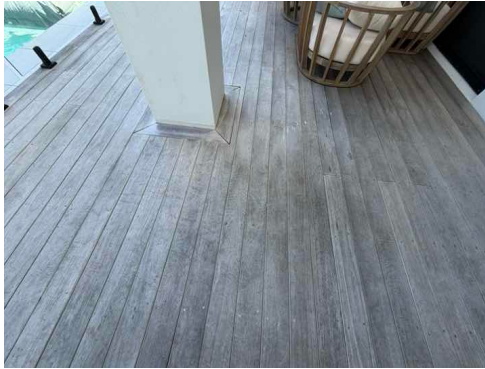
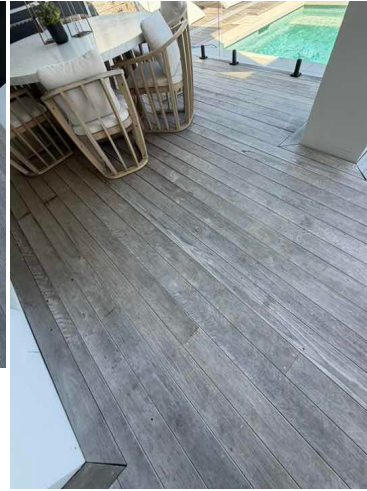
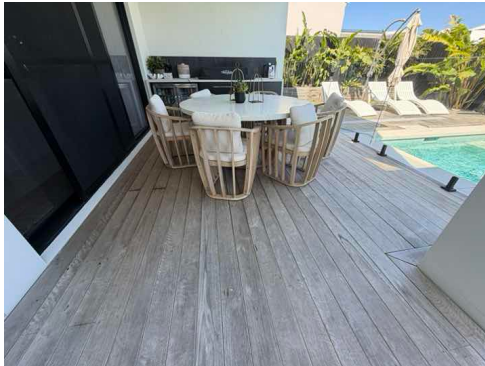
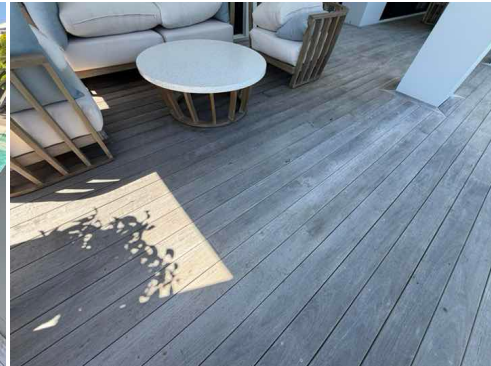
Of areas visible, the decking appears to be in a serviceable condition.

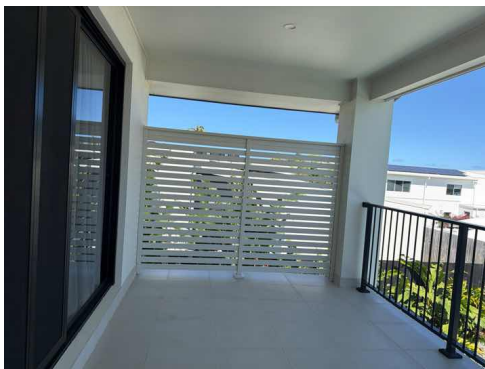
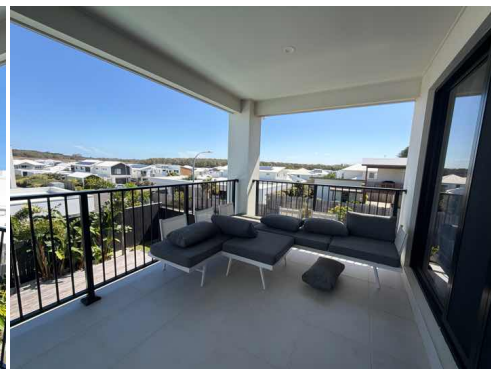
Though we are not structural engineers the balcony/s appear to be in a serviceable condition.

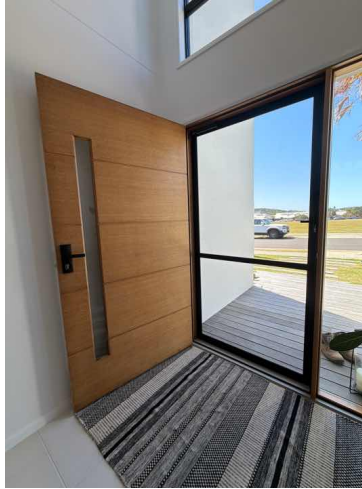
The doors are in serviceable condition with no notable defects observed.

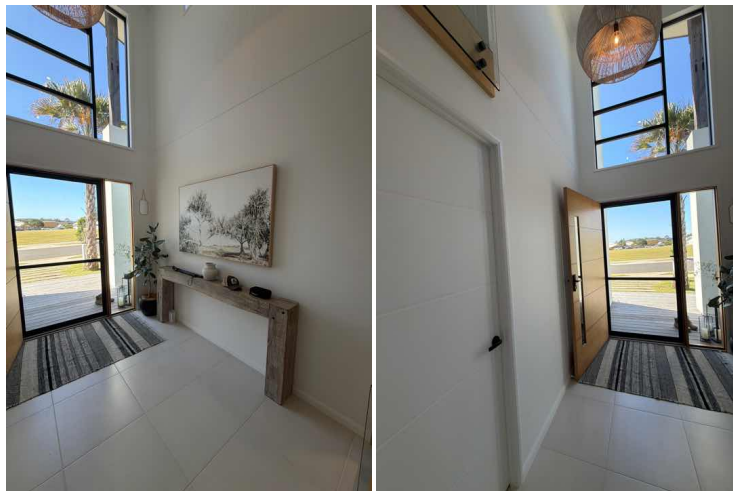
From the visible and accessible areas, this area appears to be in a serviceable condition for the age of the property with no notable structural defects sighted.

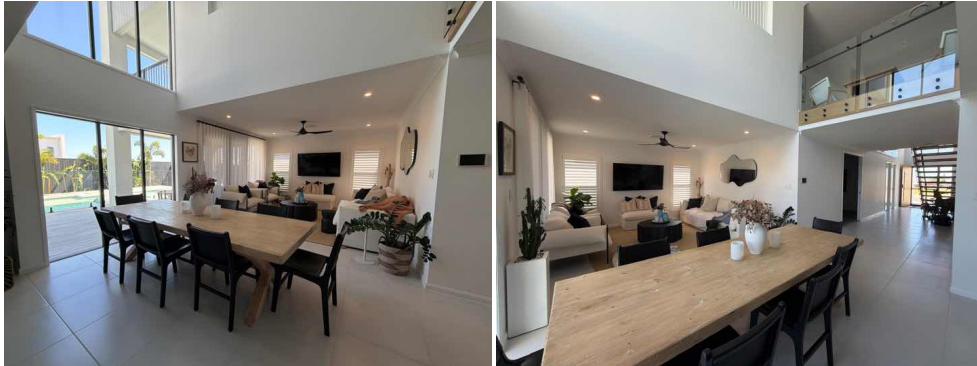
From the visible and accessible areas, this room appears to be in a serviceable condition for the age of the property with no notable structural defects sighted.

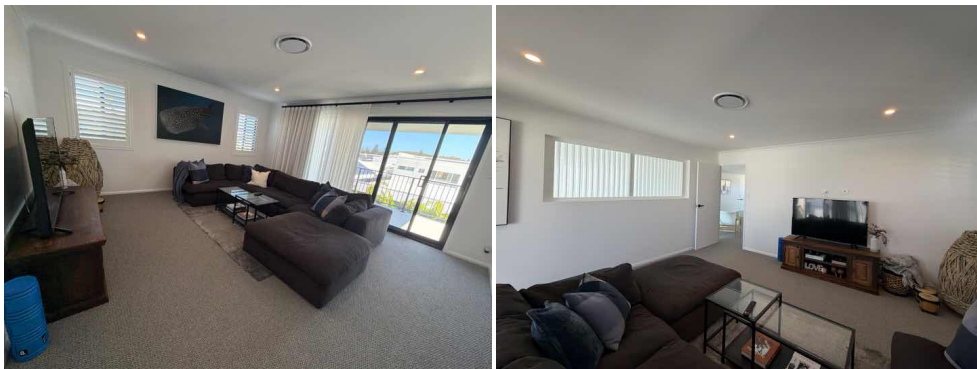
From the visible and accessible areas, this room appears to be in a serviceable condition for the age of the property with no notable structural defects sighted.

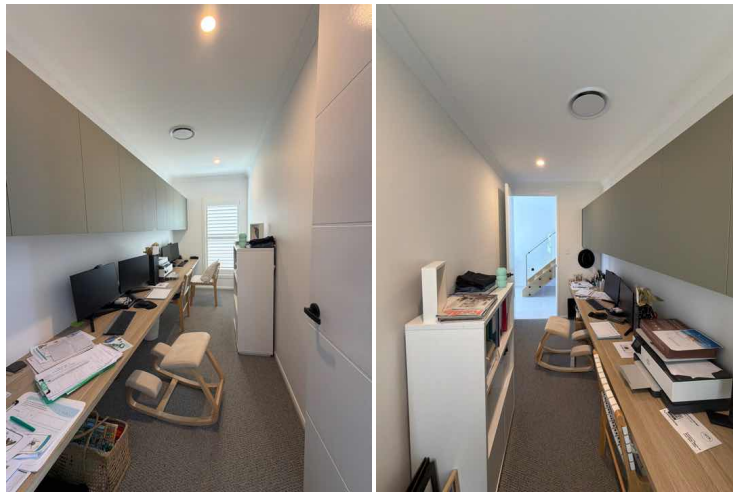
From the visible and accessible areas, this room appears to be in a serviceable condition for the age of the property with no notable structural defects sighted.

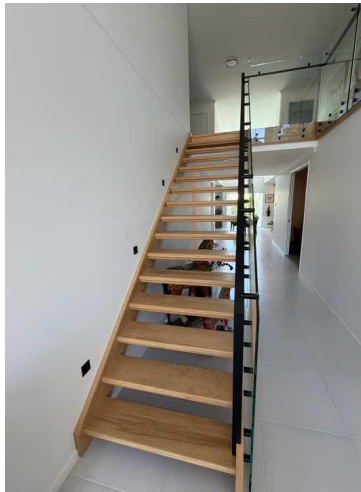
The internal staircase and components appear to be in a serviceable condition for the age with no notable defects sighted.

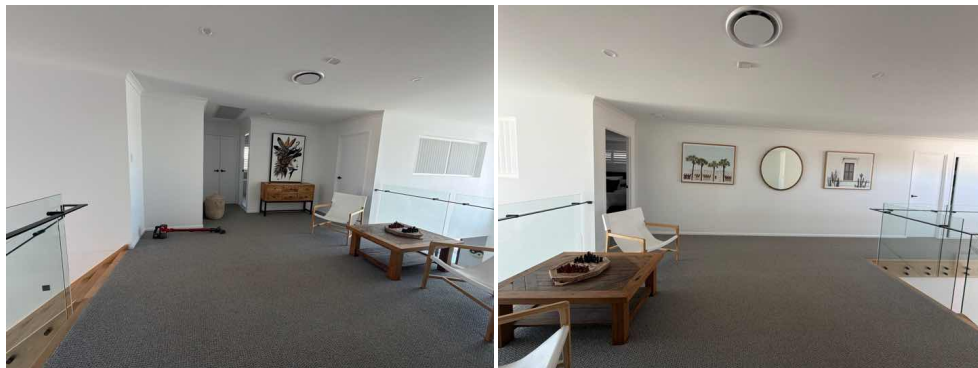
From the visible and accessible areas, this room appears to be in a serviceable condition for the age of the property with no notable structural defects sighted.

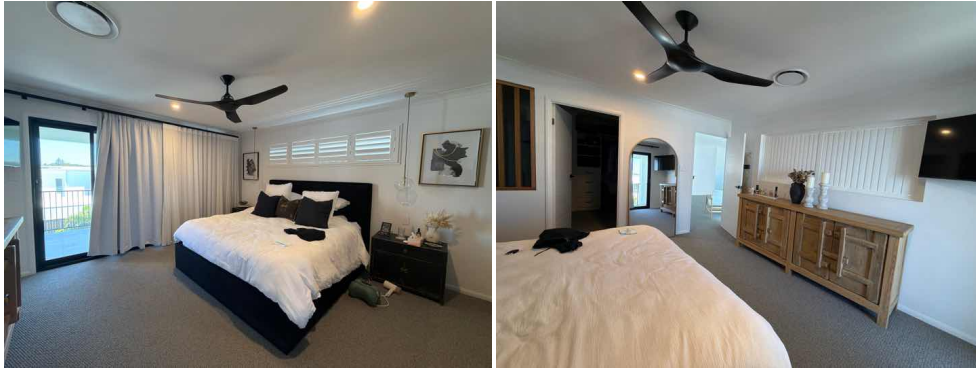
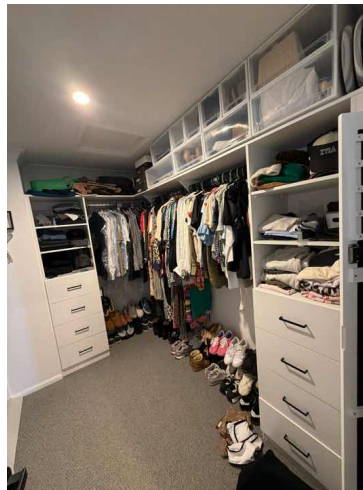
From the visible and accessible areas, this bedroom appears to be in a serviceable condition for the age of the property with no notable structural defects sighted.

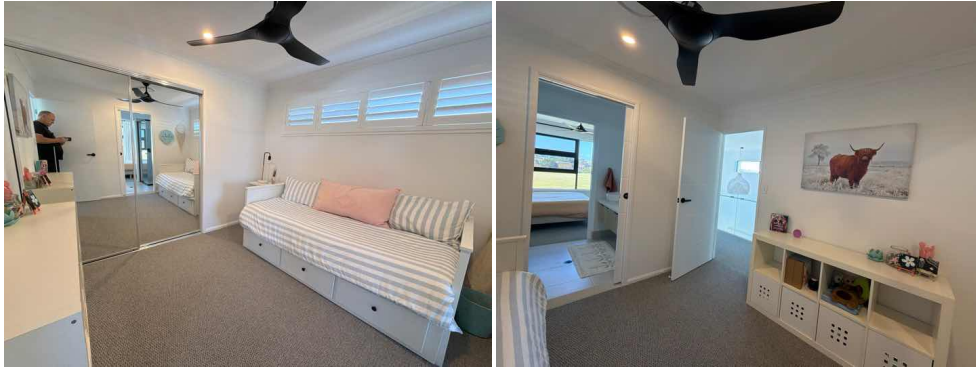
From the visible and accessible areas, this bedroom appears to be in a serviceable condition for the age of the property with no notable structural defects sighted.

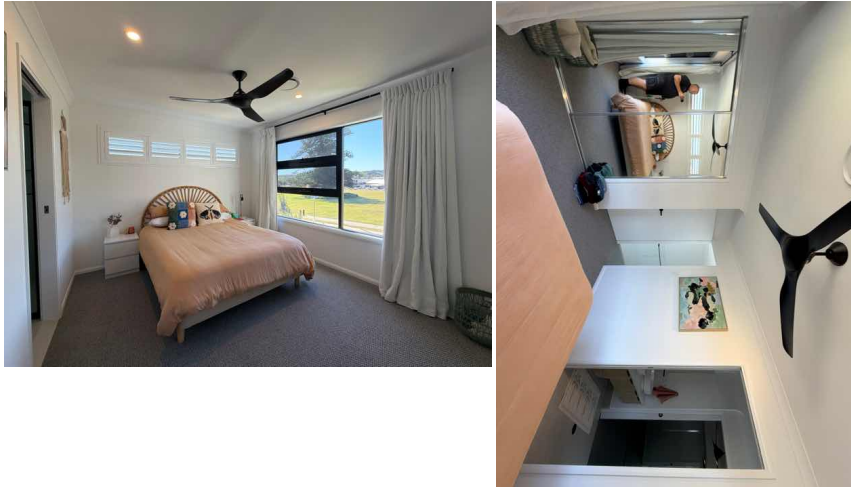
From the visible and accessible areas, this bedroom appears to be in a serviceable condition for the age of the property with no notable structural defects sighted.

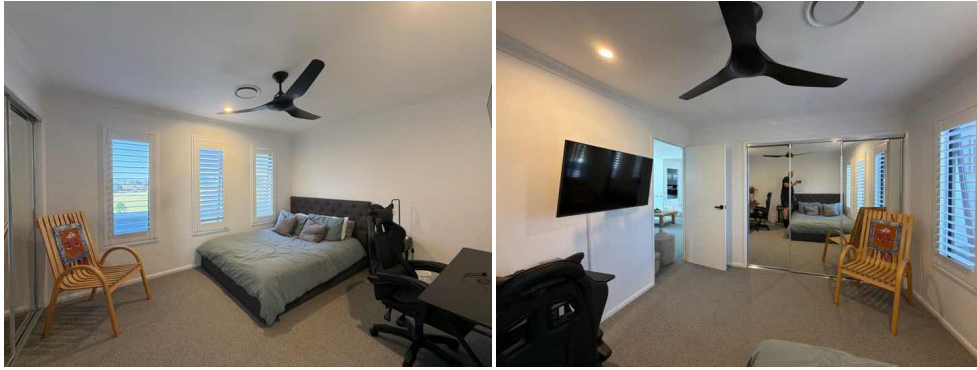
From the visible and accessible areas, this bedroom appears to be in a serviceable condition for the age of the property with no notable structural defects sighted.

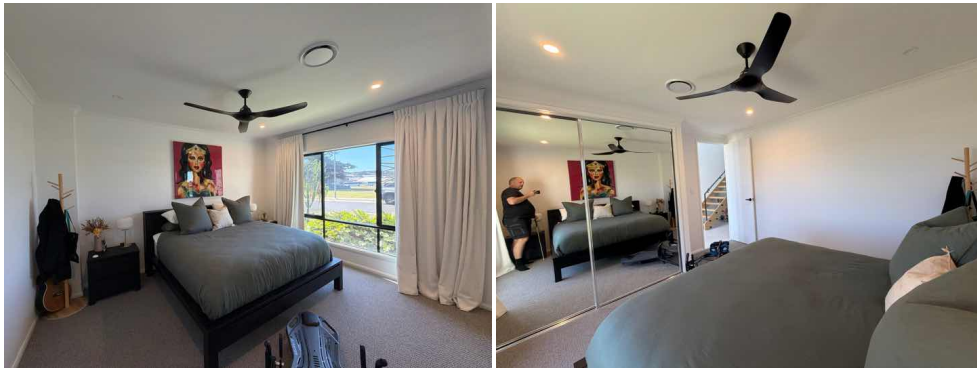
From the visible and accessible areas, this bedroom appears to be in a serviceable condition for the age of the property with no notable structural defects sighted.

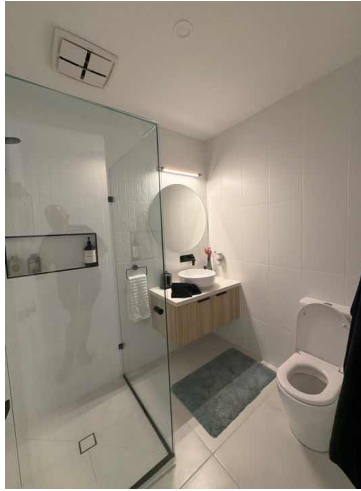
Of the visible areas, the general condition of this bathroom is serviceable or in reasonable condition for age of dwelling.

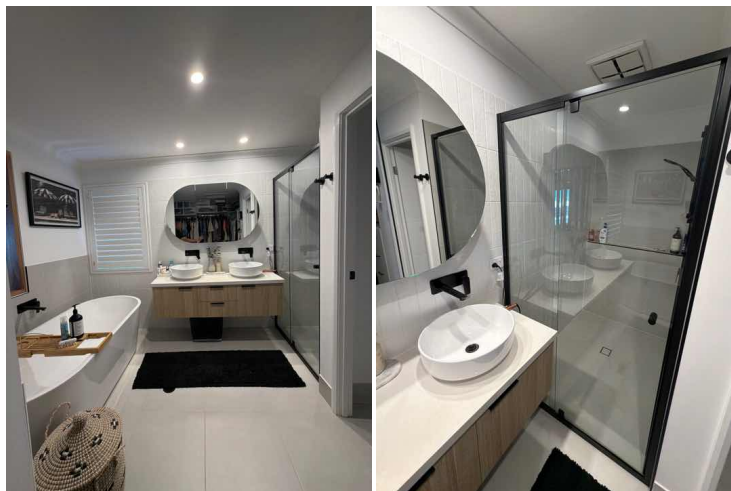
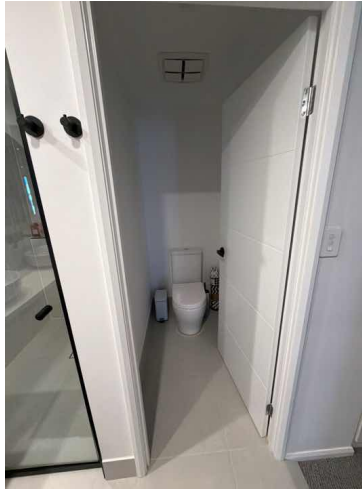
Of the visible areas, the general condition of this bathroom is serviceable or in reasonable condition for age of dwelling.

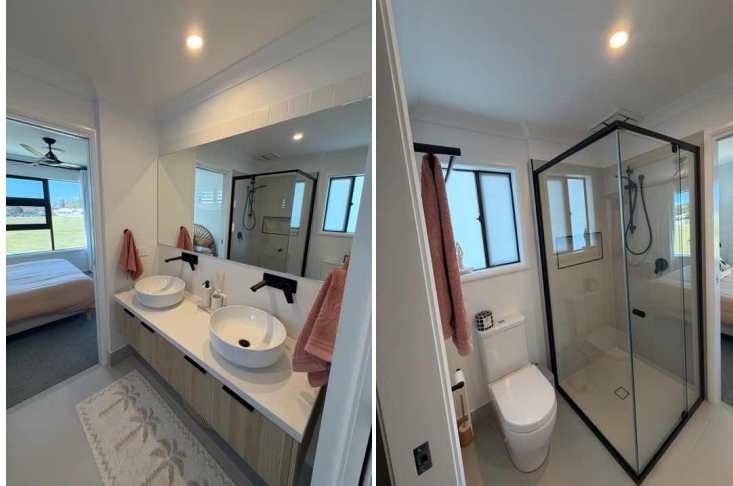
Of the visible areas, the general condition of this bathroom is serviceable or in reasonable condition for age of dwelling.

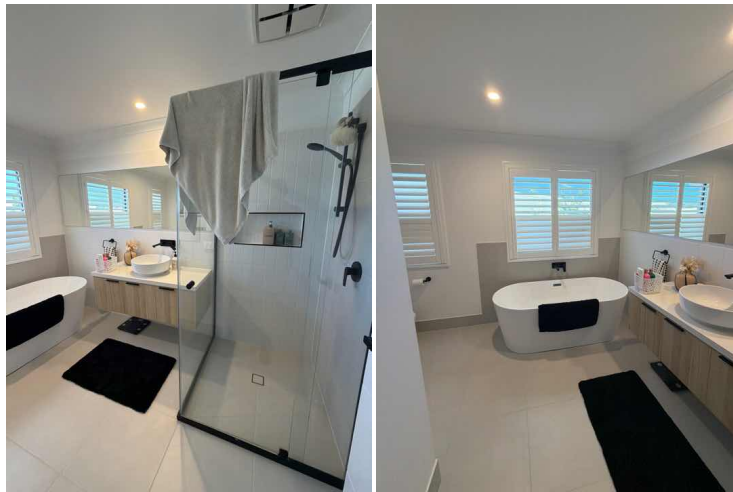
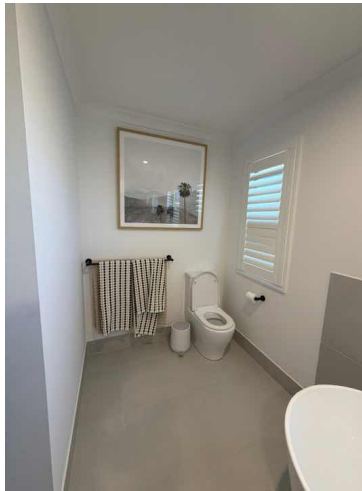
Of the visible areas, the general condition of this bathroom is serviceable or in reasonable condition for age of dwelling.

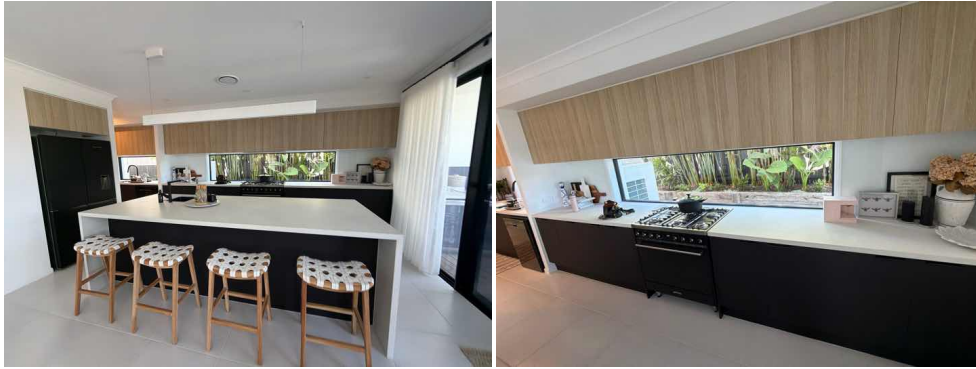
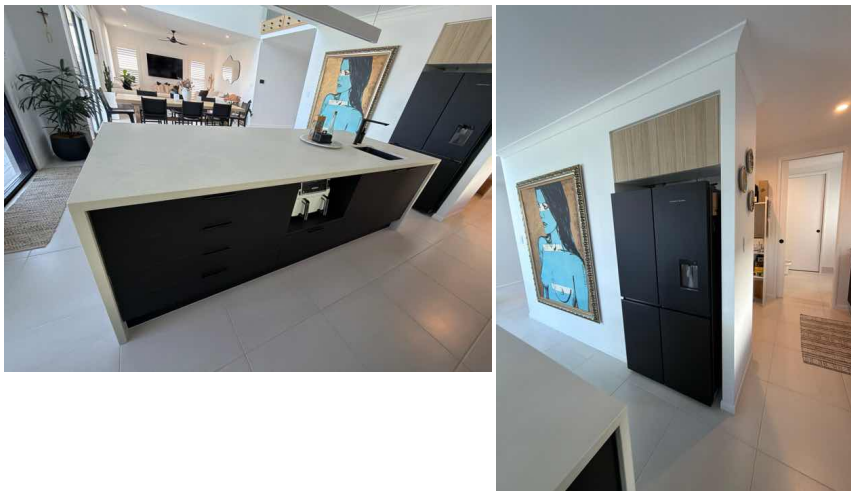
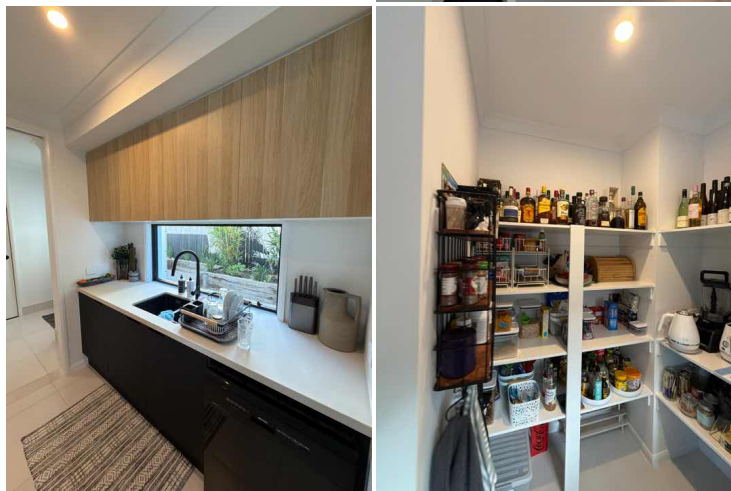
Of the visible areas, the general condition of the kitchen and pantry is serviceable or in reasonable condition for age of dwelling.

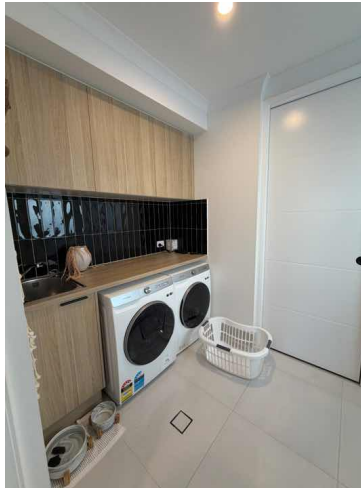
Of the visible areas, the general condition of the laundry is serviceable or in reasonable condition for age of dwelling.
