# PEST AND BUILDING PRE-PURCHASE REPORTS

# BPI BUILDING & PEST INSPECTIONS

1/8 Stewart Street  
Lennox Head

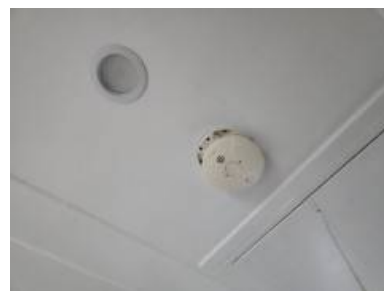
Present - Hall, (new backup battery required)

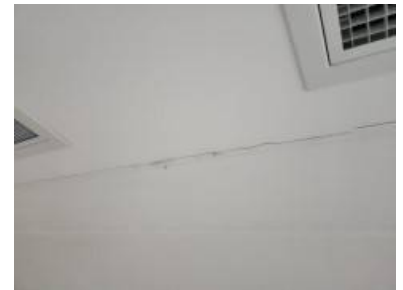
**Cracking / Sagging / Defective Lining**

Gaps to some cornice / ceiling junctions require filling.

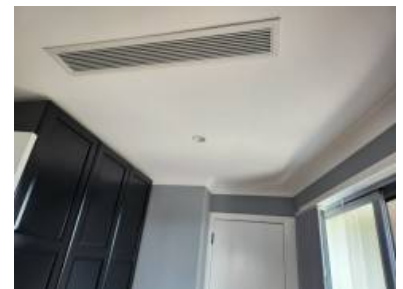
**Damp Damage**

There is evidence of water penetration to ceiling sheeting to Master bedroom.

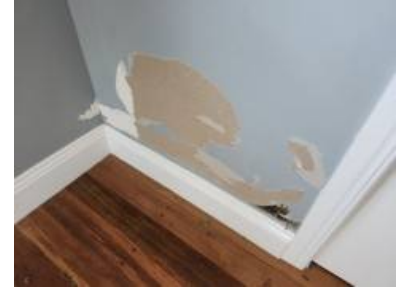
### Cracking / Defective Lining

Some damage to wall sheeting requires touching up / repair / repainting.

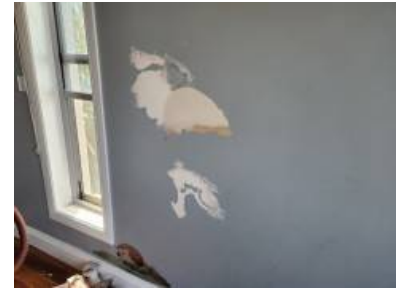
### Other (specify)

Some minor surface damage / paintwork to some walls requires touching up / repainting.

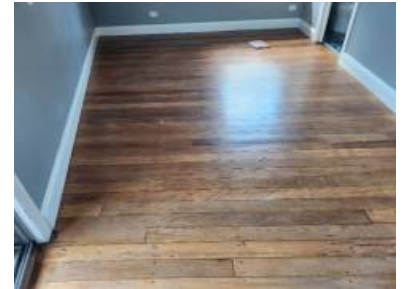
**Out of Level**

There is evidence of undulations to some flooring consistent with a house of its age & construction.

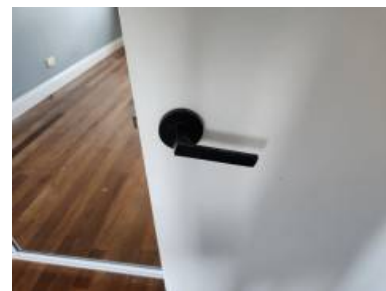
**Door Hardware**

Some door handles require refixing / adjustment.

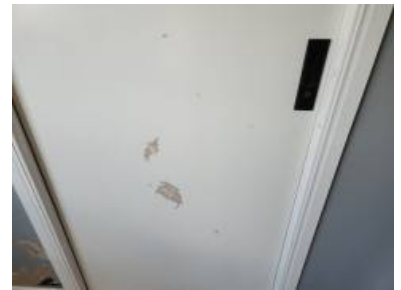
**Doors**

Paintwork to some doors requires touching up / repainting.

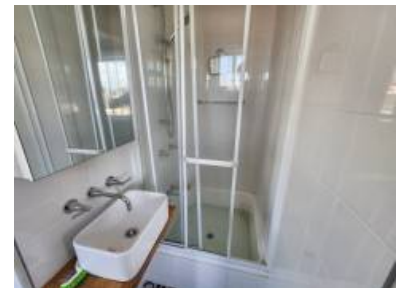
### Screen

Bathroom shower screen door is binding on the frame and requires adjustment / refixing.

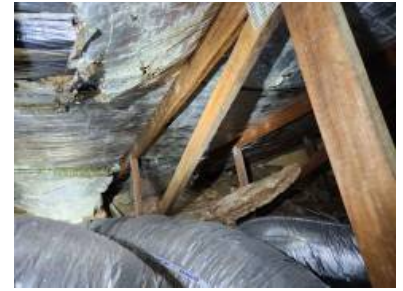
### Roof Void & Framing - Condition

Older roof frames do not comply with current wind ratings. The roof framing is in satisfactory / typical condition for the age / construction date.

There is evidence of past water penetration within the Roof Void.

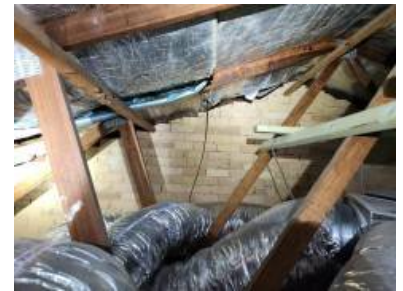
### Party / Fire Walls

The fire wall is not constructed to current AS. It may or may not have complied with building requirements at the time of inspection. Refer to the Local Authority Building Department for advice.

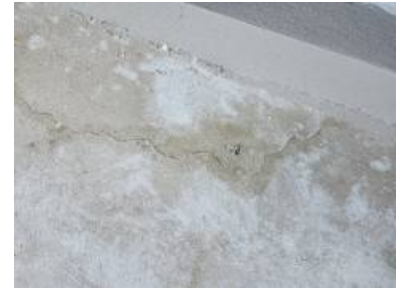
Some minor cracks present to the Patio slab.

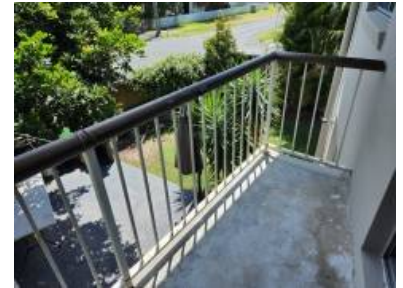
The handrail & balustrades do not comply with current BCA standards however, they may comply with the date of construction. Although this report does not generally comment on items of compliance, this issue may become a safety issue / fall hazard and therefore was included in this report. We recommend you further investigate this matter and upgrade if / where necessary.

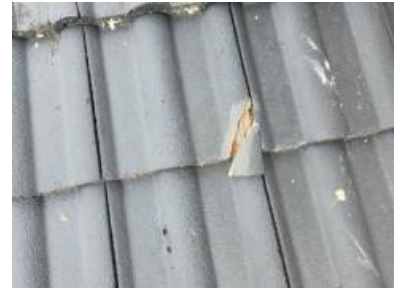
Some cracked corners and edges to roof tiles require resealing.

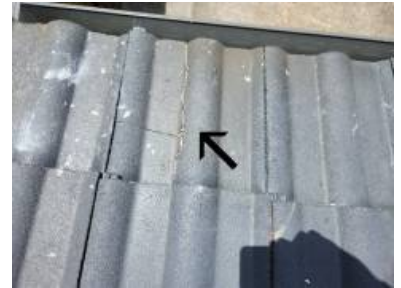
1 x cracked roof tile requires repair / replacement. To front of garage.
