Building and Pest Report

72 Amber Drive Lennox Head

Pest And Building Inspection

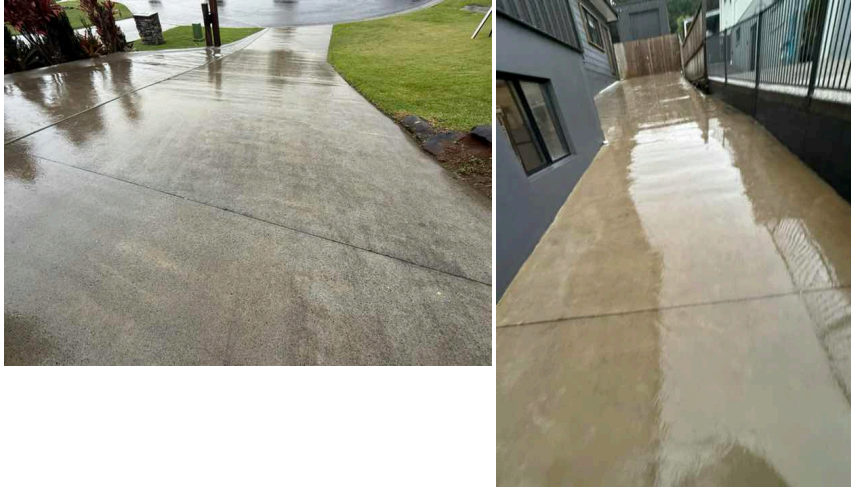
Driveway Condition

On visual inspection, the general condition of the driveway is serviceable.

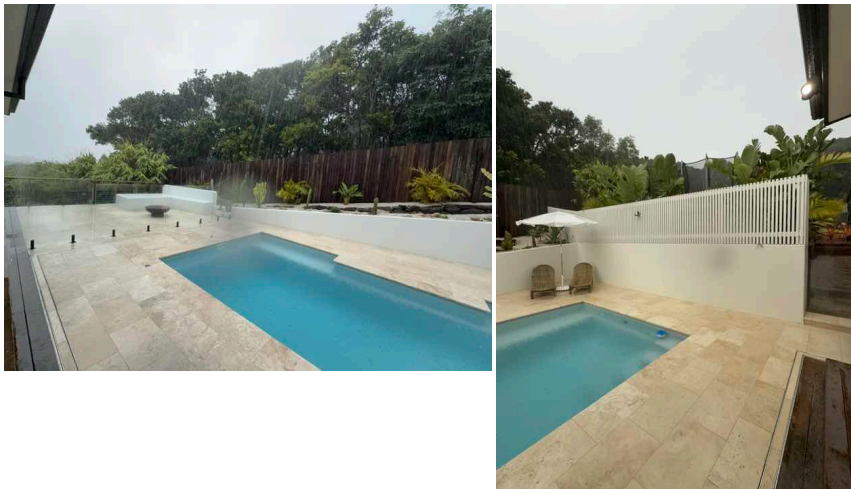
Pool Fence

Pool fence and signage were sighted.

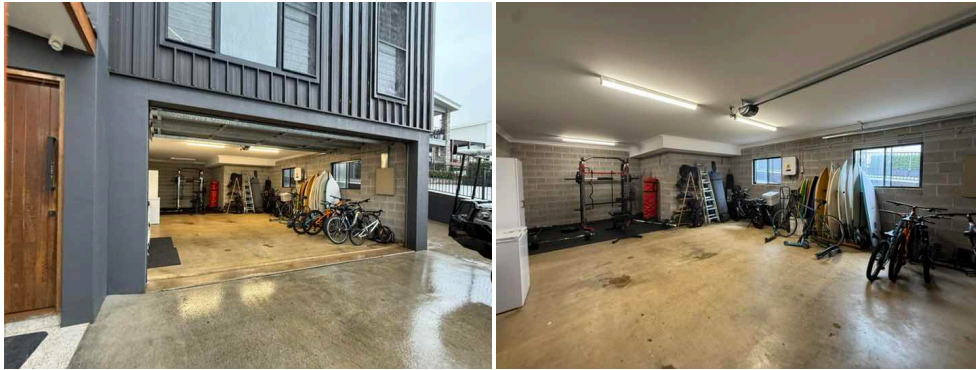
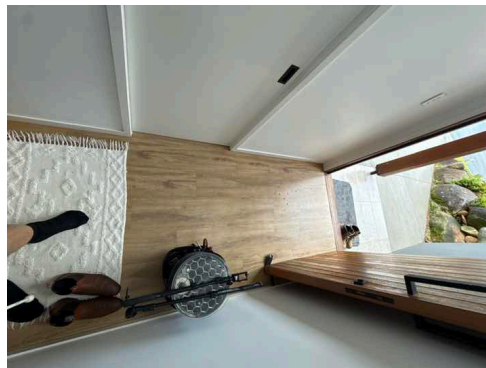
Lower wall salt residue - Moisture/damp detected. It is imperative that specialist advice be sought to obtain accurate diagnosis of the cause and extent of the damp problem and it is advised that you have assessed prior to purchasing the dwelling as can be quite costly if a damp proof course has to be reinstated.

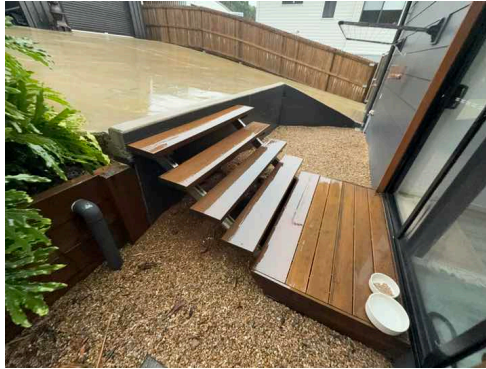
There are no rails on the stairs. This presents a fall risk. Have repaired immediately.

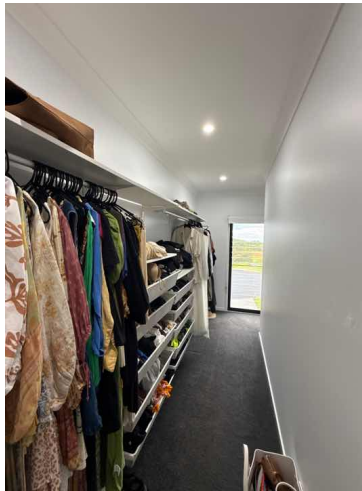
Door
Door stop should be fitted - Wall damage from door handle impacting wall lining has occurred. I recommend you contact a qualified painter for repairs.

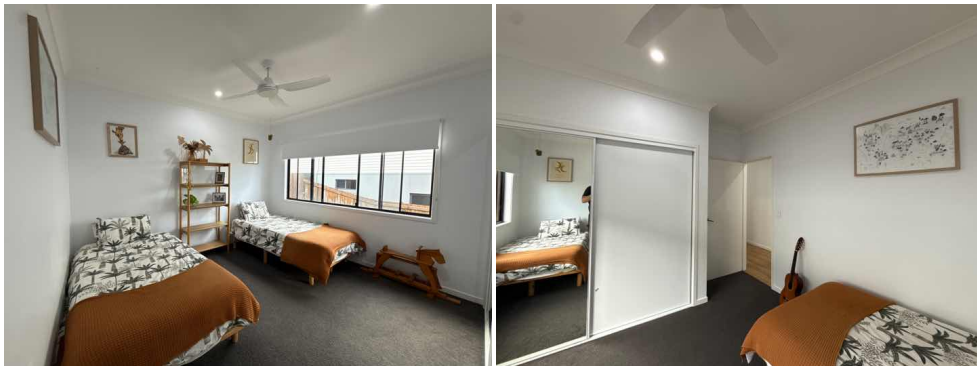
Impact damage noted. Contact a qualified painter for repairs.

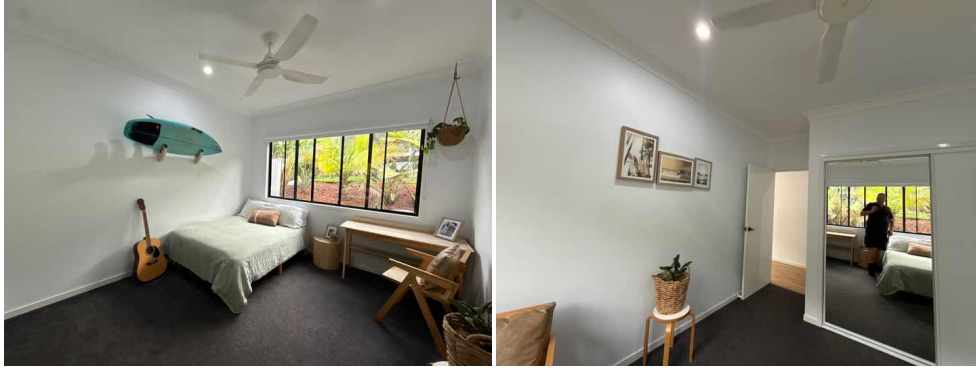
Door stop should be fitted - Wall damage from door handle impacting wall lining has occurred. I recommend you contact a qualified painter for repairs.

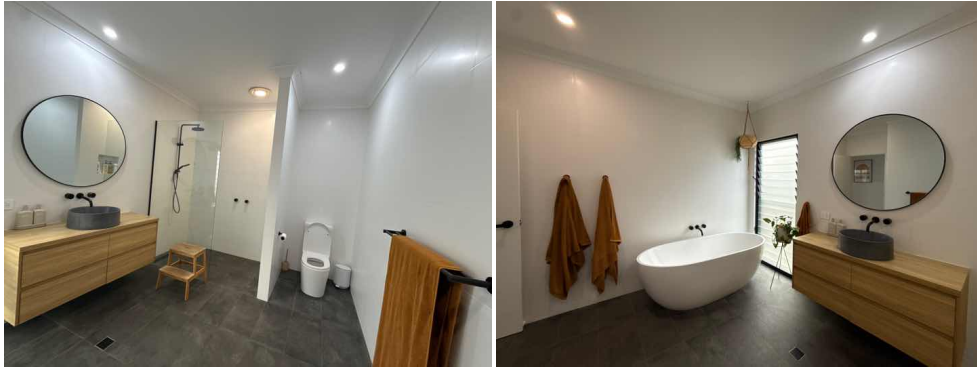
The exhaust fan is noisy - Have assessed by a qualified electrician.

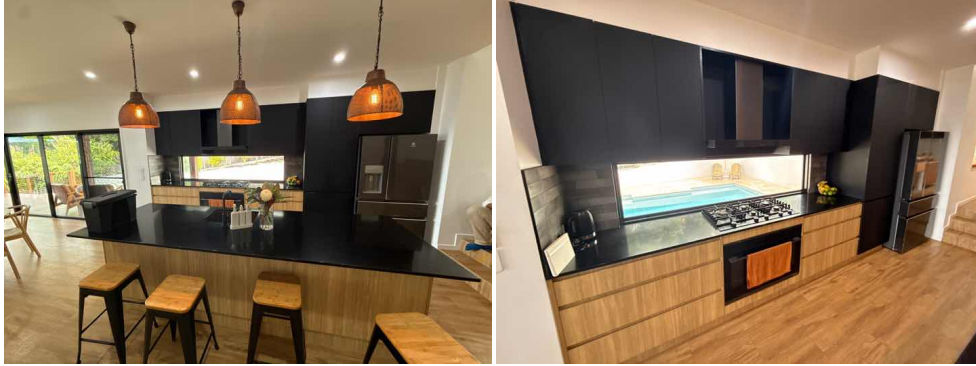
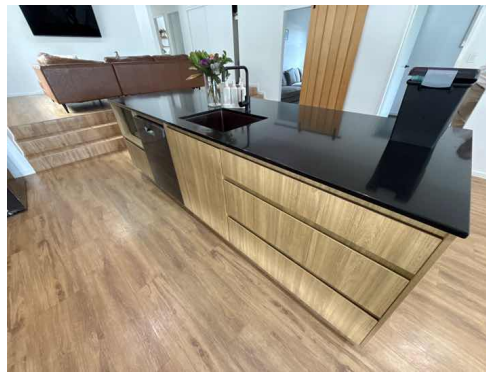
Adjustment to cabinet doors required, in some instance hinges may need to be replaced.

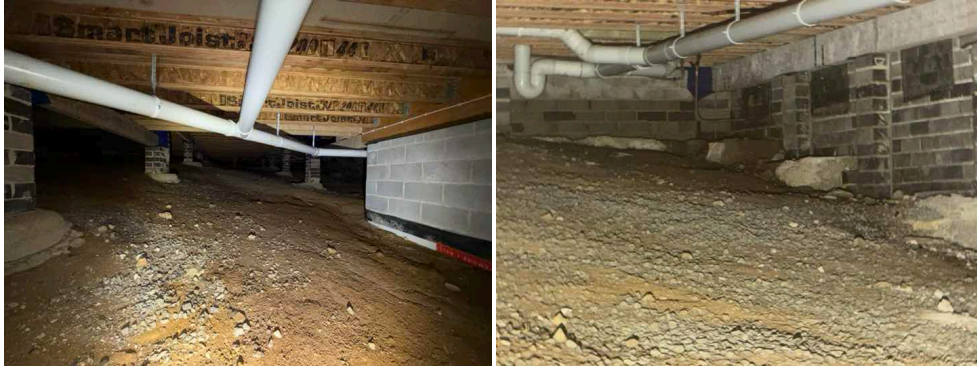
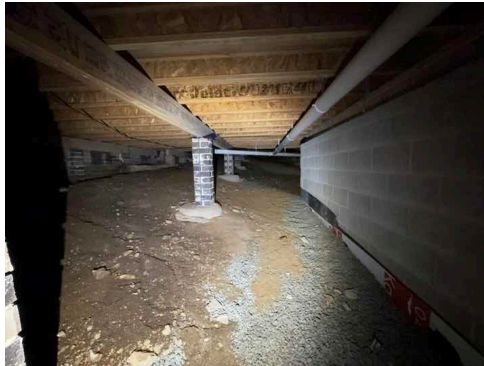
Though dry at the time of inspection there is evidence of previous water ingress in sub floor. This is likely to happen again during periods of heavy rain. Further assessment and rectification is required as this may cause possibly create/add further footings problems and settlement to piers.

There was debris and other material in the subfloor, we recommend cleaning these to aid with ventilation and reduce the likely hood of rodents and pests.
