# Building and Pest Report

## 18 Montwood Drive Lennox Head

# **BPI BUILDING & PEST INSPECTIONS**

## BPI - INSPECTION REPORT

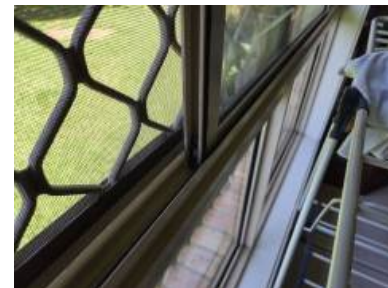
Some window slider rollers show signs of wear or are worn and require lubrication.

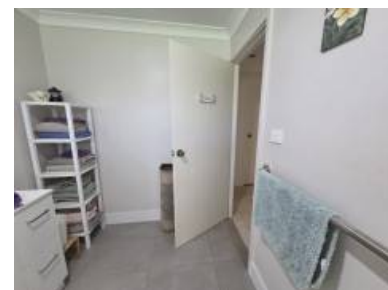
Bathroom door is binding and requires repair / easing / adjustment.

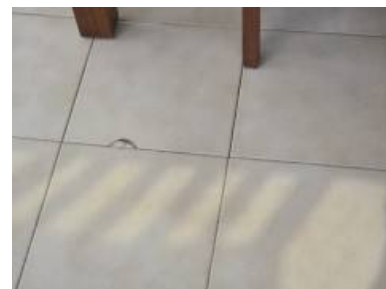
Some dining room floor tiles are cracked & chipped.

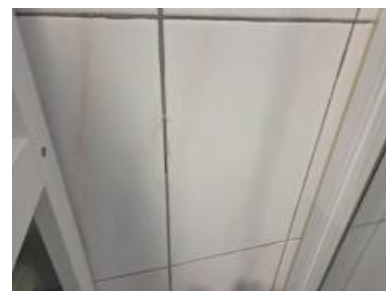
Some wall tiles require regrouting to Ensuite.

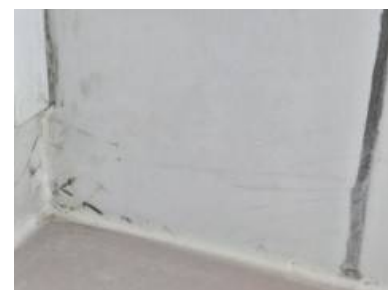
Some hairline cracks to some wall tiles at the base of the ensuite shower.

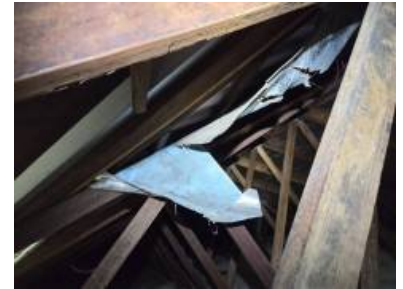
Sarking paper is present in the roof cavity to the underside of the roof tiles. Some sarking paper requires refixing.

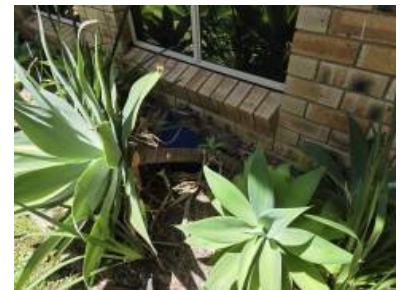
**Visible Flashings, Weepholes, Vents**  
Some weepholes are covered by vegetation and require exposing.

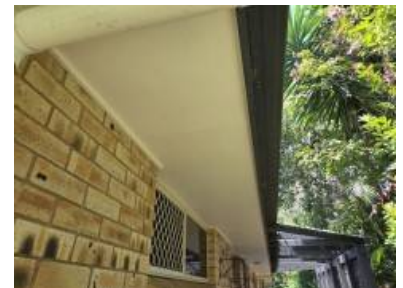
**Condition:**  
The external paintwork / finish to the external surfaces and timberwork is generally satisfactory. There are some sections / areas that require touching up / repainting.

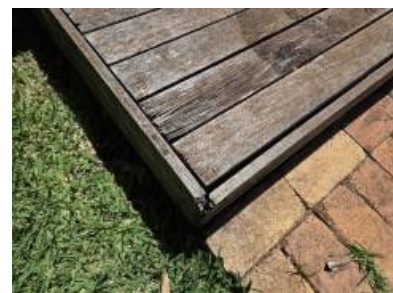
Some verandah decking timbers show signs of weather damage / decay and require repair / replacement.

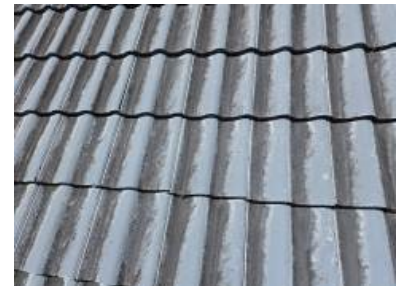
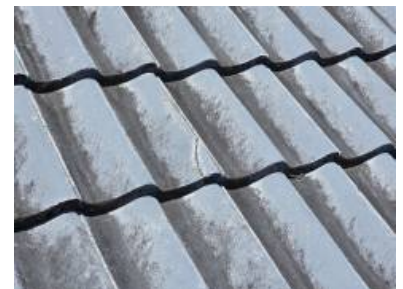
Some cracked corners and edges to roof tiles require resealing.

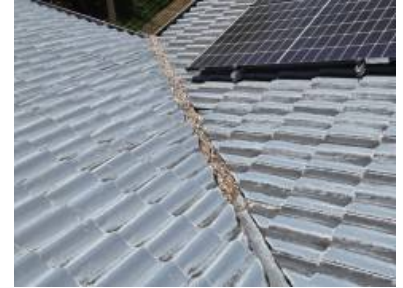
Some sections of valleys are full of debris and require cleaning. Failure to do so may allow water to become blocked and back flow into the roof void causing water damage.

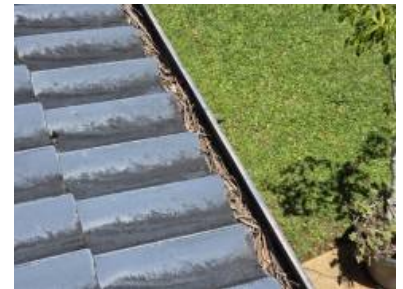
Some sections of guttering are full of debris and require cleaning. Failure to do so may allow water to become blocked and back flow into the roof void causing water damage.

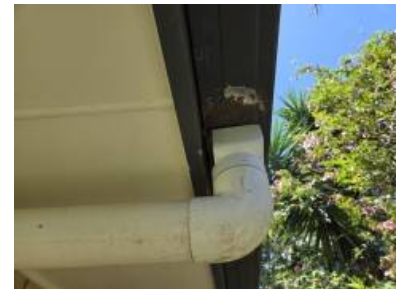
Some sections of guttering show signs of rust and require repair / painting with Killrust or better.

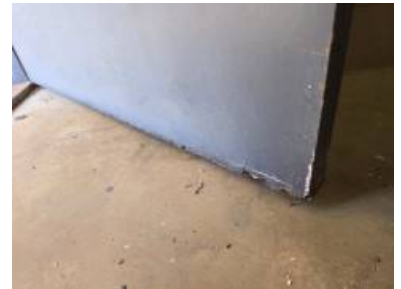
**Condition:**  
Hinged door show signs of weather damage and requires repair / sealing.

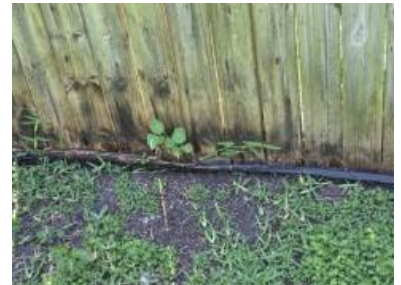
**Condition:**  
The timber fencing shows signs wood decay to the bases and will require rectification work / replacement at some stage in the future as timbers decay further.

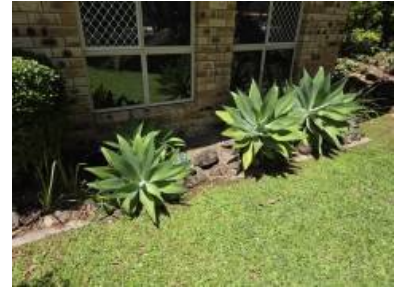
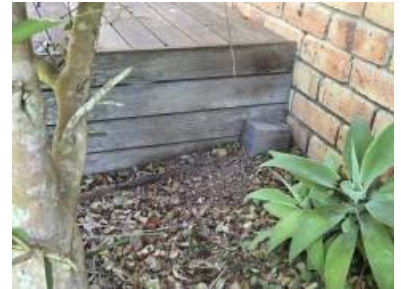
- Some external timbers to the Building are in contact with the ground / soil. Timber to ground contact may allow concealed termite entry / attack. The situation should be modified so that timber to soil contact does not occur (by creating a 75mm visual barrier) or have them treated with termiticide

- We strongly recommend that all garden beds and vegetation close to or abutting the external walls of the structure be removed. Garden beds and vegetation can attract / allow concealed termite entry and should be removed.
