# Inspection Report

## East Coast Building Solutions

**2 Karalauren Crt , Lennox Head, NSW, 2478**

### Pest And Building Inspection

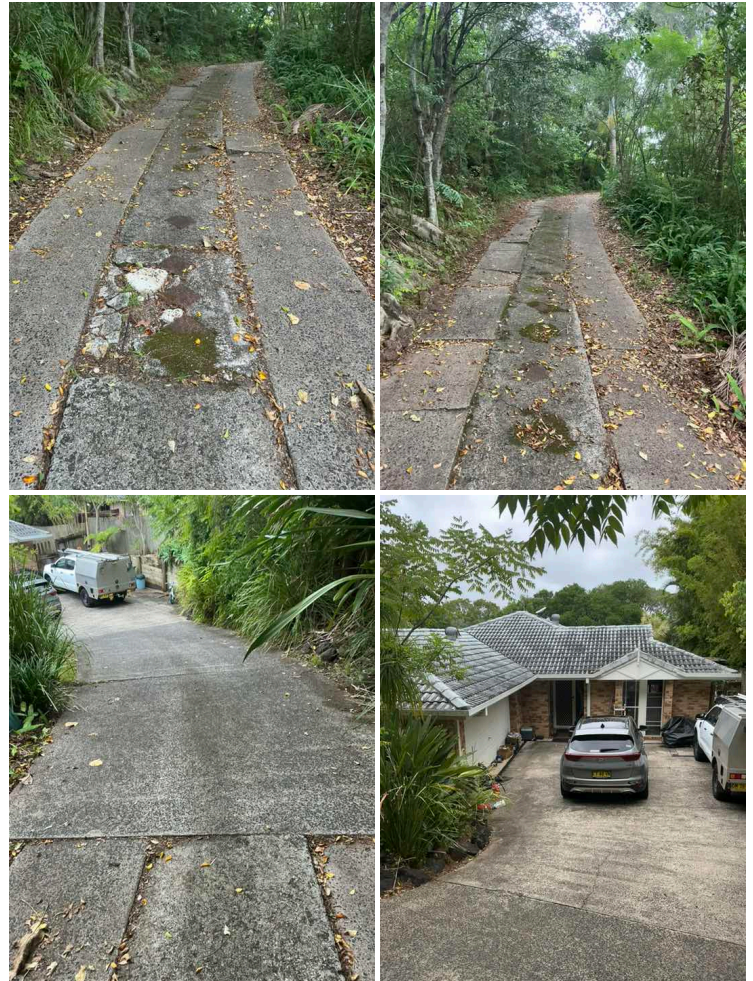
Common cracks were observed on the driveway. Whilst these cracks appeared to be typical at the time of inspection, we strongly recommend you monitor these cracks and if worsening occurs contact a concreter for further advice.

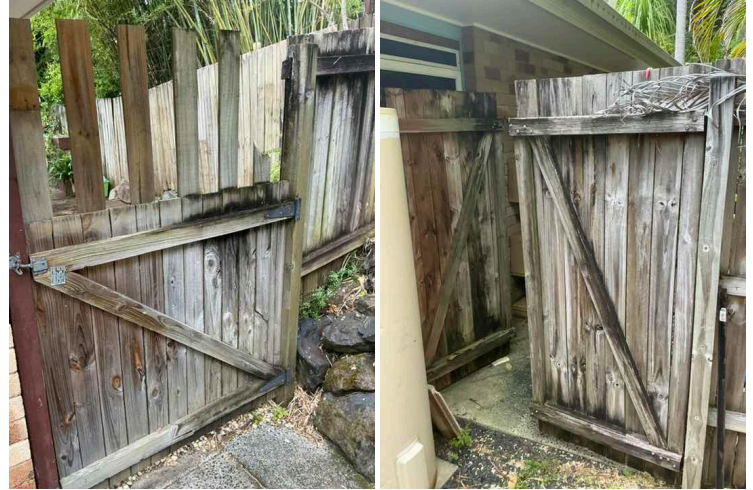
General age/damage/binding of gate/s components -  
 Recommendations: A qualified fencing contractor  
 should be engaged for advice and recommendations.

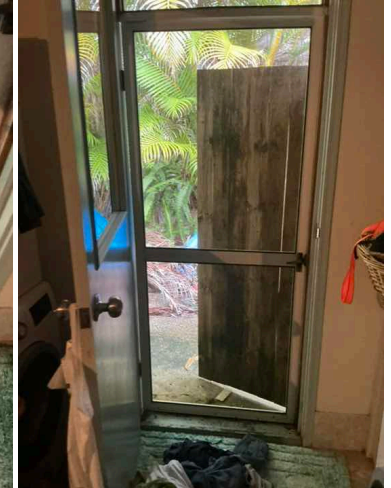
#1. The laundry door is weathered and deteriorated. Replacement recommended  
 Upon visual inspection, the door frame exhibits signs of wood rot and paint deterioration. Recommend engaging a licensed carpenter to replace or repair the damaged wood and repaint to prevent further decay. Ensure proper sealing to protect against moisture ingress.

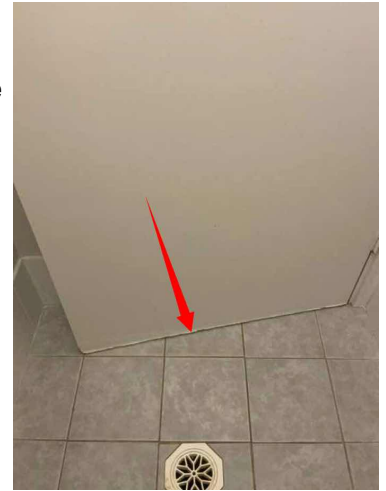
Upon visual inspection, there appears to be water damage at the base of the door, indicated by discoloration. Recommend engaging a licensed tradesperson to assess and repair potential leaks. Ensure proper sealing and waterproofing to prevent future issues.

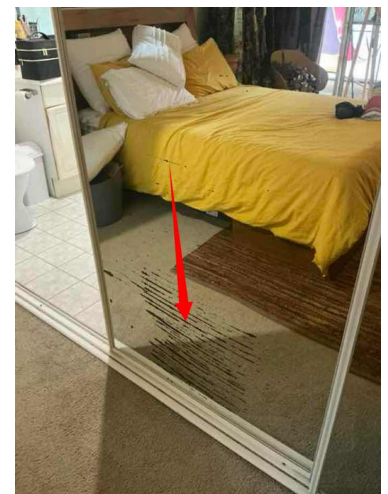
Door / frame deterioration - General age/damage has occurred to door frame, face or components. Recommendations: A qualified carpenter should be engaged for advice and recommendations.

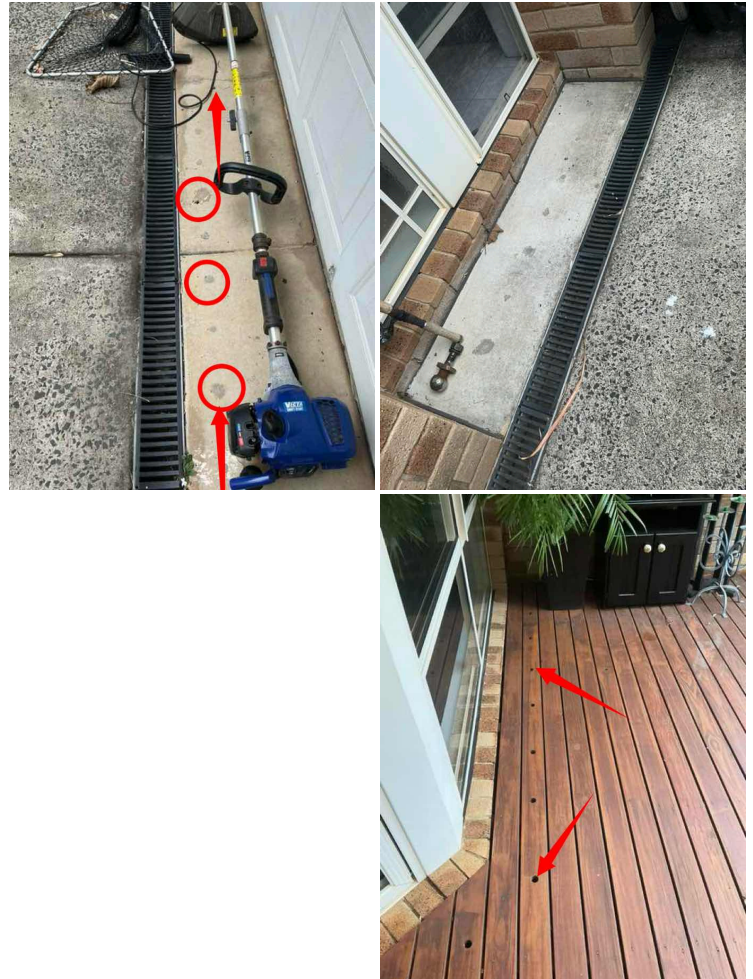
Yes, Drill Holes (Chemical Treatment) were located at the property.

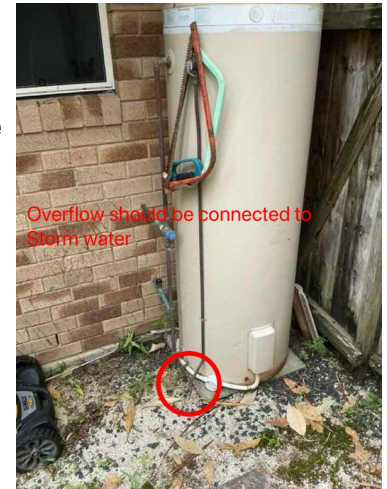
There was water leakage detected during the inspection from the hot water overflow. This should be diverted away from the dwellings walls or into a drain.

Though no immediate leak detected, the subfloor was very wet and requires further investigation. Consult an appropriate trade for a scope of works and cost of repairs for the issue prior to contracts becoming binding.

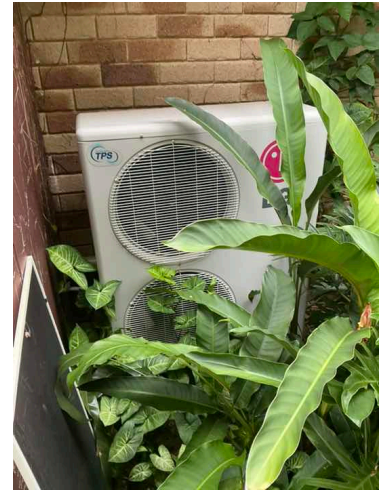
No - Divert A/C overflow away from the building perimeter.
