PEST AND BUILDING PRE-PURCHASE REPORTS

Inspection Report

45 Headlands Dr, Skennars Head, NSW, 2478

Pest And Building Inspection

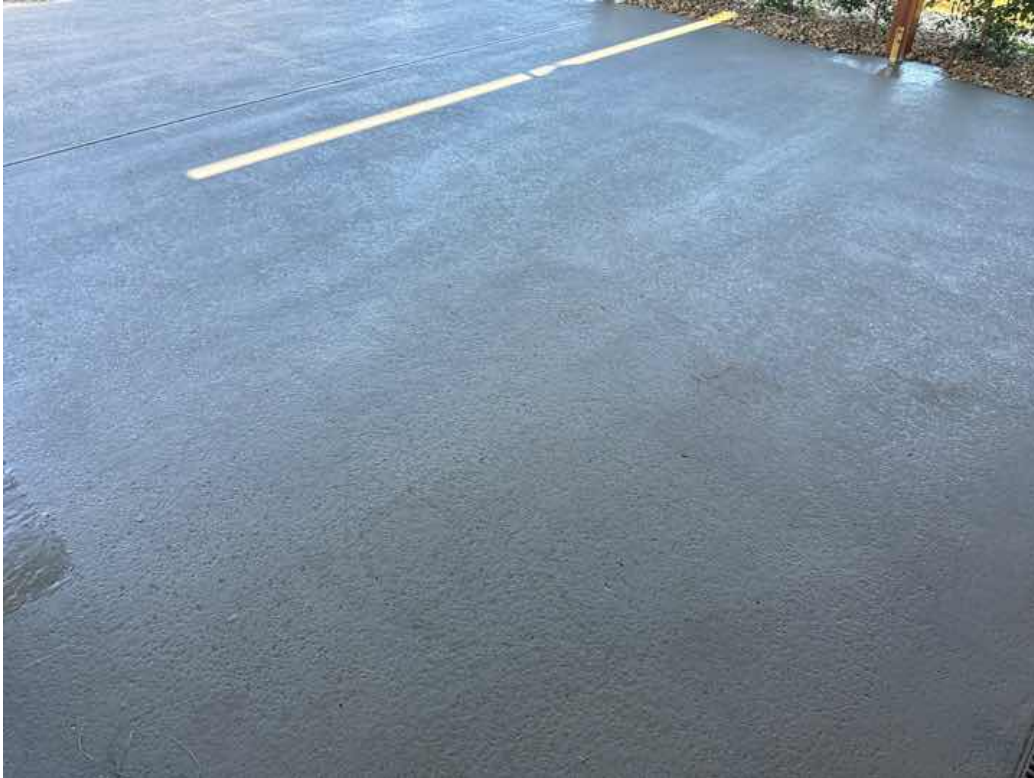
Driveway Condition

On visual inspection, the general condition of the driveway is serviceable.

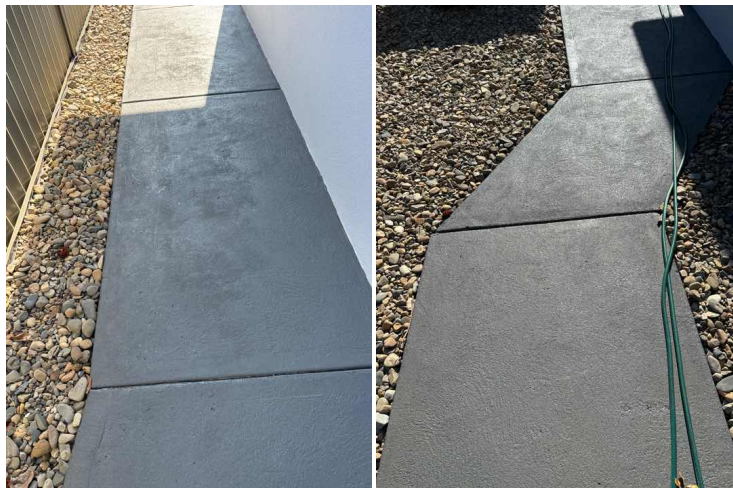
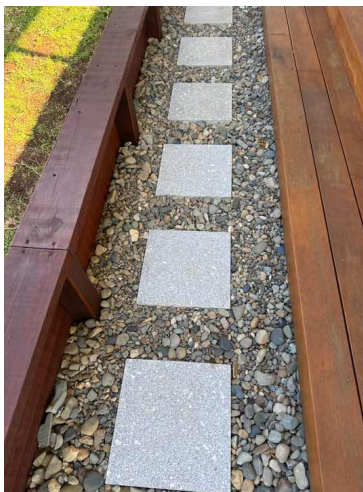
Pathways Condition

The paths around the home are in a serviceable condition for the age of this dwelling with no major defects visible.

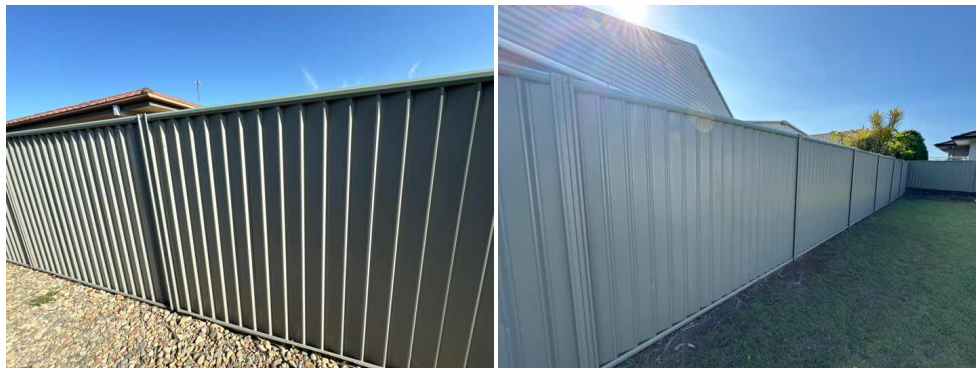
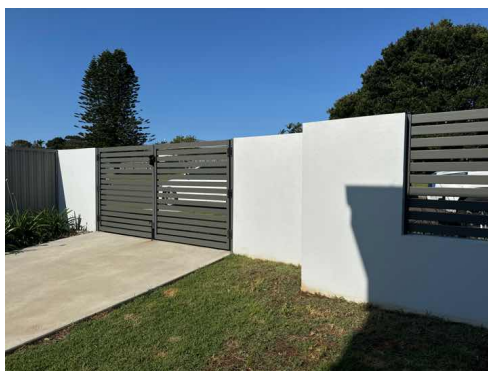
Fences & Gates

Of the visible areas, the general condition of the fences and gates is serviceable for the age of dwelling.

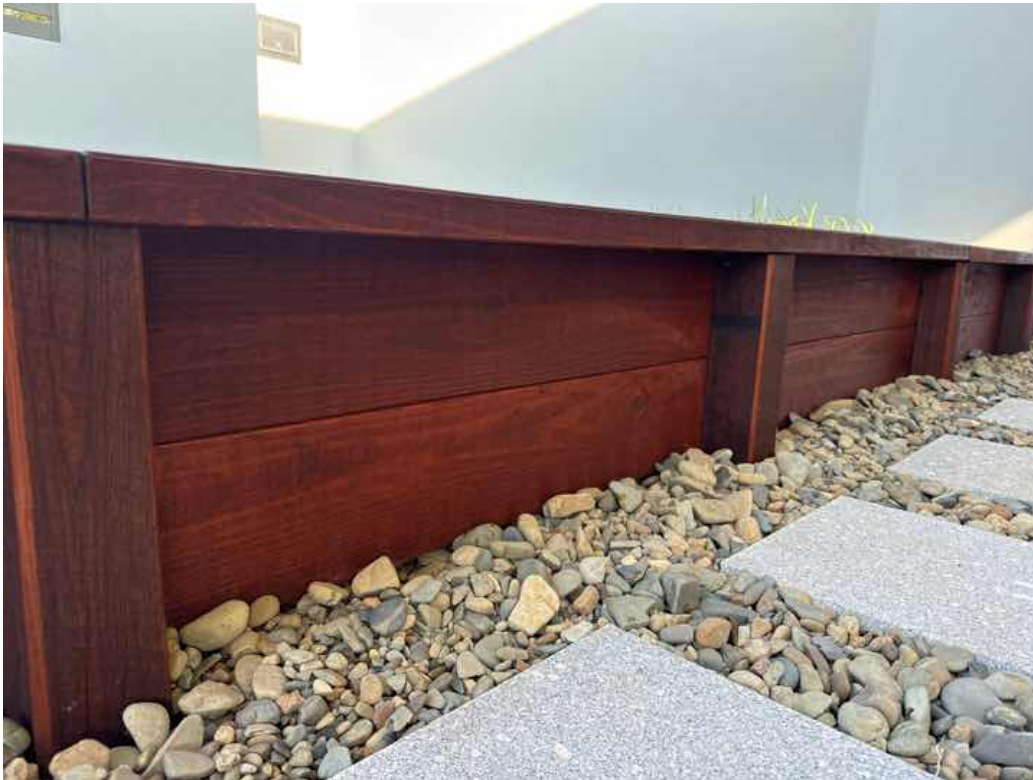
Retaining Walls

Of the visible areas, the general condition is serviceable or in reasonable condition for age of dwelling.

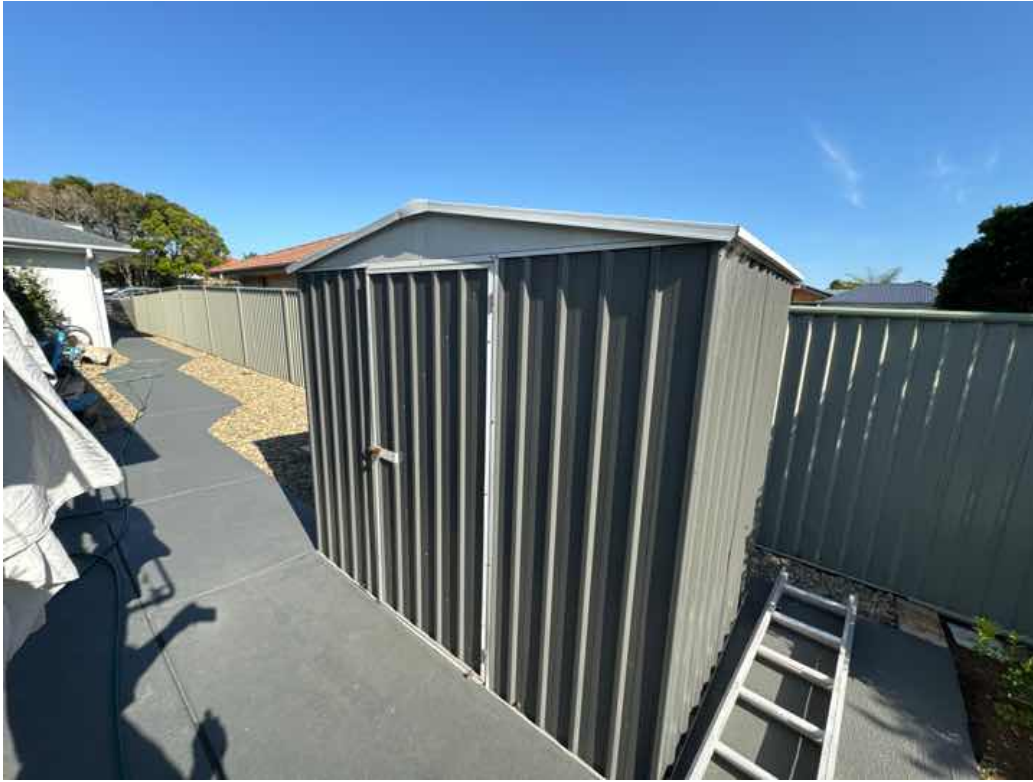
Shed Condition

The shed is in fair usable condition.

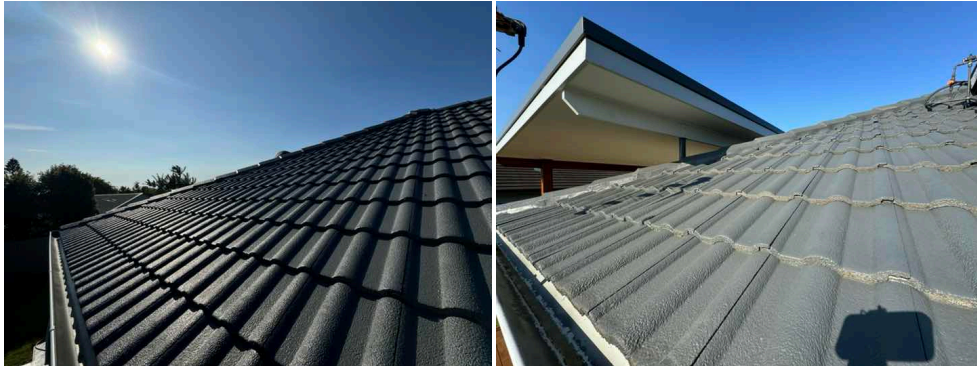
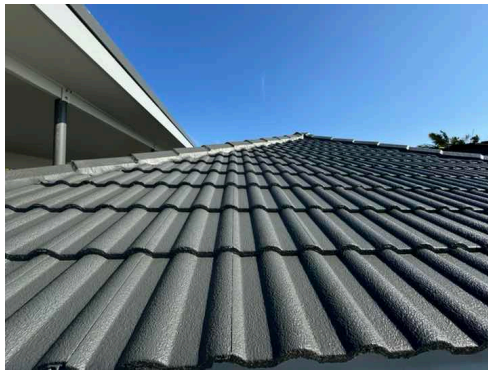
Of the visible areas, the general condition of the roof is in serviceable condition for the age.

Note: In the absence of rainfall there is no guarantee that the roof won't leak.

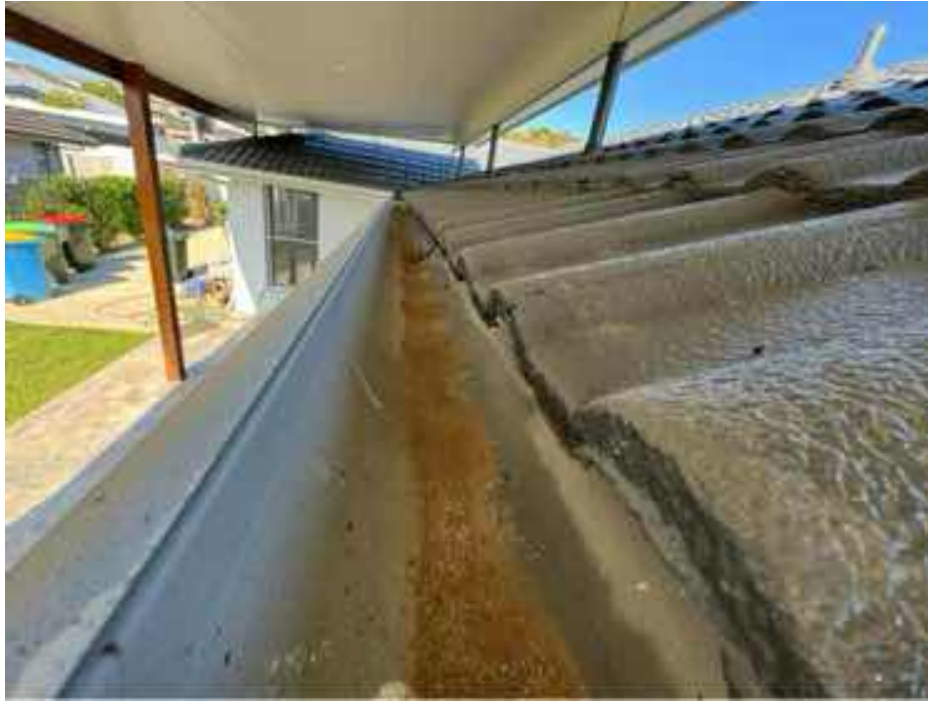
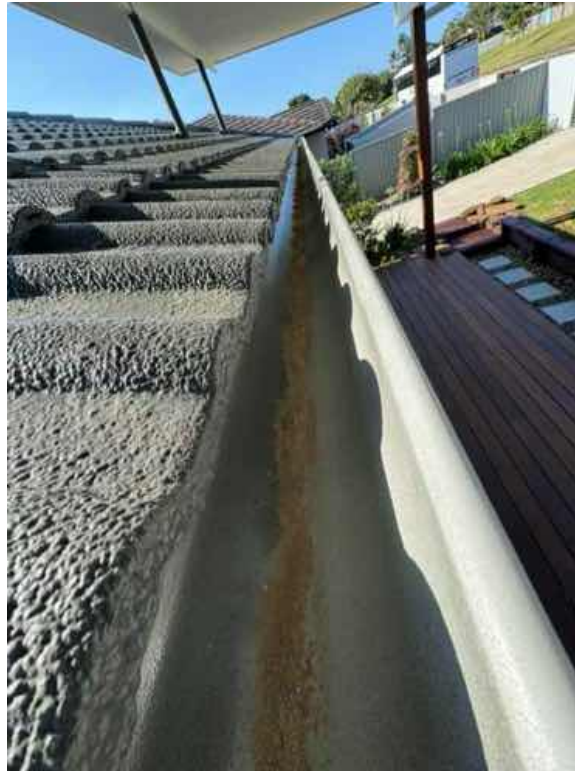
Guttering

All visible and accessible of the physical nature of the guttering system appears to be in a serviceable condition with no apparent defects at the time of inspection. In the absence of prolonged rain fall efficiency of the guttering can not be assessed and you may find that further investigation or repairs maybe required. Note: Periodic maintenance checks should be carried out for rust penetrations and leaks.

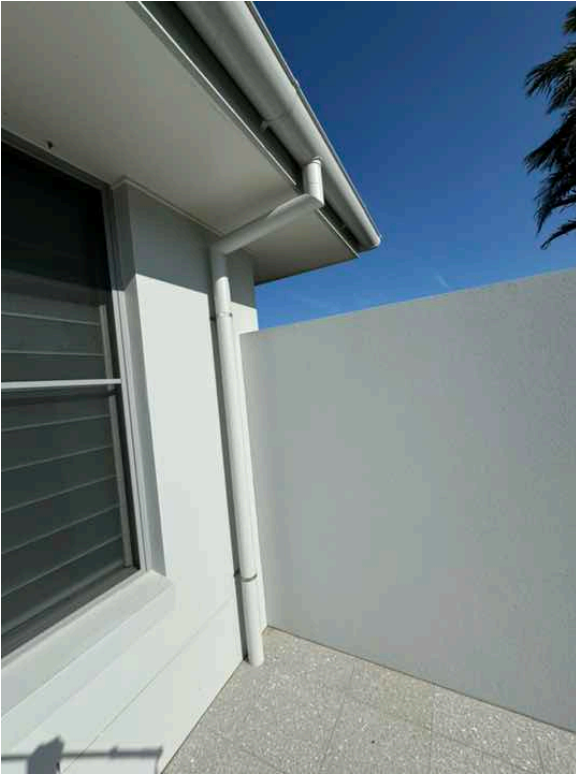
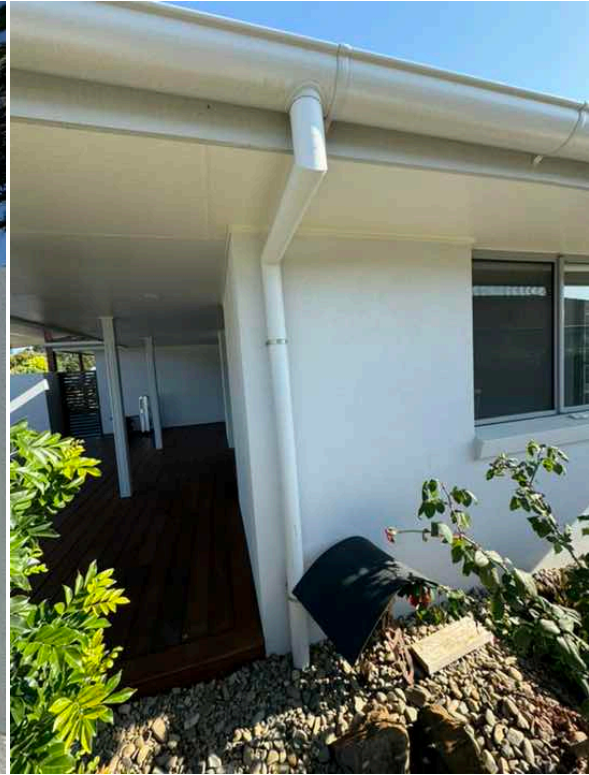
Downpipes

On visual inspection no apparent defects were noted to the down pipes and are considered serviceable, however no comment can be made with regard to blockages or connections to stormwater or functionality in the absence of rain. Note: Periodic maintenance checks should be carried out for rust penetrations and leaks.

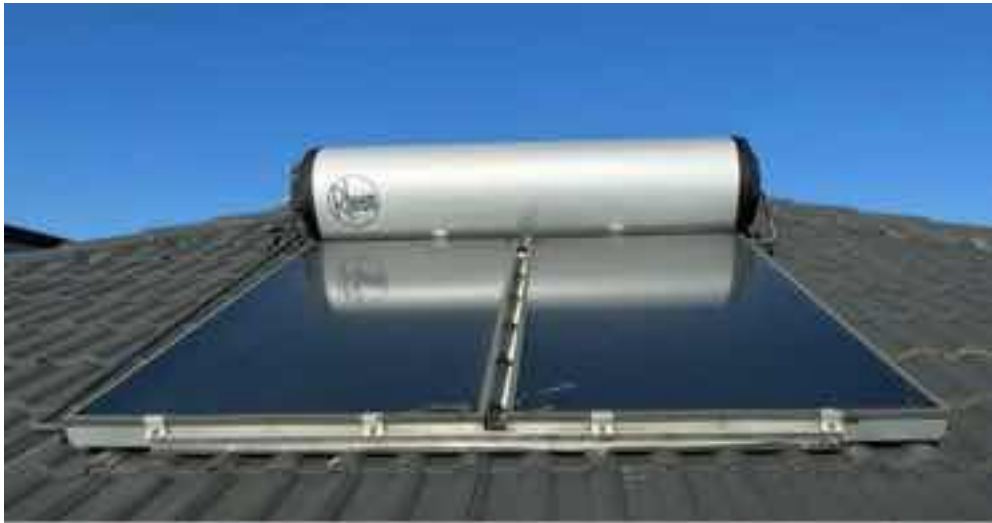
System Make

The make of the hot water unit is rheem.

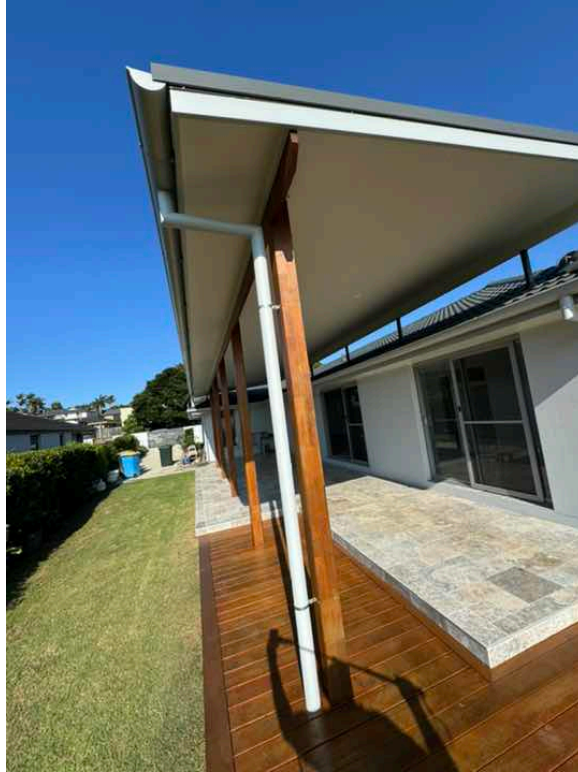
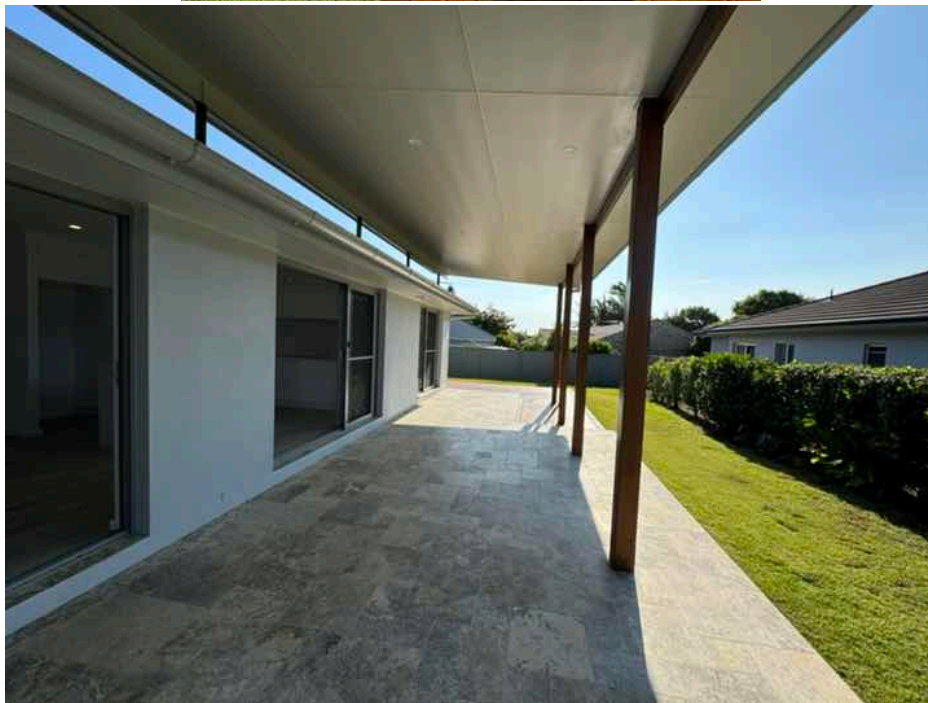
Visible sections of the Alfresco area are serviceable or in reasonable or condition for the age of this dwelling.

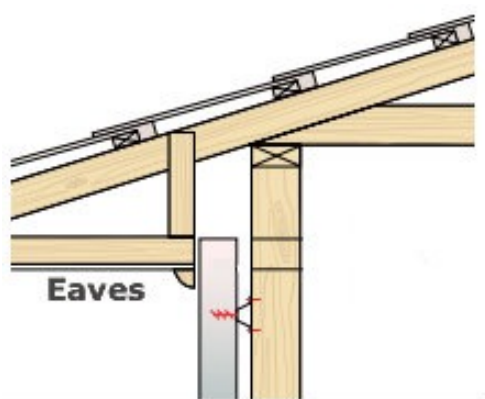
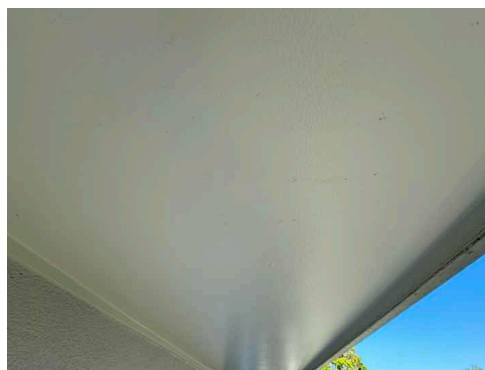
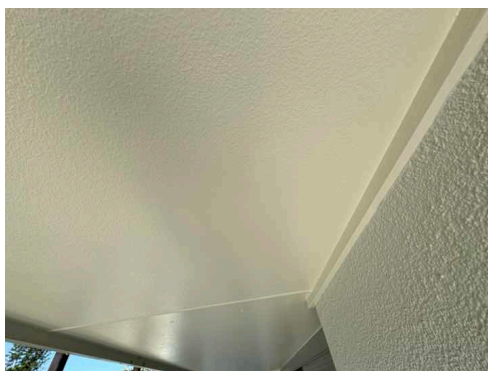
Eaves

The soffit lining (eaves) are in a serviceable condition with no notable defects.

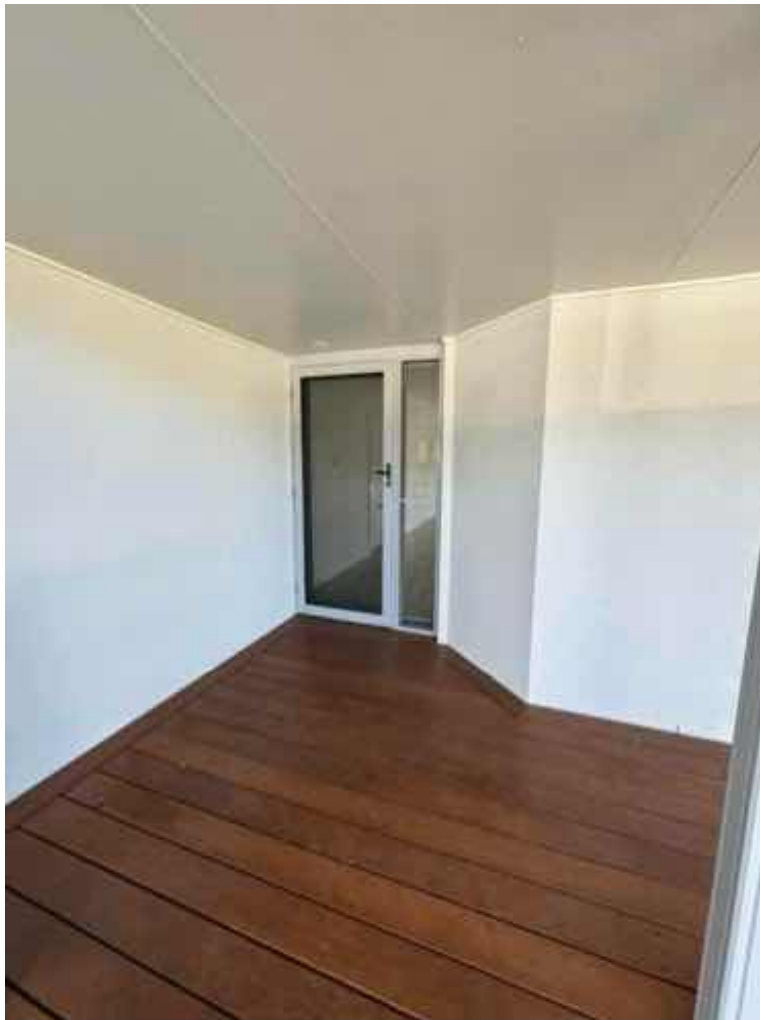
Entry Porch Area

The entry porch serviceable or in reasonable or condition for the age of this dwelling.

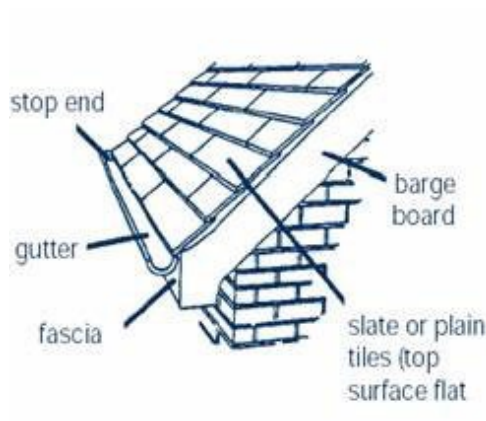
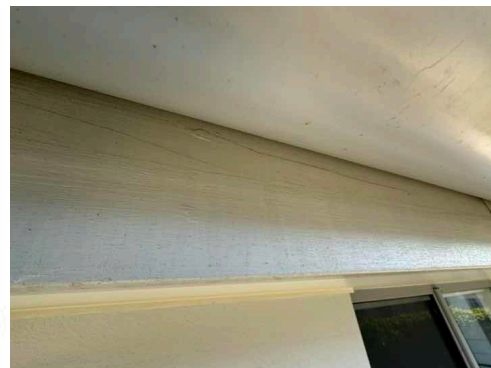
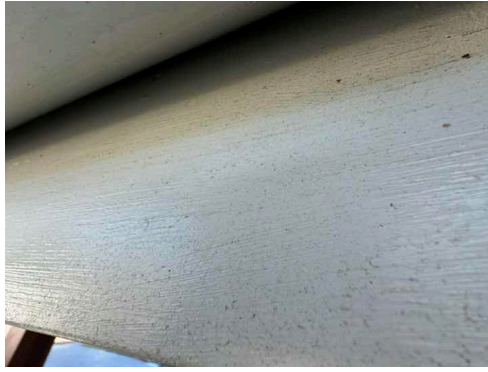
On visual inspection, the general condition of the fascia/barge boards is serviceable.

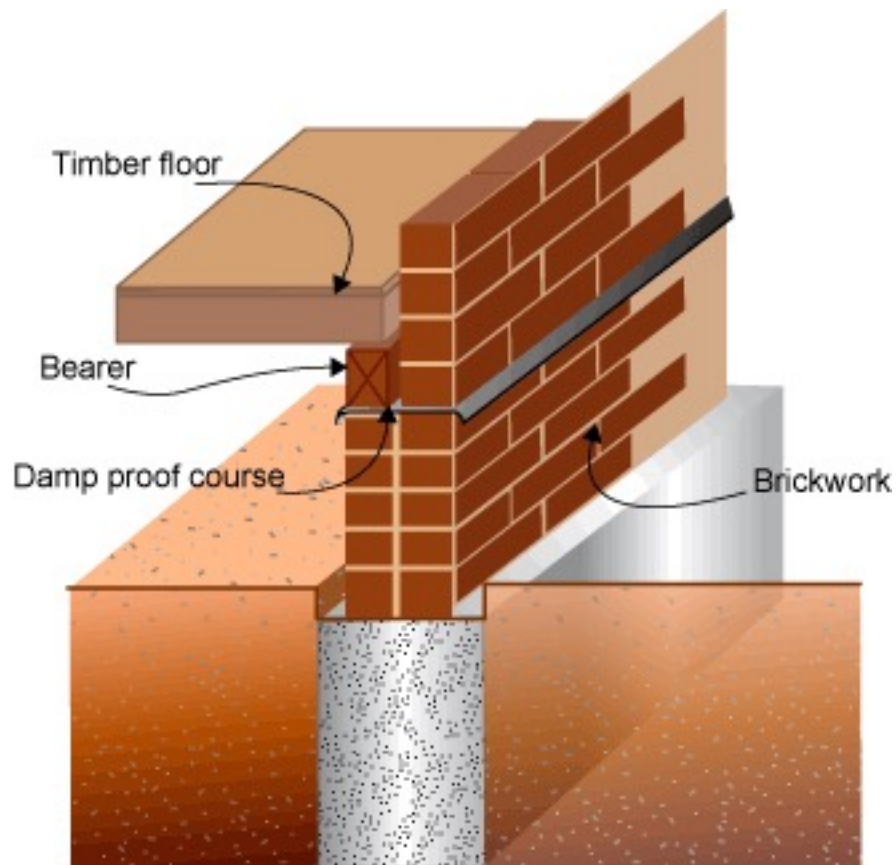
Damp Proof Course

A damp proof course (DPC) was noted.

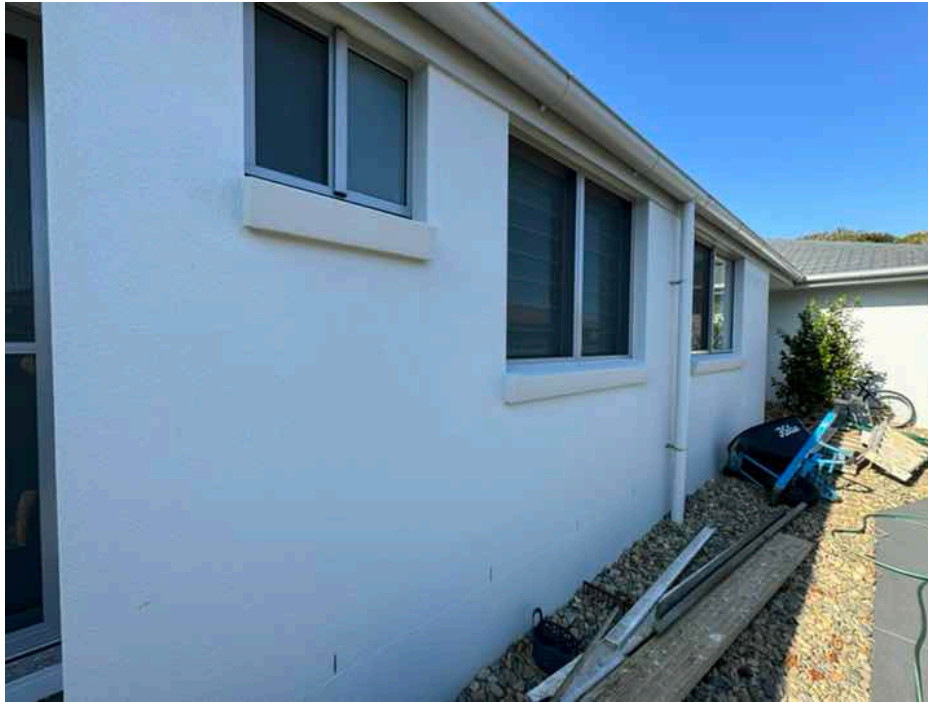
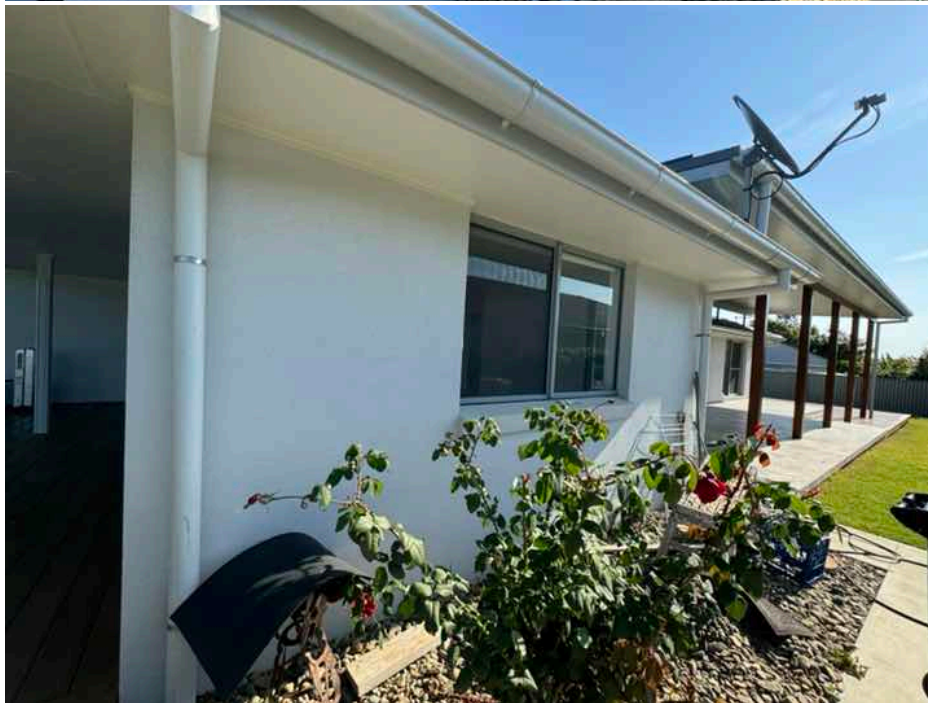
Walls

On visual inspection, the general condition of the exterior walls is serviceable for the age.

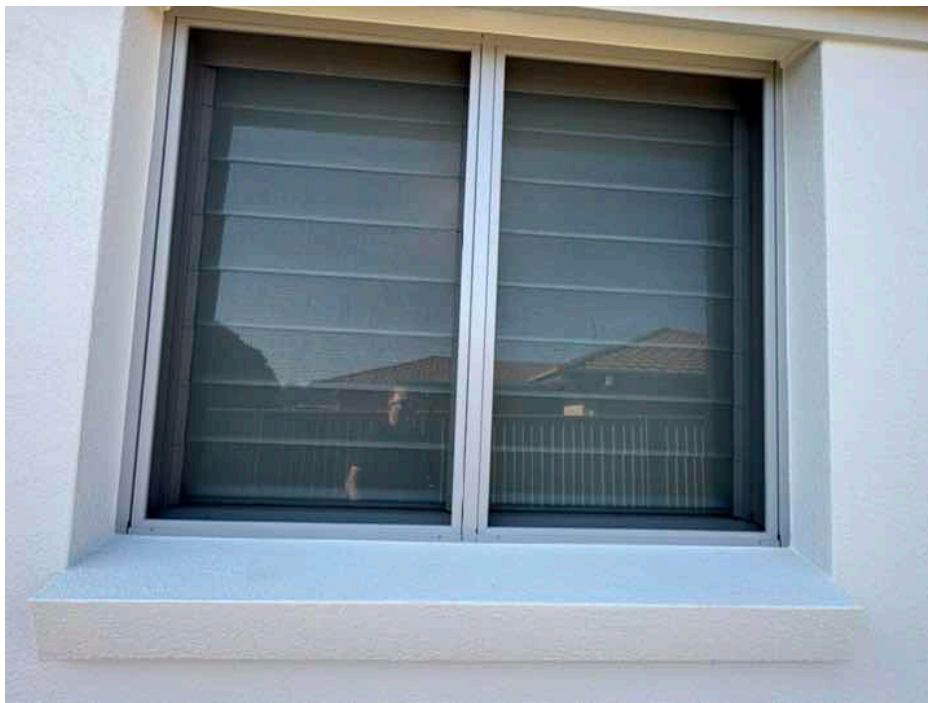
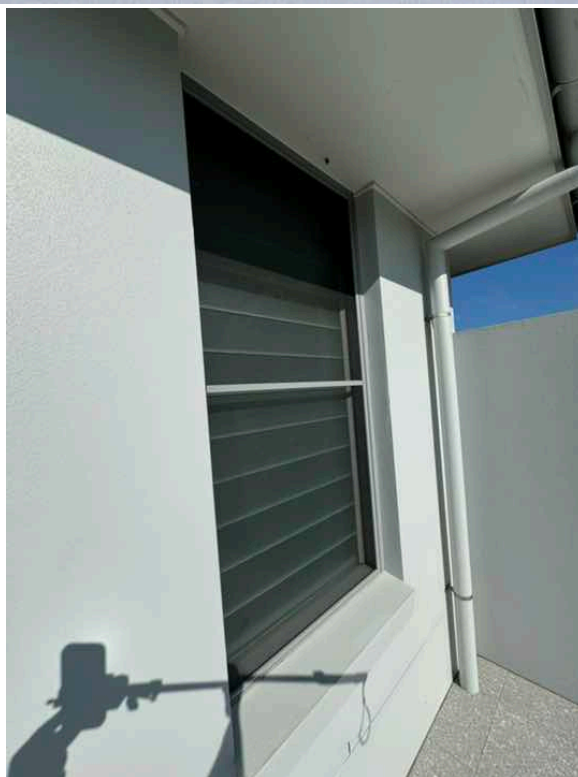
Windows

On visual inspection, the general condition of the windows is serviceable for the age.

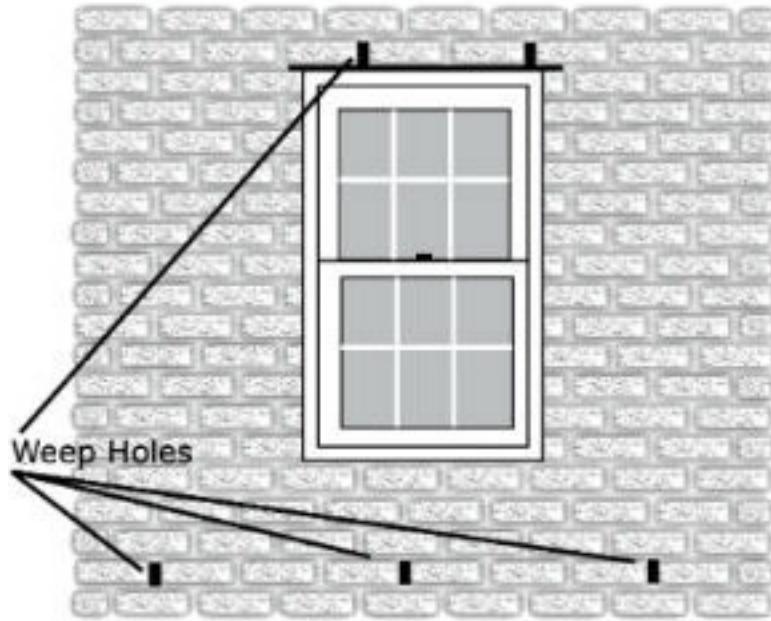
Weep Holes and Ventilation

The weep holes are unobstructed .

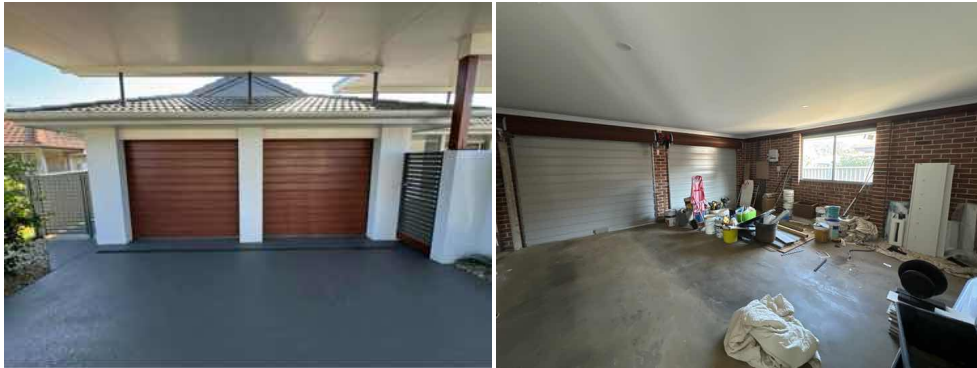
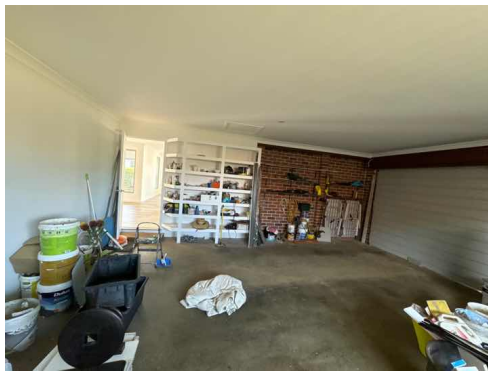
From the visible and accessible areas, the garage appears to be in a serviceable condition for the age of the property with no notable structural defects sighted.

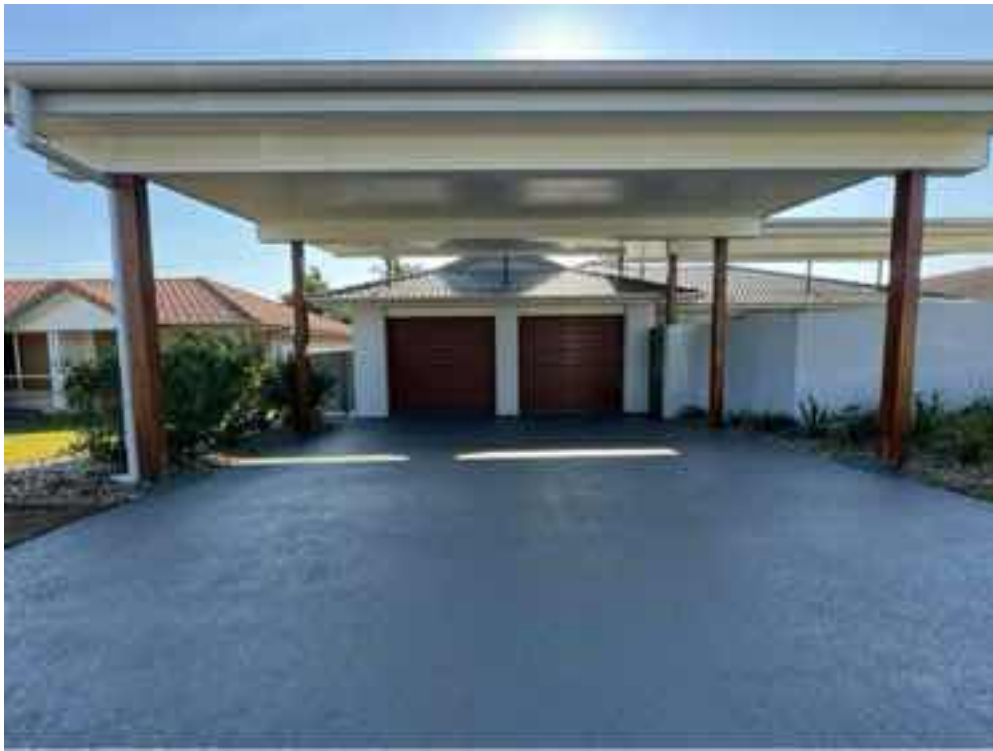
Carport

The overall condition of the carport is serviceable for the age.

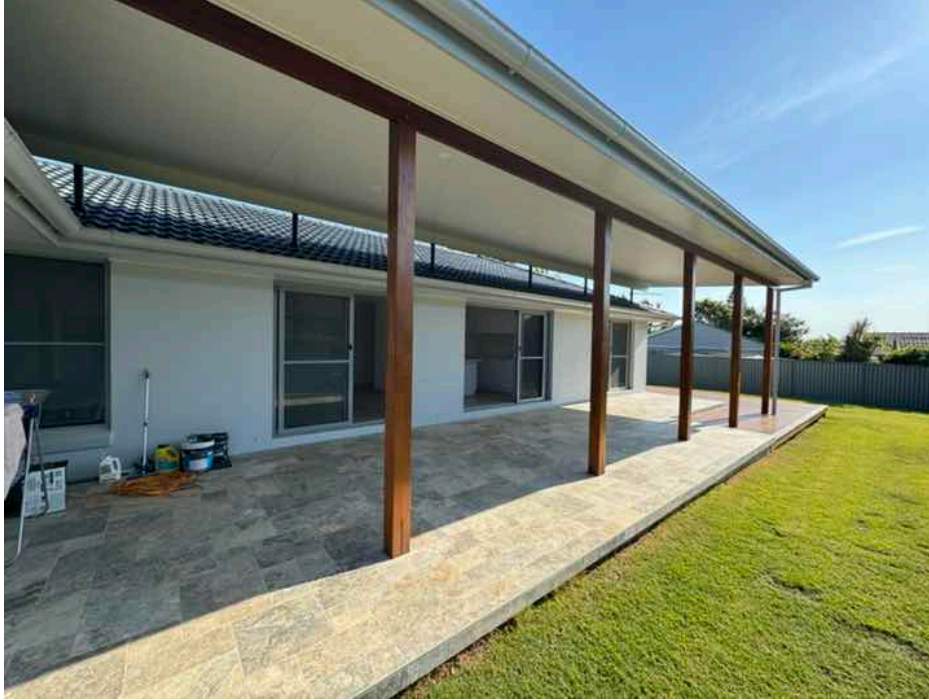
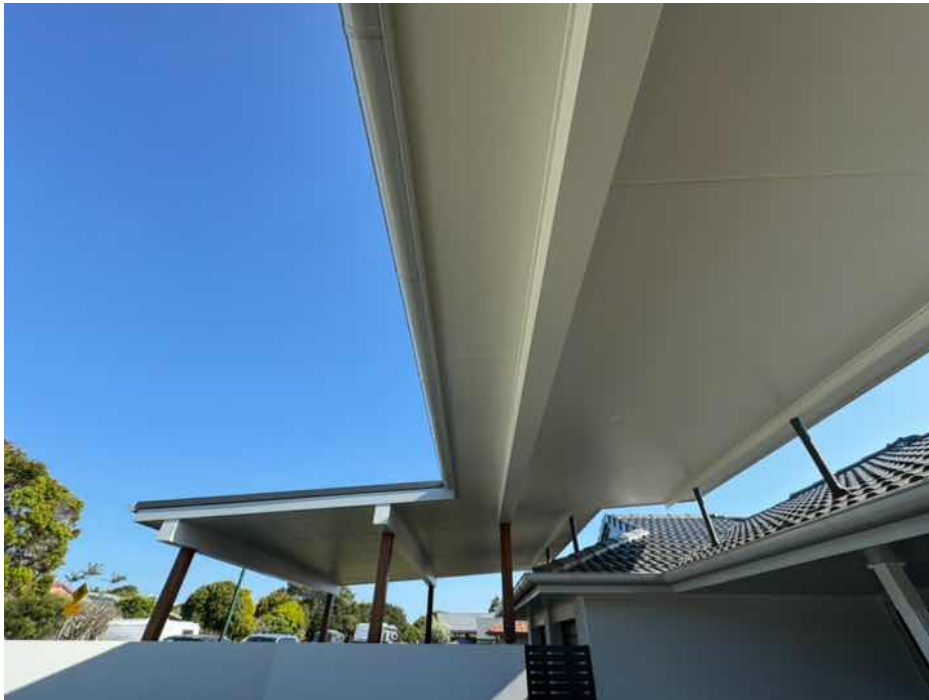
The Pergola is in a serviceable condition with no notable defects sighted.

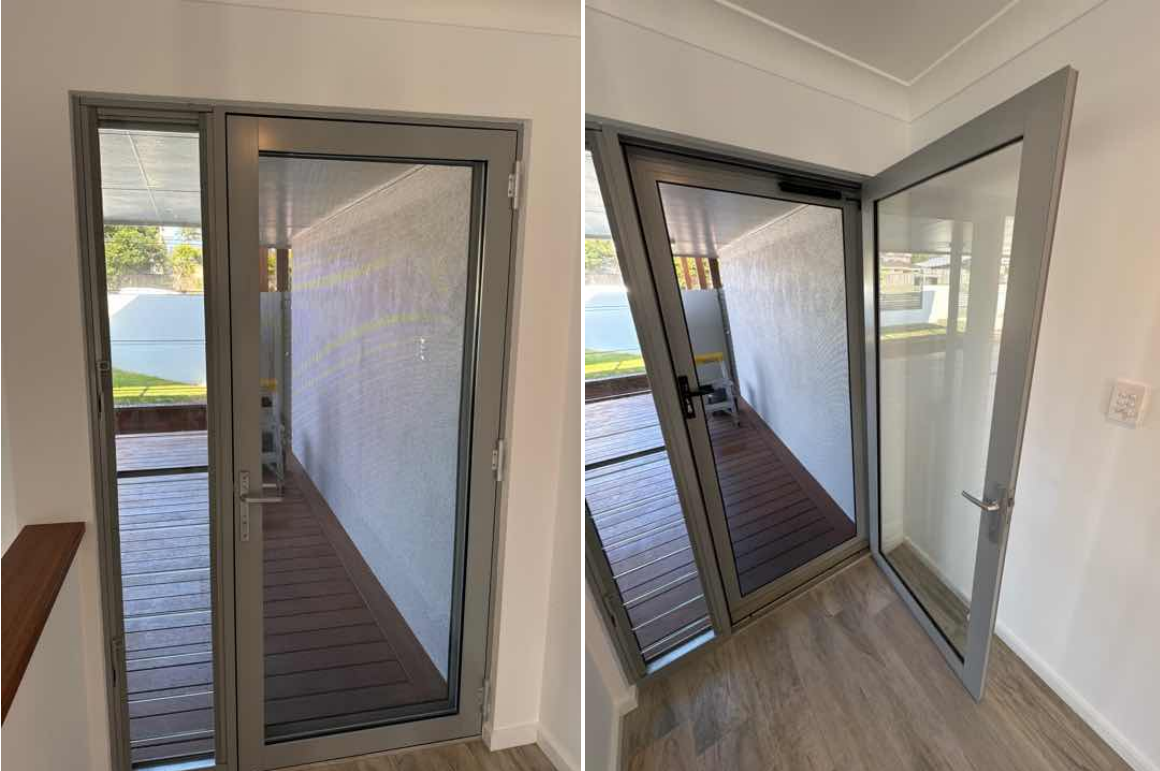
Front Entry Doors

The doors are in serviceable condition with no notable defects observed.

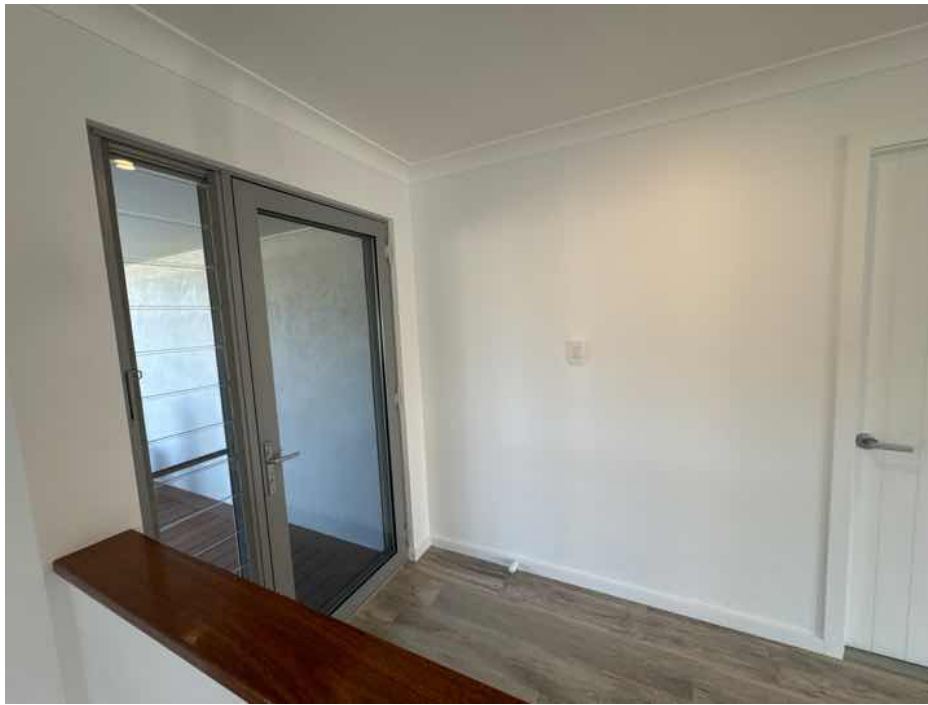
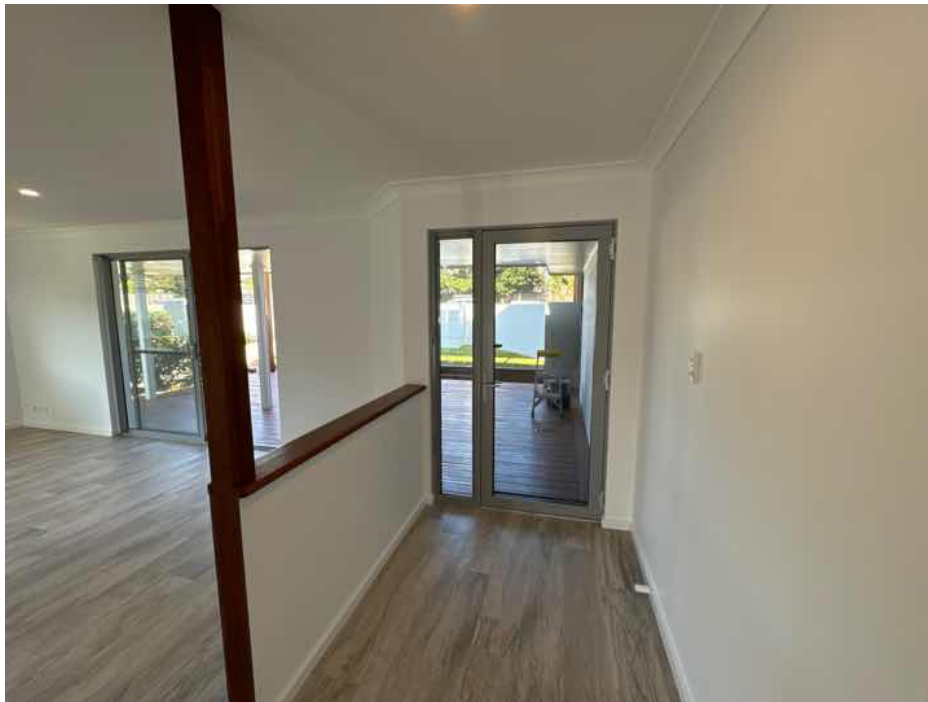
From the visible and accessible areas, this area appears to be in a serviceable condition for the age of the property with no notable structural defects sighted.

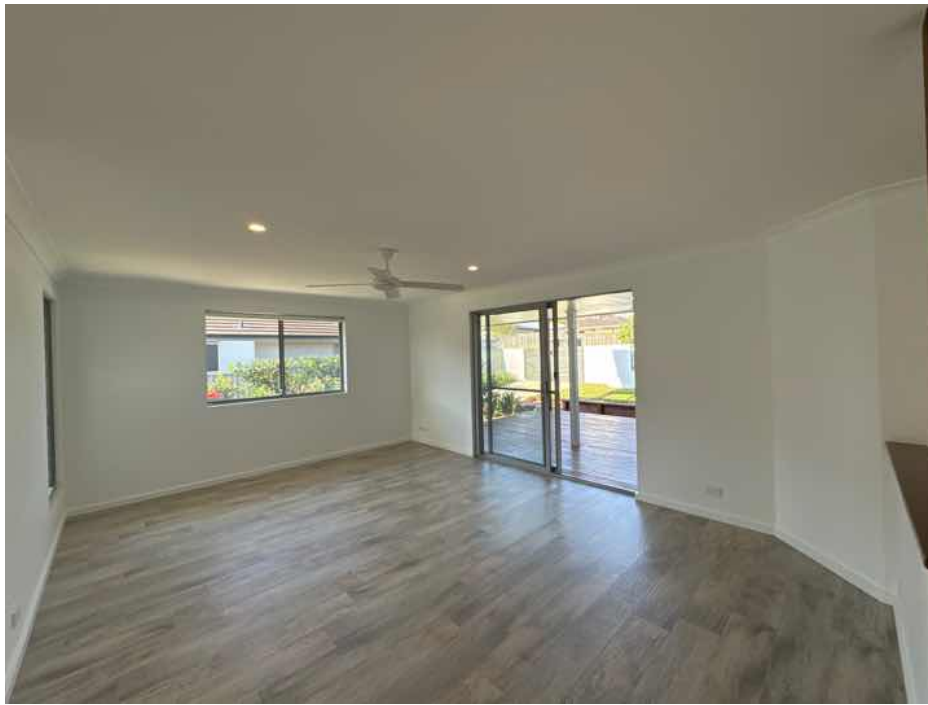
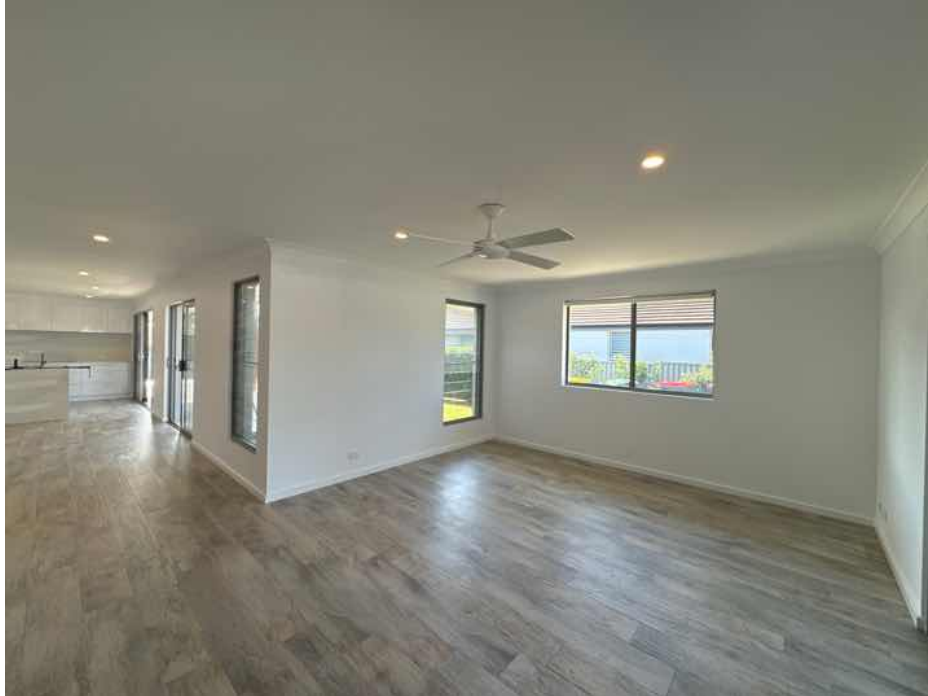
Living Room

From the visible and accessible areas, this room appears to be in a serviceable condition for the age of the property with no notable structural defects sighted.

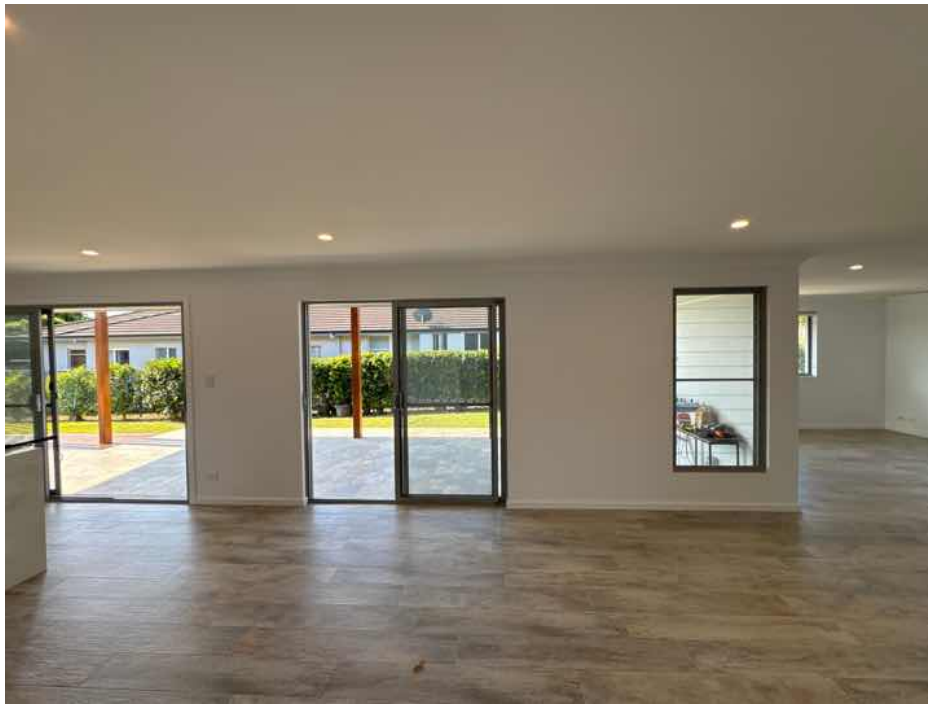
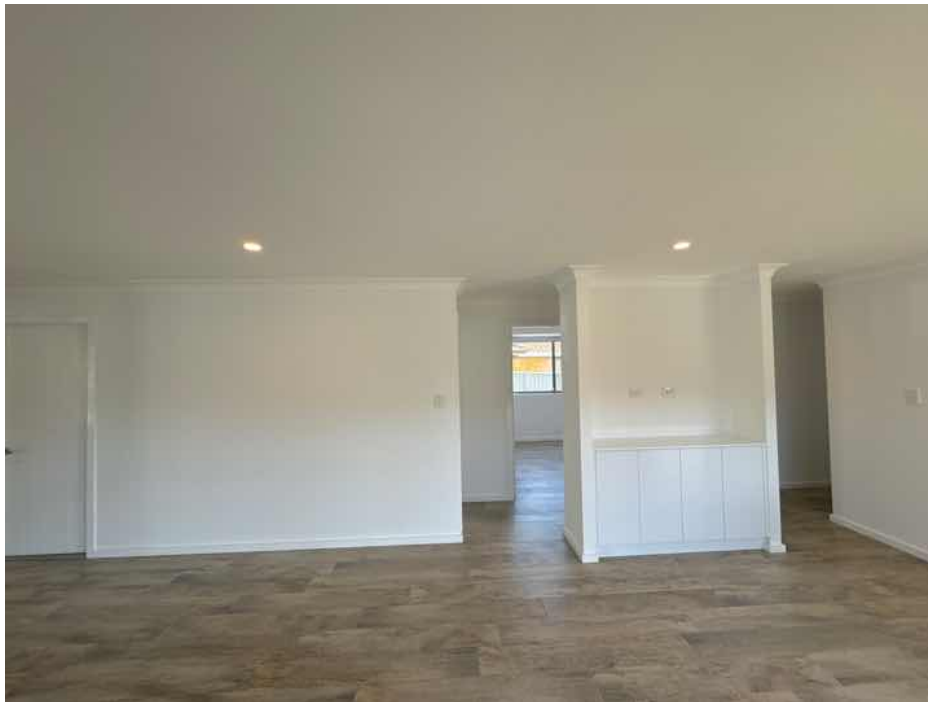
Dining Room

From the visible and accessible areas, this room appears to be in a serviceable condition for the age of the property with no notable structural defects sighted.

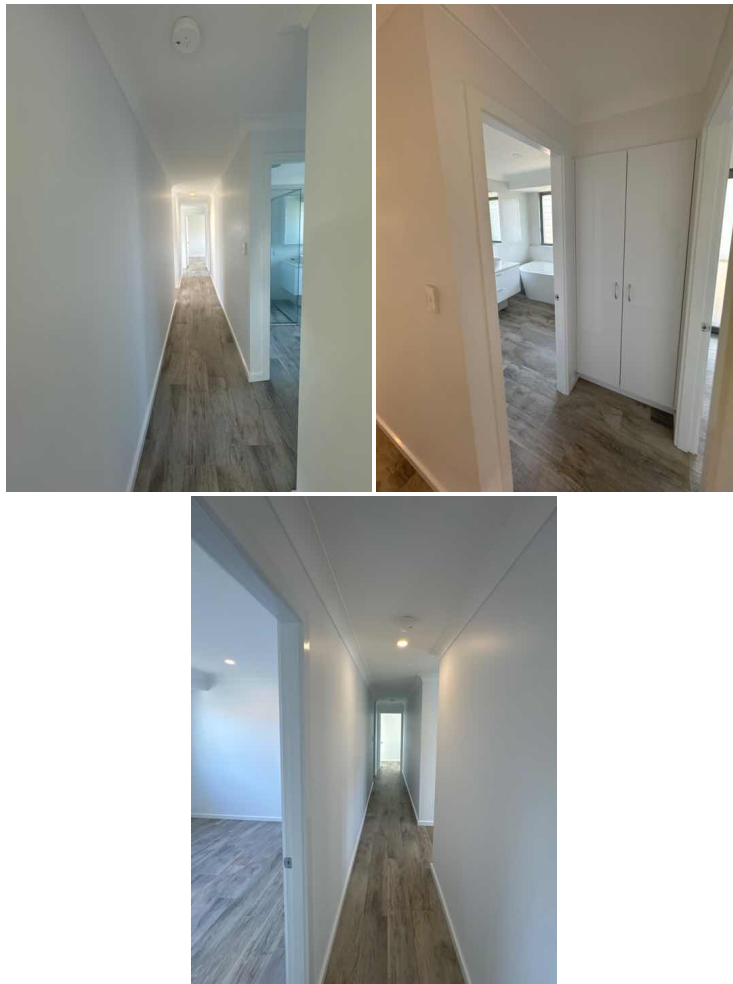
Hallway/s

From the visible and accessible areas, the hallway/s/ appears to be in a serviceable condition for the age of the property with no notable structural defects sighted.
