PEST AND BUILDING PRE-PURCHASE REPORTS

Inspection Report

45 Headlands Dr, Skennars Head, NSW, 2478

Pest And Building Inspection

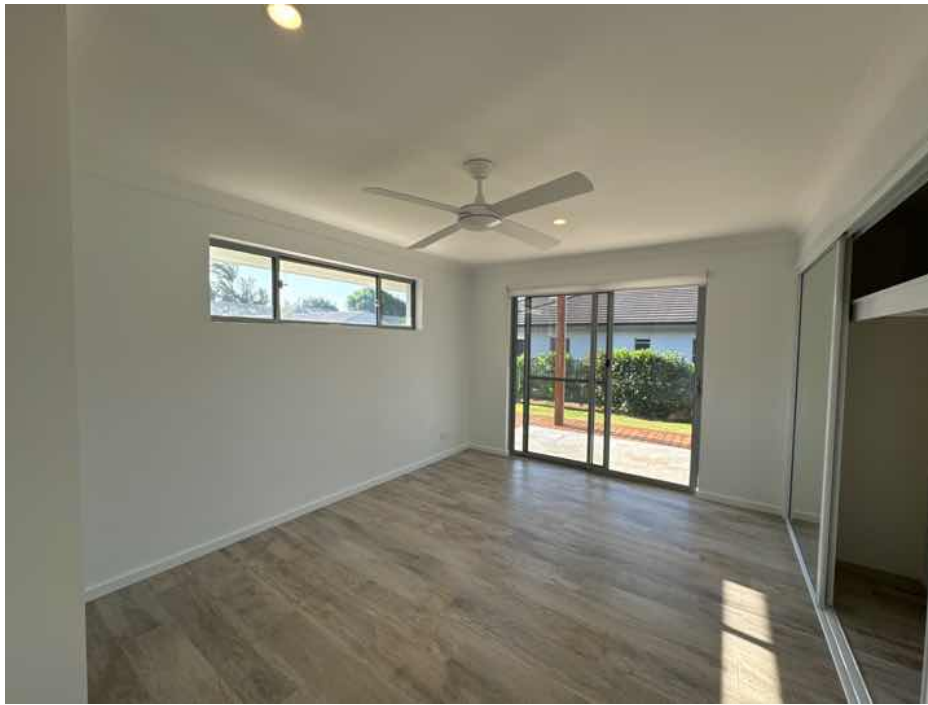
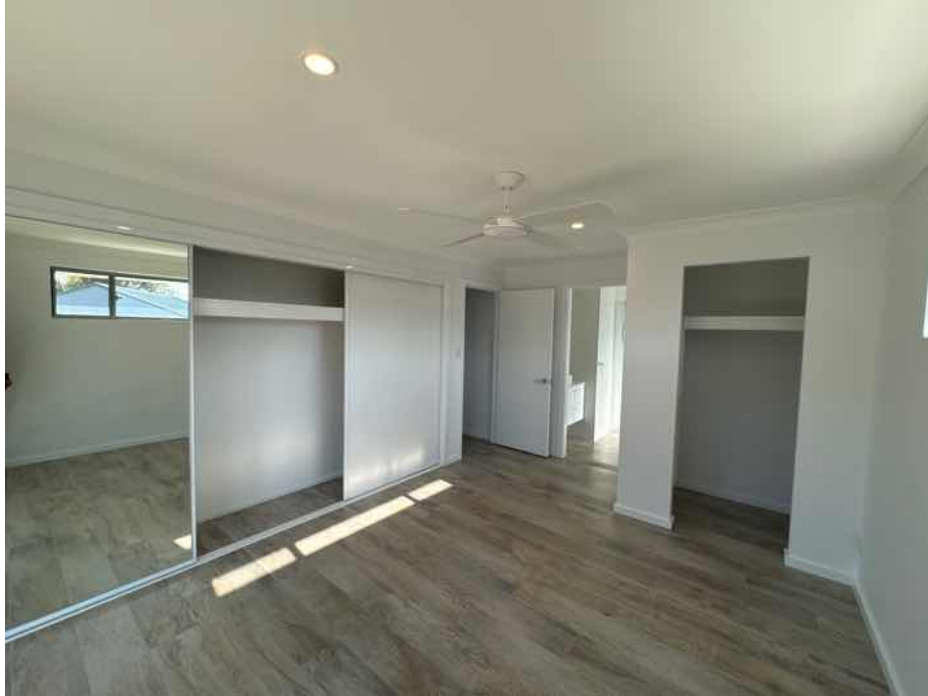
From the visible and accessible areas, this bedroom appears to be in a serviceable condition for the age of the property with no notable structural defects sighted.

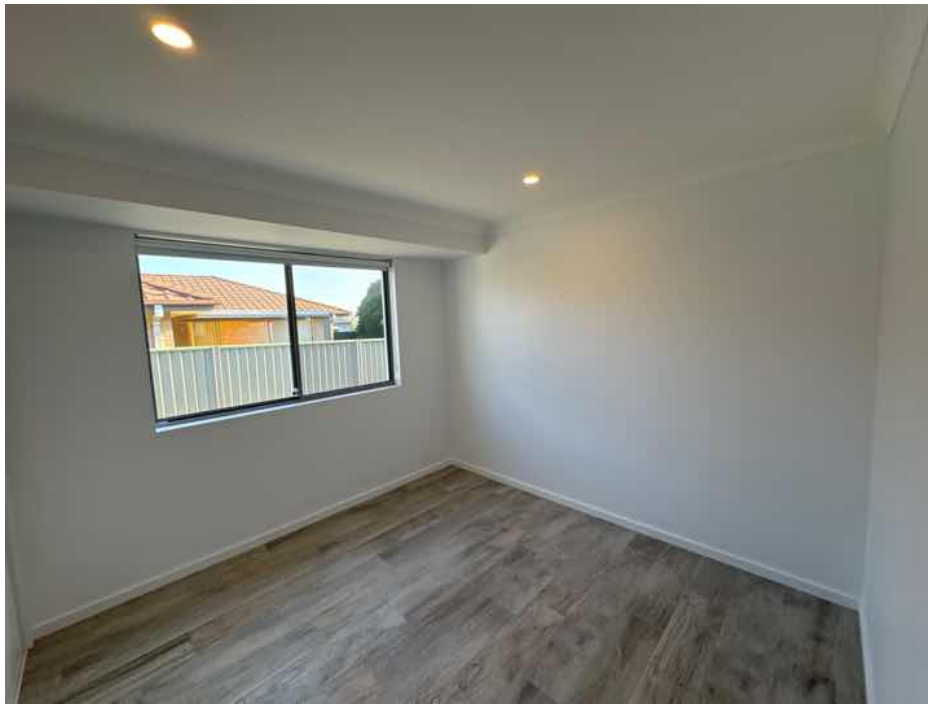
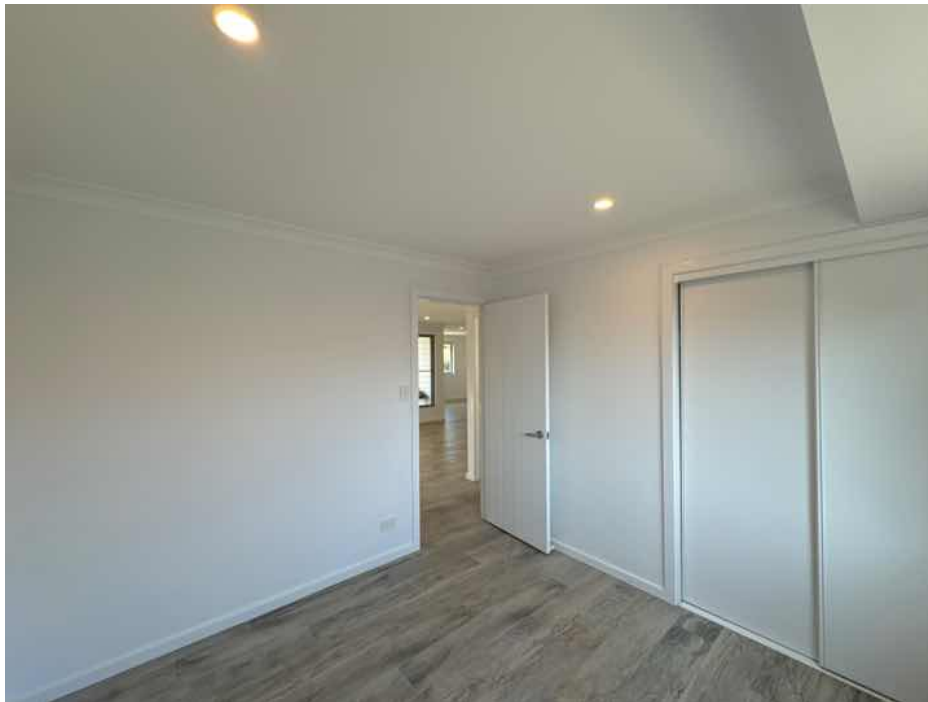
Bedroom 2

From the visible and accessible areas, this bedroom appears to be in a serviceable condition for the age of the property with no notable structural defects sighted.

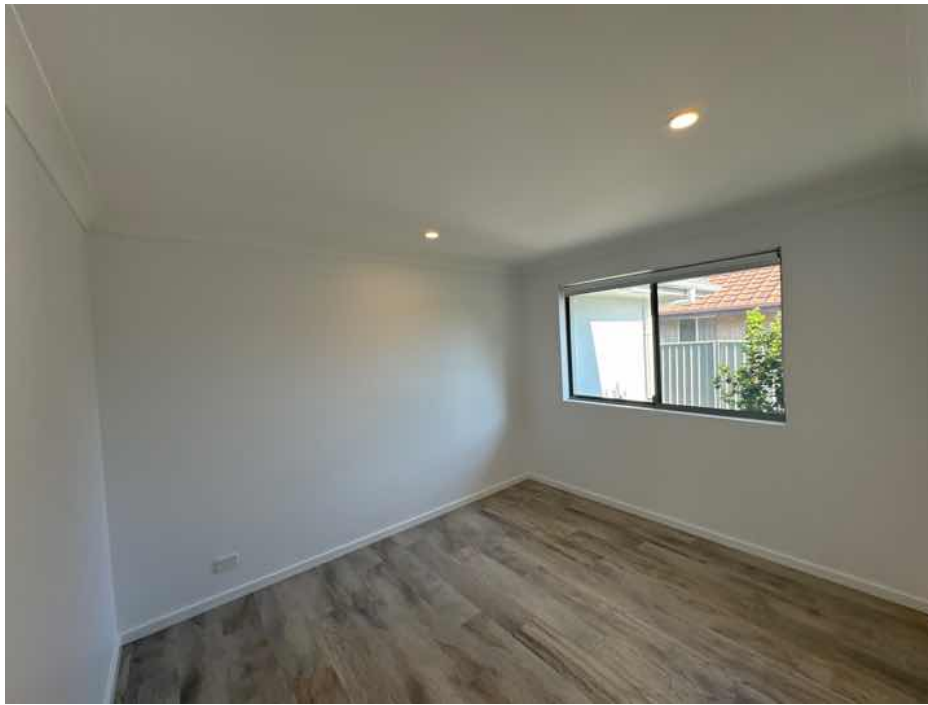
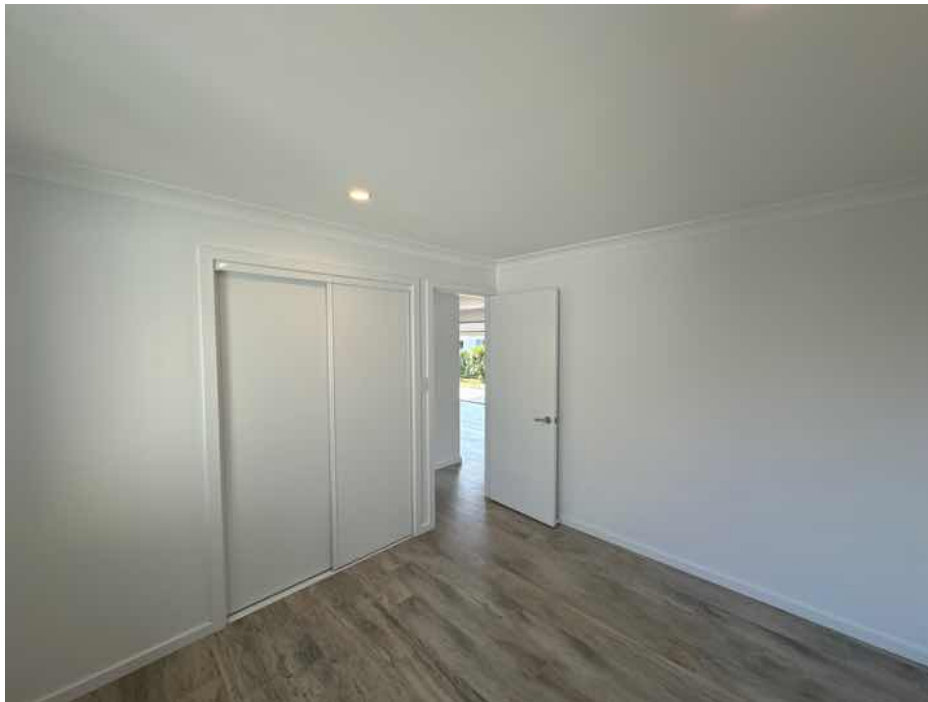
Bedroom 3

From the visible and accessible areas, this bedroom appears to be in a serviceable condition for the age of the property with no notable structural defects sighted.

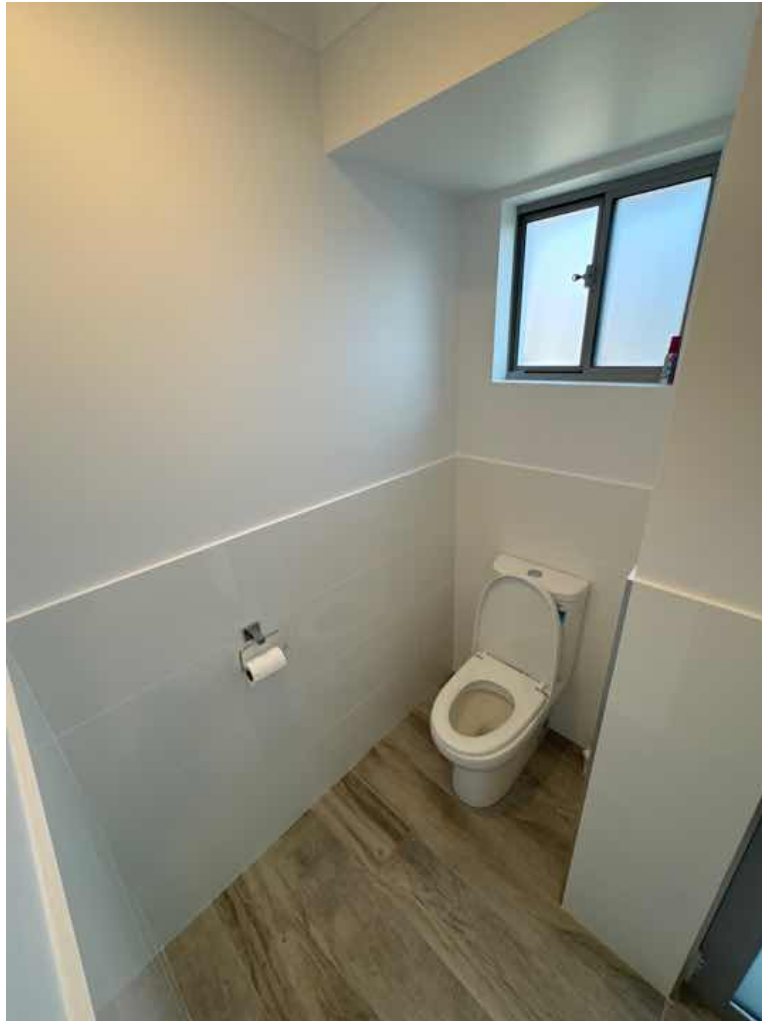
Of the visible areas, the general condition of this bathroom is serviceable or in reasonable condition for age of dwelling.

No exhaust fan is installed - Recommend having one installed.

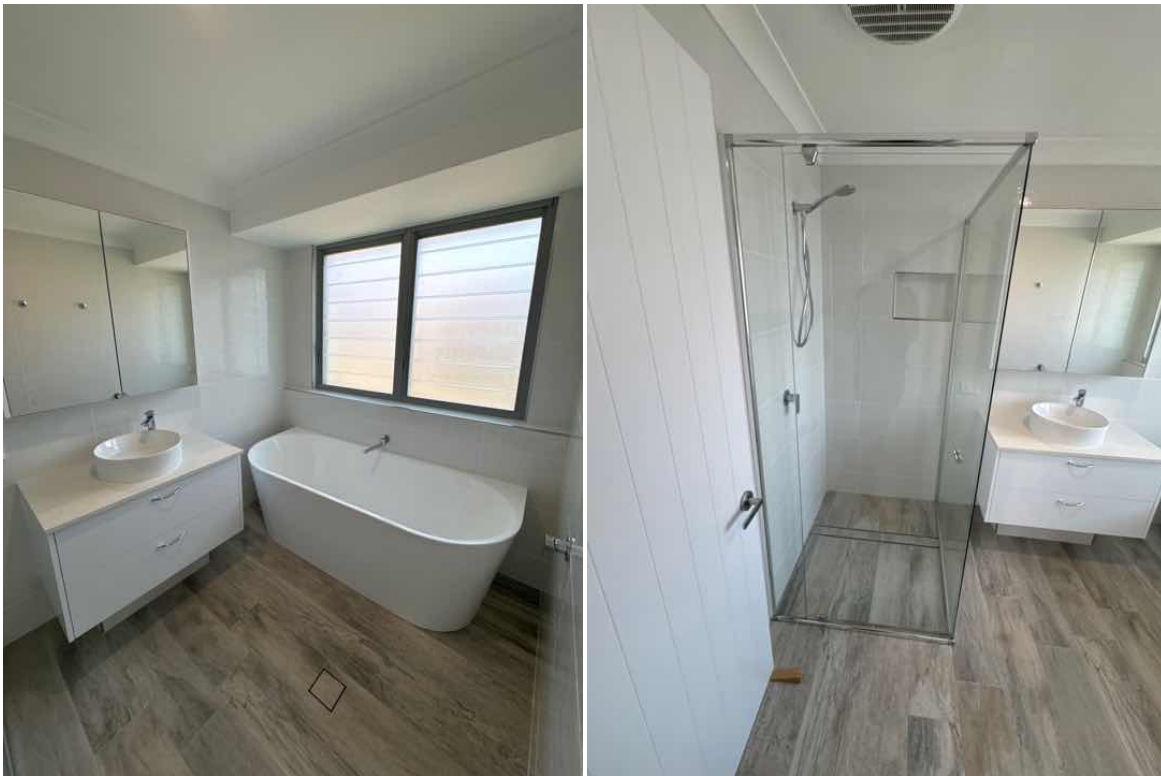
Of the visible areas, the general condition of this bathroom is serviceable or in reasonable condition for age of dwelling.

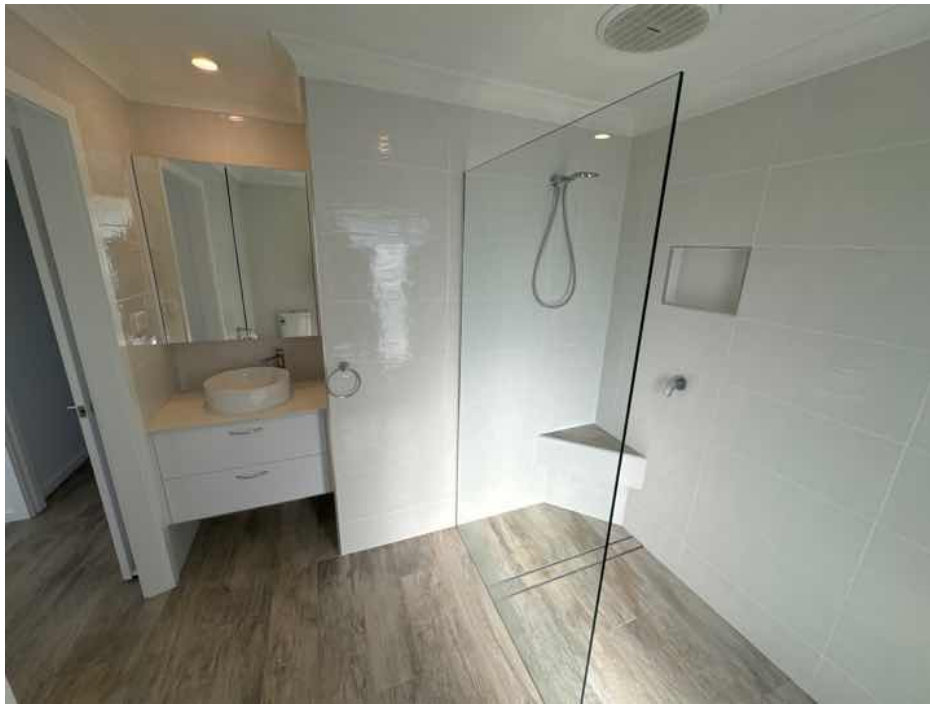
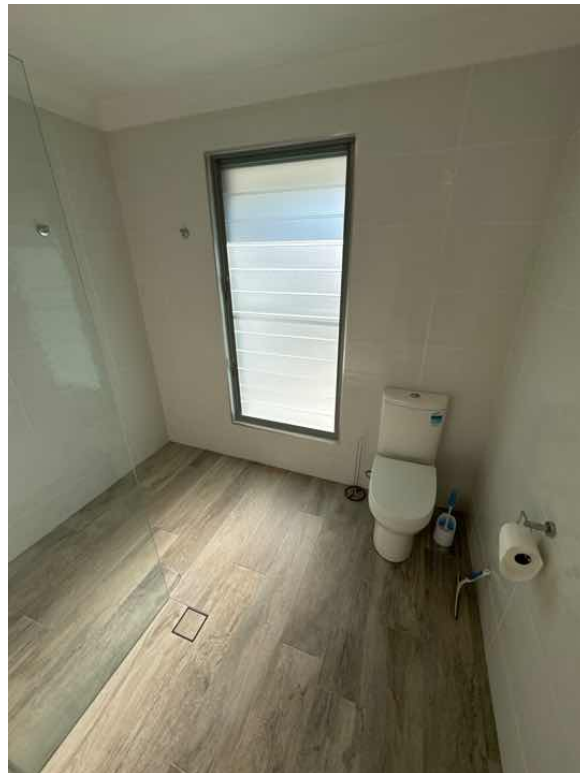
Of the visible areas, the general condition of this bathroom is serviceable or in reasonable condition for age of dwelling.

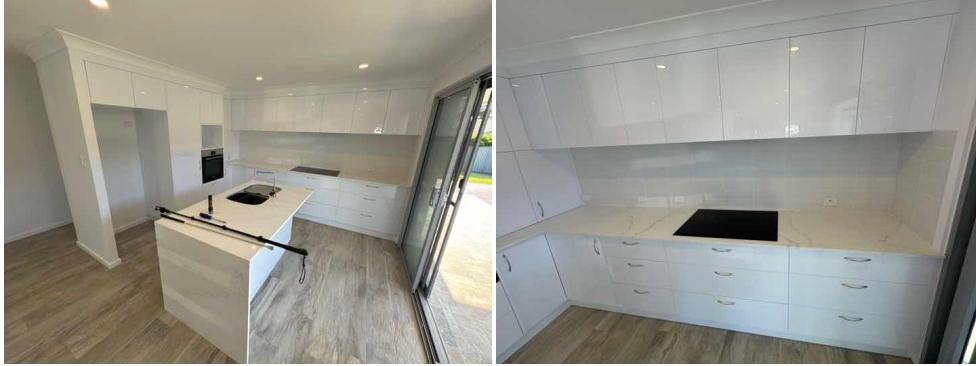
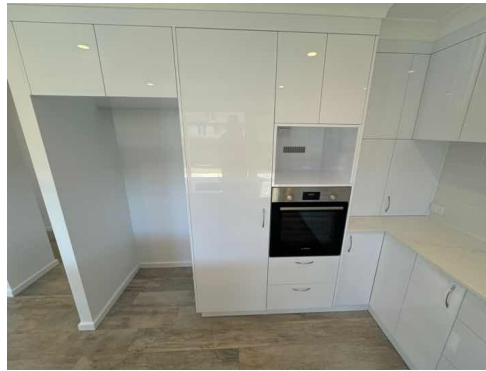
Of the visible areas, the general condition of the kitchen and pantry is serviceable or in reasonable condition for age of dwelling.

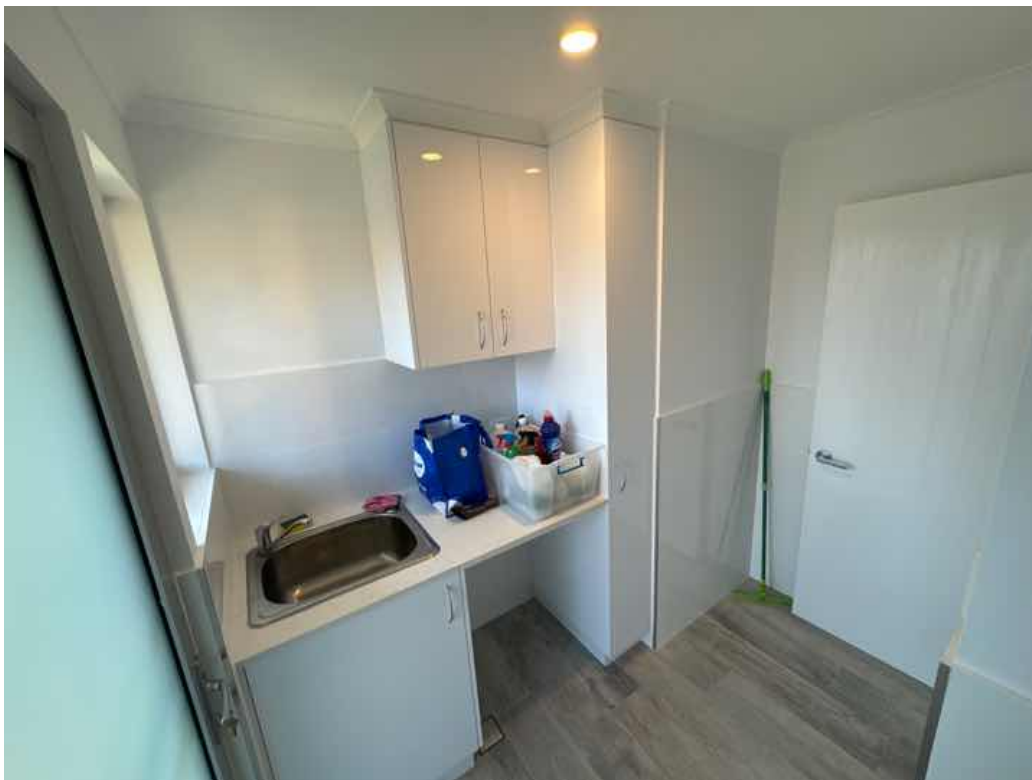
Of the visible areas, the general condition of the laundry is serviceable or in reasonable condition for age of dwelling.

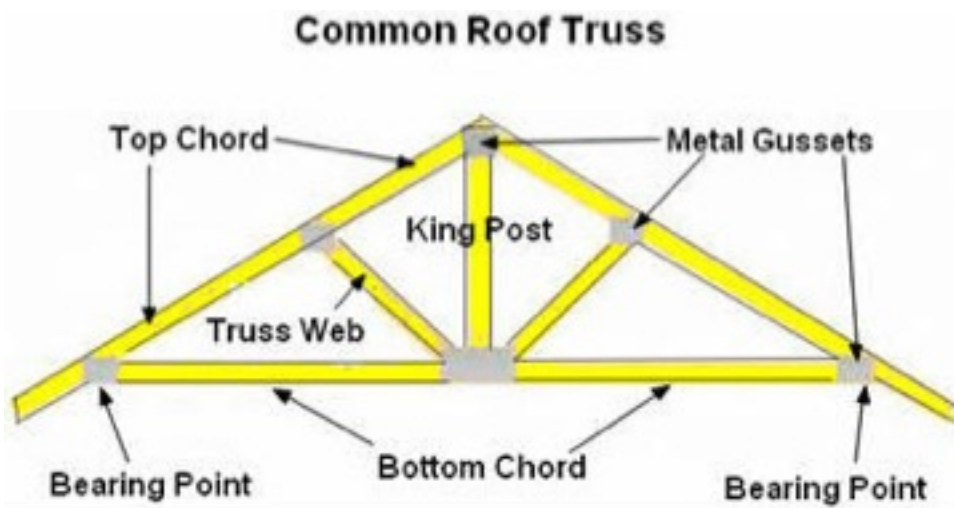
Roof Frame Type

The roof frame is a truss timber frame.

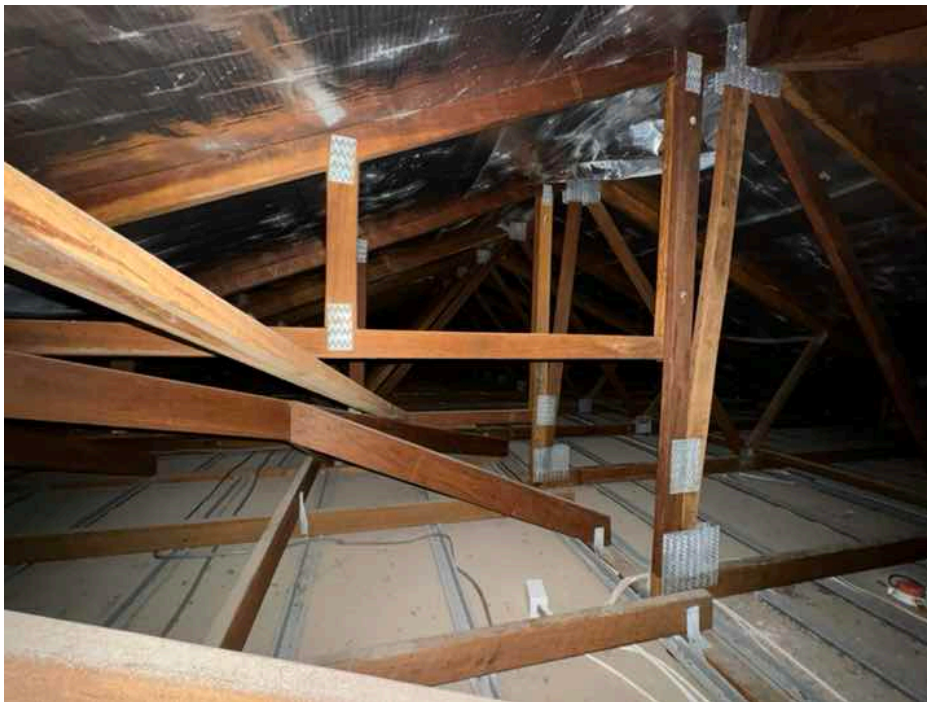
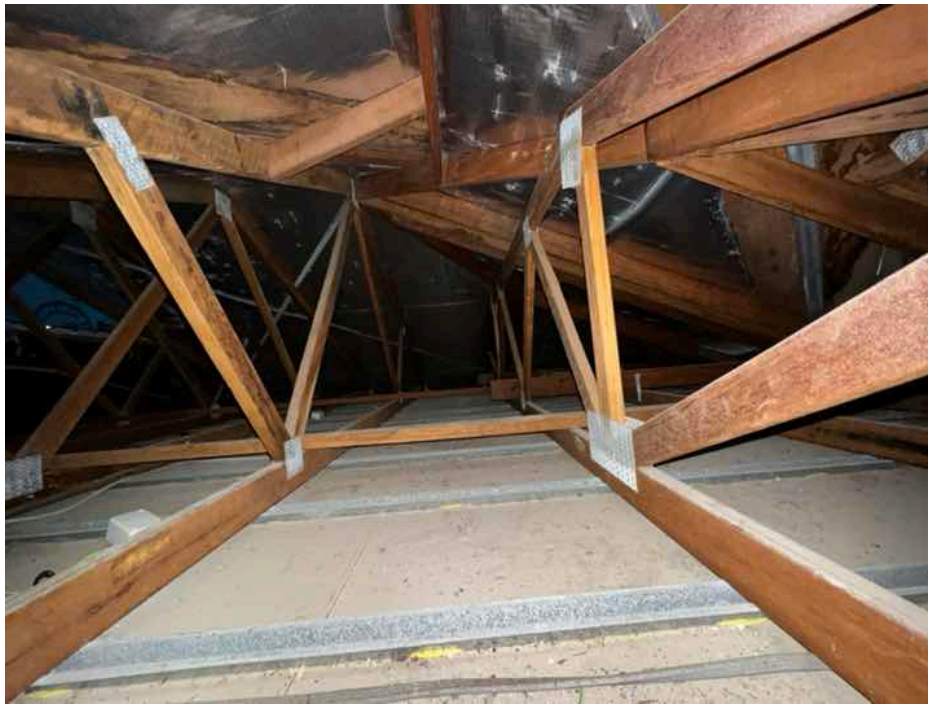
Visible sections of the roof void is in a serviceable condition for age of this dwelling.

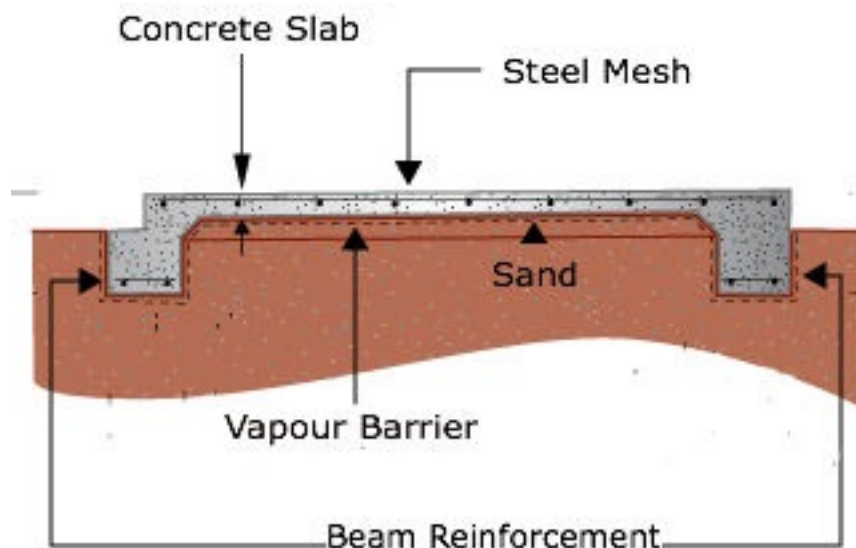
Footings Type

Slab on ground construction.
