Building and Pest Report

2/33 Allens Pde Lennox Head

Report/Agreement #	170625011853507
Inspection Date:	17 Jun 2025
Inspection Time:	01:18 pm

Pest And Building Inspection

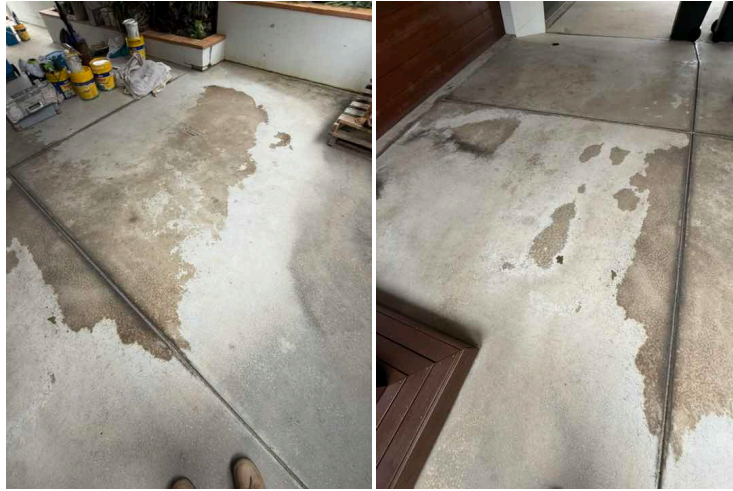
Driveway Condition

On visual inspection, the general condition of the driveway is serviceable.

Common cracks were observed on the driveway. Whilst these cracks appeared to be typical at the time of inspection, we strongly recommend you monitor these cracks and if worsening occurs contact a concreter for further advice.

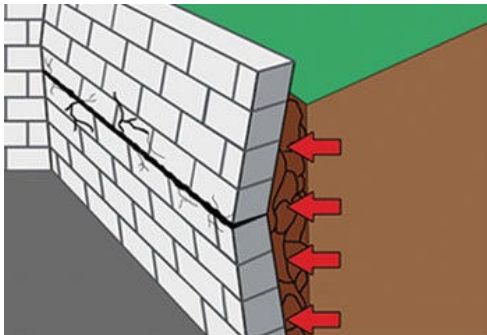
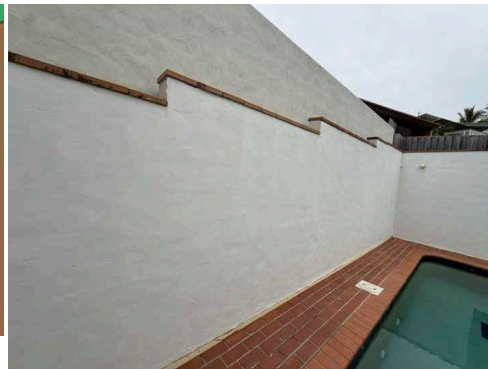
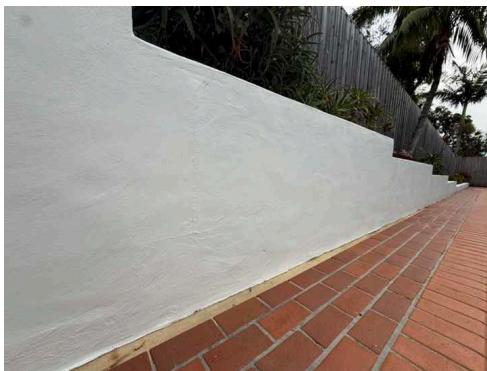
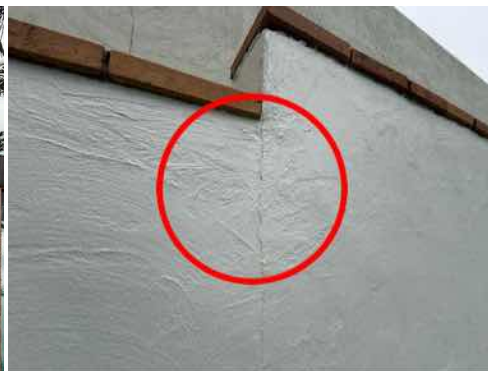
Retaining Walls

Of the visible areas, the general condition is serviceable or in reasonable condition for age of dwelling.

Retaining wall cracking. Normally this occurs if adequate drainage has not been provided (Ag Line) or a poor footing system or a combination of reasons. A qualified brick layer should be engaged for advice and recommendations.

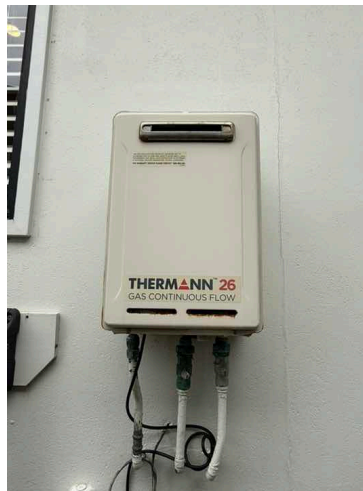
The hot water system appears to be in a serviceable condition. No specific tests other than running the hot water from a tap was carried out. No determination has been made as to the suitability or adequacy of the hot water system in relation to capacity or otherwise.

General rust deterioration was observed on the hot water unit casing. We recommend you replace the unit.

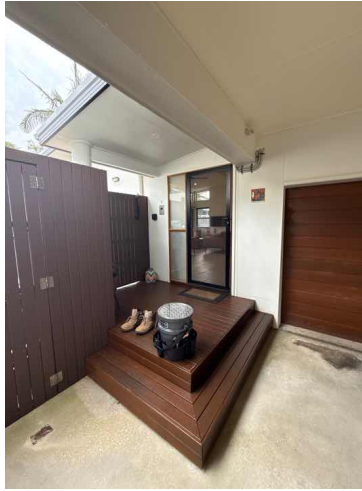
External Door Components

On Visual Inspection the external condition of the doors is serviceable.

General age/damage has occurred to door frame, face or components. Recommendations: A qualified carpenter should be engaged for advice and recommendations.

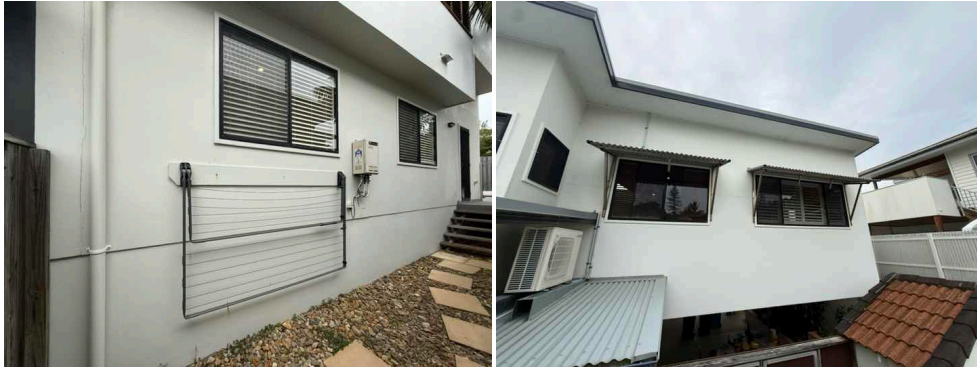
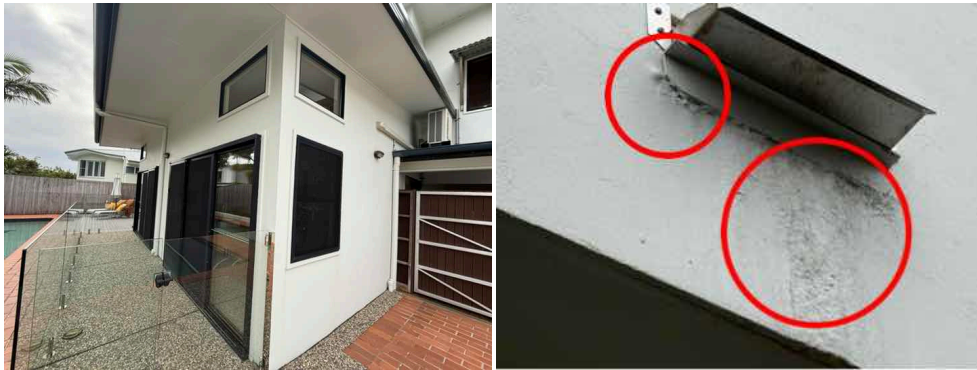
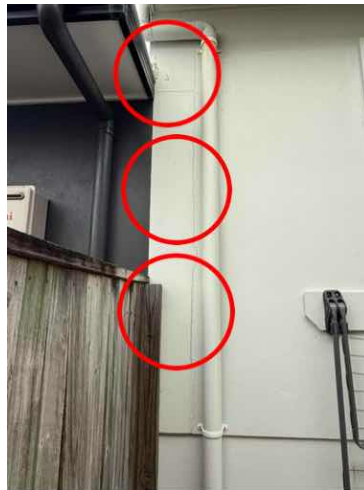
Walls

On visual inspection, the general condition of the exterior walls is serviceable for the age.

Paneling/cladding damaged. Have a suitably qualified tradesman assess and repair.

There appears to have been some settlement in the building which has caused some cracking to the walls. These cracks are categorized as 0 to 2. This can also cause some doors to bind or be out of square. In the inspectors opinion these cracks are due to settlement, usually due to ground movement and subsequent movement to building materials can be expected. Any cracks should be monitored and if cracks increase in size, further investigation should be carried out by a structural engineer.

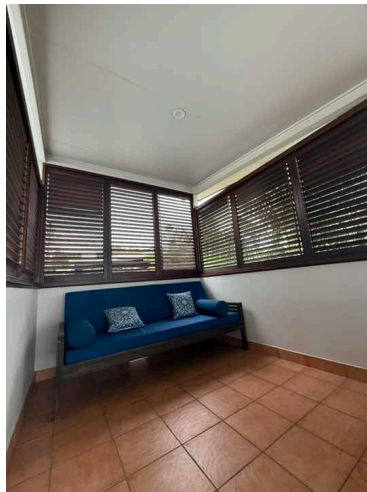
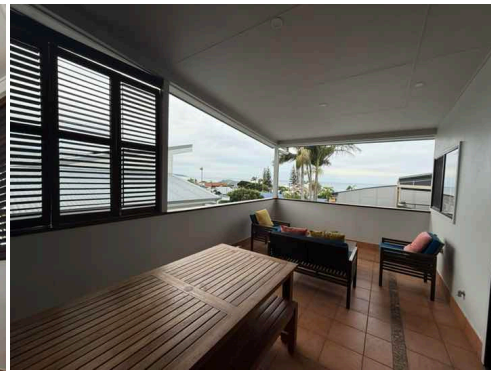
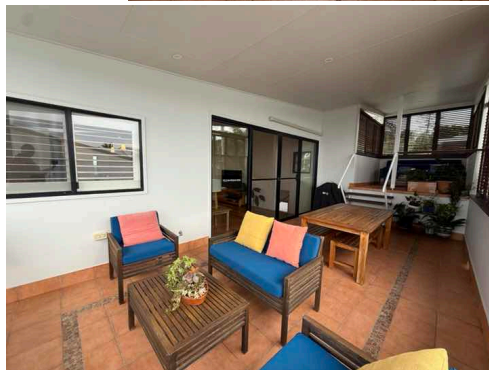
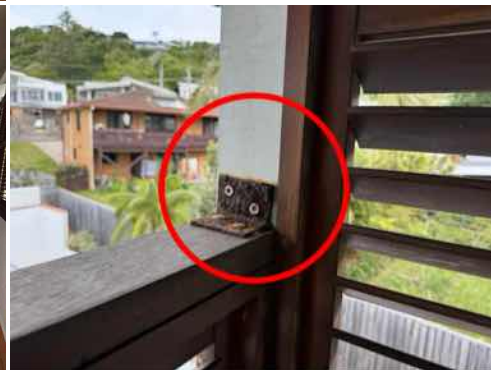
Balustrade Condition

Timber decay evident on rails / balustrade. A qualified carpenter should be engaged for advice and recommendations.

Rusty bracketa

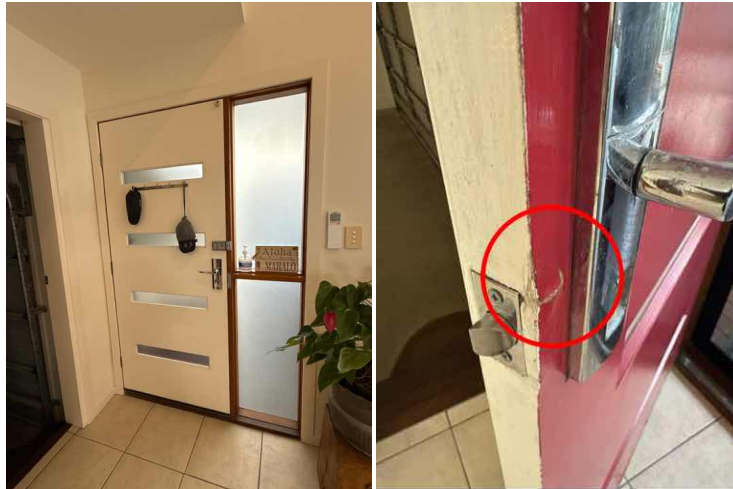
Entry door / frame deterioration - General age/damage has occurred to door frame, face or components. A qualified carpenter should be engaged for advice and recommendations.

Binding entry door - Doors that bind on the frame can relate to some differential settlement, frame movement, age, expansion, shrinkage or poor hanging. A qualified carpenter should be engaged for repairs.

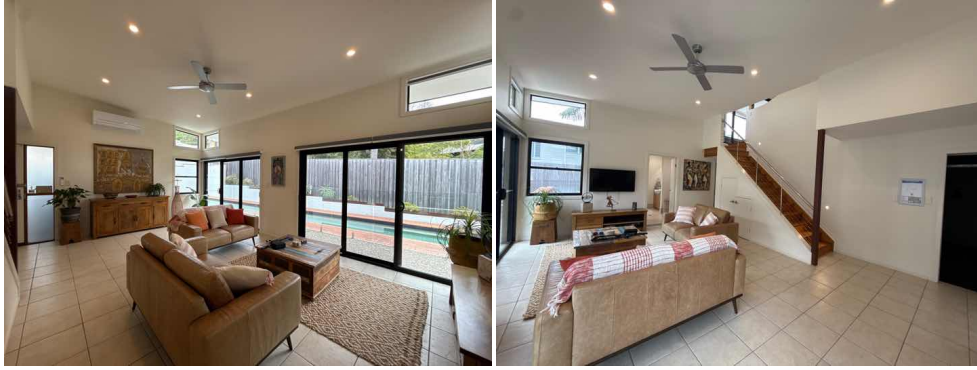
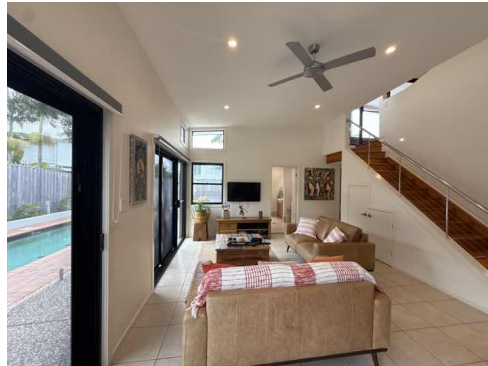
Flooring

Some chipped and damaged tiled were noted. Replacement recommended by a qualified tiler

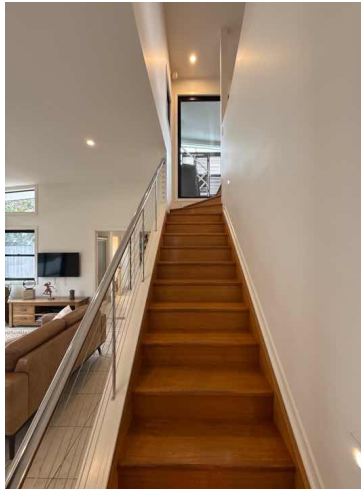
Internal Stair Case

The internal staircase and components appear to be in a serviceable condition for the age with no notable defects sighted.

The stair treads squeak and require maintenance.

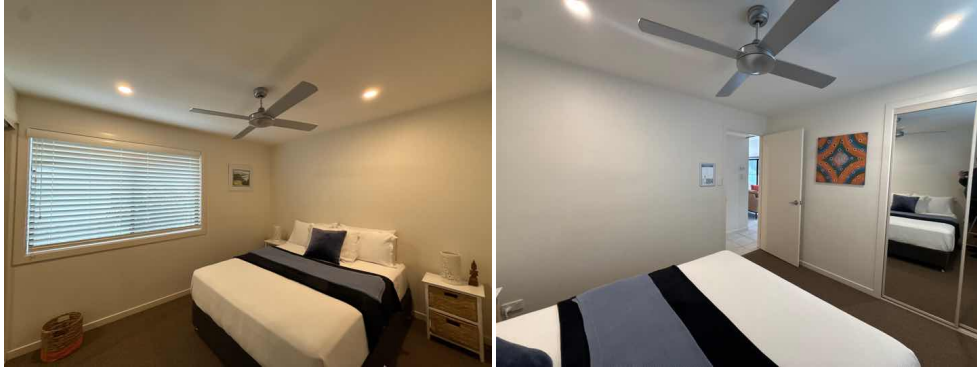
Ceiling

Typical cornice separation/detachment observed. I recommend you contact a qualified painter for repairs.

Settlement Cracks Noted. These are typical and generally patch and paint will suffice, however we recommend monitor these cracks and if become wider or longer, you will need to contact a structural engineers to assess.

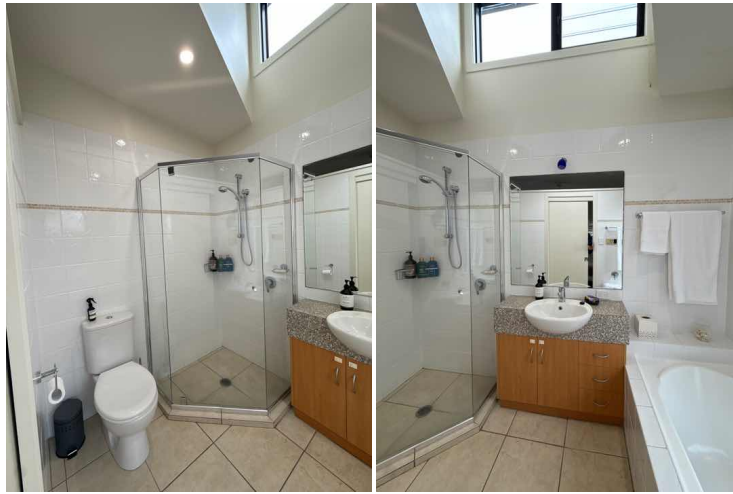
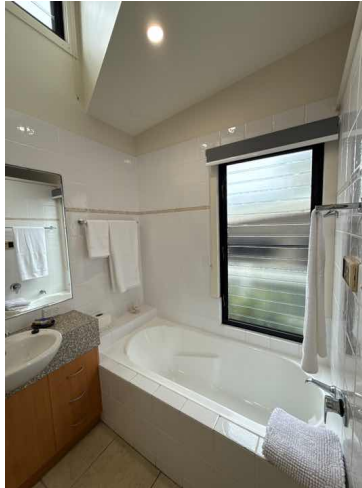
Vanity/Sink/Taps

The vanity mirror is desilvering at edges. Replacement recommended.

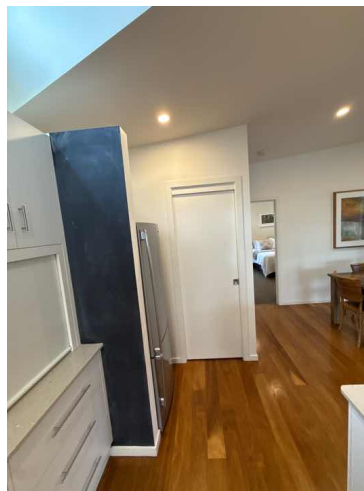
Cupboards And Bench Tops

Adjustment to cabinet doors required, in some instance hinges may need to be replaced.
