Building and Pest Report

273 Hutley Drive Skennars Head

BUILDING & PEST INSPECTIONS

273 Hutley Drive
Lennox Head

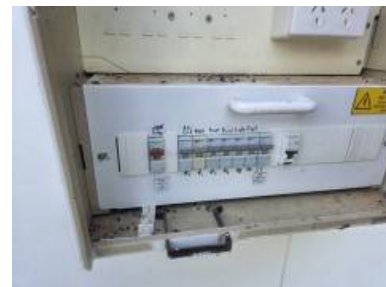
Whilst not an electrician, it appears that an electrical safety switch is present.

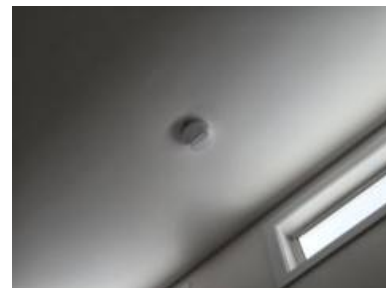
Present - Hall, Top of Stairs.

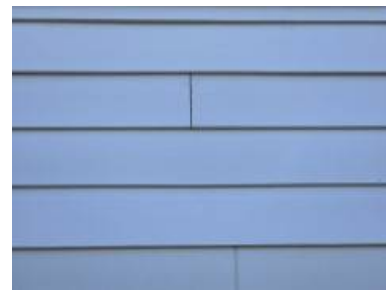
Some hardiplank or similar sheeting joins require resealing with a suitable sealant.

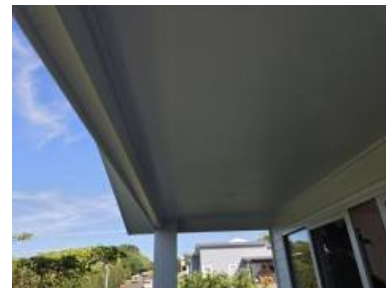
The external paintwork / finish to the external surfaces and timberwork is generally in good condition. There may be sections / areas that require touching up / repainting.

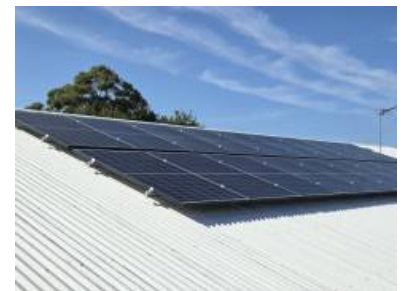
Solar Panels are present to the Roof Exterior and restricted the inspection of the roofing material beneath. Concealed damage may be present but not identified in the report.

We recommend that a qualified roofer be engaged to inspect & detail the condition of the roof exterior, gutters, downpipes & stormwater pipes and any rectification required prior to making a final purchase decision.

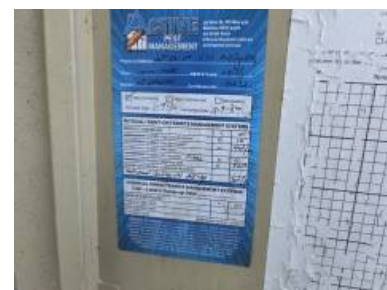
A termite barrier / treatment notice in the Meter Box / Kitchen Cupboard indicates that the slab penetrations and perimeters are protected from termite activity by Kordon Barriers. We strongly recommend you obtain all barrier paperwork & warranty information. These barriers were installed in 2020.
