# Building and Pest Report

## 26 Outrigger Rd Lennox Head

| Report/Agreement # | 090226092419112 |
| Inspection Date: | 09 Feb 2026 |

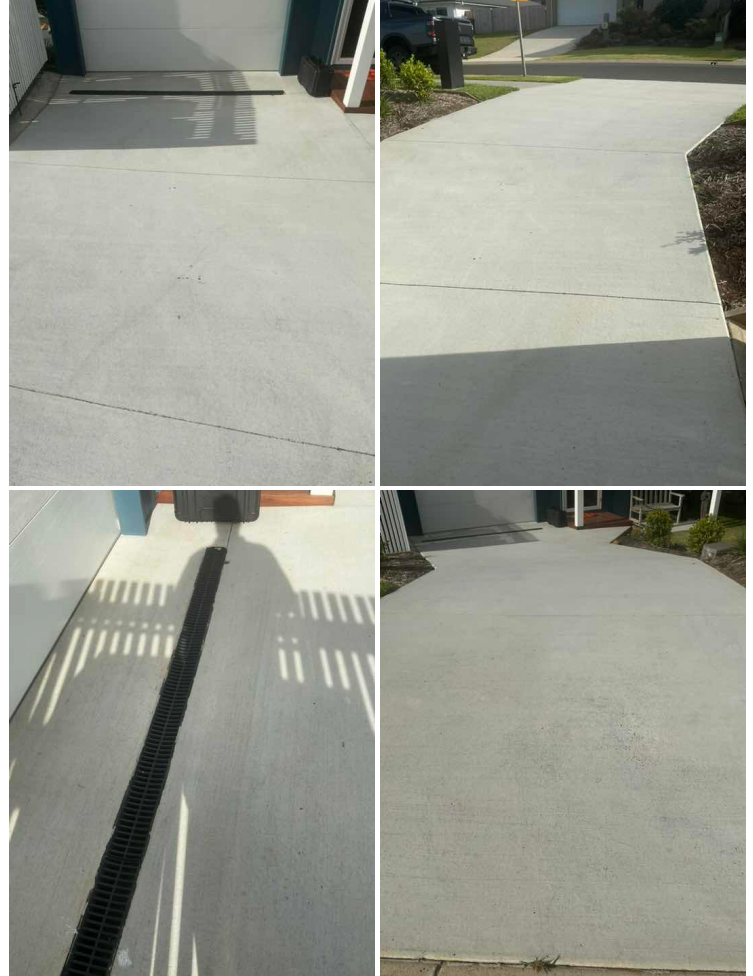
#### Driveway Condition

On visual inspection, the general condition of the driveway is serviceable.

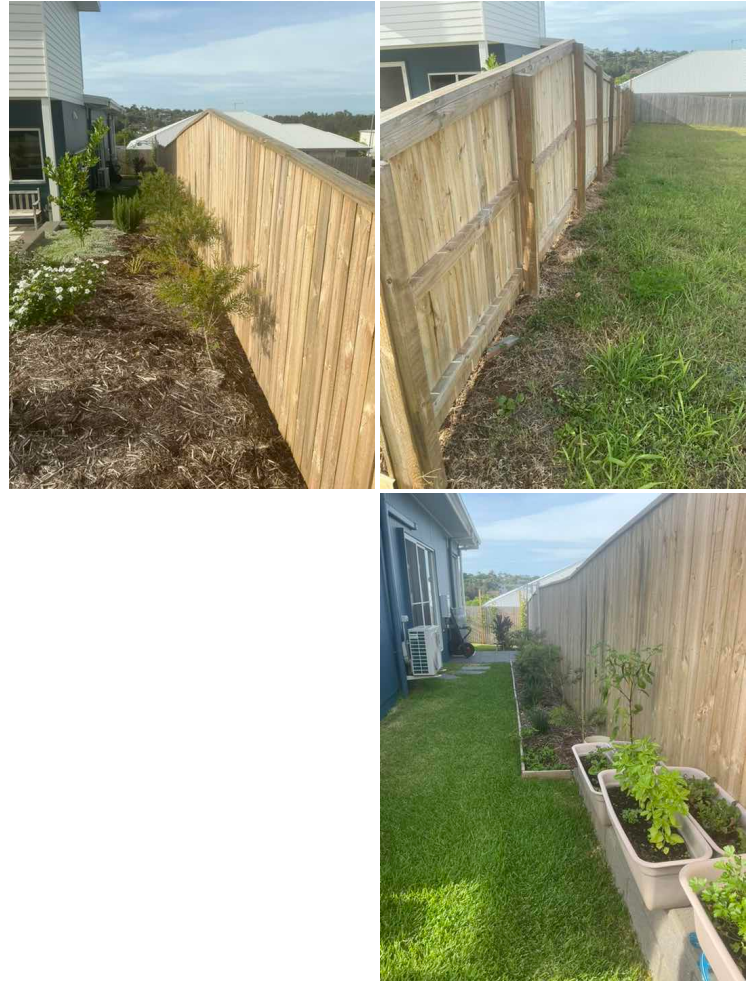
Of the visible areas, the general condition of the fences and gates is serviceable for the age of dwelling.

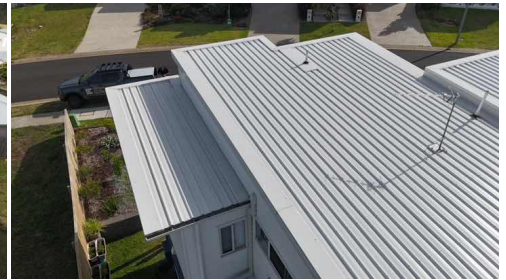
Of the visible areas, the general condition of the roof is in serviceable condition for the age.

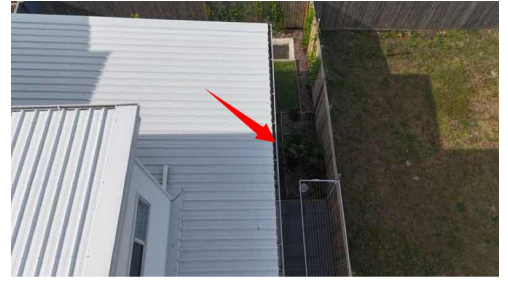
All visible and accessible of the physical nature of the guttering system appears to be in a serviceable condition with no apparent defects at the time of inspection. In the absence of prolonged rain fall efficiency of the guttering can not be assessed and you may find that further investigation or repairs maybe required. Note: Periodic maintenance checks should be carried out for rust penetrations and leaks.

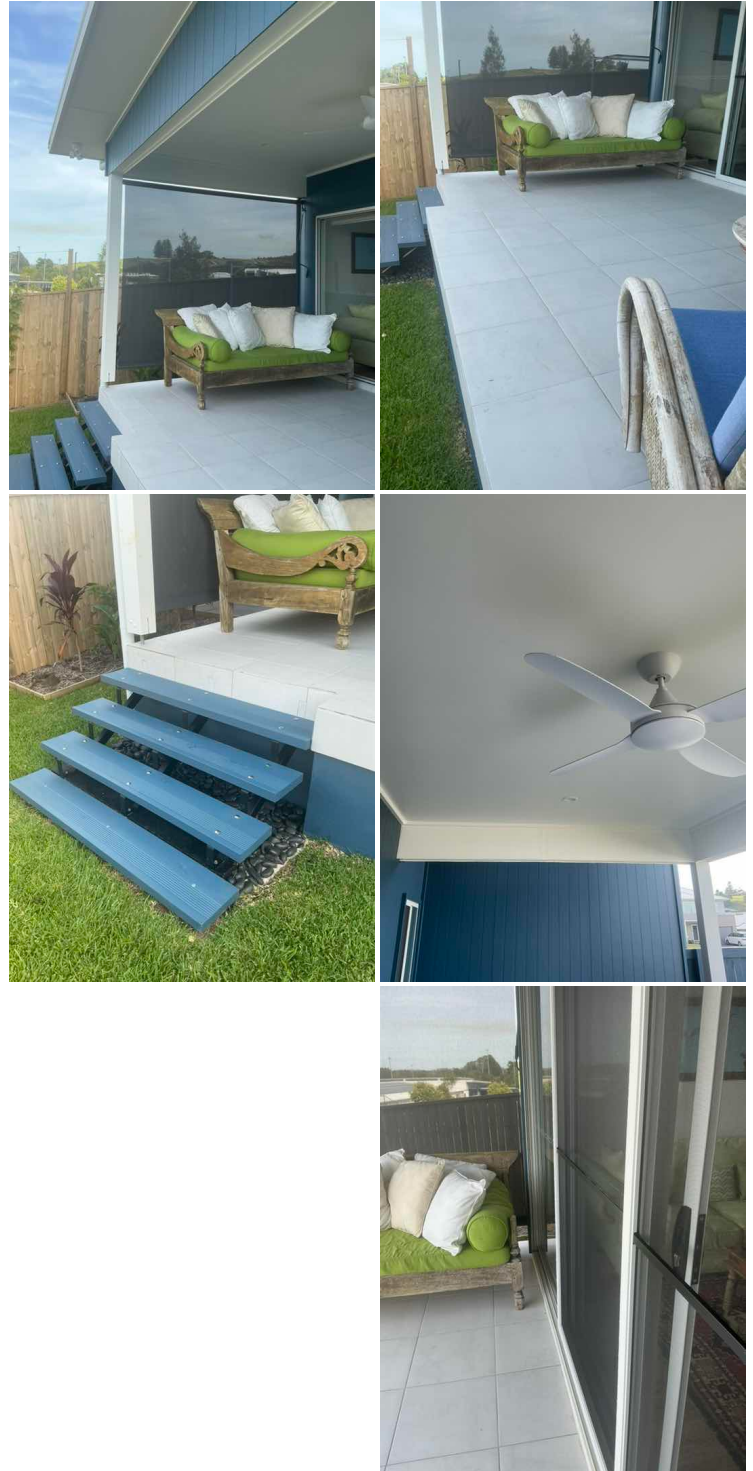
Visible sections of the Alfresco area are serviceable or in reasonable or condition for the age of this dwelling.

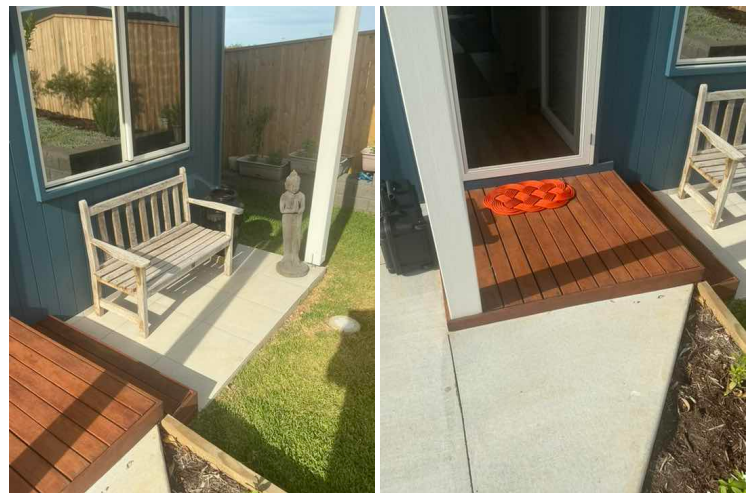
The entry porch serviceable or in reasonable or condition for the age of this dwelling.

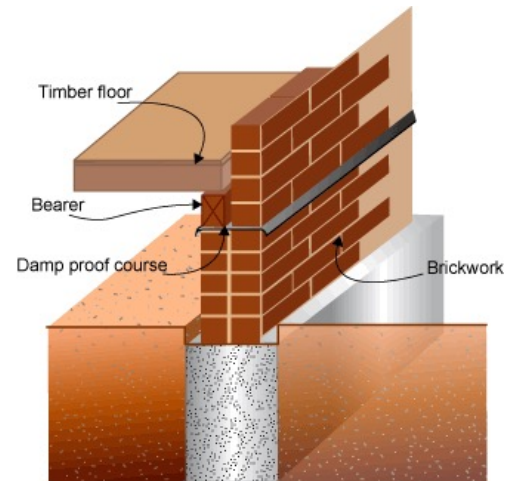
A damp proof course (DPC) was noted.

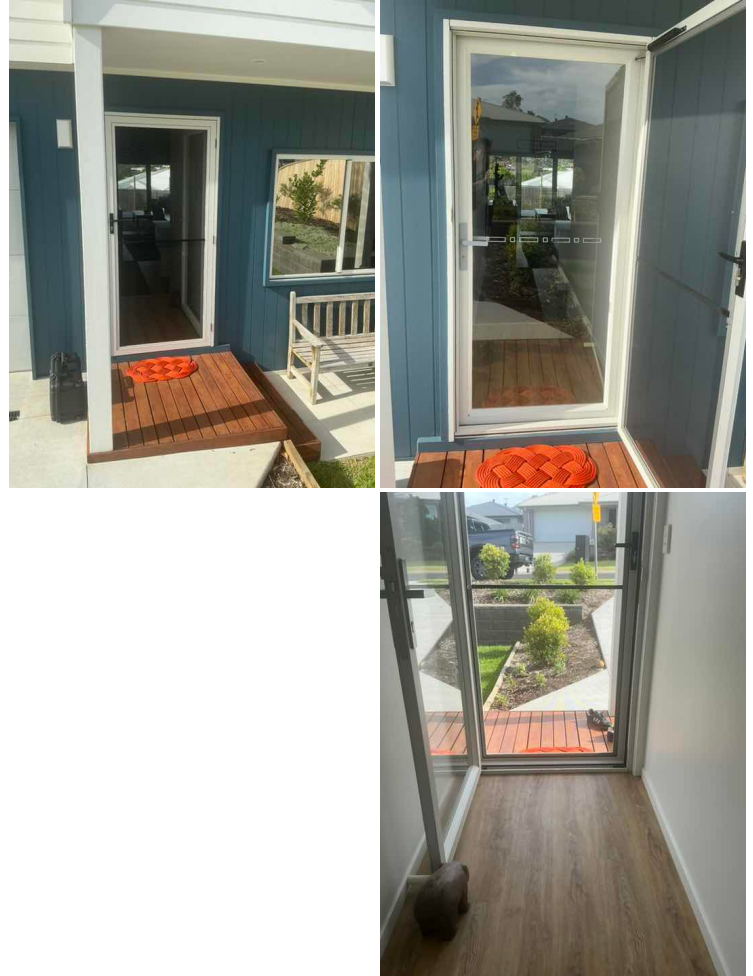
The doors are in serviceable condition with no notable defects observed.

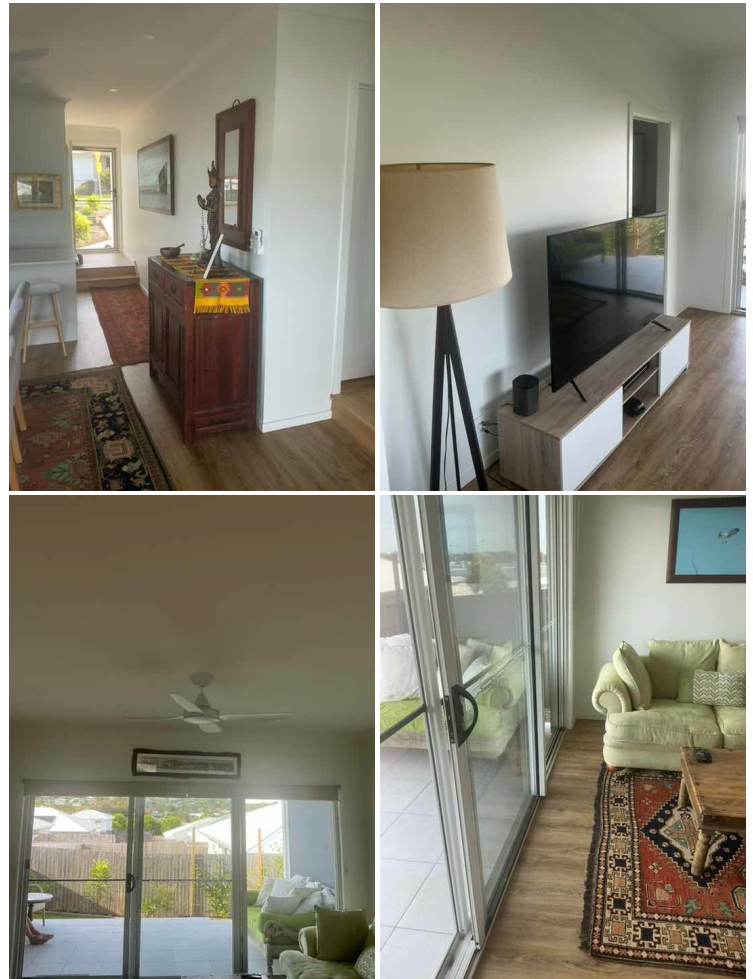
## Combined Living & Dining

From the visible and accessible areas, this room appears to be in a serviceable condition for the age of the property with no notable structural defects sighted.

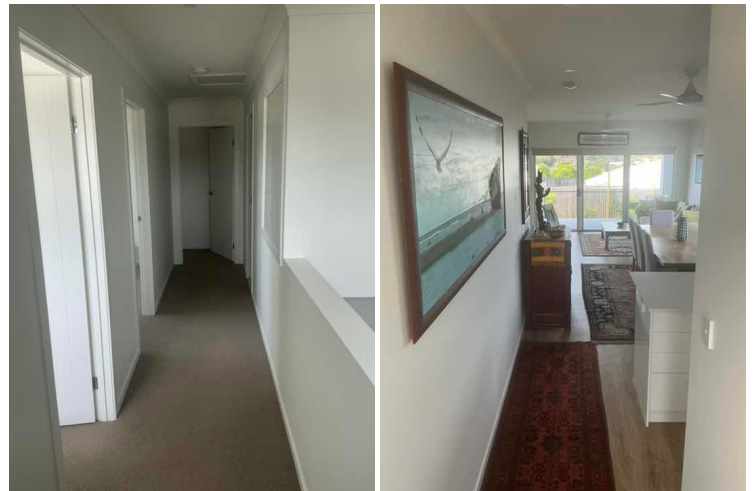
## Hallway/s

From the visible and accessible areas, the hallway/ appears to be in a serviceable condition for the age of the property with no notable structural defects sighted.

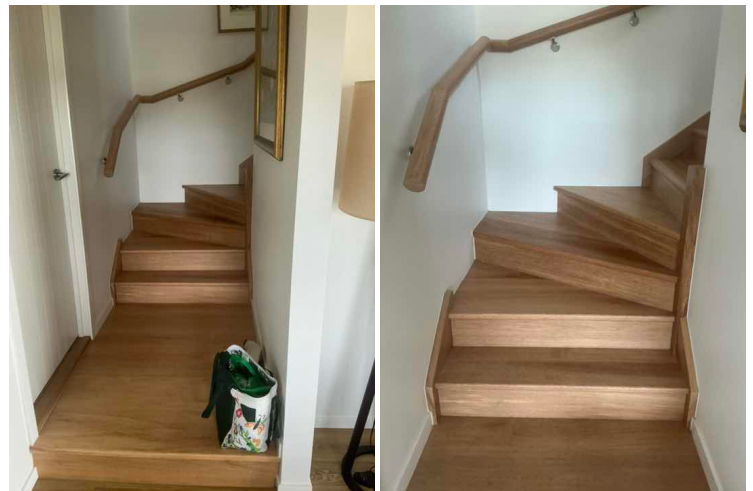
## Internal Stair Case

The internal staircase and components appear to be in a serviceable condition for the age with no notable defects sighted.

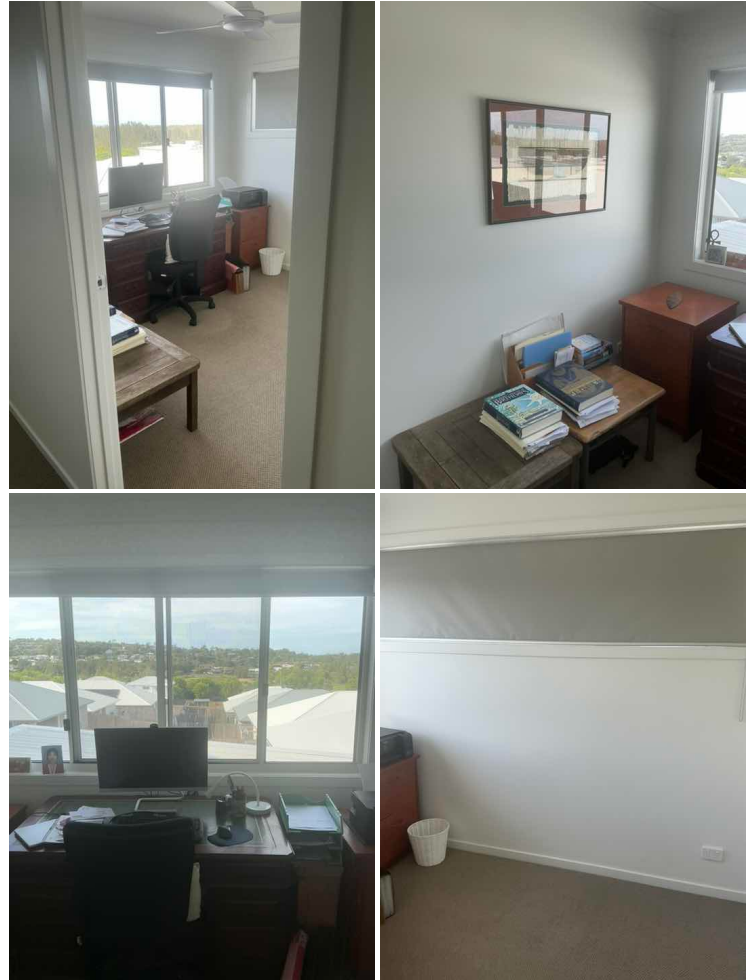
## **Bedroom 1**

From the visible and accessible areas, this bedroom appears to be in a serviceable condition for the age of the property with no notable structural defects sighted.

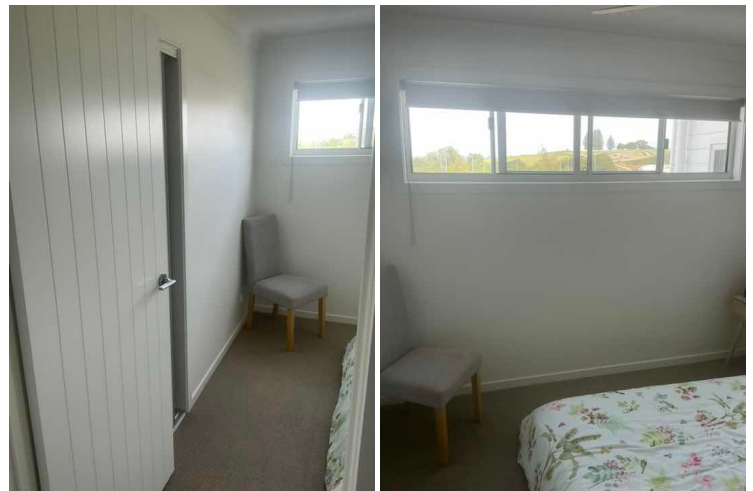
## **Bedroom 2**

From the visible and accessible areas, this bedroom appears to be in a serviceable condition for the age of the property with no notable structural defects sighted.

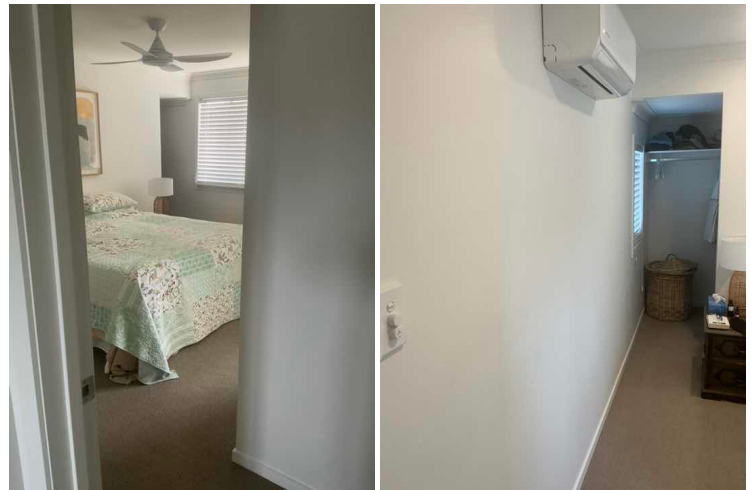
### **Bedroom 3**

From the visible and accessible areas, this bedroom appears to be in a serviceable condition for the age of the property with no notable structural defects sighted.

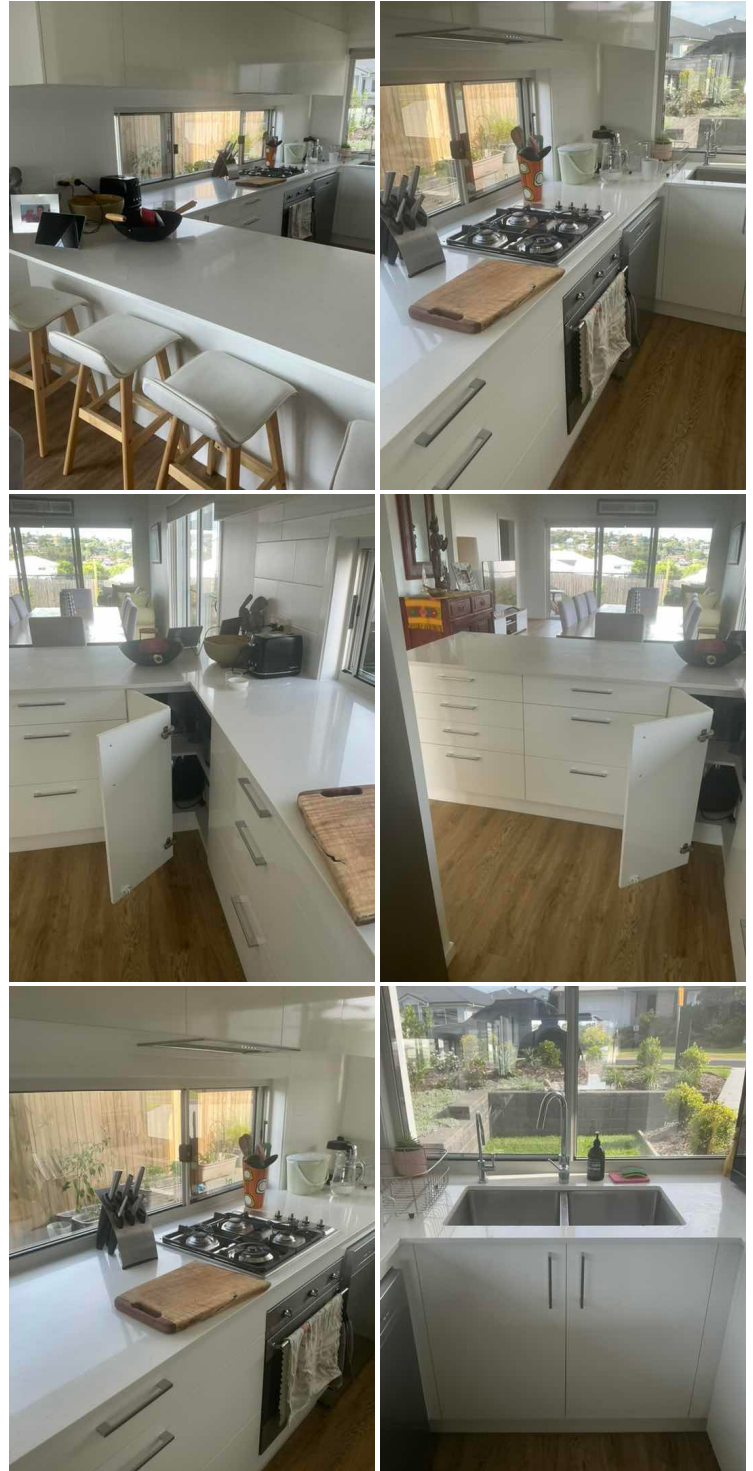
Of the visible areas, the general condition of the kitchen and pantry is serviceable or in reasonable condition for age of dwelling.

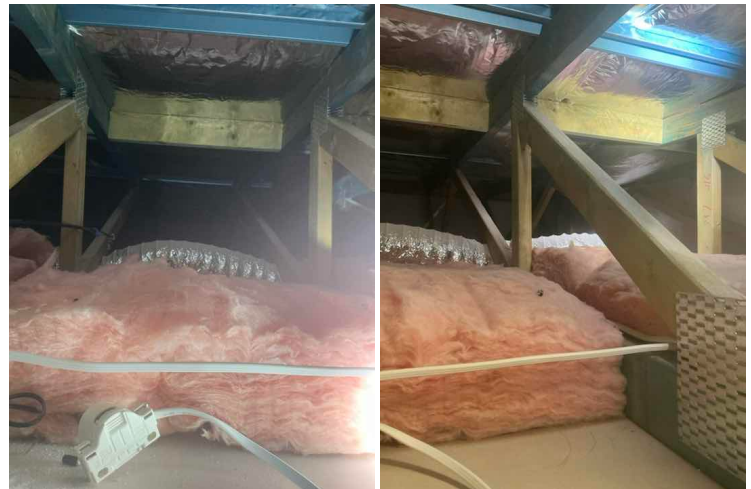
Visible sections of the roof void is in a serviceable condition for age of this dwelling.

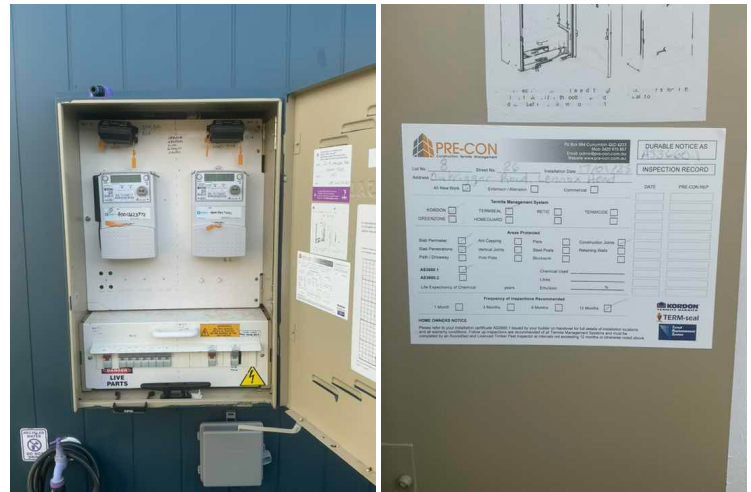
Yes, a durable notice was found in the meter-box during the inspection.
