Building and Pest Report

7 Outrigger Road Lennox Head

Report/Agreement #	010825084035615
Inspection Date:	01 Aug 2025
Inspection Time:	08:40 am

Pest And Building Inspection

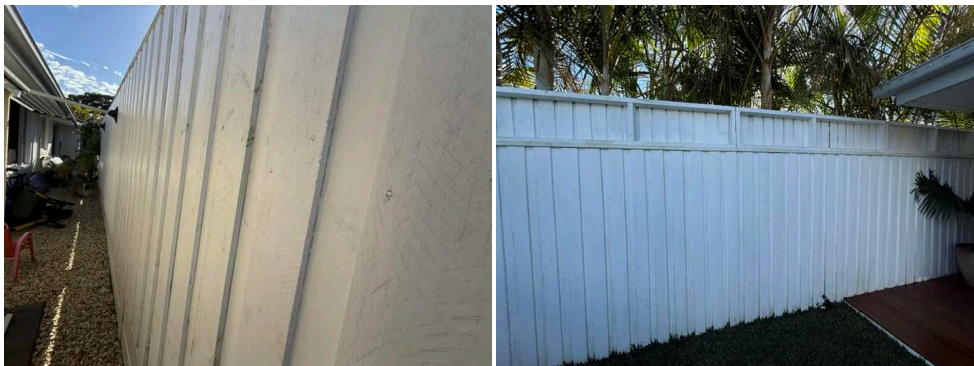
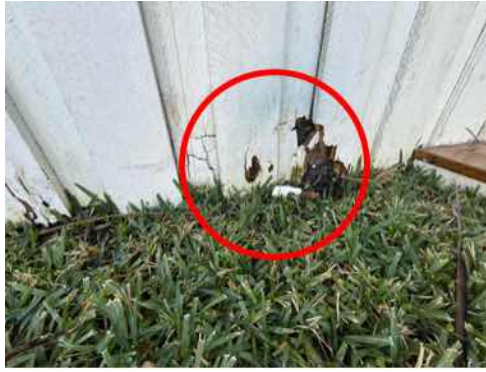
General age to fence components. General upkeep and maintenance required. A qualified fencing contractor should be engaged for repairs.

Minor post base timber fungal decay. Repairs as required. Timber rot is conducive to termite infestation.

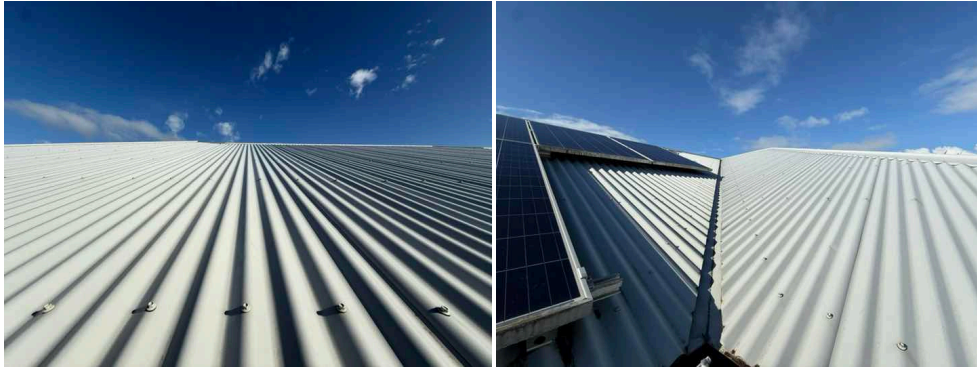
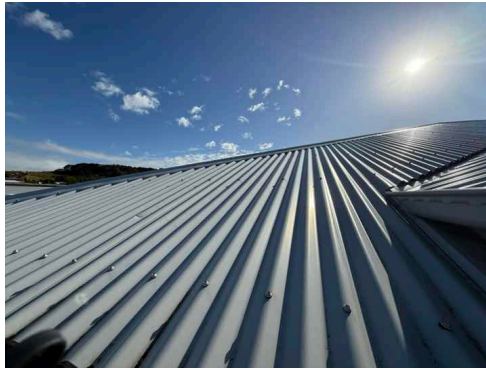
Visible section of The roof cladding appeared in a serviceable condition for the age of this dwelling. Annual maintenance inspection recommended.

Corrosion noted to the screw fixings of the metal roof. Have these checked and replaced by qualified roofing contractor.

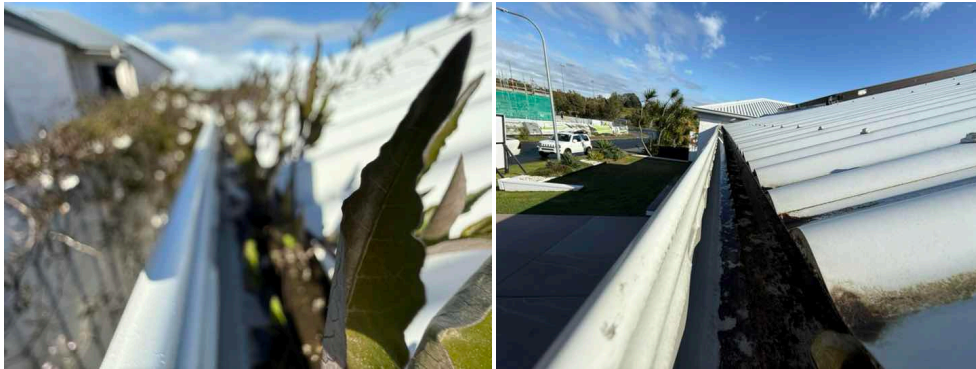
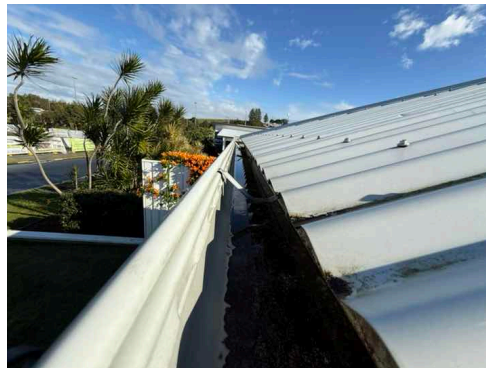
Debris in guttering areas- this requires cleaning out to prevent blocking of downpipes and leaking into eaves and fascia. Have gutters cleaned and assessed by a plumber for adequate fall. Regularly clean to prevent ponding. Ponding water will contribute to rust.

Gutter ponding - This can relate to poor fall, inadequate down pipes, gutter or debris build up. If debris presence has been noted above clean same out and re-assess for any ponding. If clean guttering is ponding it can be a blocked down pipe or the guttering fall is inadequate. A qualified roof plumber should be engaged for advice and recommendations.

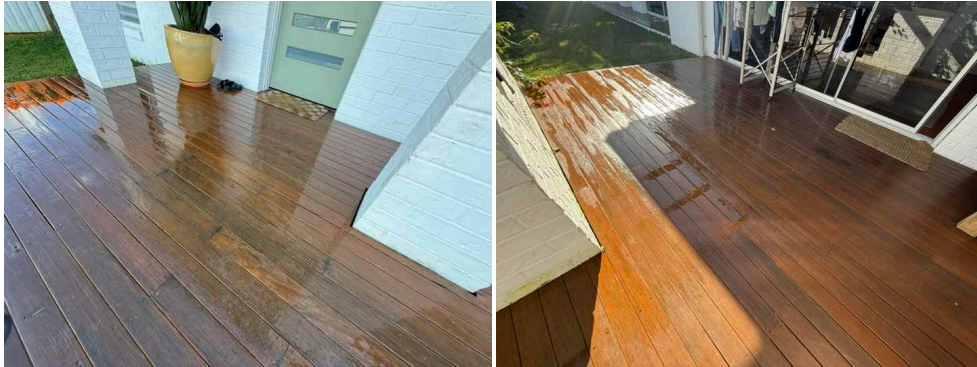
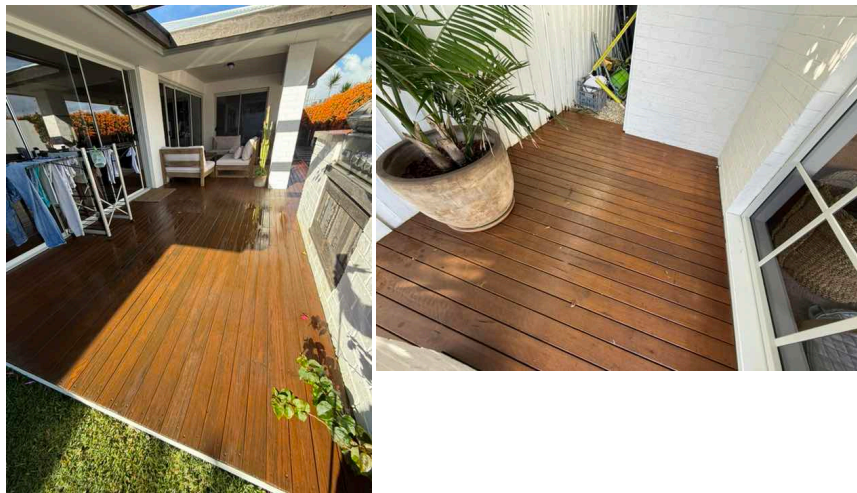
Of areas visible, minor defects and/or maintenance issues were visible. These will require assessment and subsequent repairs by a licensed tradesperson. Please read below for details. Please note that the inspector believes these to be of a minor nature relative to the age of the dwelling and or lack of proper and continual maintenance. Others, including other inspectors may differ in their opinions.

Too low to inspect the underside

Decking board surfaces are weathered. We recommend cleaning and maintenance as needed.

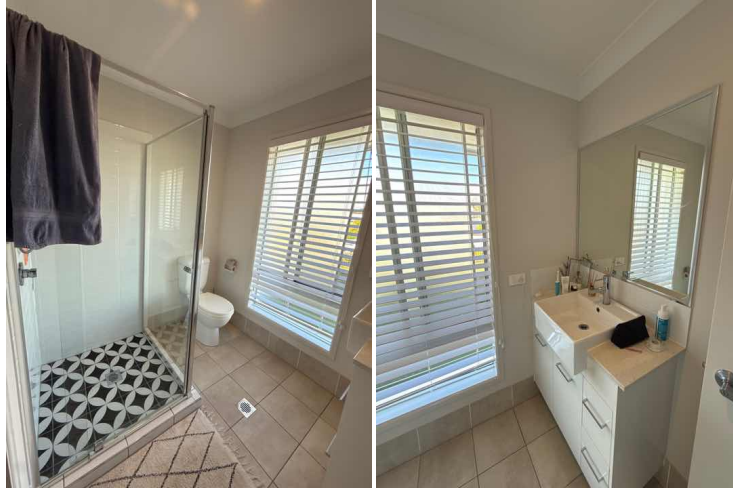
No exhaust fan is installed - Recommend having one installed.

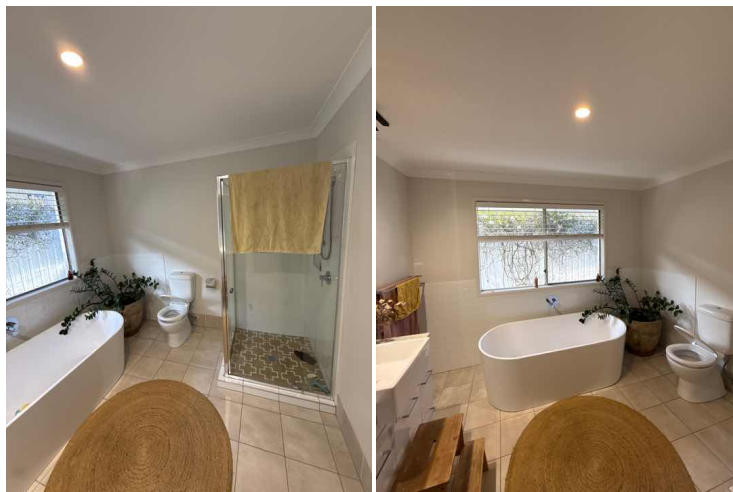
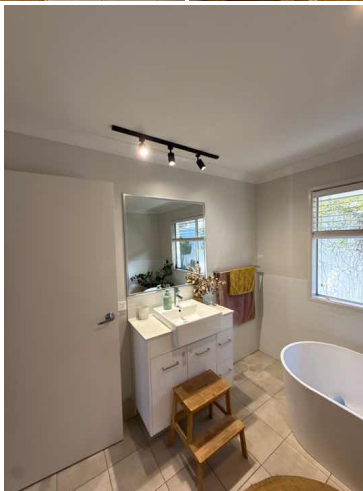
No exhaust fan is installed - Recommend having one installed.

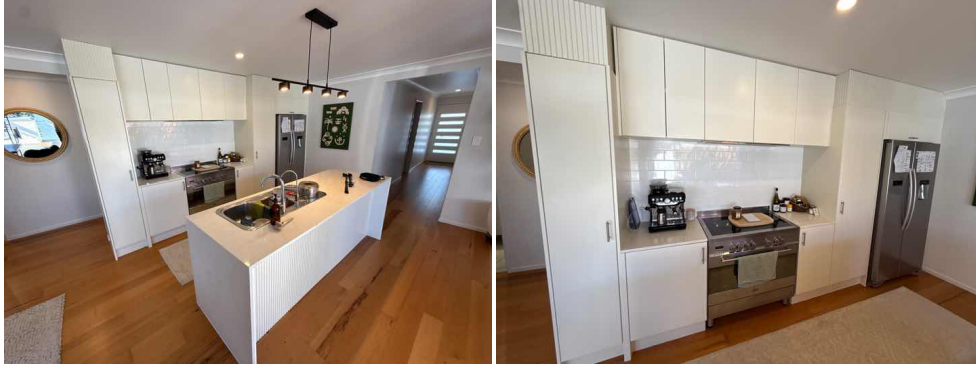
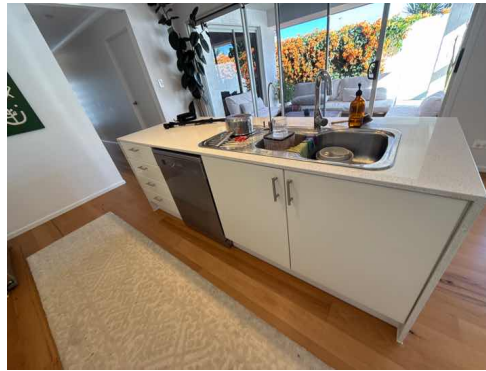
Adjustment to cabinet doors required, in some instance hinges may need to be replaced.
