# Building and Pest Report

## 239 Hutley Drive, Skennars Head

| Report/Agreement # | 260326115130350 |
| Inspection Date: | 26 Mar 2026 |

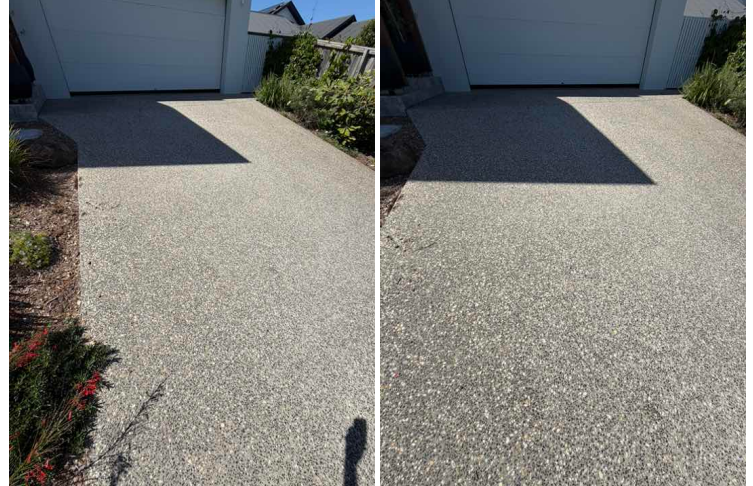
On visual inspection, the general condition of the driveway is serviceable.

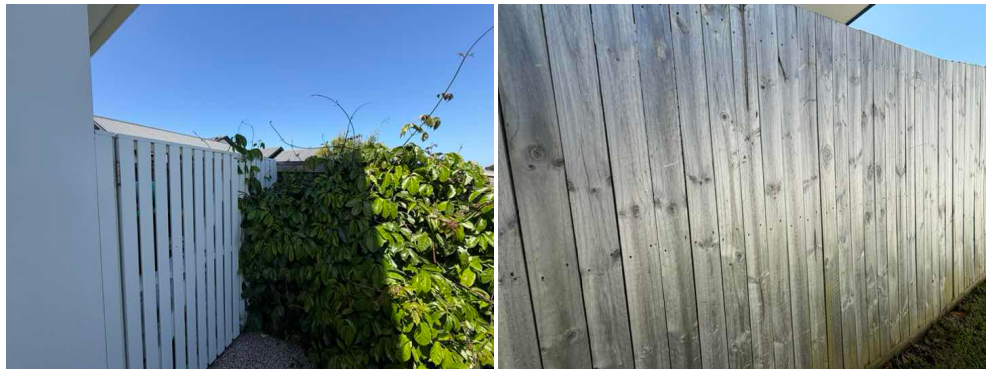
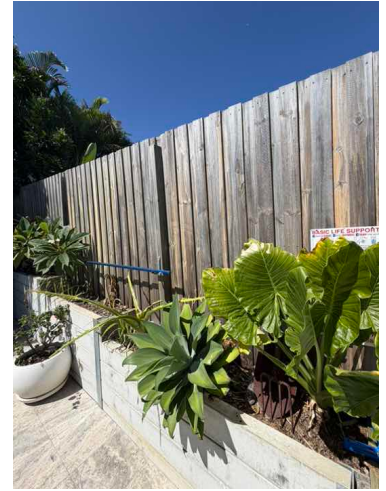
Of the visible areas, the general condition of the fences and gates is serviceable for the age of dwelling.

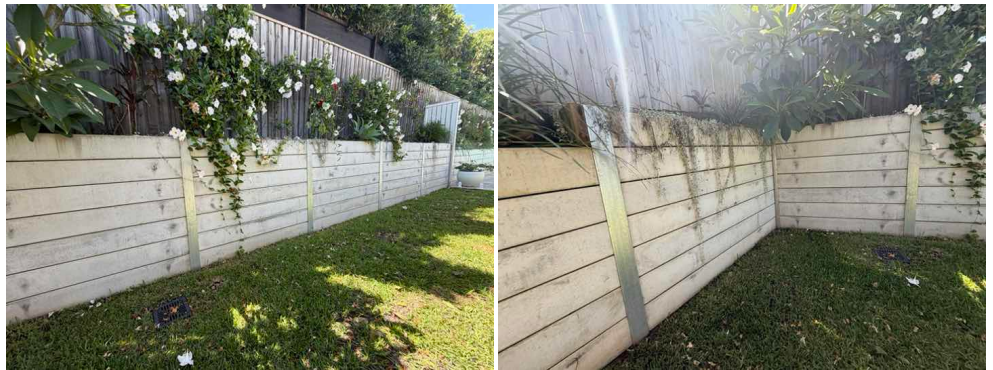
Of the visible areas, the general condition is serviceable or in reasonable condition for age of dwelling.

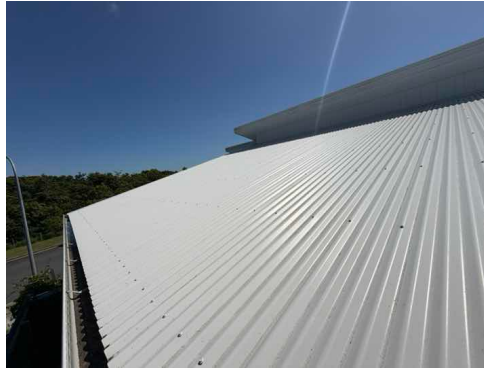
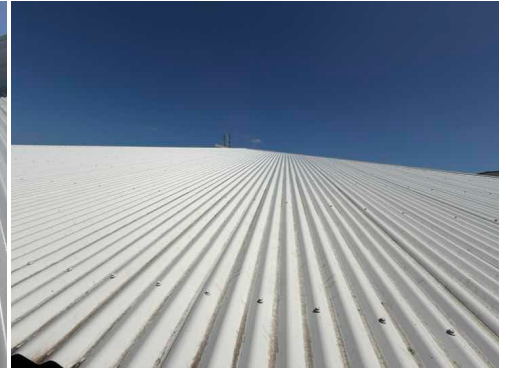
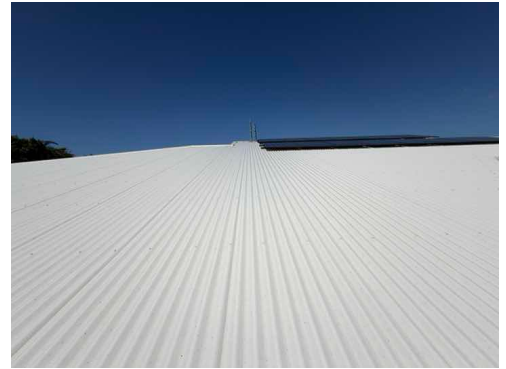
Of the visible areas, the general condition of the roof is in serviceable condition for the age.

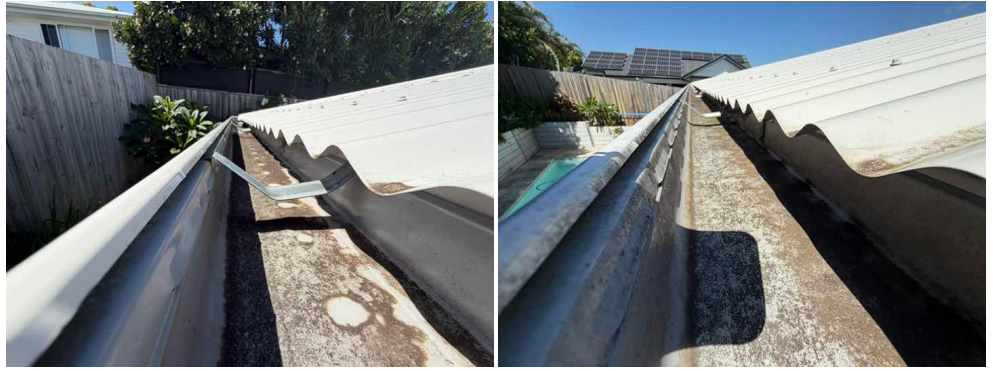
All visible and accessible of the physical nature of the guttering system appears to be in a serviceable condition with no apparent defects at the time of inspection. In the absence of prolonged rain fall efficiency of the guttering can not be assessed and you may find that further investigation or repairs maybe required. Note: Periodic maintenance checks should be carried out for rust penetrations and leaks.

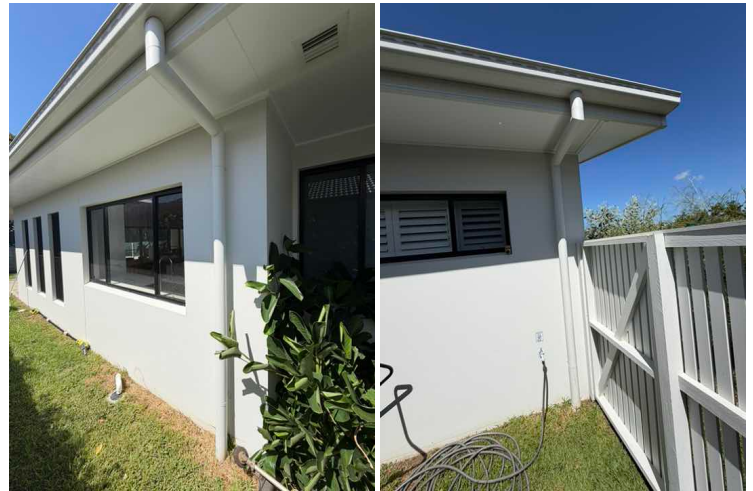
On visual inspection no apparent defects were noted to the down pipes and are considered serviceable, however no comment can be made with regard to blockages or connections to stormwater or functionality in the absence of rain. Note: Periodic maintenance checks should be carried out for rust penetrations and leaks.

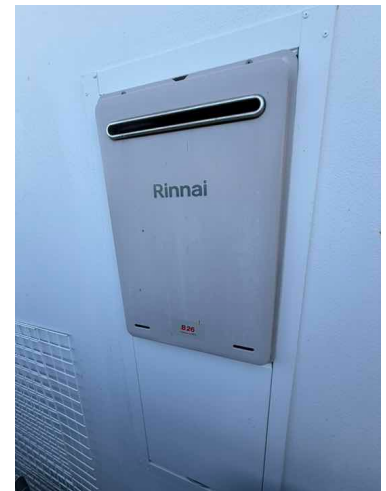
The make of the hot water unit is rinnai.

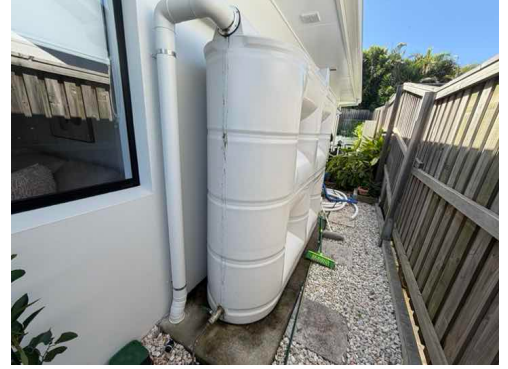
On Visual Inspection the water tank appears serviceable, but should be checked by a qualified plumber.

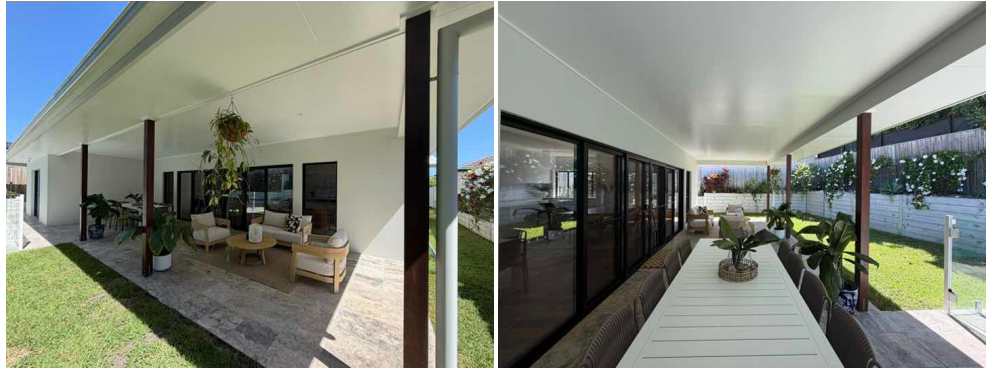
Visible sections of the Alfresco area are serviceable or in reasonable or condition for the age of this dwelling.

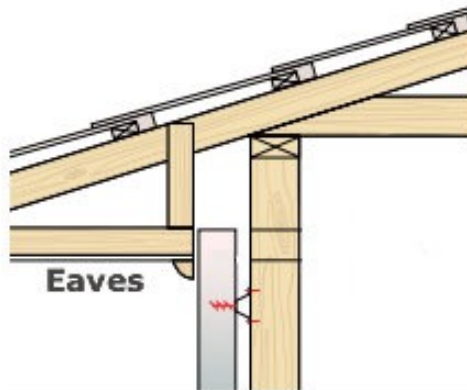
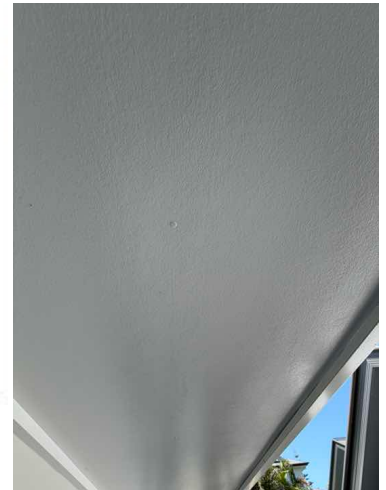
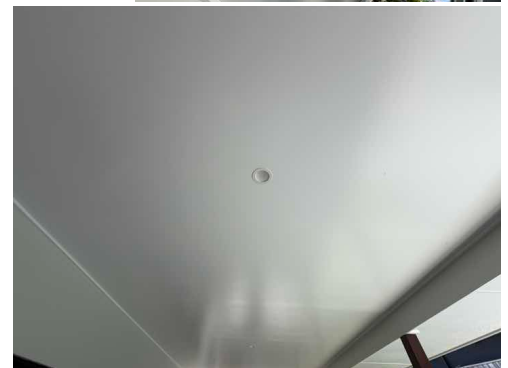
The soffit lining (eaves) are in a serviceable condition with no notable defects.

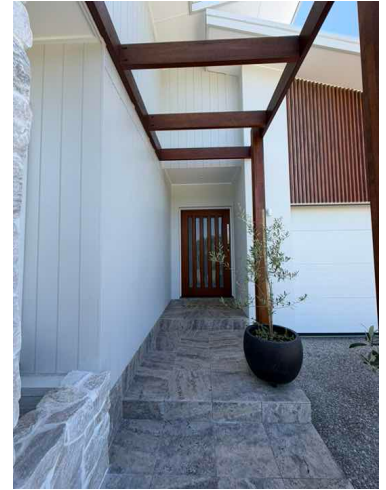
The entry porch serviceable or in reasonable or condition for the age of this dwelling.

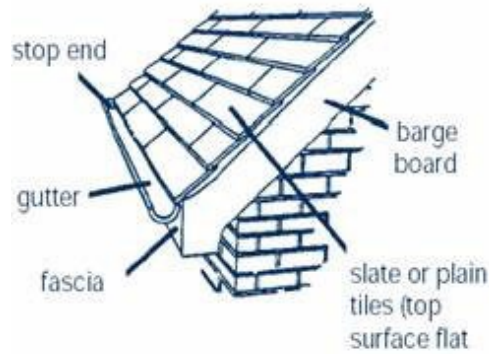
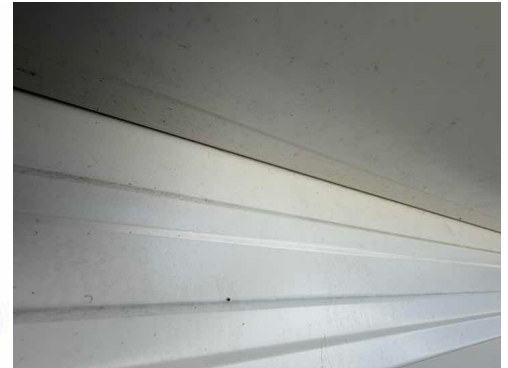
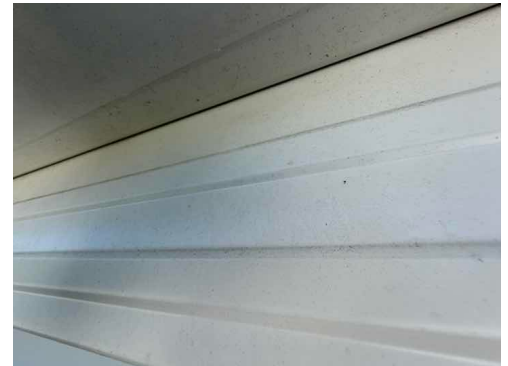
On visual inspection, the general condition of the fascia/barge boards is serviceable.

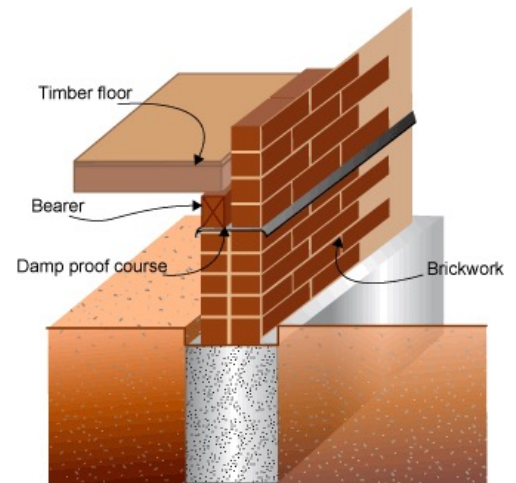
A damp proof course (DPC) was noted.

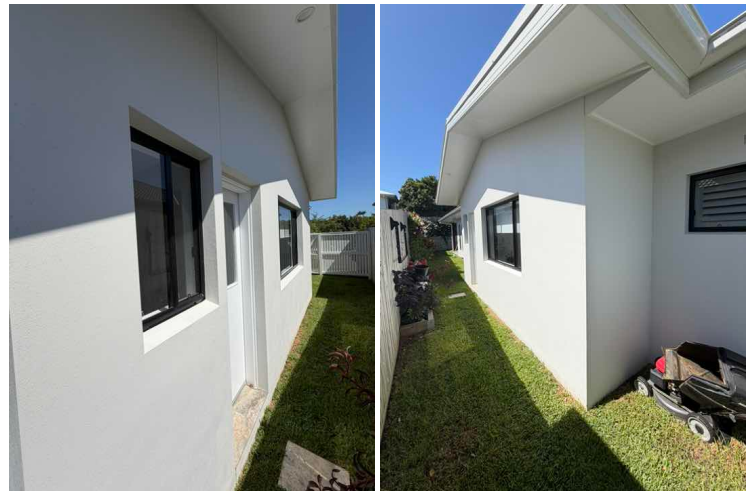
On visual inspection, the general condition of the exterior walls is serviceable for the age.

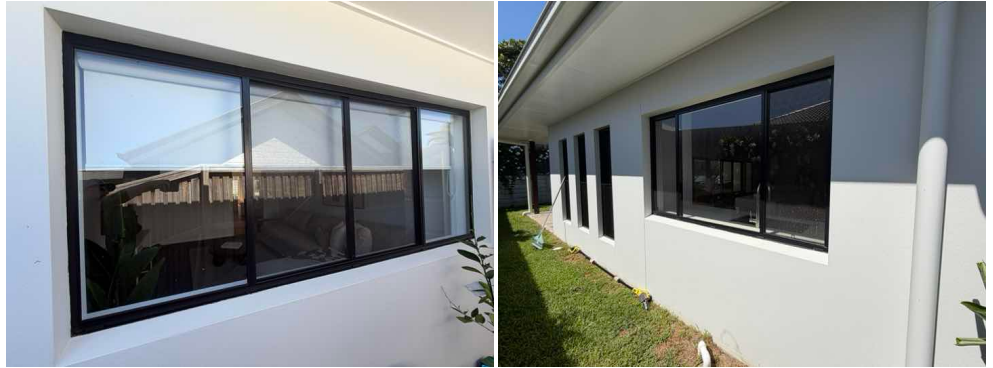
On visual inspection, the general condition of the windows is serviceable for the age.

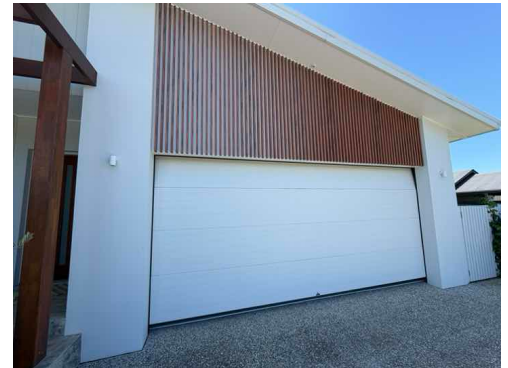
From the visible and accessible areas, the garage appears to be in a serviceable condition for the age of the property with no notable structural defects sighted.

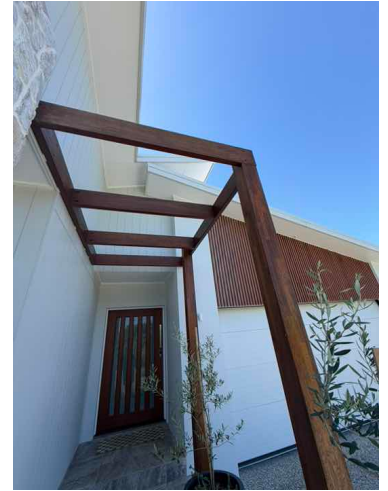
The Pergola is in a serviceable condition with no notable defects sighted.

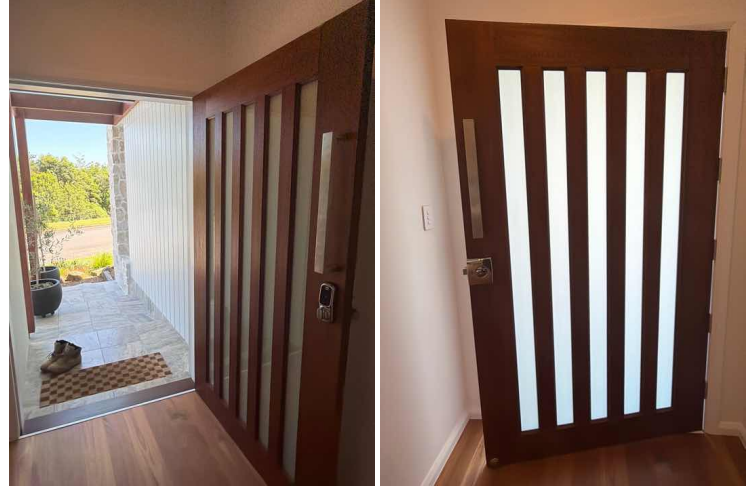
The doors are in serviceable condition with no notable defects observed.

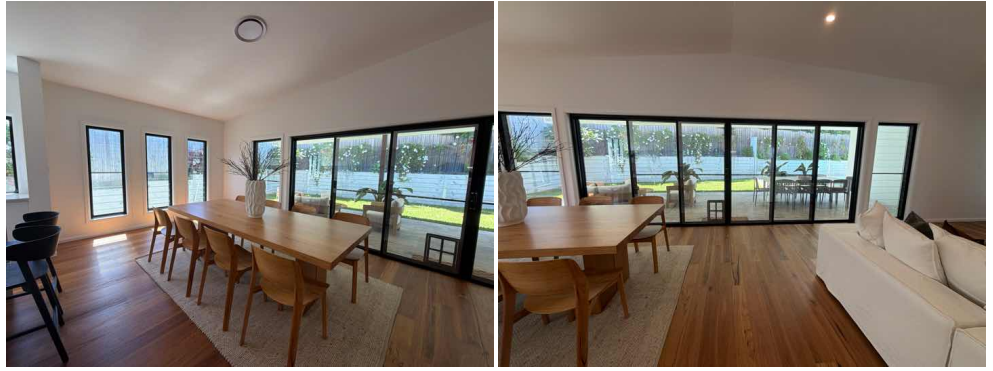
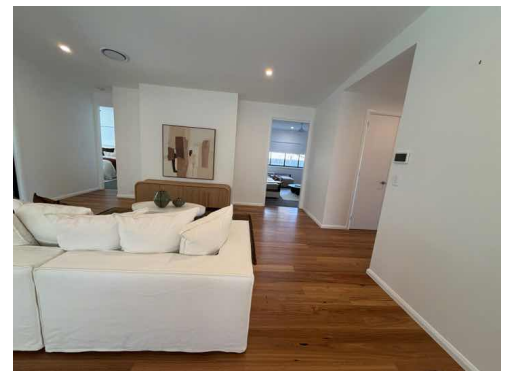
From the visible and accessible areas, this room appears to be in a serviceable condition for the age of the property with no notable structural defects sighted.

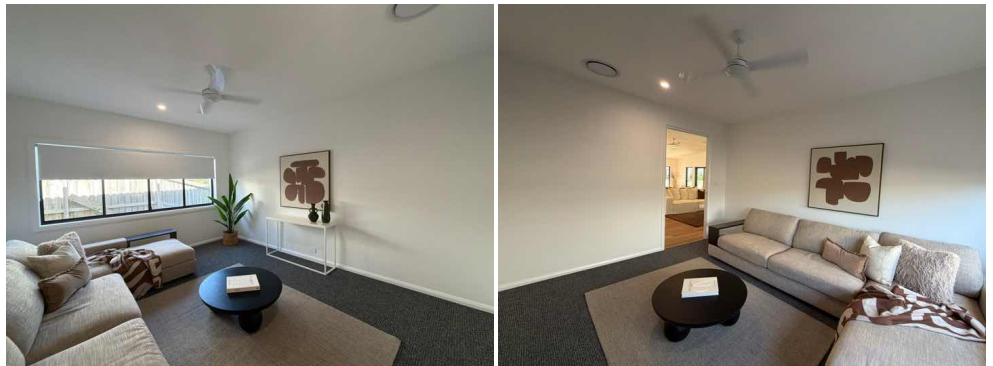
Settlement Cracks Noted. These are typical and generally patch and paint will suffice, however monitoring these cracks is advised for 12 months and if they become worse, further investigation by a suitably qualified professional is advised.

From the visible and accessible areas, this room appears to be in a serviceable condition for the age of the property with no notable structural defects sighted.

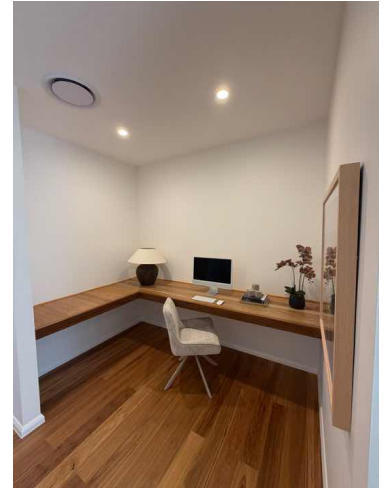
From the visible and accessible areas, this room appears to be in a serviceable condition for the age of the property with no notable structural defects sighted.

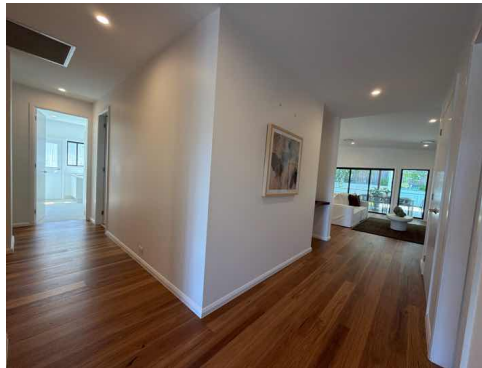
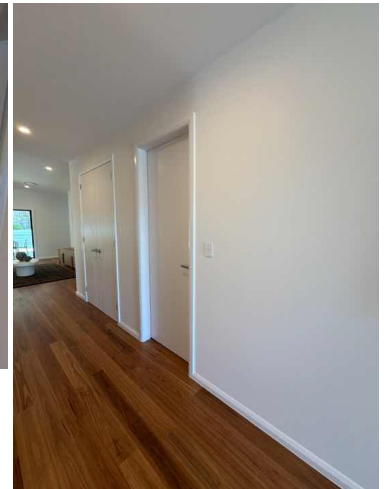
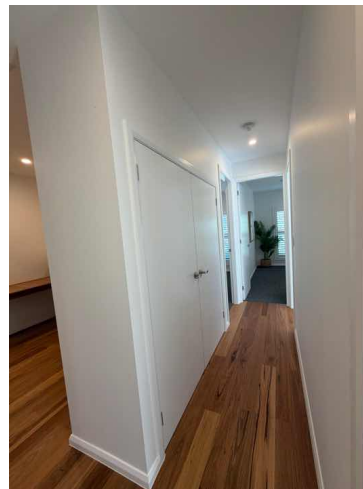
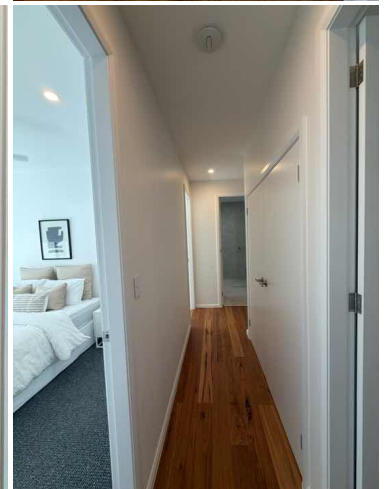
From the visible and accessible areas, the hallway/ appears to be in a serviceable condition for the age of the property with no notable structural defects sighted.

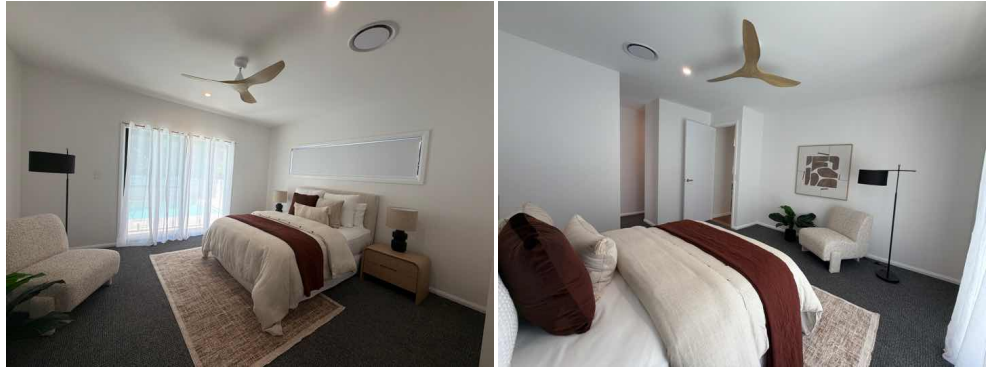
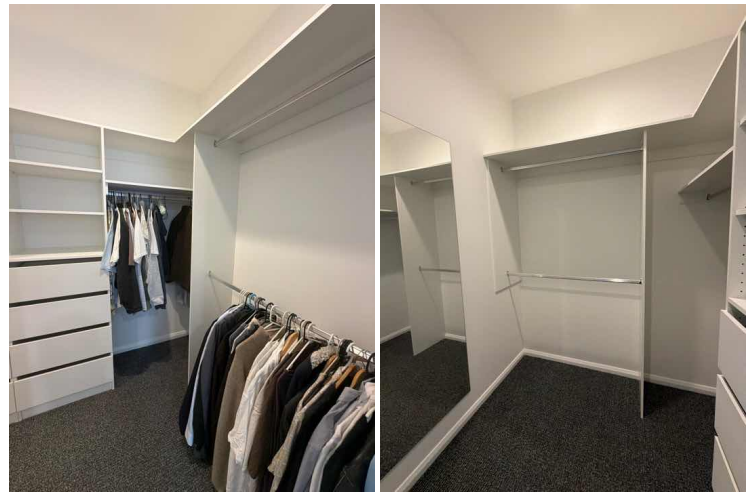
From the visible and accessible areas, this bedroom appears to be in a serviceable condition for the age of the property with no notable structural defects sighted.

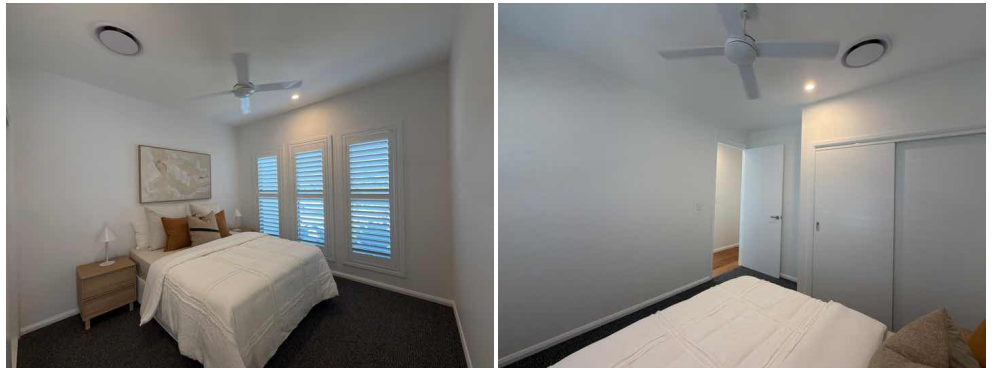
From the visible and accessible areas, this bedroom appears to be in a serviceable condition for the age of the property with no notable structural defects sighted.

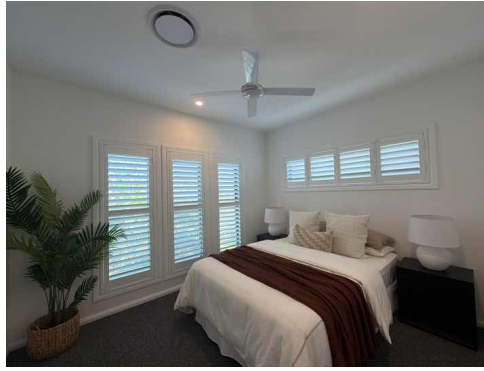
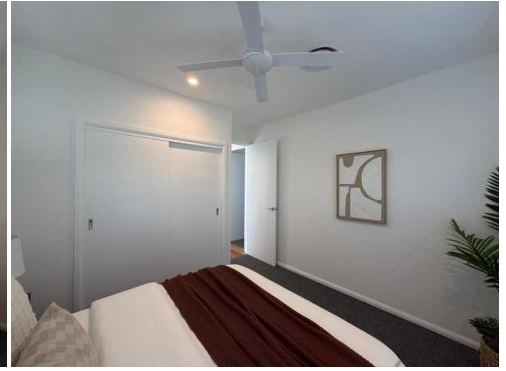
From the visible and accessible areas, this bedroom appears to be in a serviceable condition for the age of the property with no notable structural defects sighted.

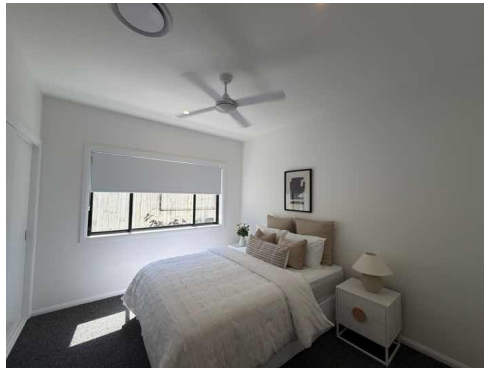
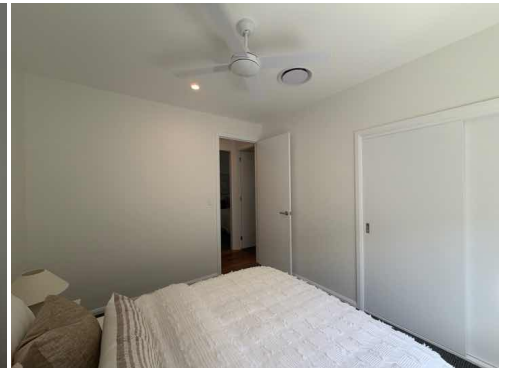
From the visible and accessible areas, this bedroom appears to be in a serviceable condition for the age of the property with no notable structural defects sighted.

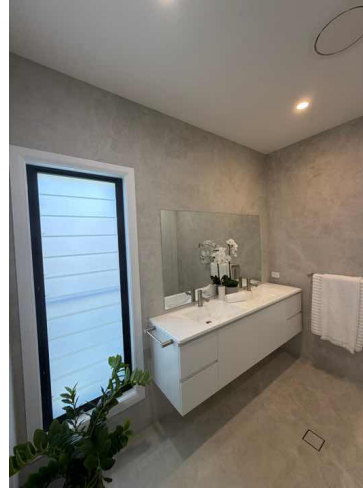
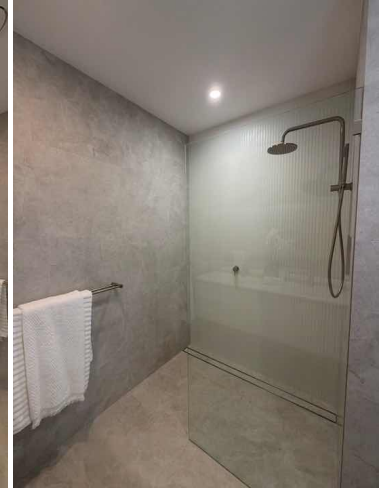
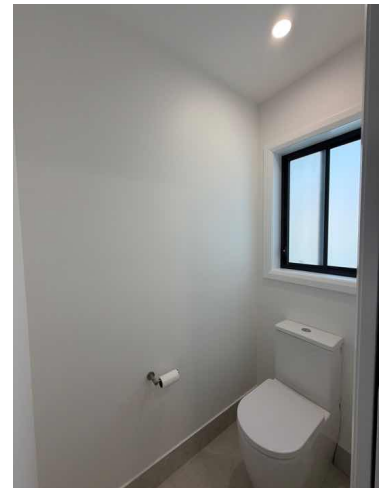
Of the visible areas, the general condition of this bathroom is serviceable or in reasonable condition for age of dwelling.

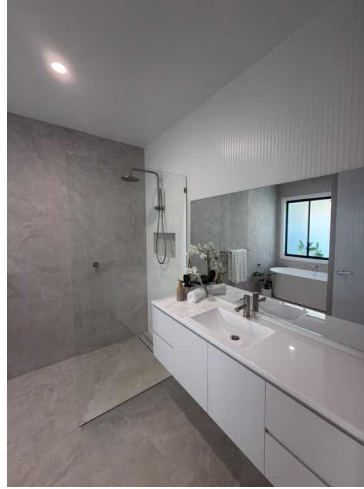
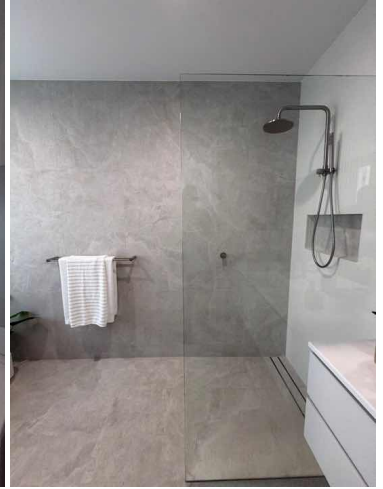
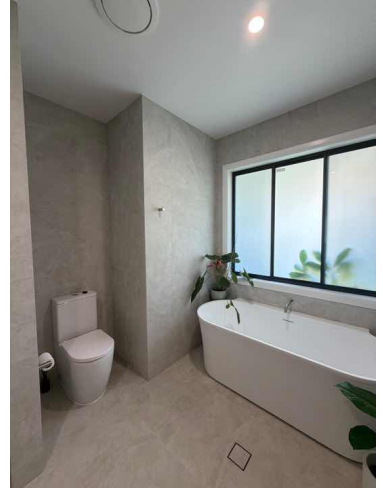
Of the visible areas, the general condition of this bathroom is serviceable or in reasonable condition for age of dwelling.

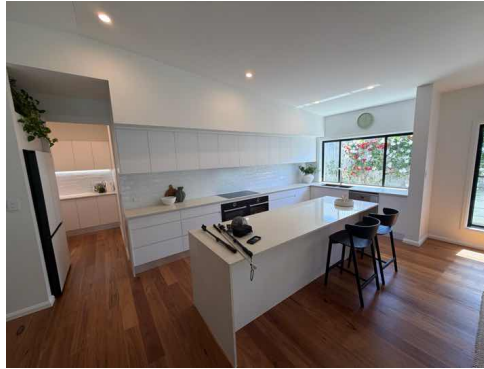
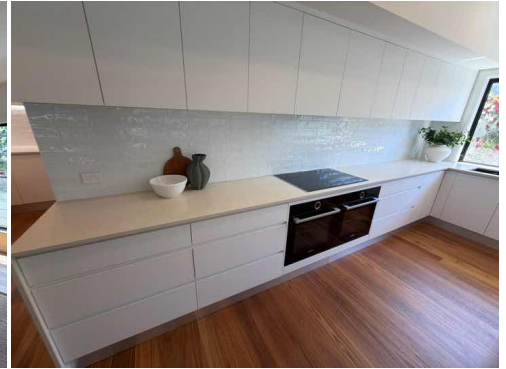
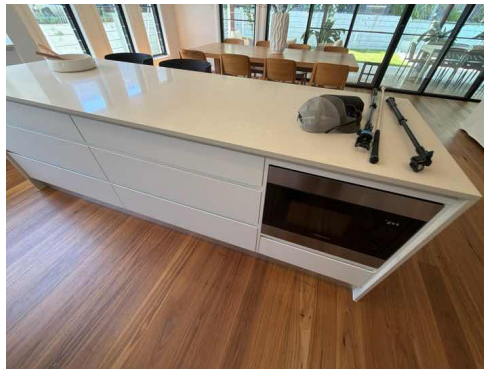
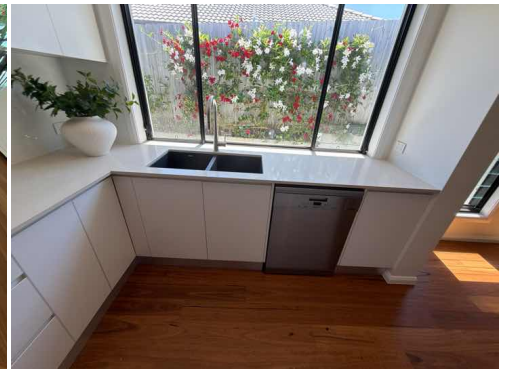
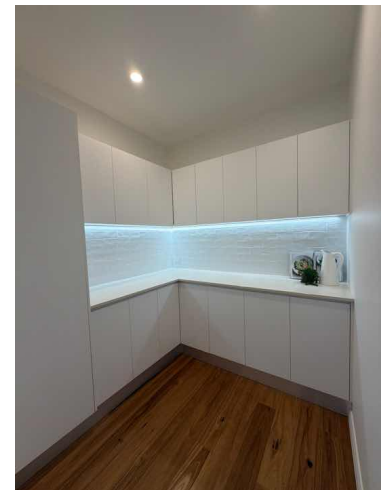
Of the visible areas, the general condition of the kitchen and pantry is serviceable or in reasonable condition for age of dwelling.

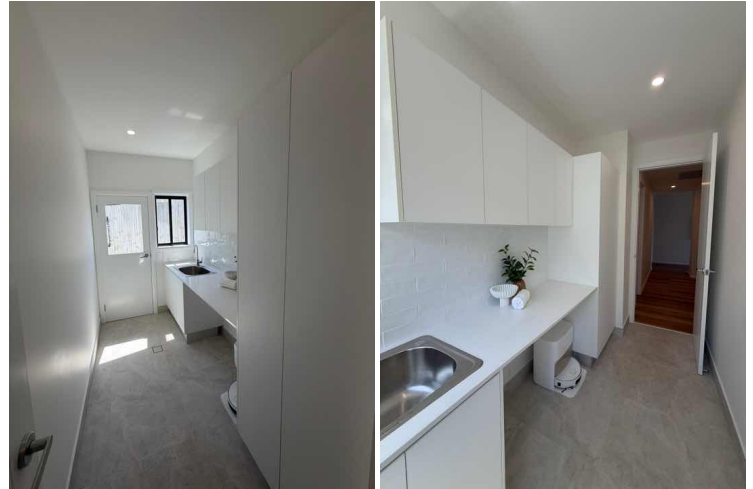
Of the visible areas, the general condition of the laundry is serviceable or in reasonable condition for age of dwelling.
