# Building and Pest Report

## 42 Phoenix Drive Tintenbar

| Inspection Date: | 23 Sep 2025 |

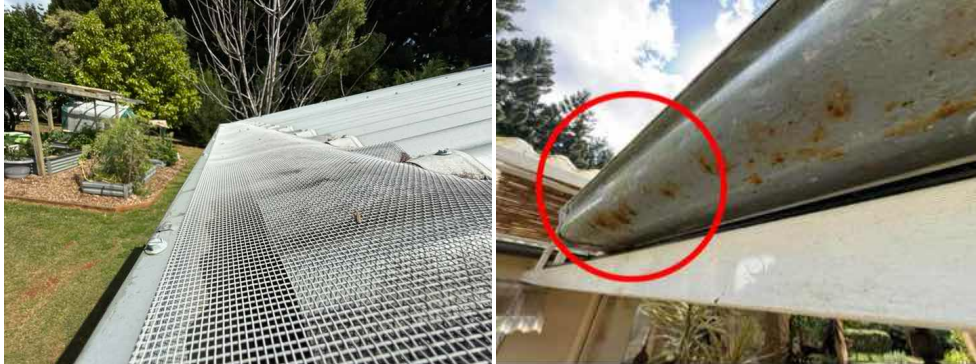
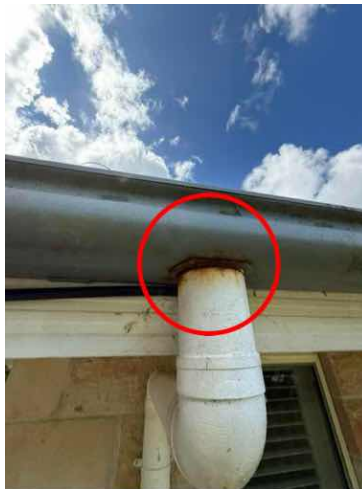
Impact/Denting damage observed. Replace as required.

Gutter surface rust in sections- the rust is yet to penetrate and repairs/sealing may be an option. A qualified roof plumber should be engaged for advice and recommendations.

Gutter rust/penetrations- The guttering has excessive rust where leaking will occur. The gutters require replacement by a roof plumber.

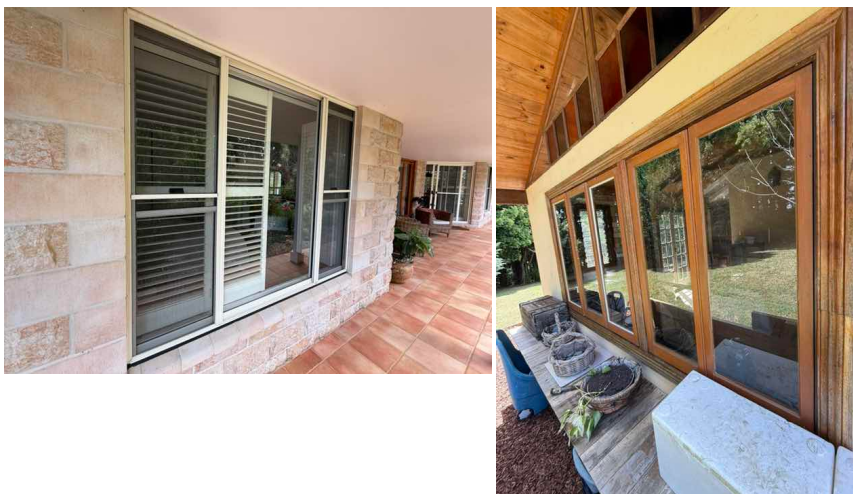
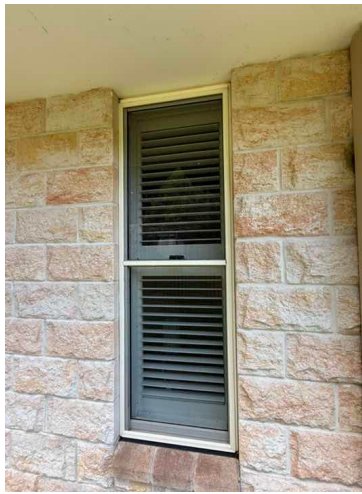
Cracked window pane. A qualified glazier should be engaged to repair.

Damaged fly screen/s replace as required.

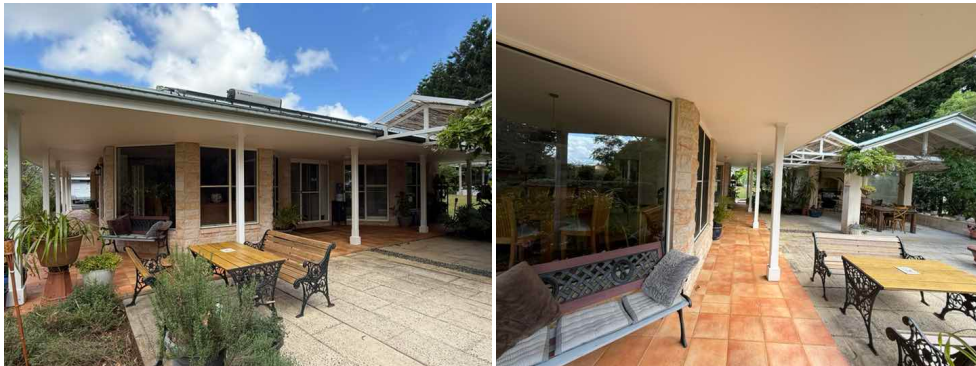
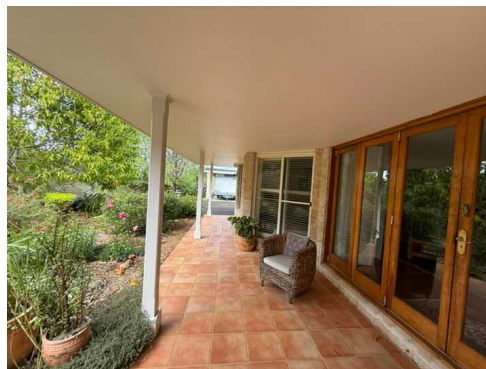
Tiles are drummy and loose. This needs to be fixed by a qualified tiler to eliminate any water penetration issues.

Tile cracking observed. A qualified tiler should be engaged for advice and recommendations. This may cause leaking and water penetration.

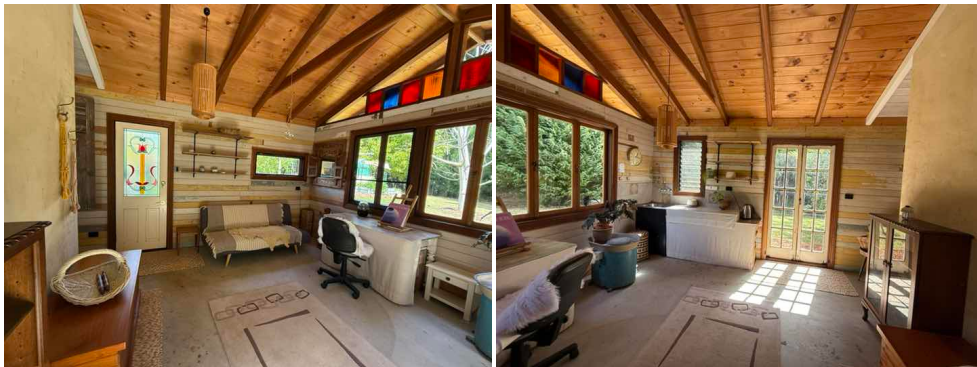
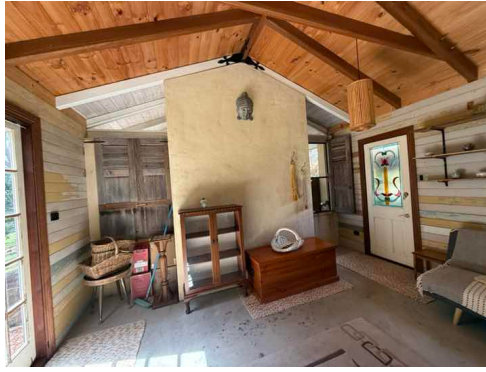
Typical cornice separation/detachment observed. I recommend you contact a qualified painter for repairs.

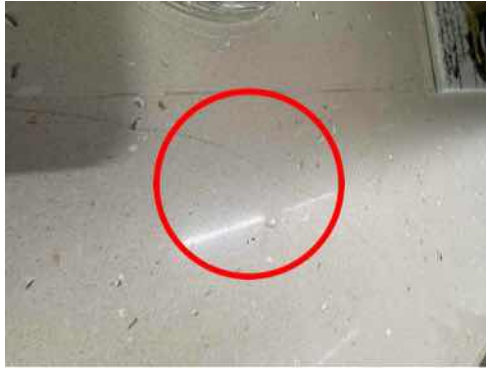
Adjustment to cabinet doors required, in some instance hinges may need to be replaced.

Damage was noted to the bench top, contact a joinery company for repairs

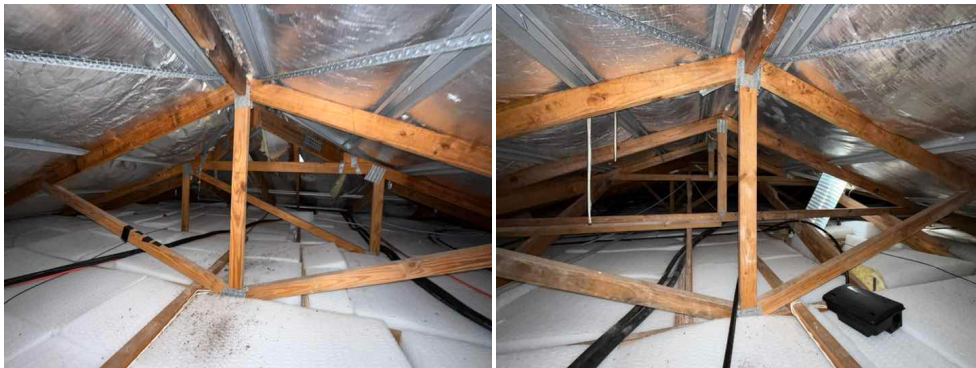
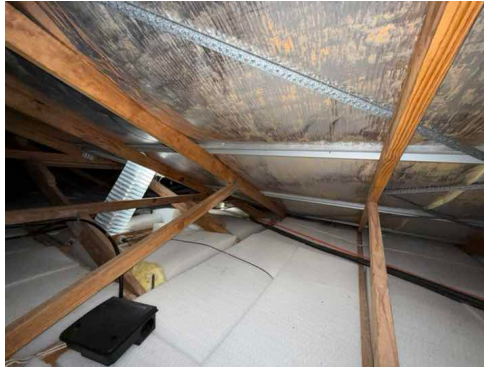
Sarking deteriorated/ damaged / aged in some sections. A qualified roofing contractor should be engaged for advice and recommendations.
