Building and Pest Report

1/33 Sunrise Cres, Lennox Head

Inspection Report

1/33 Sunrise Crescent , Lennox Head , NSW , 2478

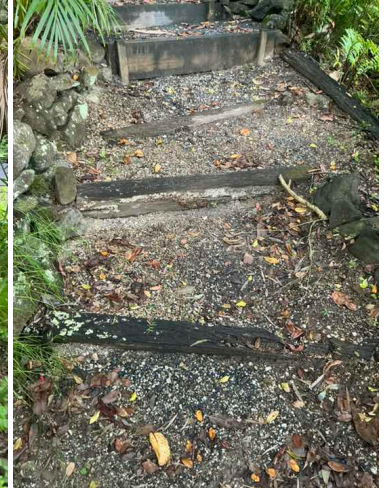
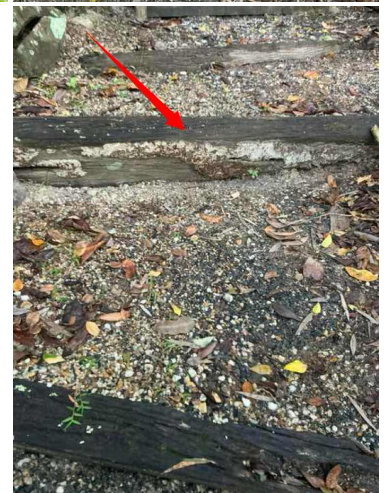
Upon visual inspection, the wooden steps exhibit signs of decay and possible termite activity. It is recommended to engage a licensed pest control professional for eradication and treatment per AS3660. Additionally, consult a licensed builder to assess and repair the structural integrity of the steps to ensure safety and longevity.

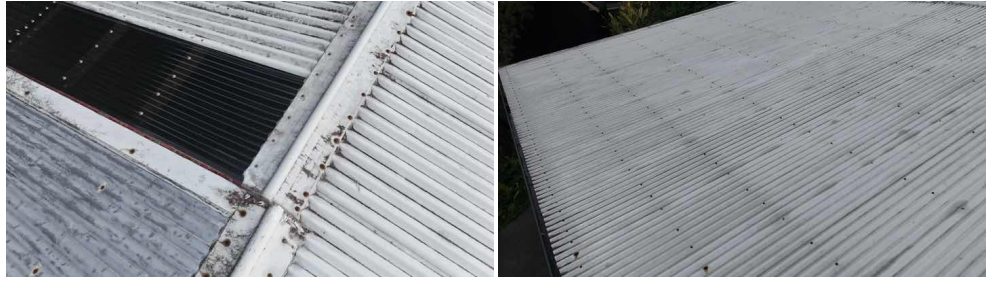
Upon visual inspection, the roof appears to have accumulated debris and possible minor surface wear. It is recommended to clean the roof thoroughly and inspect for any underlying damage. Engage a licensed roofing professional to assess and perform necessary maintenance to ensure longevity and prevent potential leaks. Rust is evident on most screws. Recommend contacting a roofer for possible rescrew of roof.

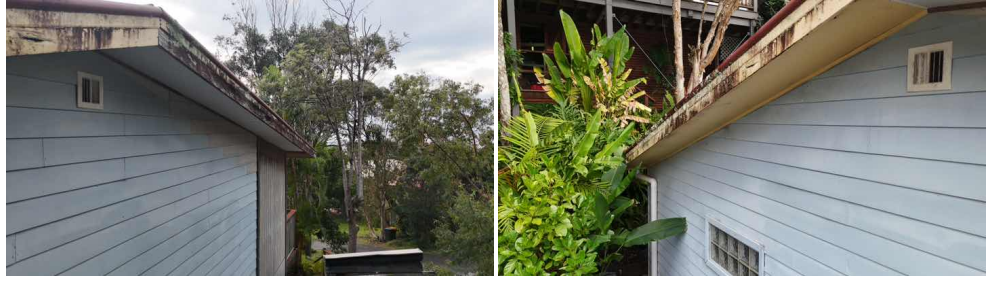
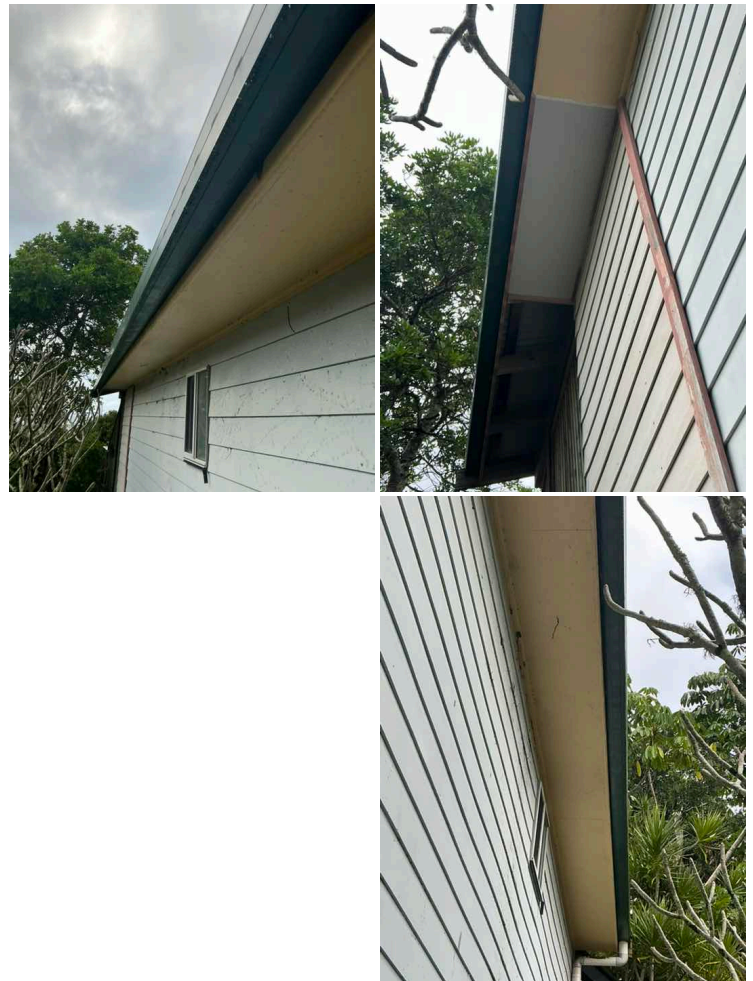
#2. We strongly recommend you re-finish and paint the eaves and timber trim to preserve same.

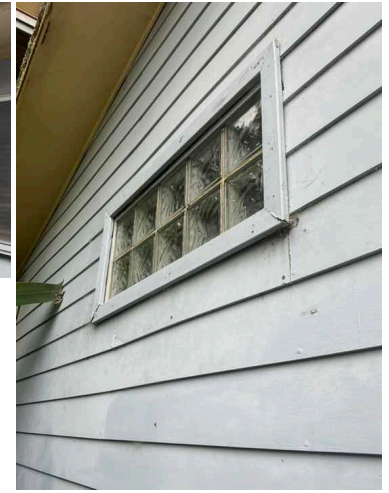
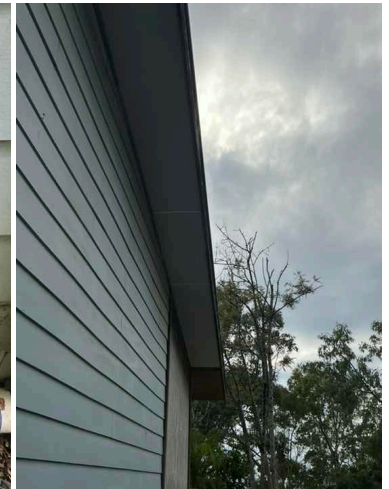
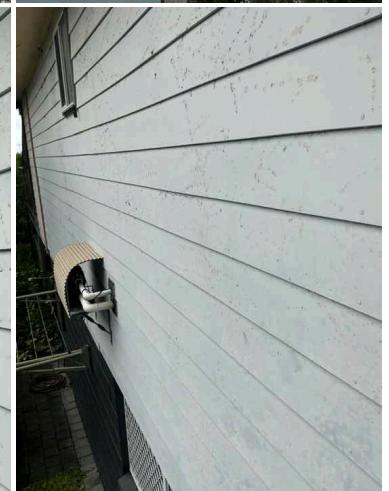
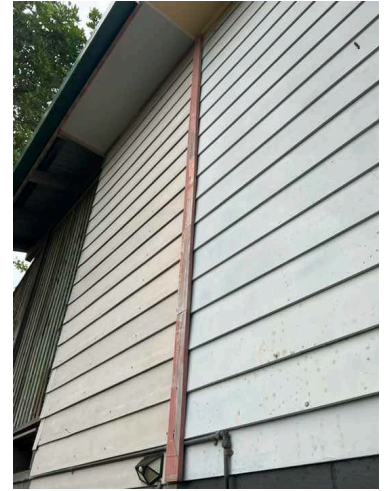
#3. Paneling/cladding damaged. Have a suitably qualified tradesman assess and repair.

#4. End trim missing / not installed

#5. The external paint has deteriorated . External wall paint preserves and protects the building elements. Contact a qualified painter for repairs.

Upon visual inspection, the siding shows signs of weathering and potential gaps between panels. Recommend sealing gaps to prevent moisture ingress and repainting to protect against further weather damage. Engage a licensed tradesperson to assess and repair any structural issues. Regular maintenance checks are advised to ensure long-term integrity.

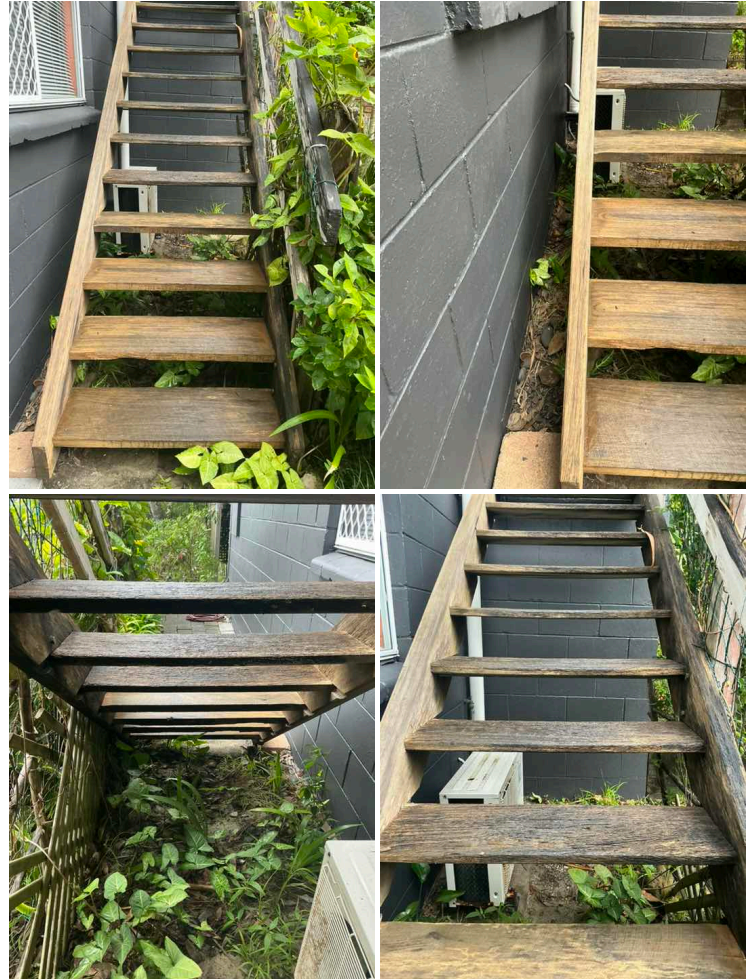
Upon visual inspection, the wooden stairs show signs of weathering and potential rot. It is recommended to have a licensed carpenter assess and replace any compromised steps. Ensure proper sealing and treatment to prevent further deterioration. Regular maintenance checks are advised to maintain safety and structural integrity.

#6. Timber fungal decay in sections of stair treads. This is a safety hazard and repair is required. A qualified carpenter should be engaged for advice and recommendations.

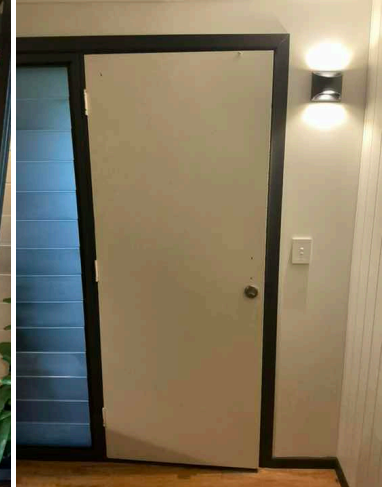
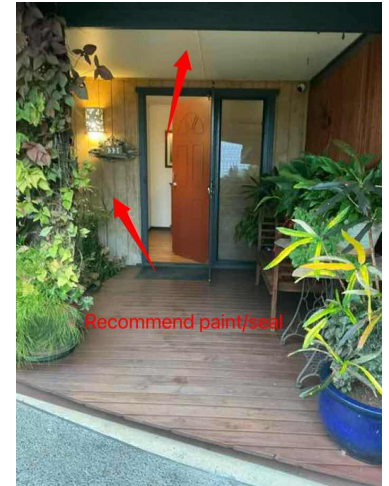
Upon visual inspection, the door appears to have minor scuff marks and potential weathering at the bottom edge. Recommend sanding and repainting to protect against further wear. Ensure the door frame is properly sealed to prevent drafts. Consult a licensed tradesperson for any necessary adjustments or repairs to the door hardware for optimal functionality.

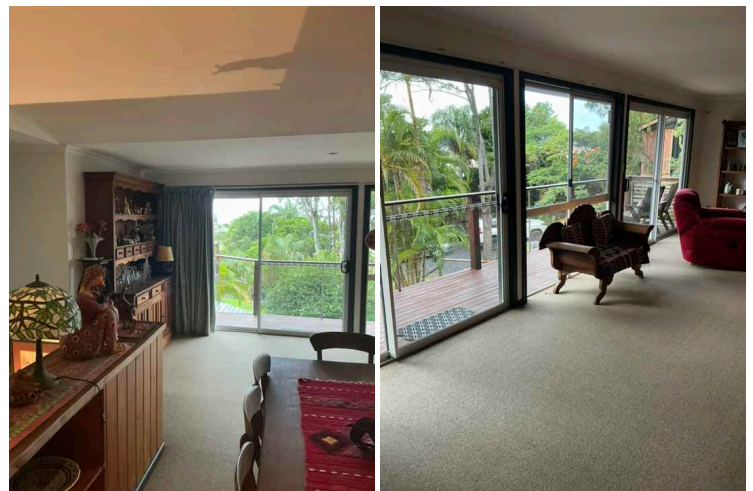
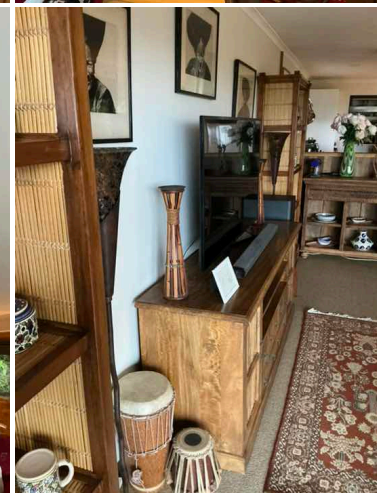
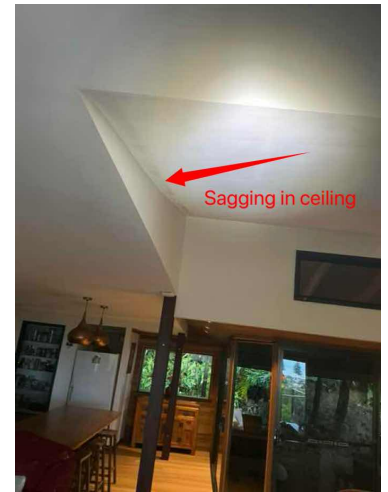
Upon visual inspection, there is a noticeable ceiling sag, possibly due to water damage or structural issues. It is recommended to engage a licensed tradesperson to assess and repair the ceiling. Ensure any leaks are addressed to prevent further damage.

#7. Ceiling sagging - Requires immediate repairs to prevent further collapse. Contact a qualified plasterer for repairs.

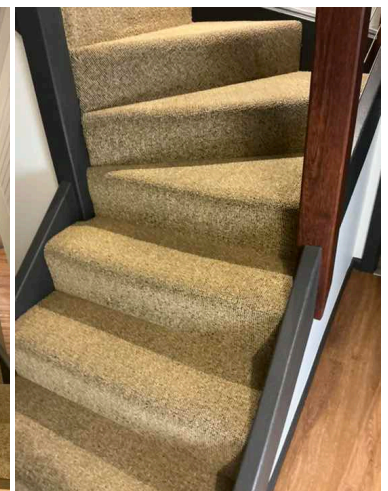
The stair treads squeak and require maintenance.

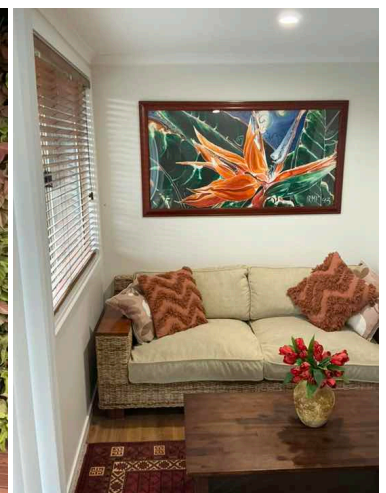
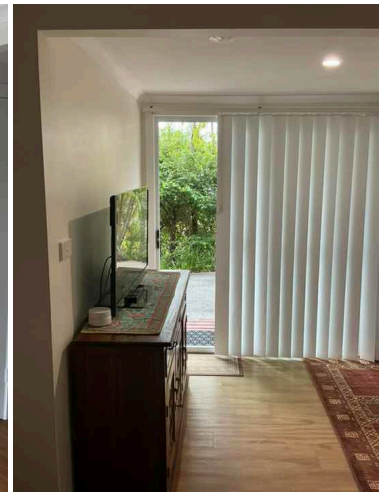
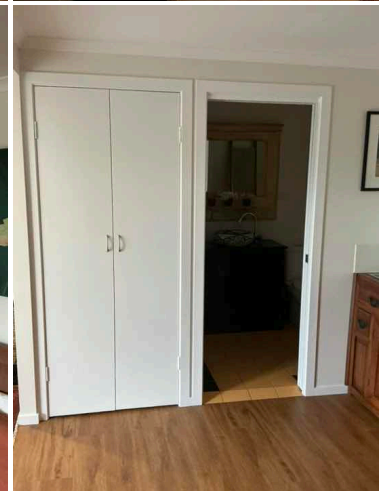
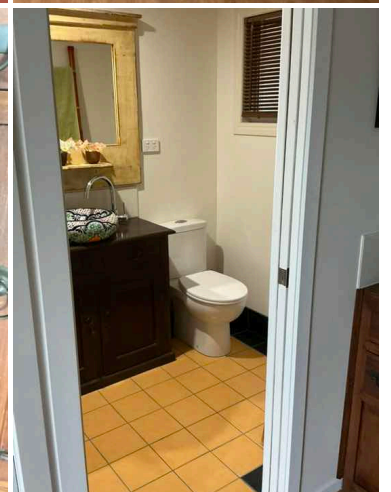
On inspection, defects were present that will require further assessing and recommendations by a qualified trades persons, please read below for details. Upon visual inspection, the moisture meter indicates elevated levels. Recommend engaging a licensed tradesperson to investigate potential water intrusion sources. Ensure proper sealing around windows and inspect for leaks. Address any water damage promptly to prevent further issues.

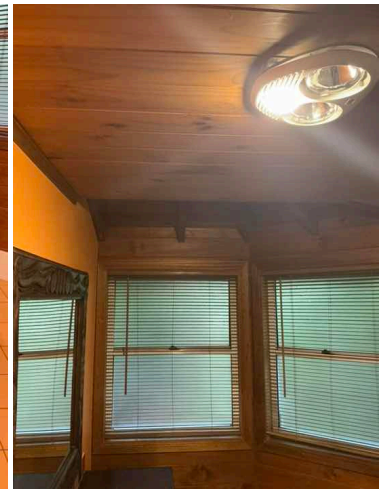
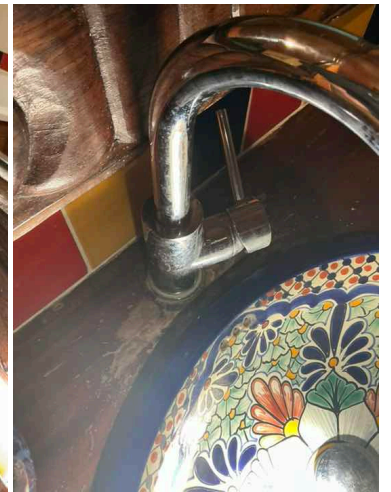
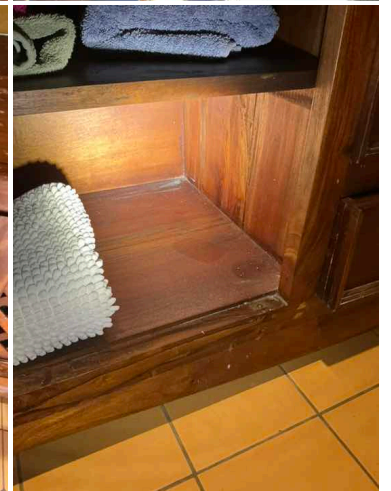
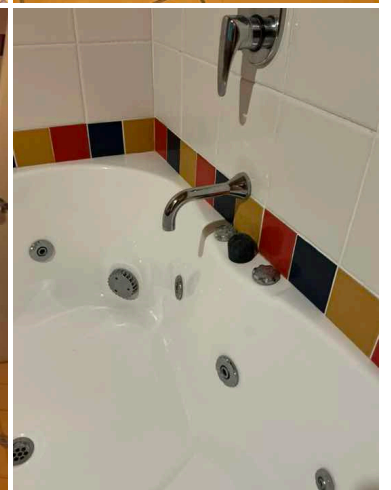
Upon visual inspection, water damage is evident around the sink area, likely due to leakage. Recommend sealing the faucet base and countertop edges with waterproof sealant. A licensed plumber should inspect and repair any leaks to prevent further deterioration. Additionally, consider refinishing or replacing the affected wood to restore integrity and appearance.

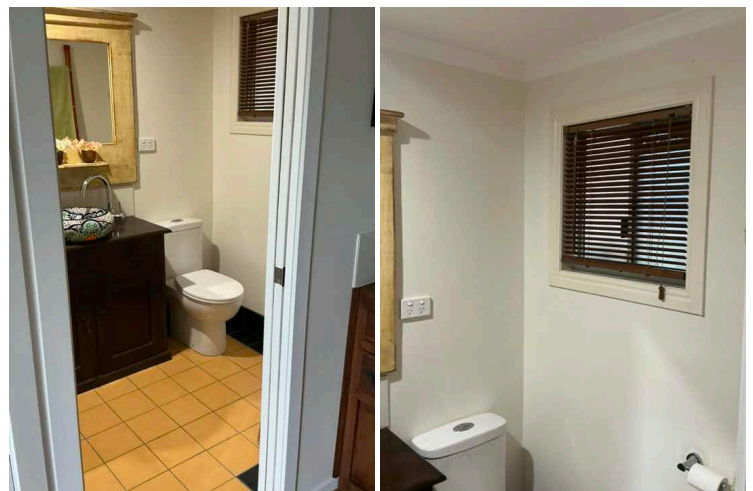
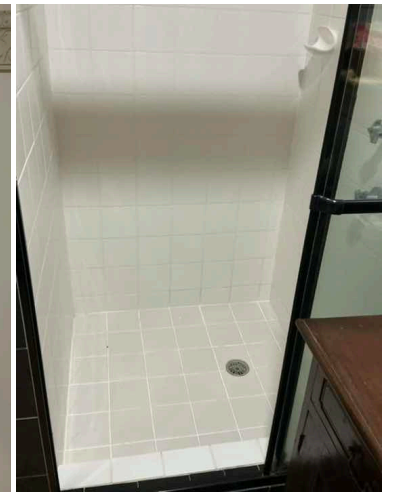
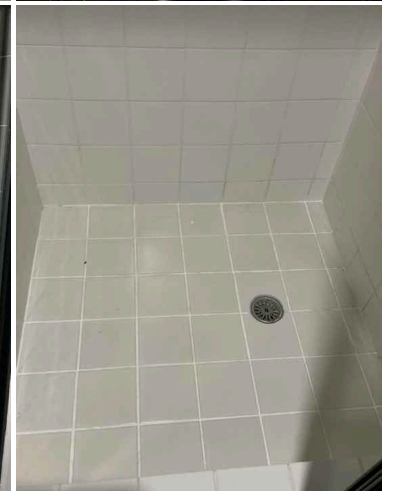
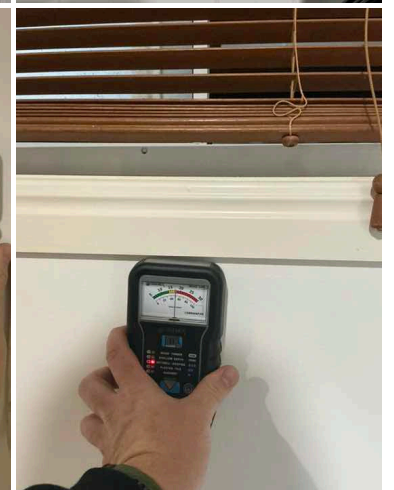
Upon visual inspection, the moisture meter indicates elevated moisture levels in the wall. It is recommended to engage a licensed plumber to investigate potential leaks or water ingress. Additionally, a licensed builder should assess any structural implications and ensure proper repairs to prevent further moisture-related issues.

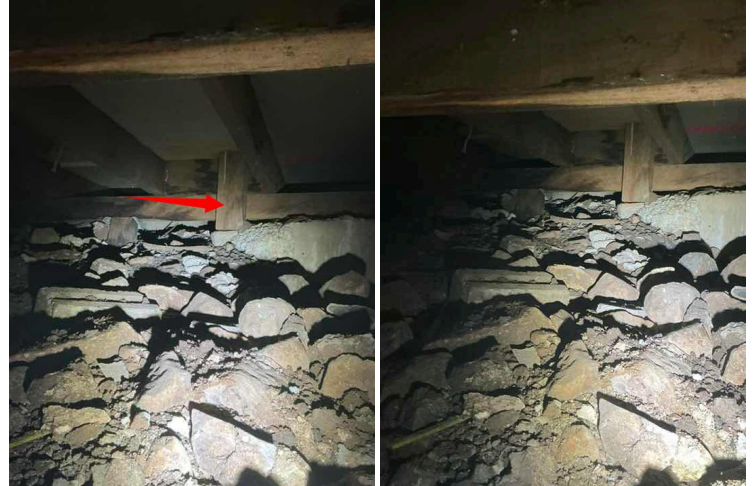
#8. Timbers are used as floor supports. These should be replaced with permanent brick piers or steel supports as there are conducive to termite entry and decay.

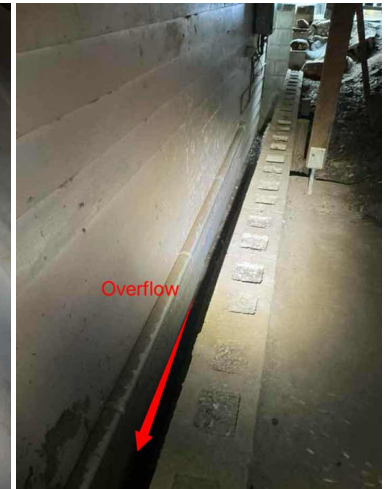
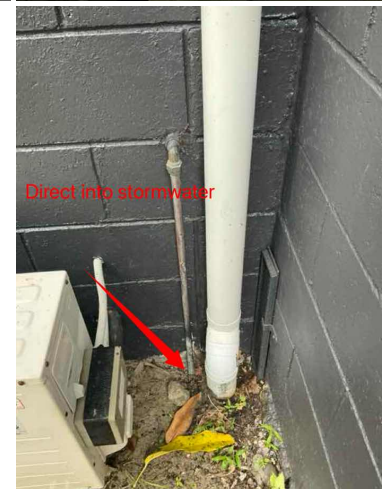
There was water leakage detected during the inspection from the hot water overflow. This should be diverted away from the dwellings walls or into a drain.

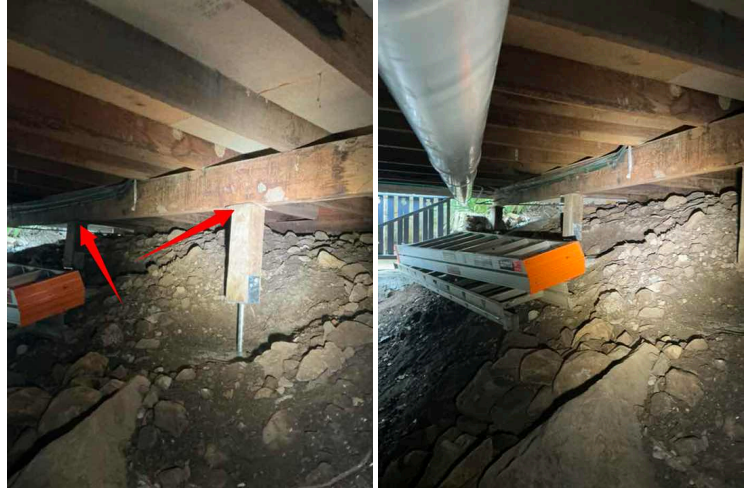
The termite shields (ant caps) are inadequate. Consult an appropriate trade for a scope of works and cost of repairs for the issue prior to contracts becoming binding.
