Building and Pest Report

12 Tidepool Street Lennox Head

Report/Agreement #	190325084503308
Inspection Date:	19 Mar 2025
Inspection Time:	08:45 am

Pest And Building Inspection

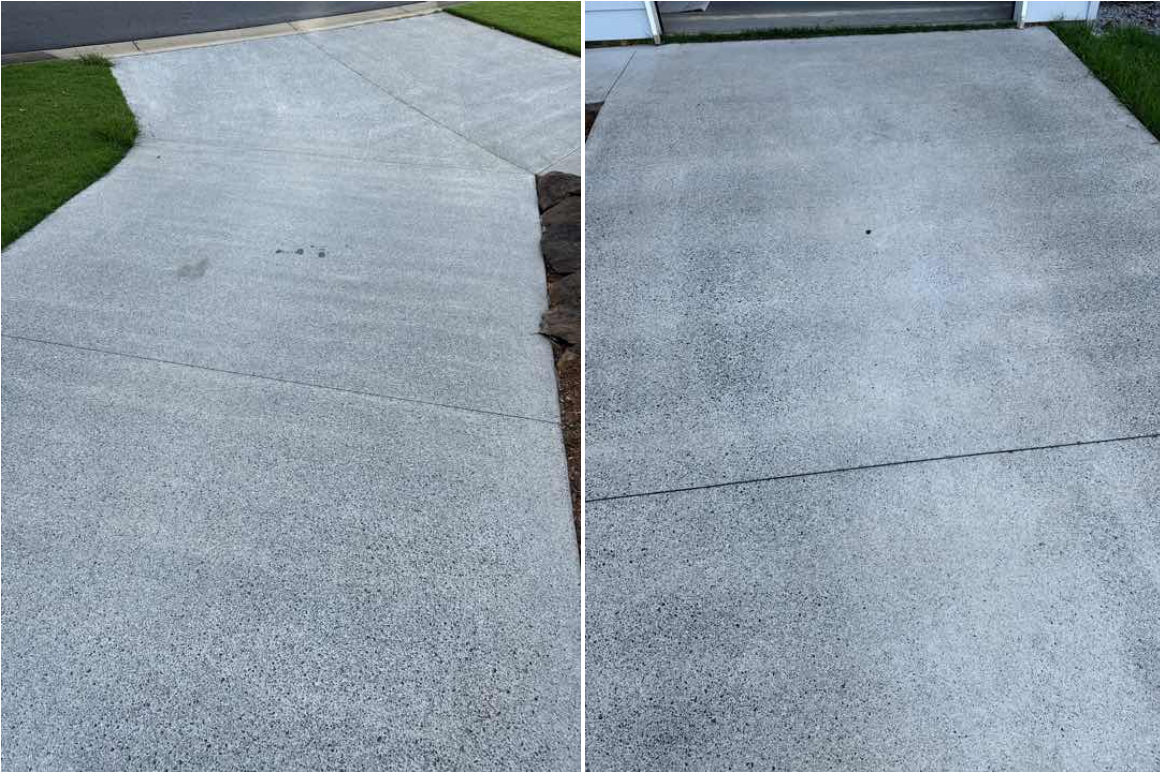
Driveway Condition

On visual inspection, the general condition of the driveway is serviceable.

Common cracks were observed on the driveway. Whilst these cracks appeared to be typical at the time of inspection, we strongly recommend you monitor these cracks and if worsening occurs contact a concreter for further advice.

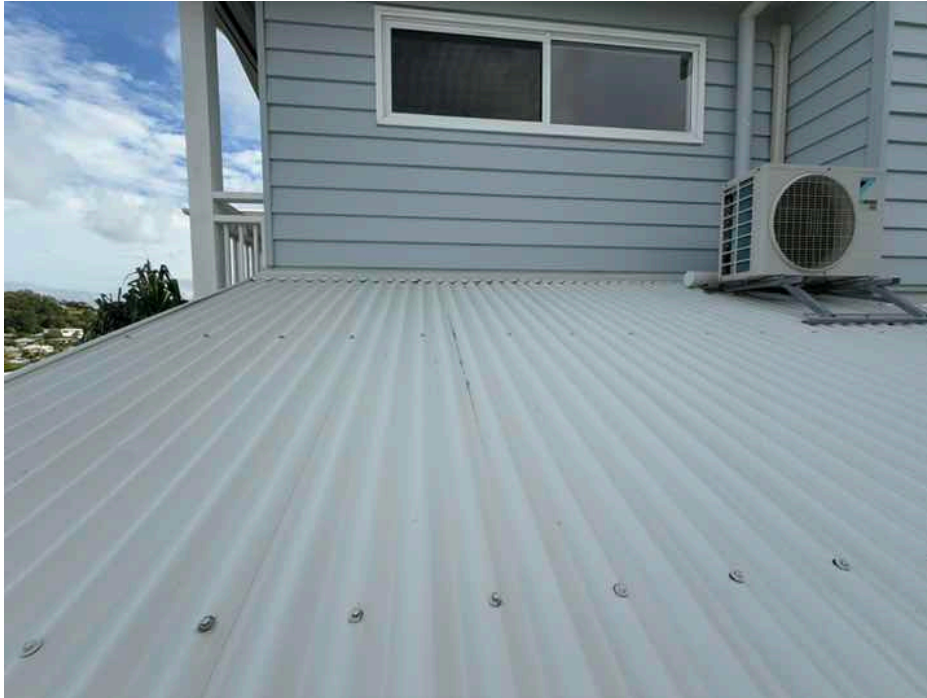
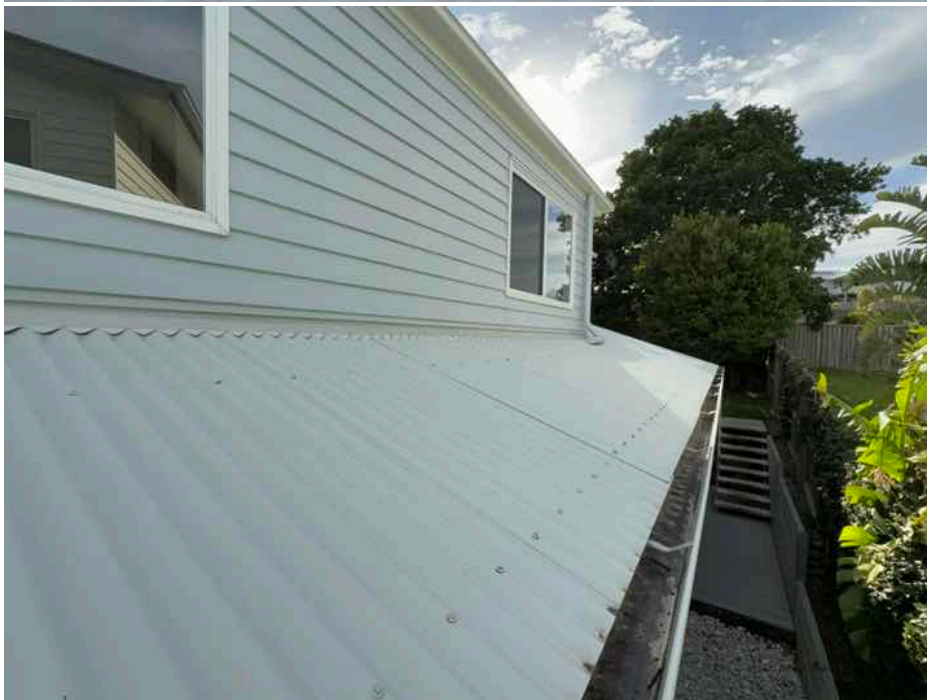
Of the visible areas, the general condition of the roof is in serviceable condition for the age.
Note: In the absence of rainfall there is no guarantee that the roof won't leak.

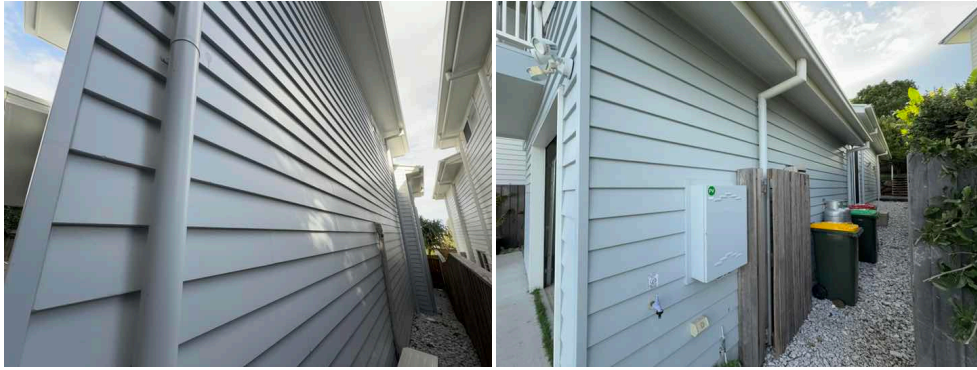
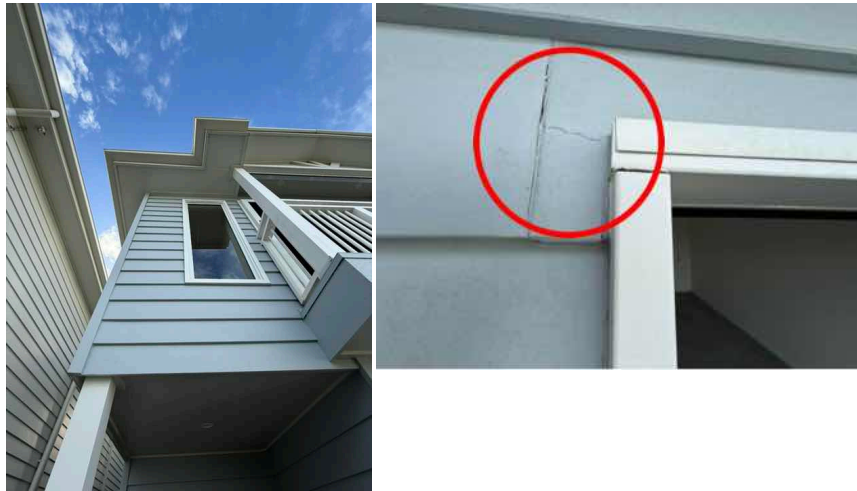
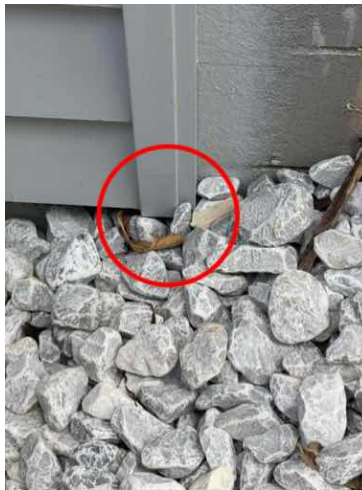
On visual inspection, the general condition of the exterior walls is serviceable for the age.

Minor cladding damage observed. This should be repaired so as to avoid moisture ingress and pests entry.

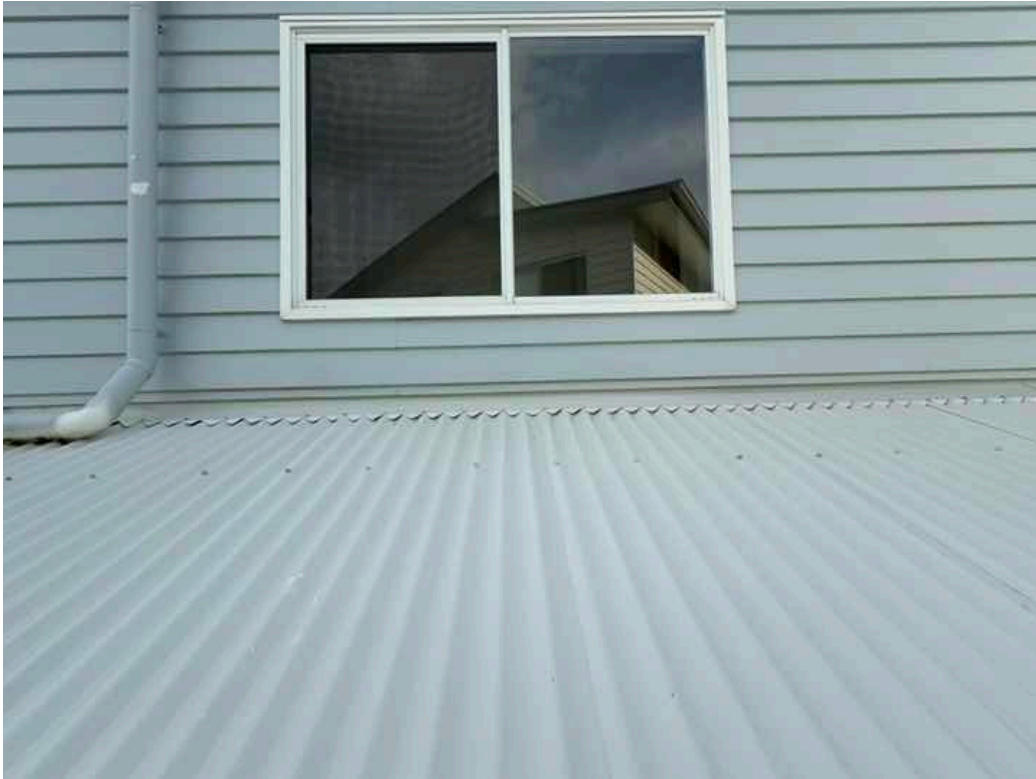
On visual inspection, the general condition of the windows is serviceable for the age.

Damaged fly screen/s replace as required.

Some rubber seals need fixing

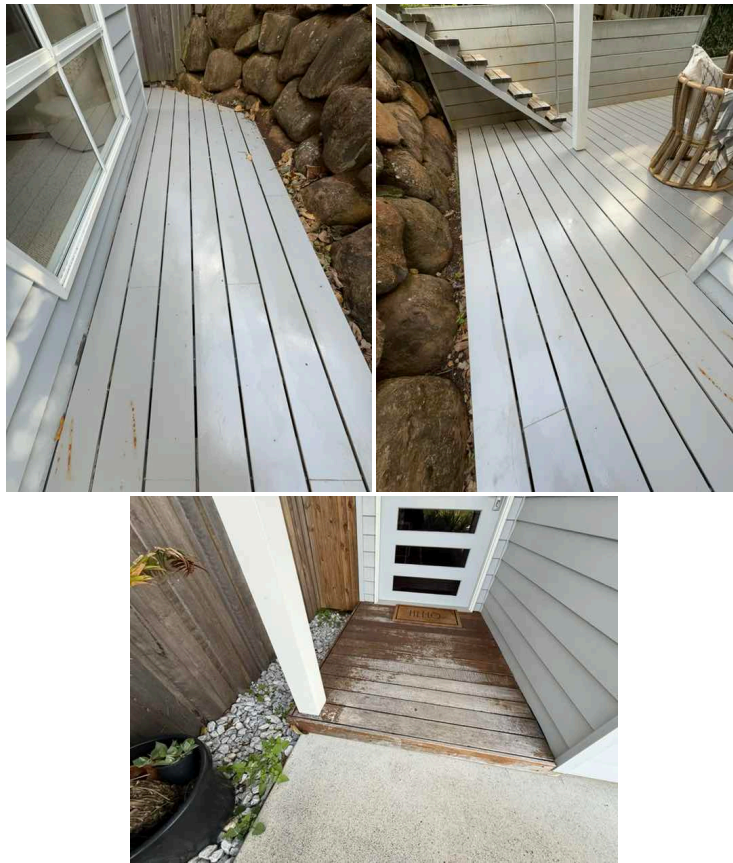
Of areas visible, the decking appears to be in a serviceable condition.

Of areas visible, minor defects and/or maintenance issues were visible. These will require assessment and subsequent repairs by a licensed tradesperson. Please read below for details. Please note that the inspector believes these to be of a minor nature relative to the age of the dwelling and or lack of proper and continual maintenance. Others, including other inspectors may differ in their opinions.

Decking board surfaces are weathered. We recommend cleaning and maintenance as needed.

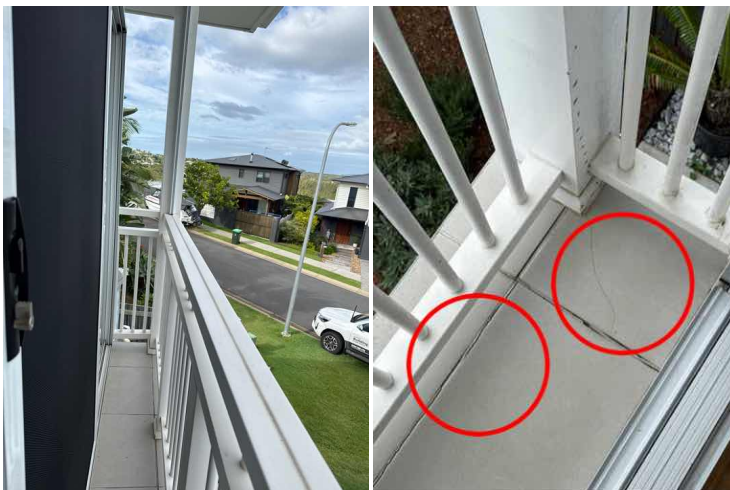
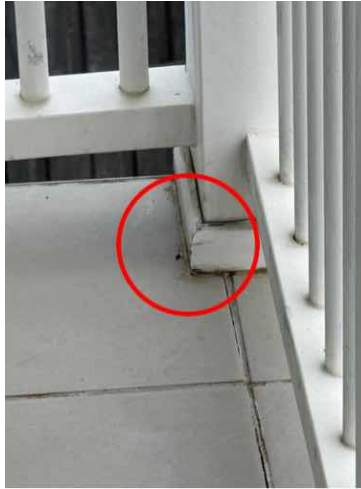
Though we are not structural engineers the balcony/s appear to be in a serviceable condition.

Minor maintenance

Moisture damage to timber trims

Tiles are drummy and loose. This needs to be fixed by a qualified tiler to eliminate any water penetration issues.

Tile cracking observed. A qualified tiler should be engaged for advice and recommendations. This may cause leaking and water penetration.

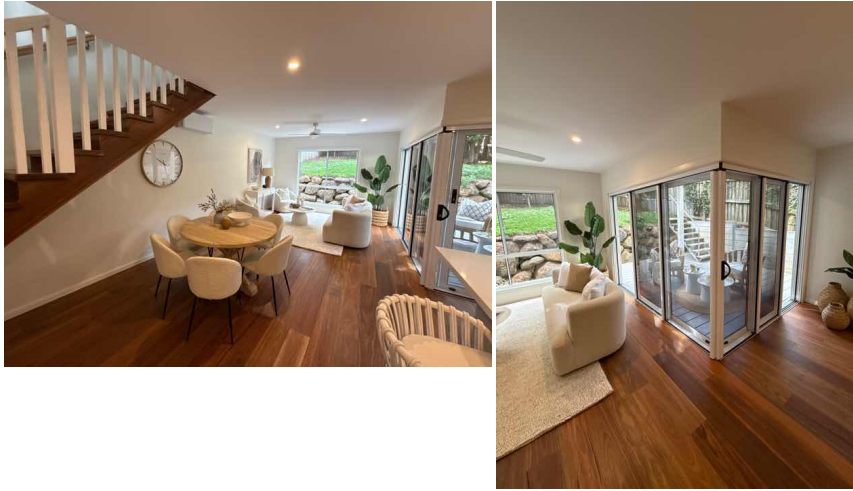
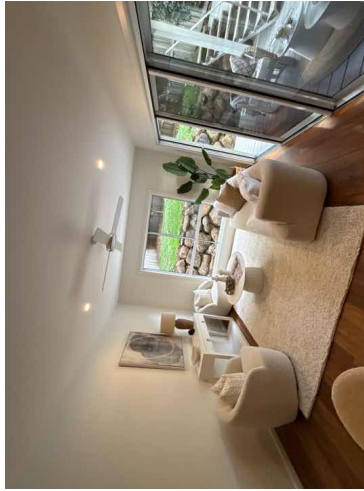
Settlement Cracks Noted. These are typical and generally patch and paint will suffice, however monitoring these cracks is advised for 12 months and if they become worse, further investigation by a suitably qualified professional is advised.

From the visible and accessible areas, this room appears to be in a serviceable condition for the age of the property with no notable structural defects sighted.

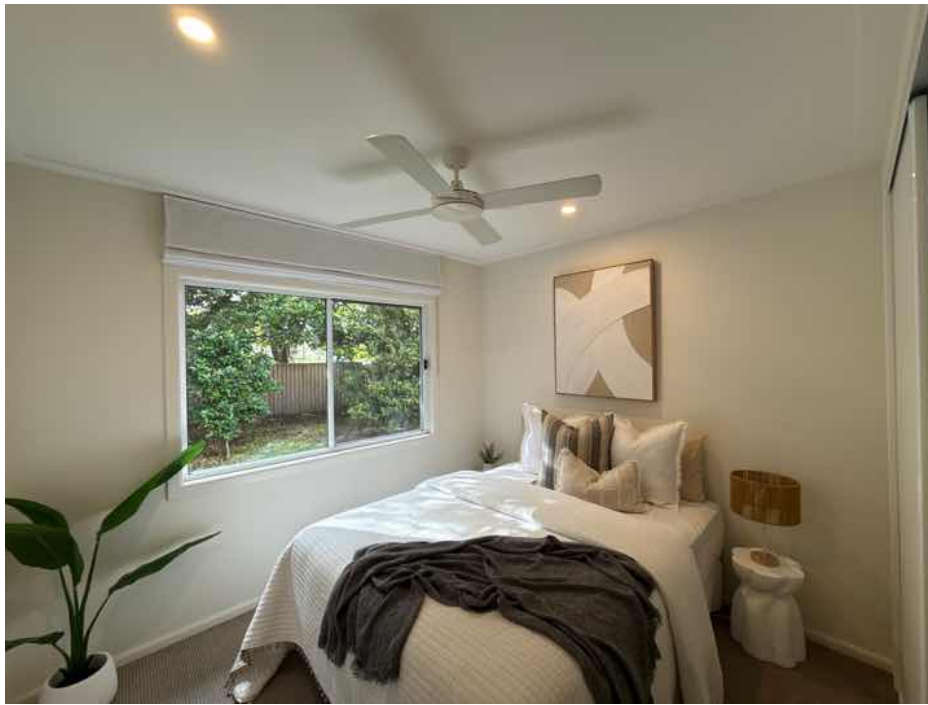
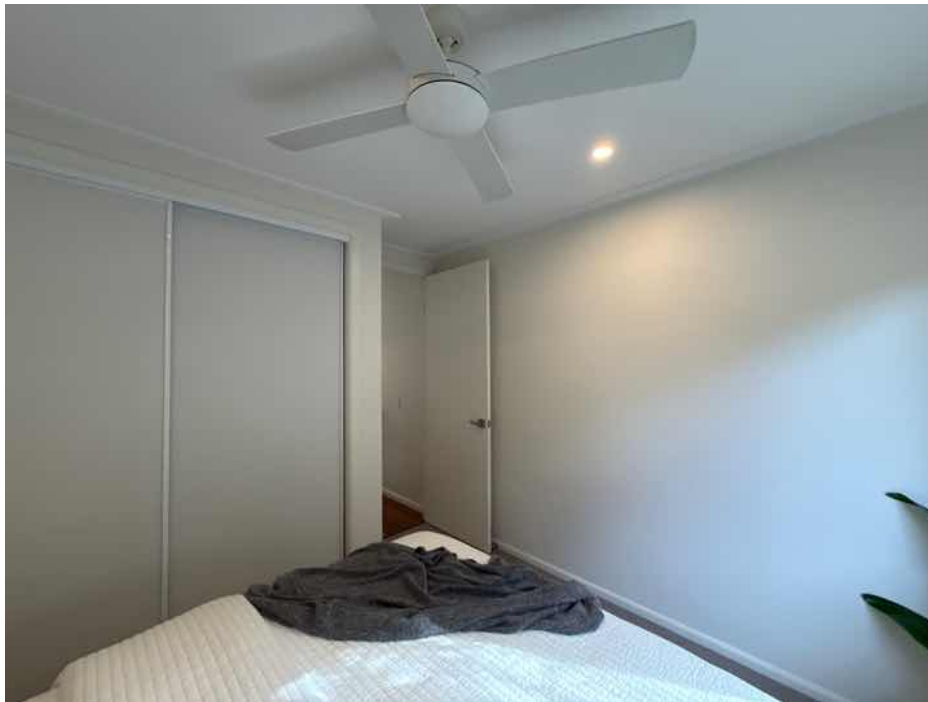
Typical cornice separation/detachment observed. I recommend you contact a qualified painter for repairs.

From the visible and accessible areas, this bedroom appears to be in a serviceable condition for the age of the property with no notable structural defects sighted.
