Building and Pest Report

107 Stoneyhurst Dr, Lennox Head

Pest And Building Inspection

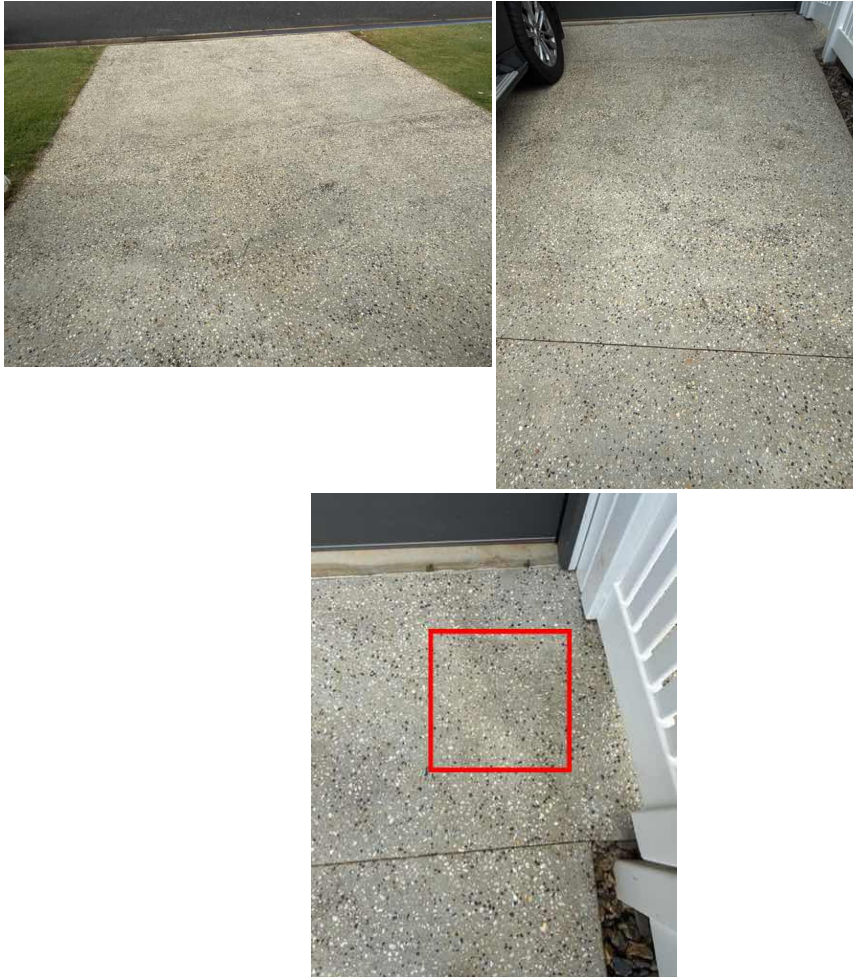
On visual inspection, the general condition of the driveway is serviceable.

Common cracks were observed on the driveway. Whilst these cracks appeared to be typical at the time of inspection, we strongly recommend you monitor these cracks and if worsening occurs contact a concreter for further advice.

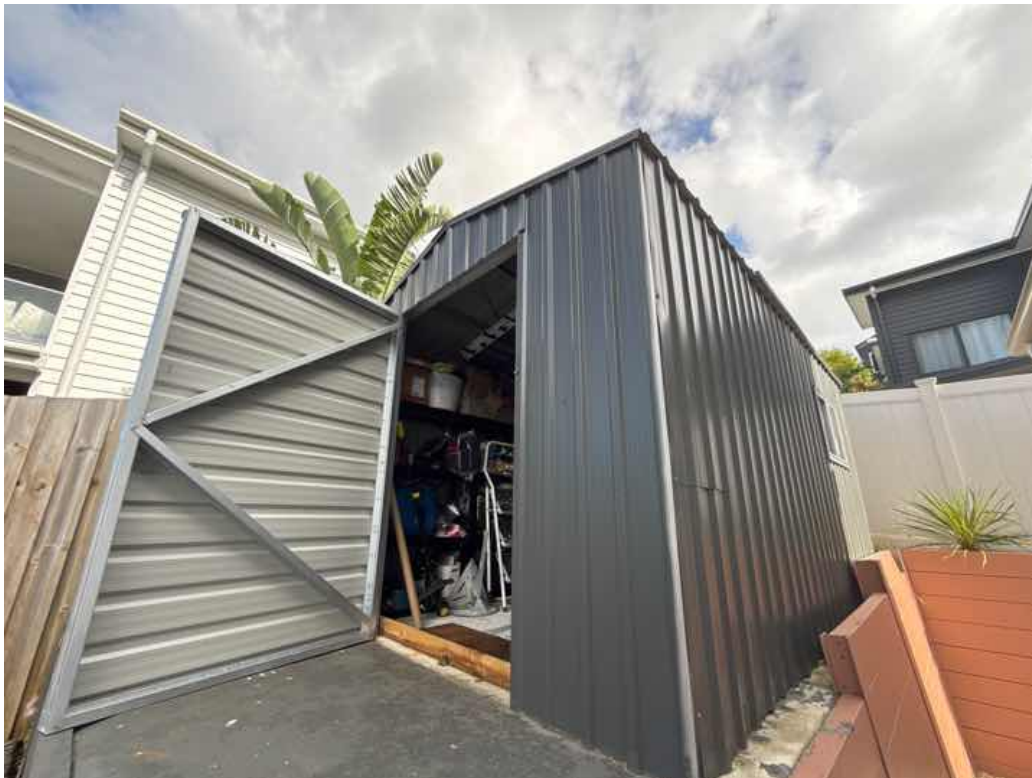
The shed is in fair usable condition.

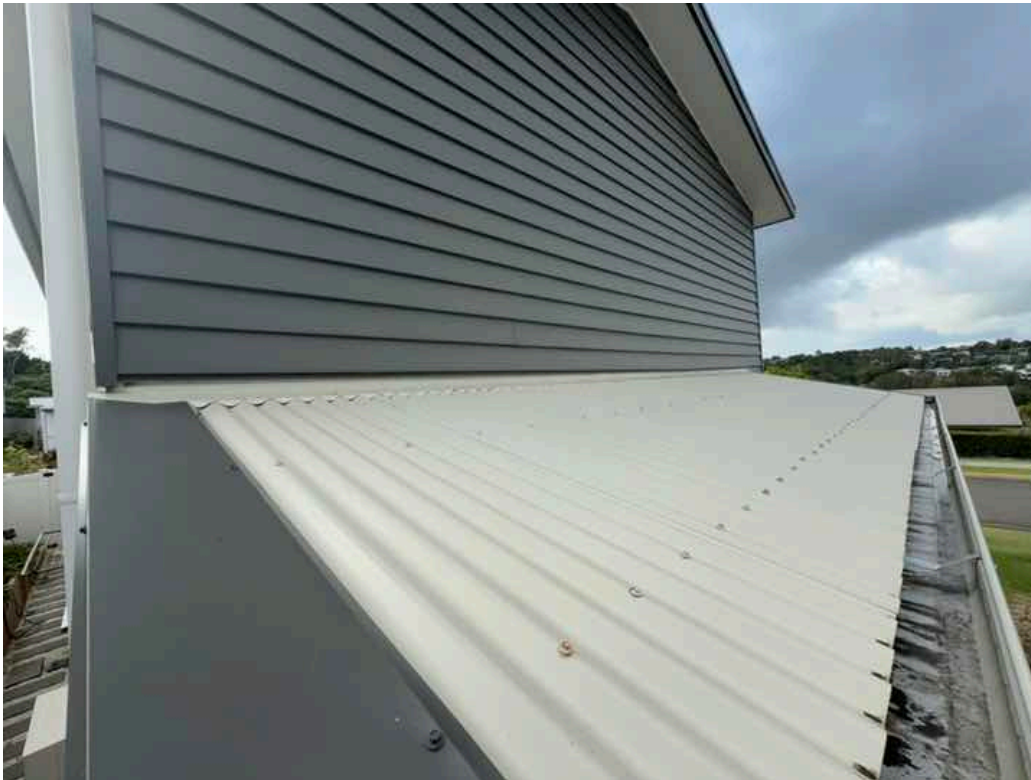
Of the visible areas, the general condition of the roof is in serviceable condition for the age.

Note: In the absence of rainfall there is no guarantee that the roof won't leak.

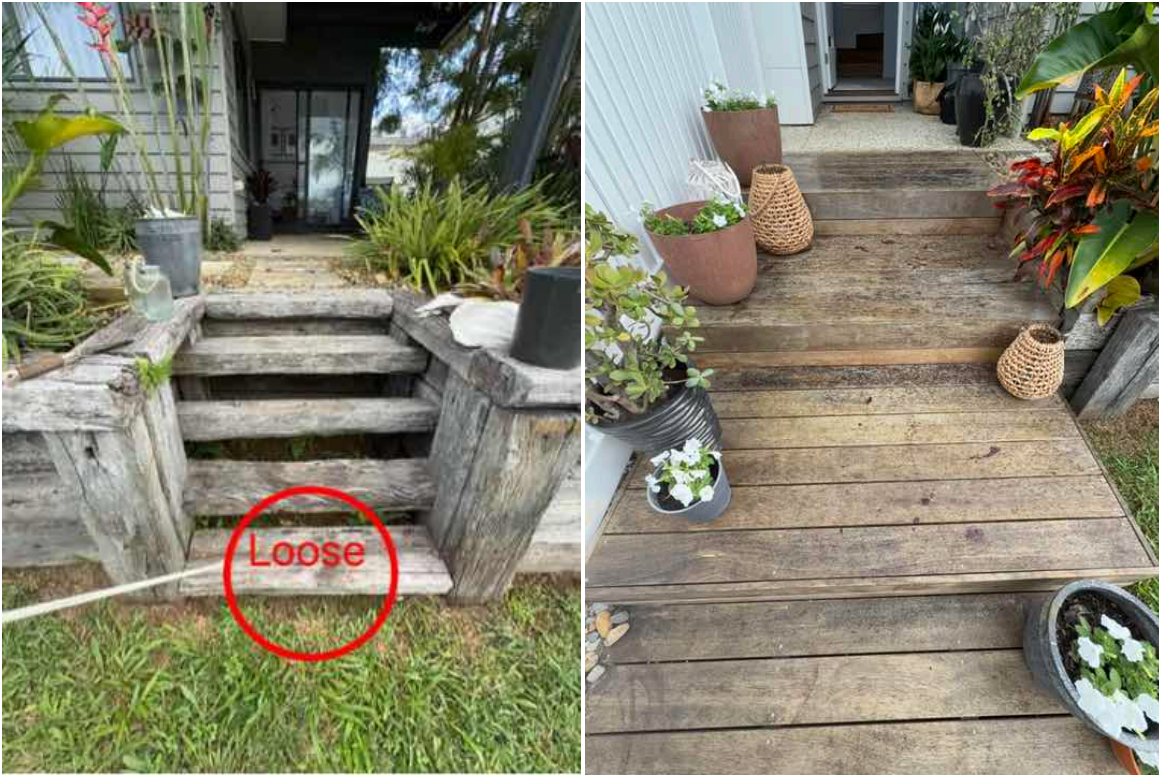
The stairs/steps appear to be serviceable with no notable defects.

Of areas visible, minor defects and/or maintenance issues were visible. These will require assessment and subsequent repairs by a licensed tradesperson. Please read below for details. Please note that the inspector believes these to be of a minor nature relative to the age of the dwelling and or lack of proper and continual maintenance. Others, including other inspectors may differ in their opinions.

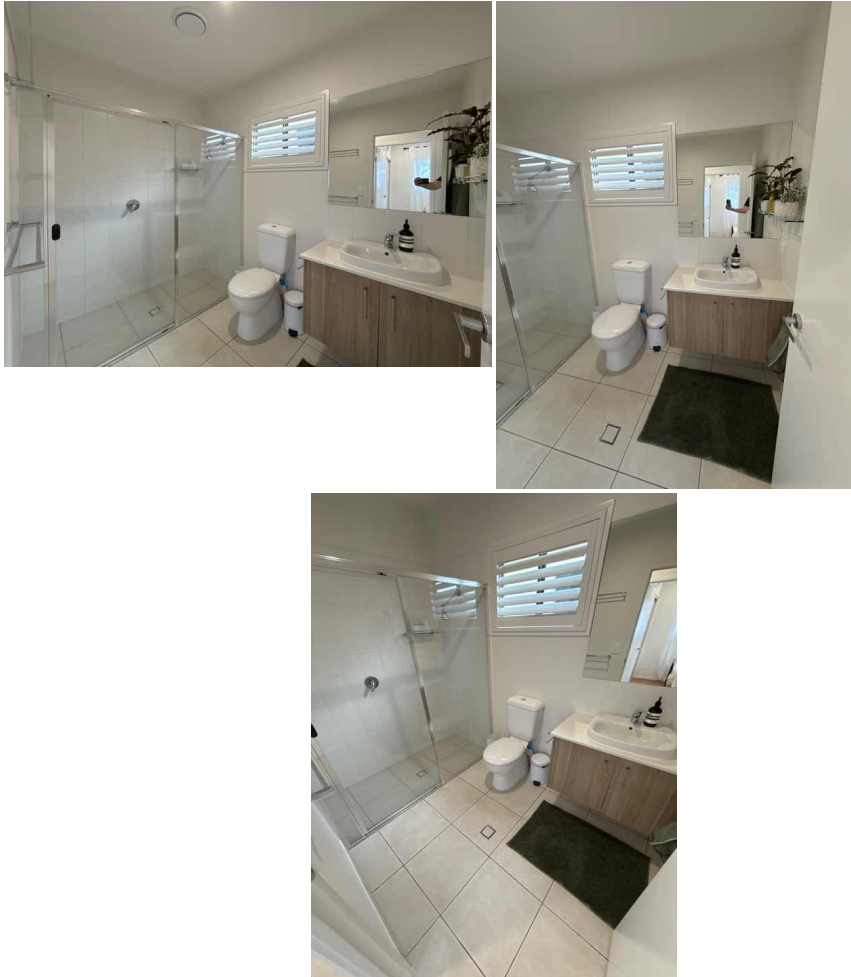
Of the visible areas, the general condition of this bathroom is serviceable or in reasonable condition for age of dwelling.

Upon visual inspection, moisture damage was observed on the door frame, causing wood rot and potential structural weakness. It is recommended to remove and replace the affected sections of the frame. Ensure proper sealing and waterproofing to prevent future issues. Consult a licensed carpenter or contractor to assess the extent of the damage and perform necessary repairs to restore integrity.

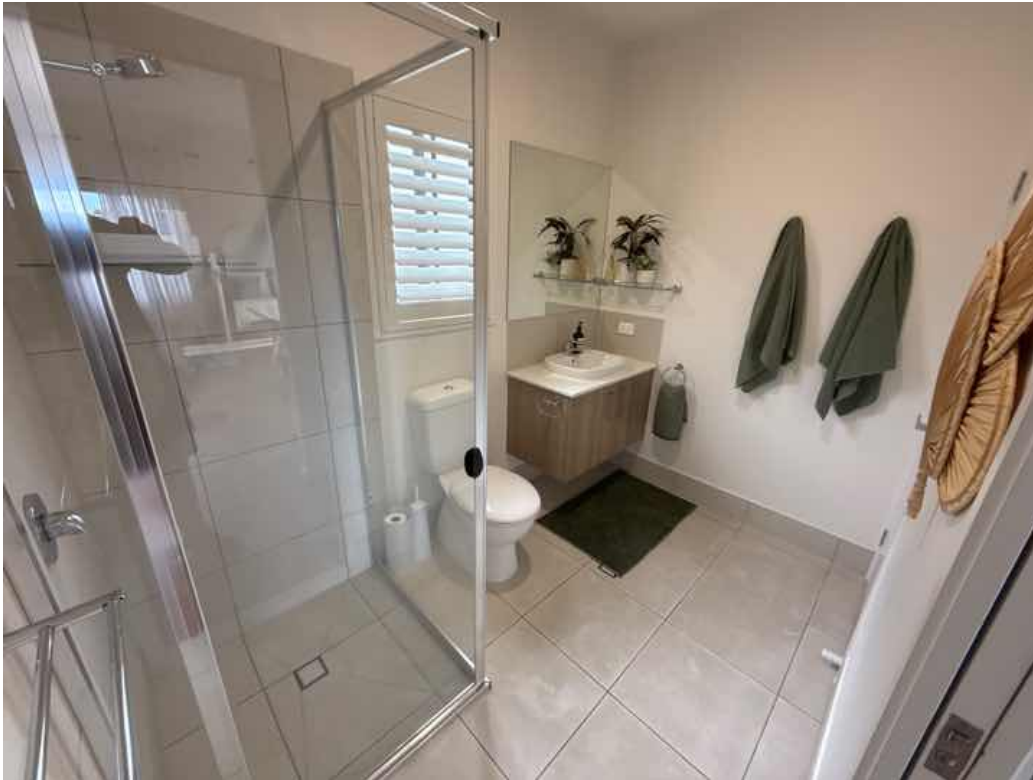
Of the visible areas, the general condition of this bathroom is serviceable or in reasonable condition for age of dwelling.

Shower head is leaking. Replacement recommended.

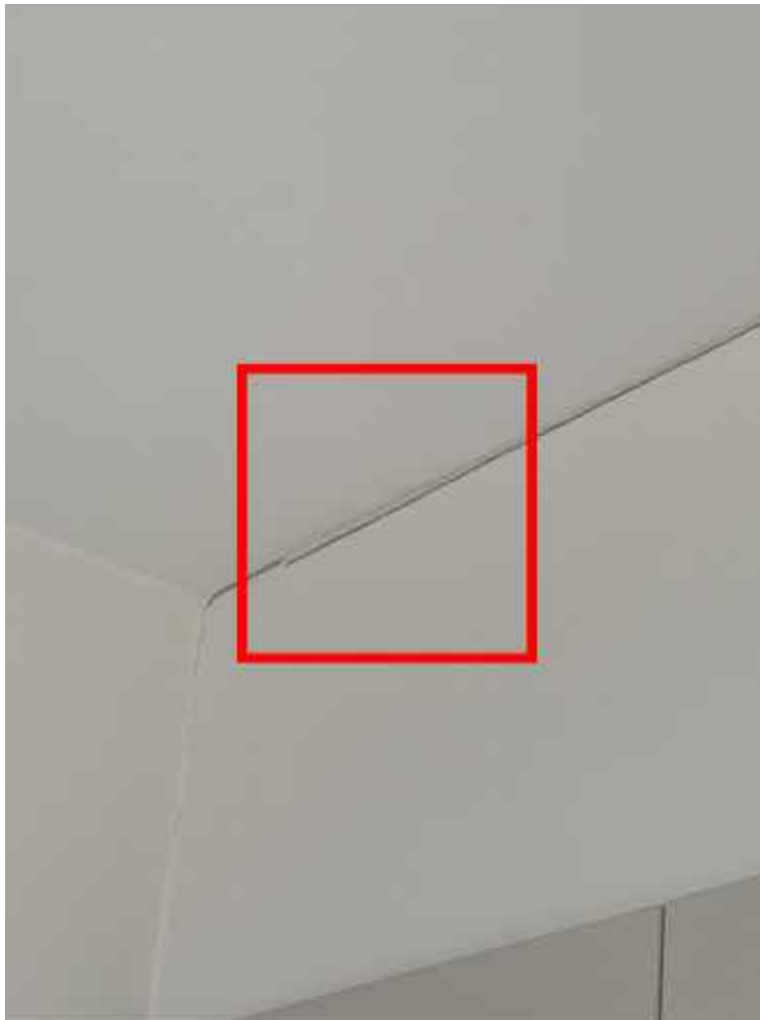
Cornice separation. I recommend you contact a licensed painter for repairs.
