Building and Pest Report

8 Tresise Place Lennox Head

Report/Agreement #	200225033017246
Inspection Date:	20 Feb 2025
Inspection Time:	03:30 pm

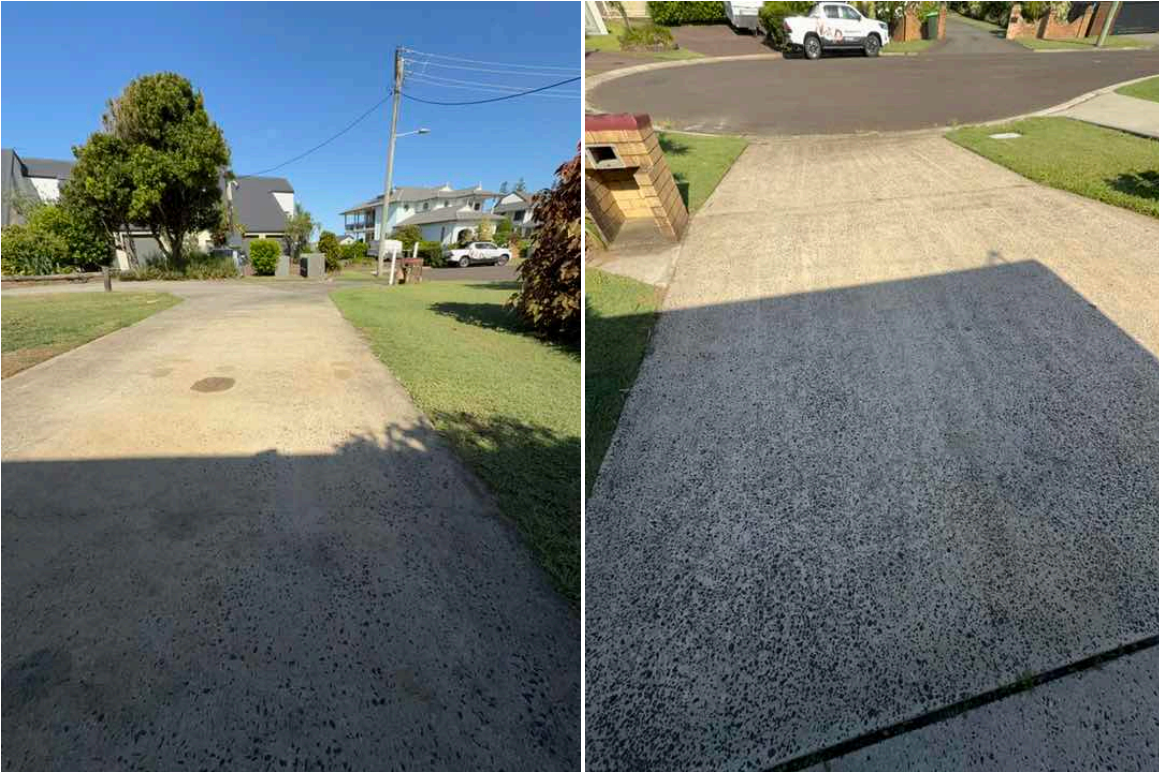
Common cracks were observed on the driveway. Whilst these cracks appeared to be typical at the time of inspection, we strongly recommend you monitor these cracks and if worsening occurs contact a concreter for further advice.

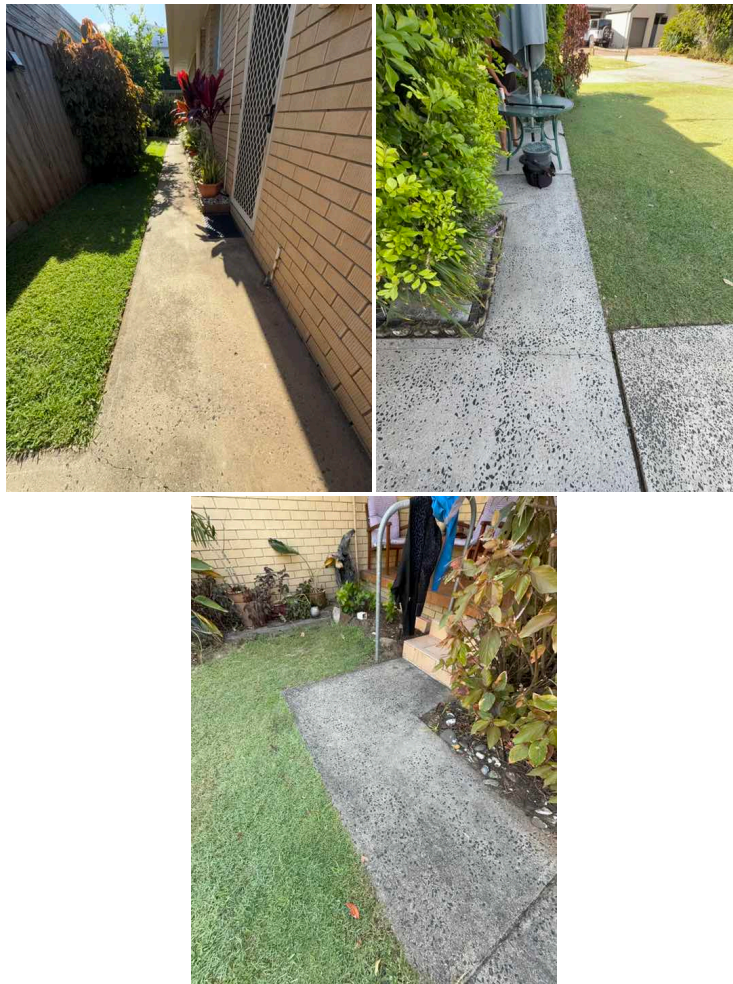
Common cracks and settlement were observed on paths. Whilst these cracks appeared to be typical at the time of inspection, we strongly recommend you monitor these cracks and if worsening occurs contact a concreter for further advice.

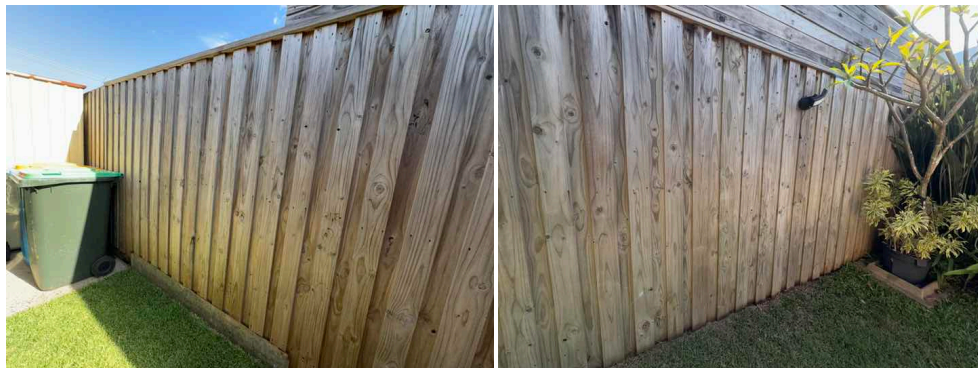
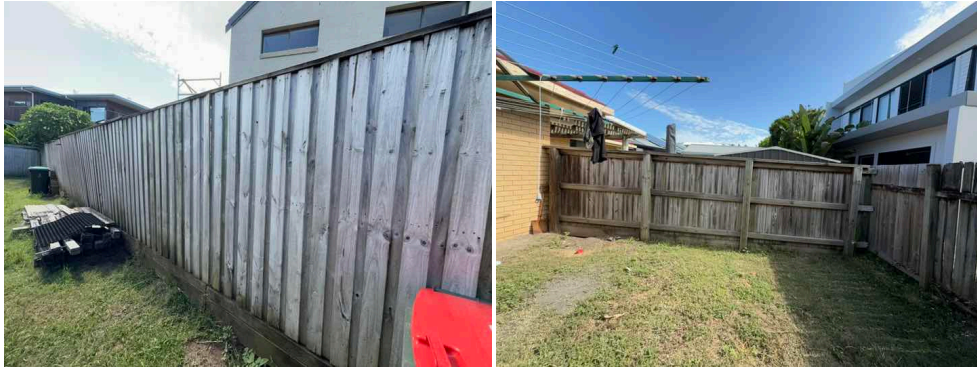
General age to fence components. General upkeep and maintenance required. A qualified fencing contractor should be engaged for repairs.

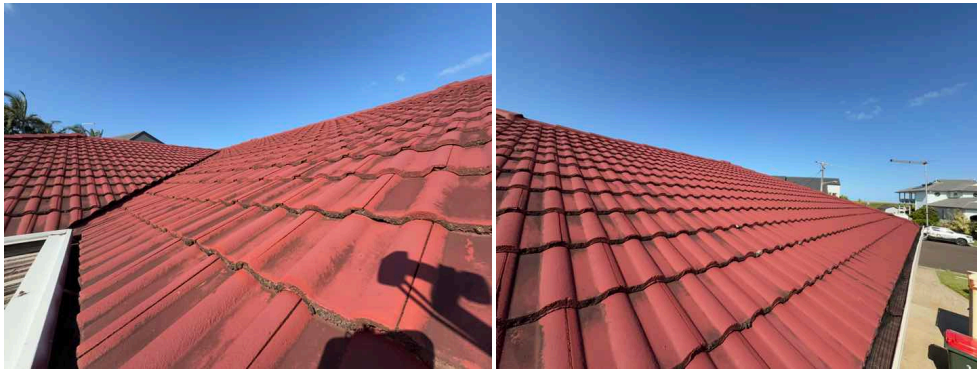
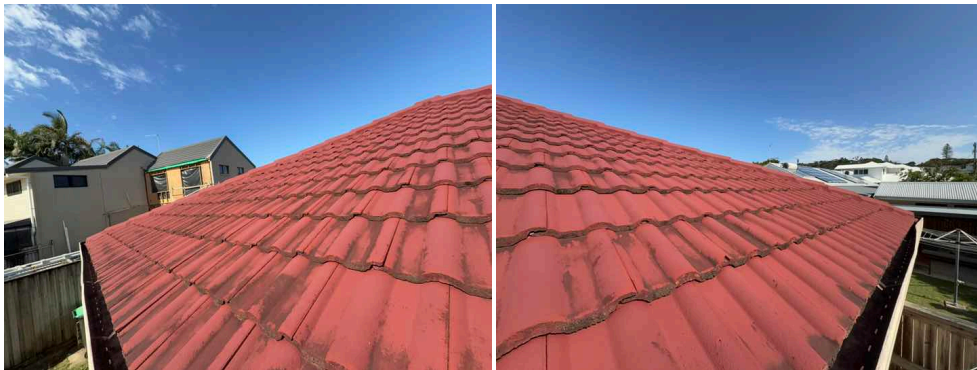
Cracked tiles visible. Contact a roof tiler for repairs. This has potential to become a serious issue if repairs aren't carried out due to water ingress into the roof cavity.

Deterioration & ageing evident. I recommend you contact a roof restorer to clean, seal, and repoint the mortar.

Cracked tile ends visible. A qualified roof tiling contractor should be engaged for advice and recommendations. Considered a minor defect but has the potential to become a Major defect if repairs aren't carried out immediately due to water ingress into the roof cavity.

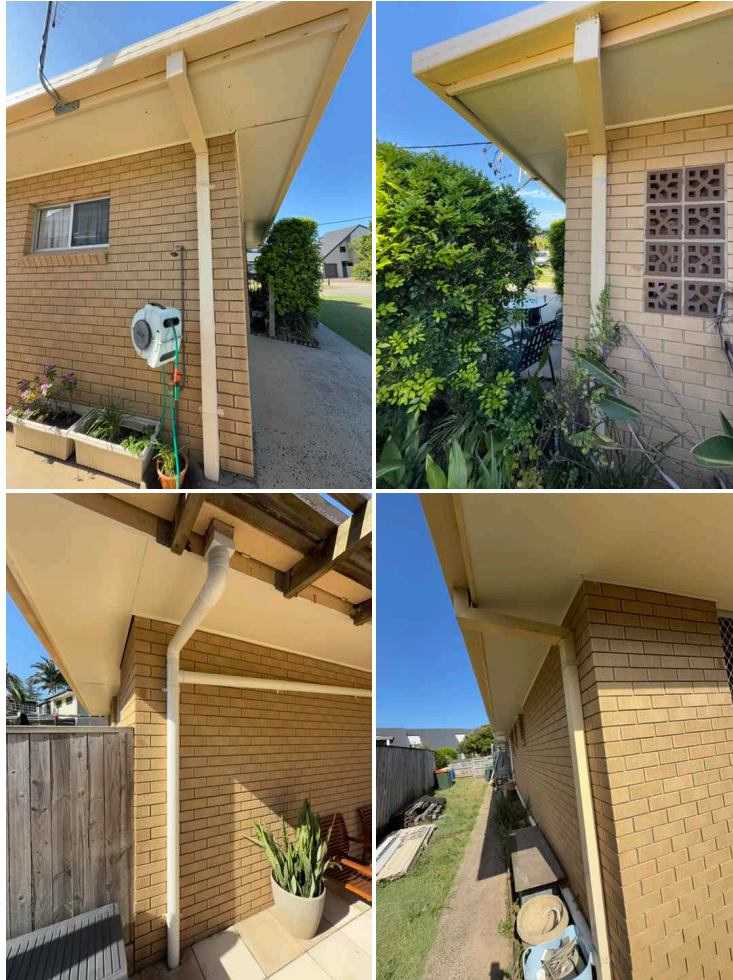
Leaking downpipe joins visible. This can be conducive to termite infestation and cause water damage to cladding over time. A qualified roof plumber should be engaged to repair.

Minor downpipe rust visible. A qualified plumber should be engaged for advice and recommendations.

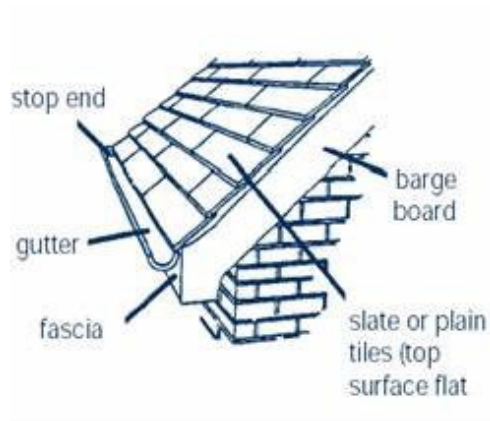
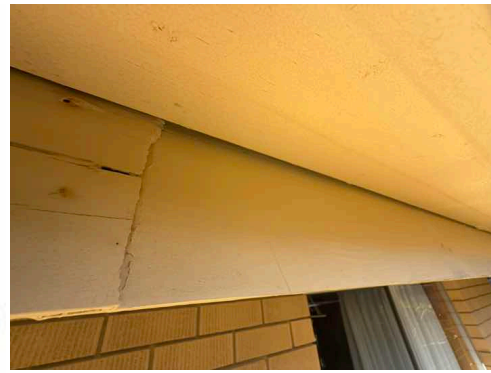
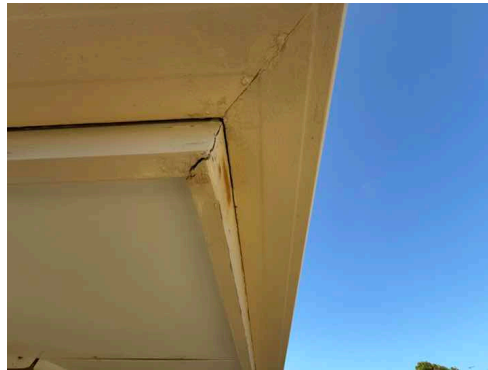
Minor deterioration & ageing evident. Recommendations: Maintenance works, general upkeep should be carried out.

Paint / finish was deteriorated in areas and is in need of maintenance - Sanding back affected areas and painting required.

Timber fungal decay (rot) visible. Recommendations: A qualified carpenter should be engaged to replace all affected timbers.

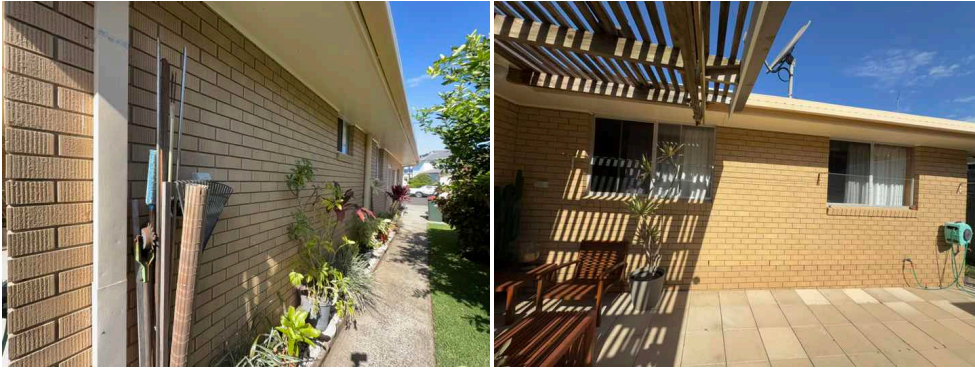
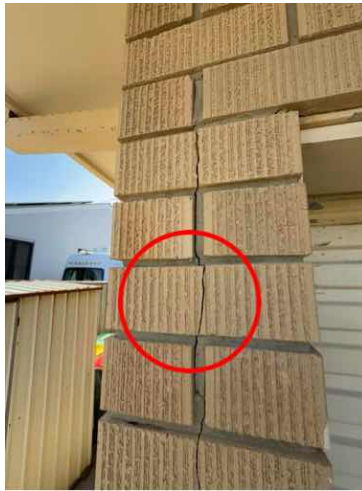
There appears to have been some settlement in the building which has caused some cracking to the walls. These cracks are categorized as 0 to 2. This can also cause some doors to bind or be out of square. In the inspector's opinion these cracks are due to settlement, usually due to ground movement and subsequent movement to building materials can be expected. Any cracks should be monitored and if cracks increase in size, further investigation should be carried out by a structural engineer.

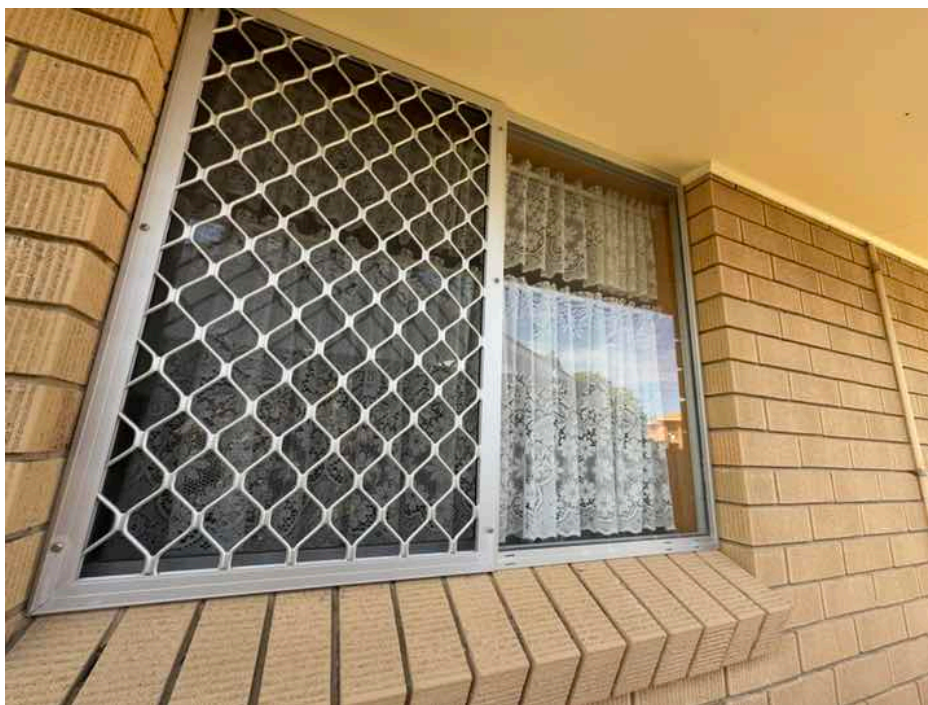
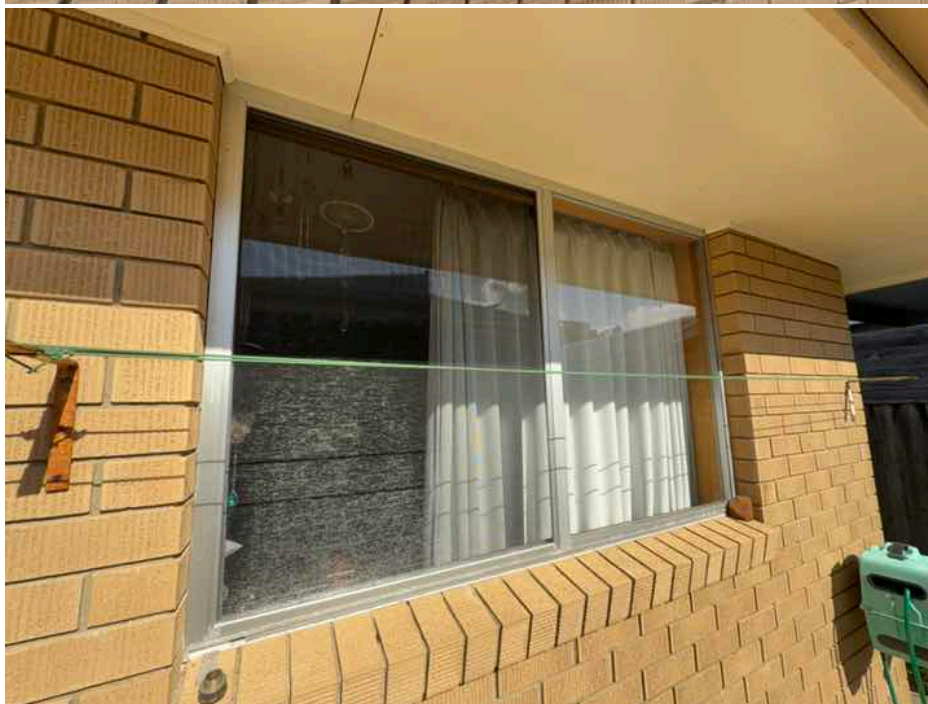
General age/damage has occurred to window components. Recommendations: Restoration work recommended. A qualified carpenter should be engaged for advice and recommendations.

Deterioration of sections of window rubber seals was observed. A qualified glazier should be engaged for advice and recommendations.

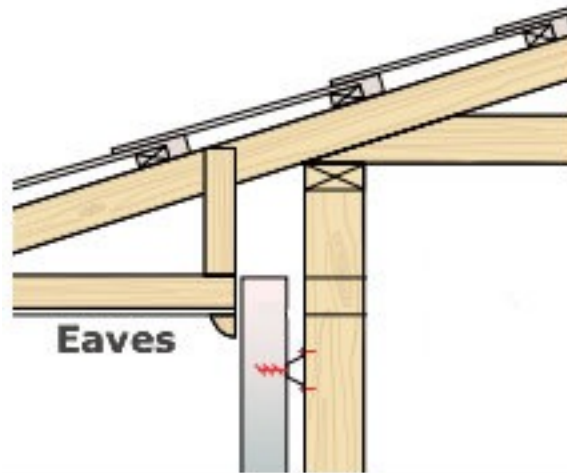
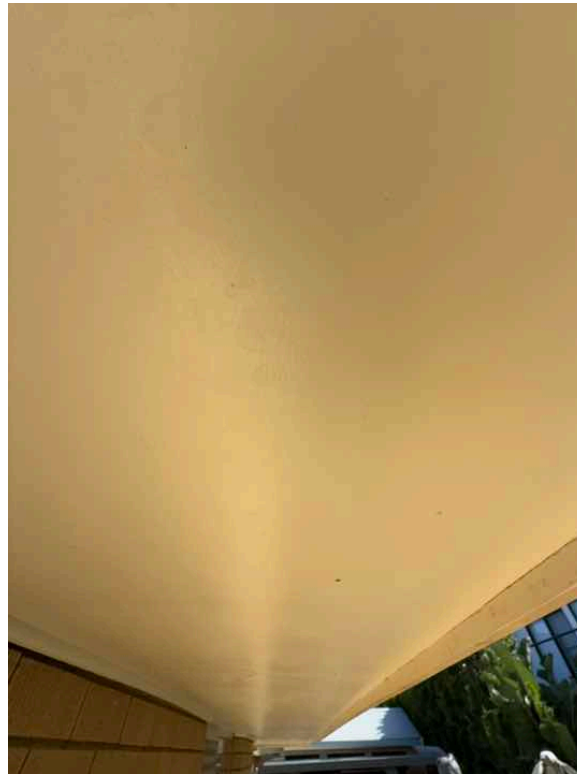
Minor eave deterioration & ageing evident. Recommendations: Maintenance works, general upkeep should be carried out.

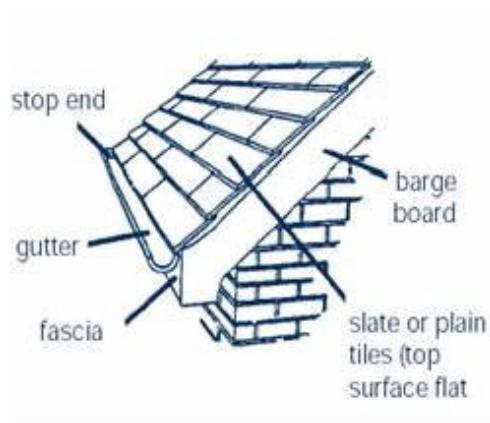
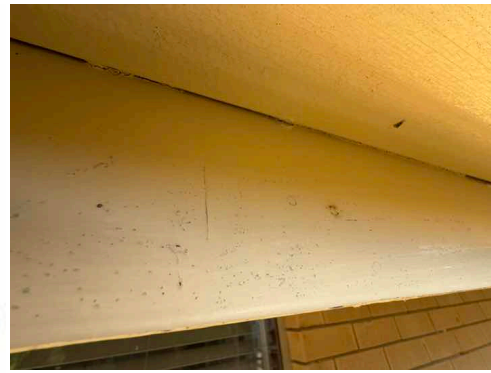
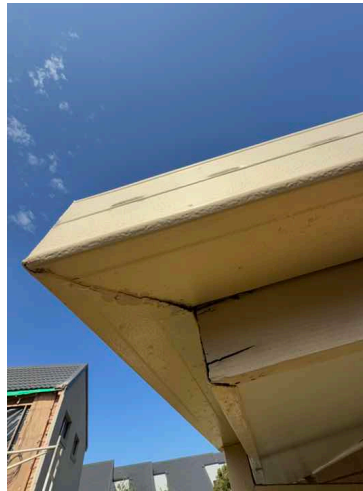
Minor deterioration & ageing evident. Recommendations: Maintenance works, general upkeep should be carried out.

Paint / finish was deteriorated in areas and is in need of maintenance - Sanding back affected areas and painting required.

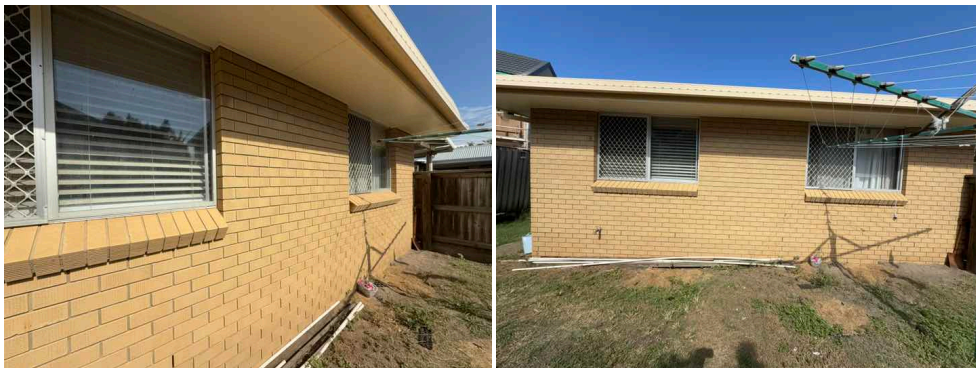
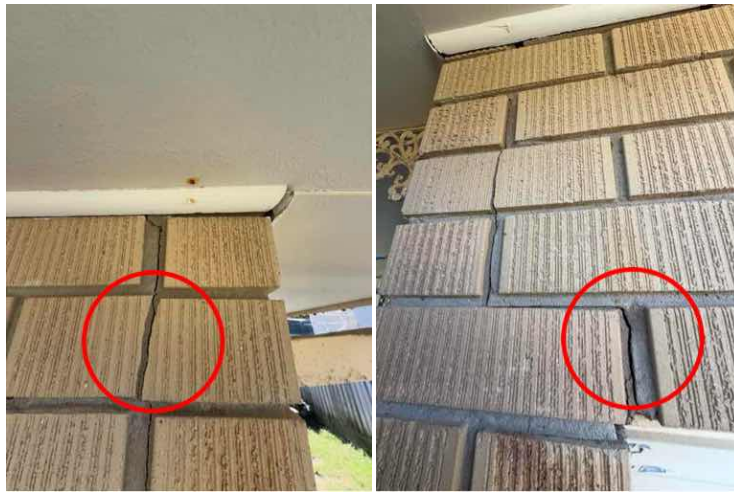
There appears to have been some settlement in the building which has caused some cracking to the walls. These cracks are categorized as 0 to 2. This can also cause some doors to bind or be out of square. In the inspectors opinion these cracks are due to settlement, usually due to ground movement and subsequent movement to building materials can be expected. Any cracks should be monitored and if cracks increase in size, further investigation should be carried out by a structural engineer.

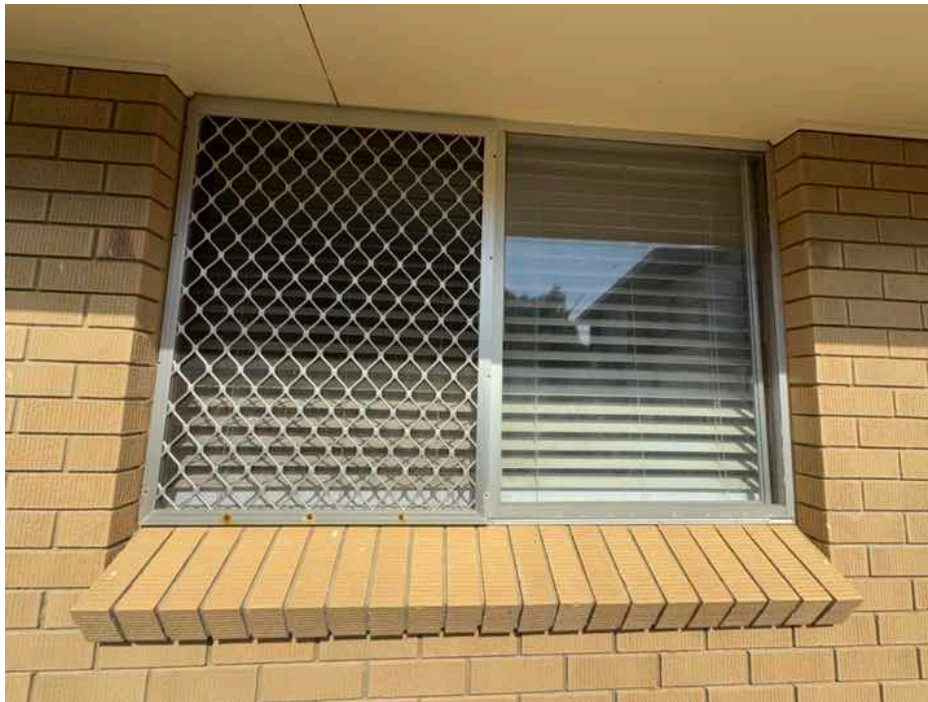
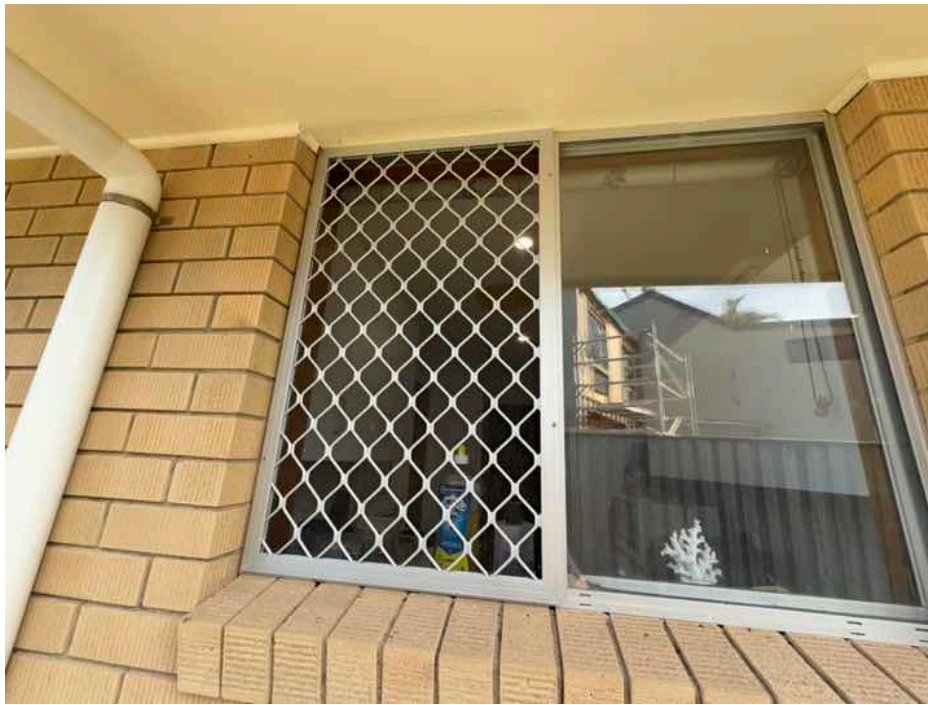
General age/damage has occurred to window components. Recommendations: Restoration work recommended. A qualified carpenter should be engaged for advice and recommendations.

Deterioration of sections of window rubber seals was observed. A qualified glazier should be engaged for advice and recommendations.

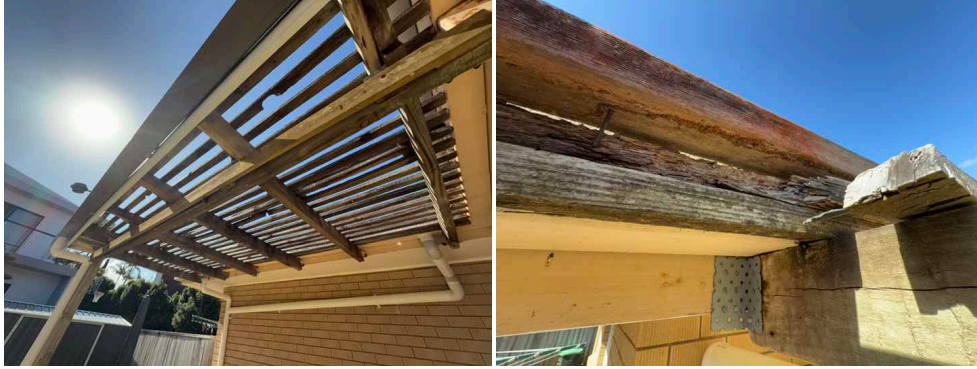
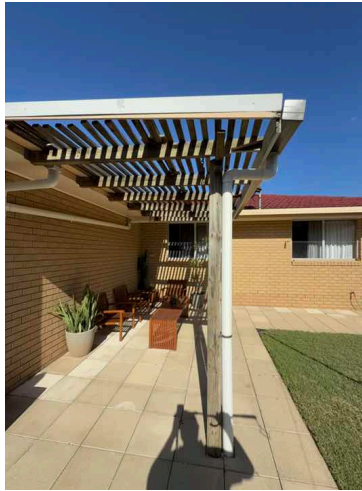
Timber fungal decay in the framework is visible. A qualified carpenter should be engaged for advice and recommendations.

Minor post base timber fungal decay. Repairs as required. It is preferable to have posts on stirrups kept out of contact with soil. Timber in contact with ground is conducive to termite infestation and timber fungal decay.

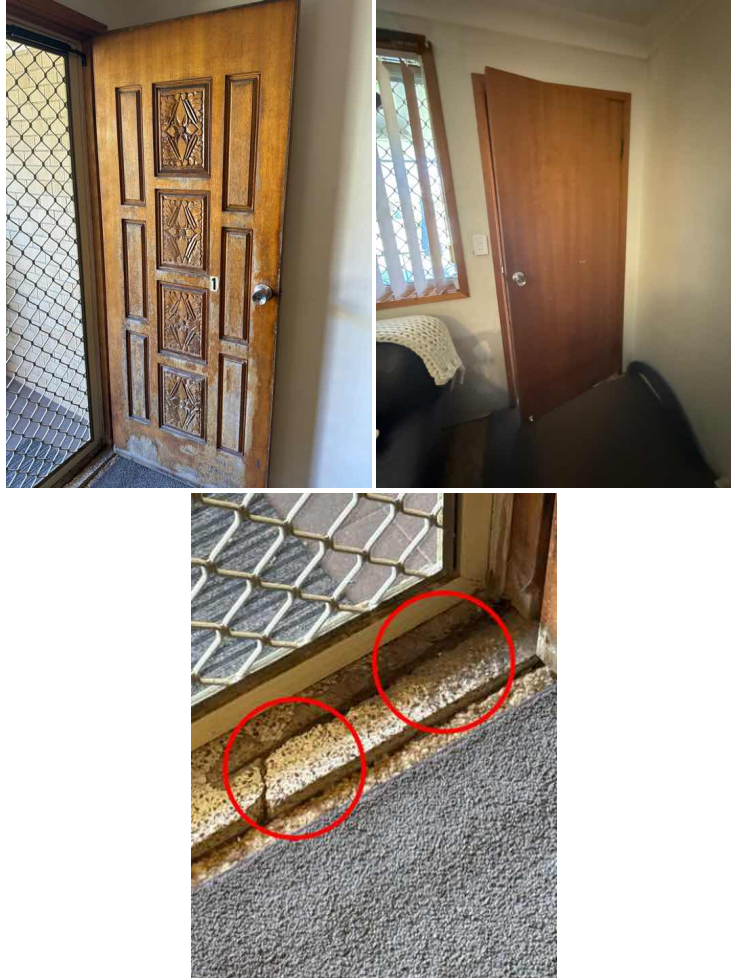
Entry door / frame deterioration - General age/damage has occurred to door frame, face or components. A qualified carpenter should be engaged for advice and recommendations.

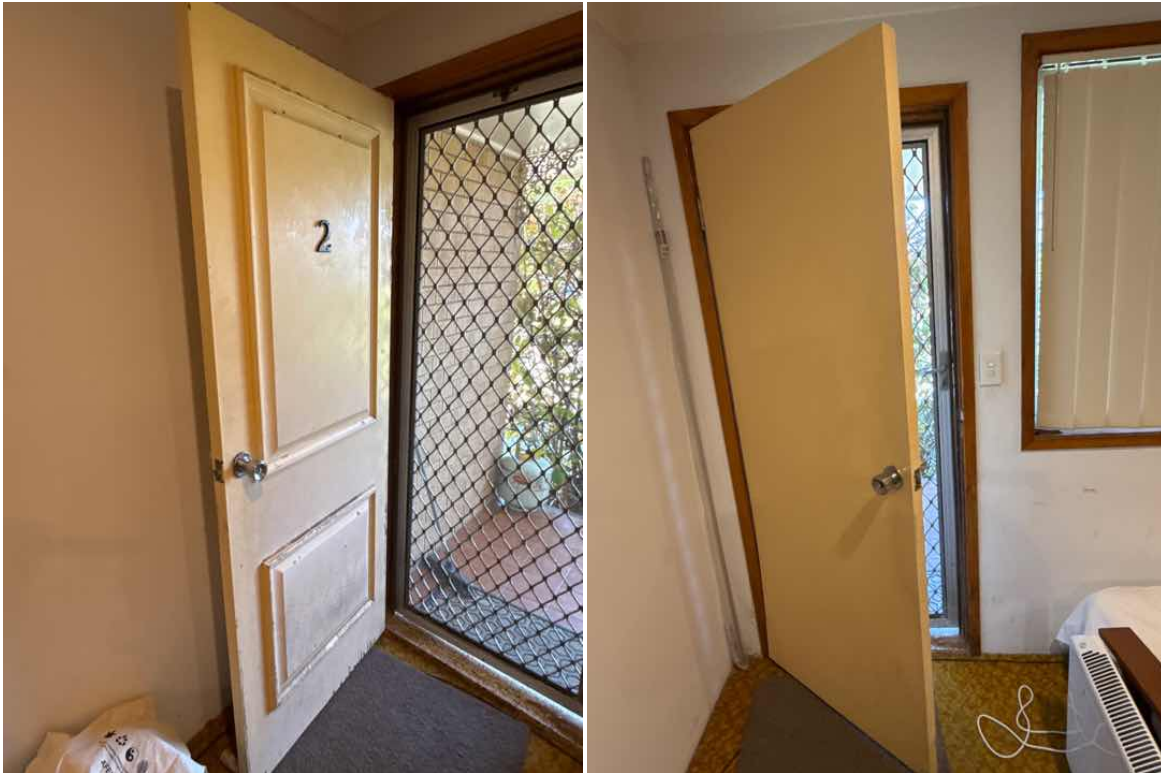
Binding entry door - Doors that bind on the frame can relate to some differential settlement, frame movement, age, expansion, shrinkage or poor hanging. A qualified carpenter should be engaged for repairs.

Damp damage to entry door/frame - It appear water has damaged / penetrated areas of the door/frame. I am not able to ascertain if this is still occurring and this can only be ascertained during heavy rainfall periods. If penetration occurs a qualified carpenter should be engaged for advice and recommendations re repair/sealing from weathering.

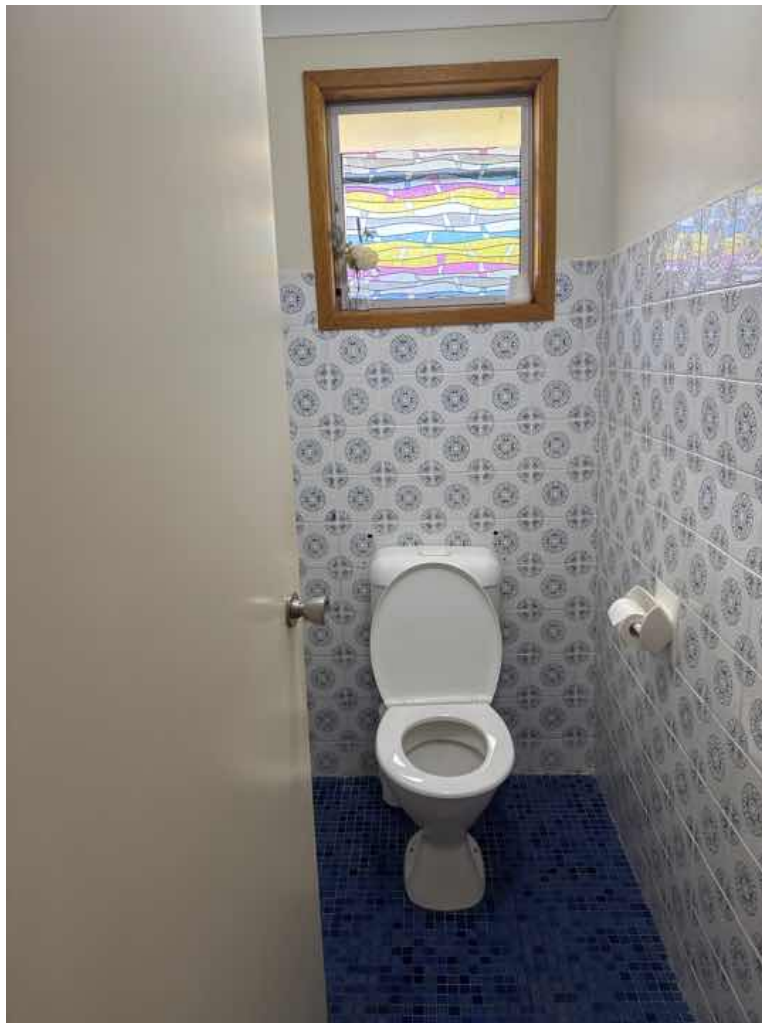
1. Wall tiles are cracked and ready to come away from the wall.

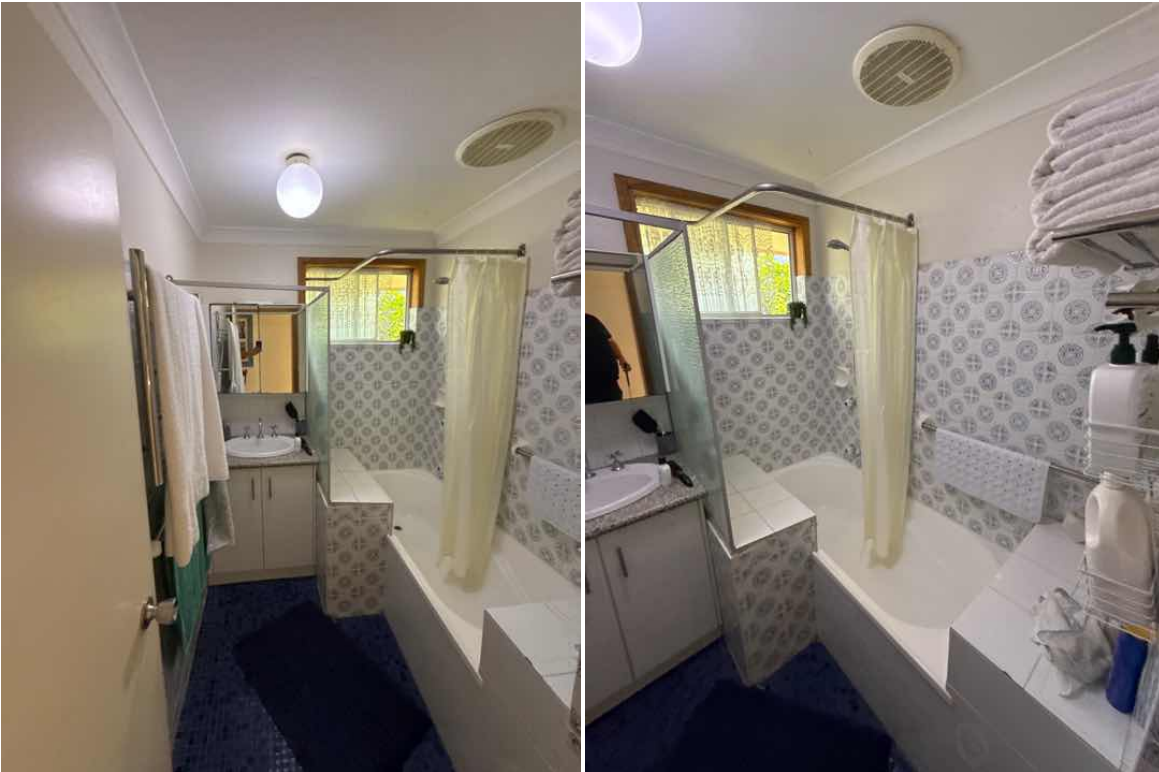
1. Cracked wall tiles which are ready to come away from the wall.

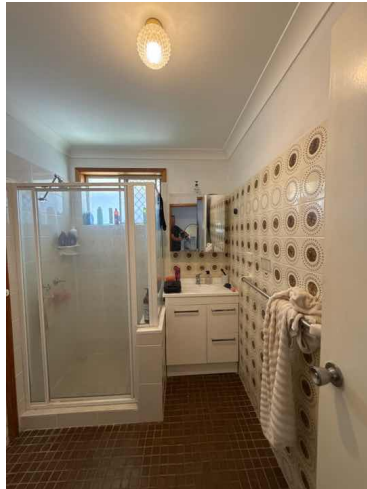
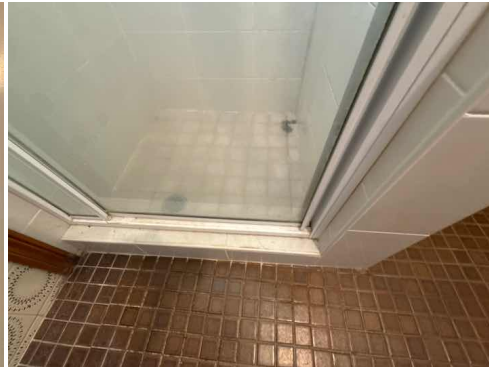
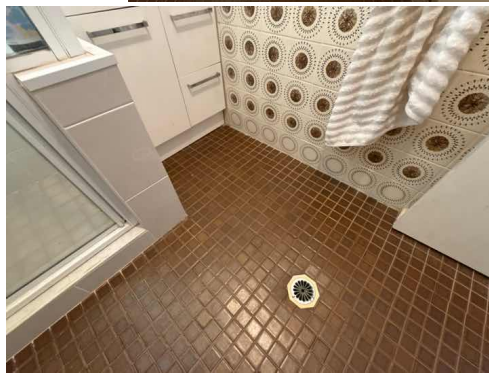
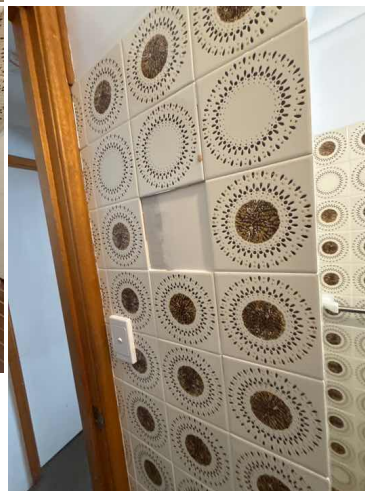
1. Cracked wall tiles which are ready to come off.
