# Building and Pest Report

31 Castle Drive  
Lennox Head

### Pest And Building Inspection

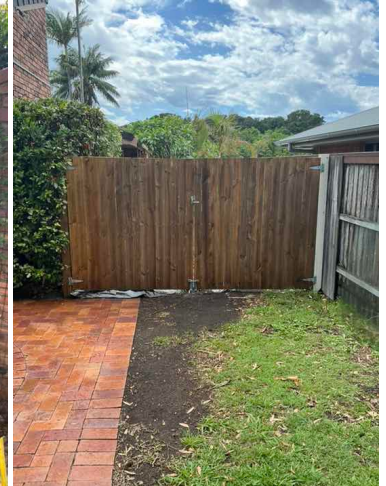
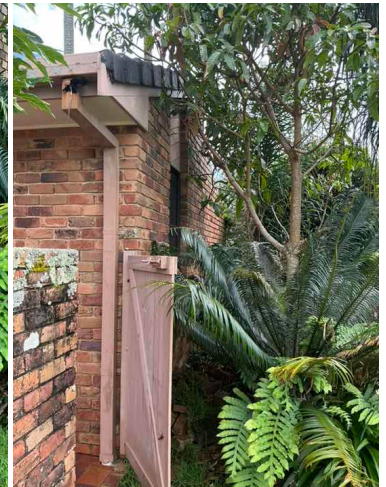
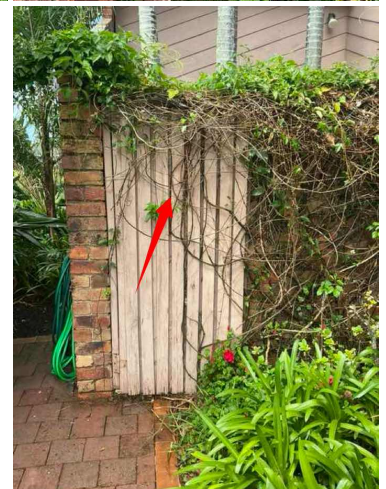
On inspection, defects were present that will require further accessing and recommendations by licensed and qualified trades persons. rear courtyard gate in accessible due to foliage

The gate does not latch. Have repaired by a qualified fencer.

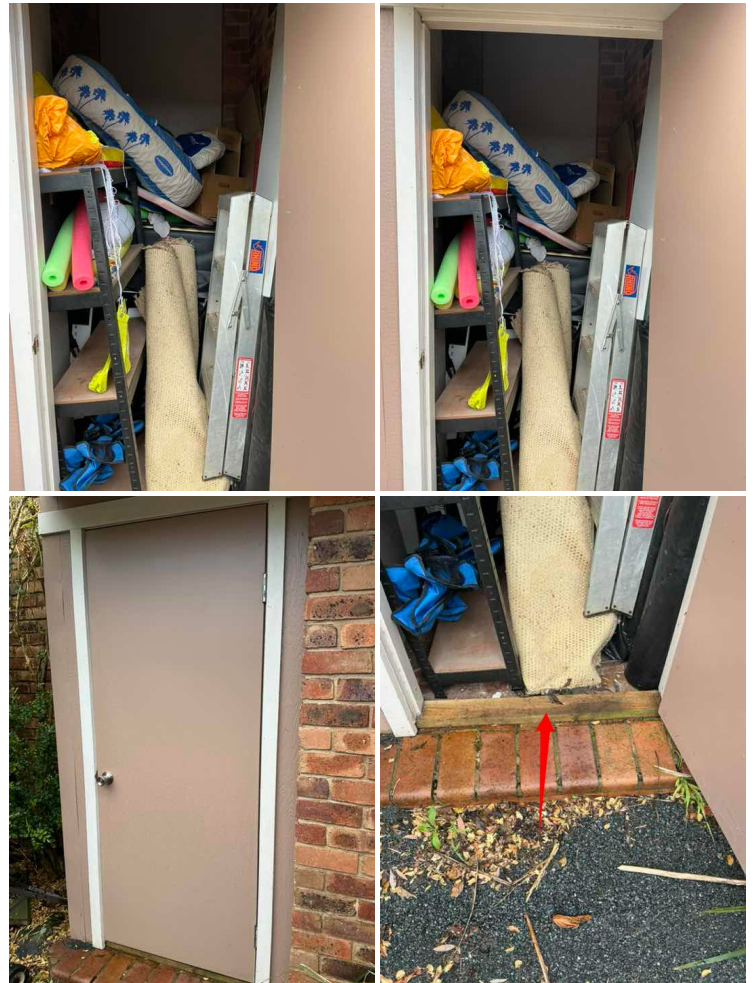
#1. Timber fungal decay in the framing. A qualified carpenter should be engaged for advice and recommendations.

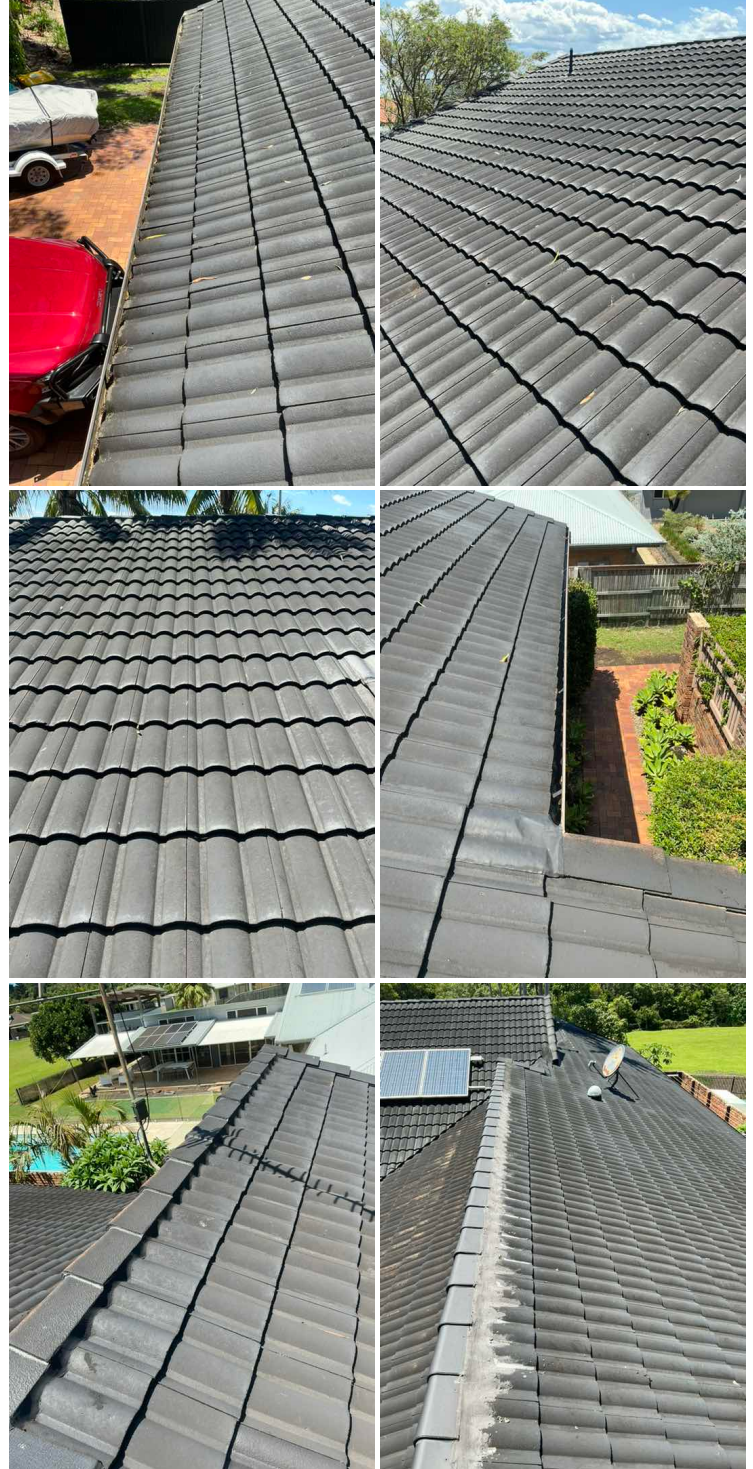
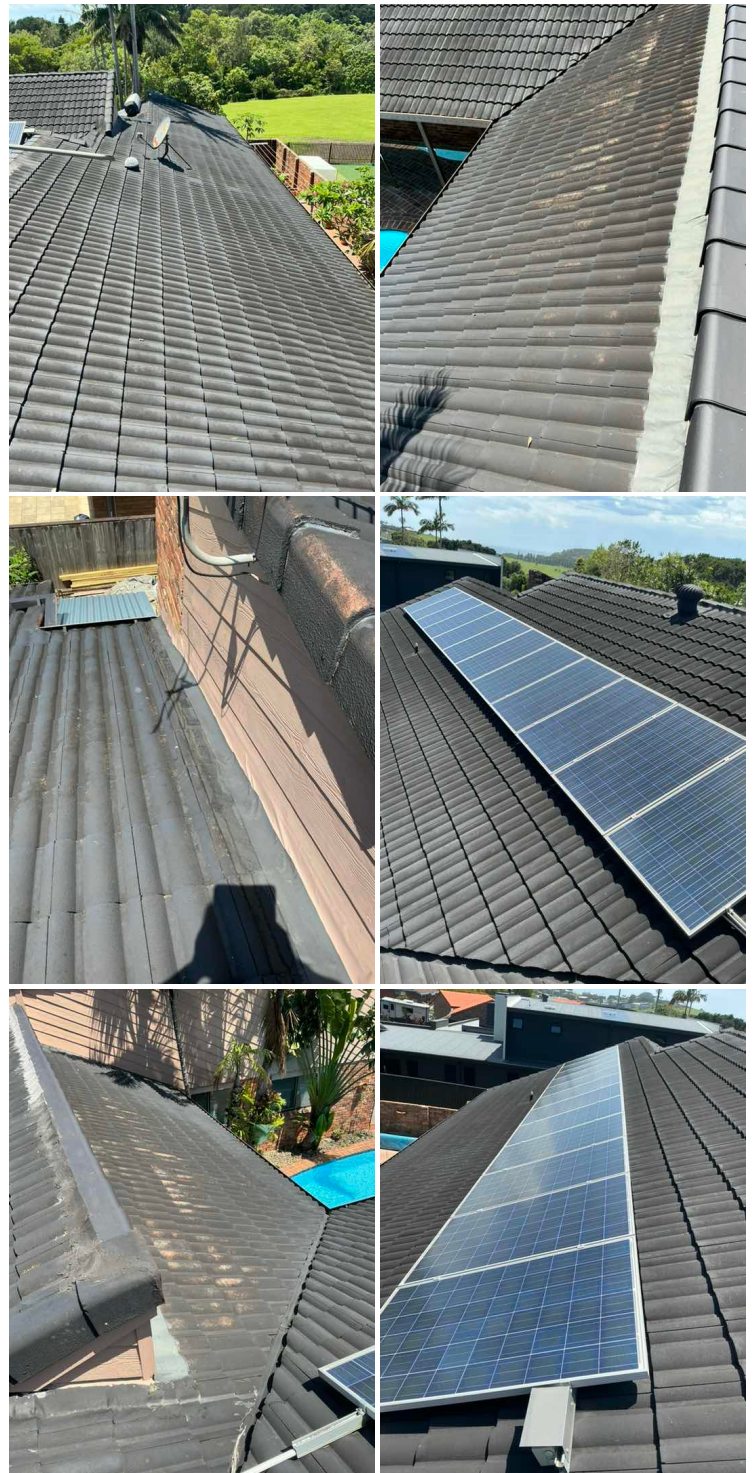
Upon visual inspection, the roof shows signs of wear with discolored and potentially damaged tiles.

Recommend a licensed roofer to assess and replace any compromised tiles to prevent leaks. Ensure proper sealing around the ridge and flashing areas to maintain weatherproofing. Regular maintenance checks are advised to prolong roof lifespan.

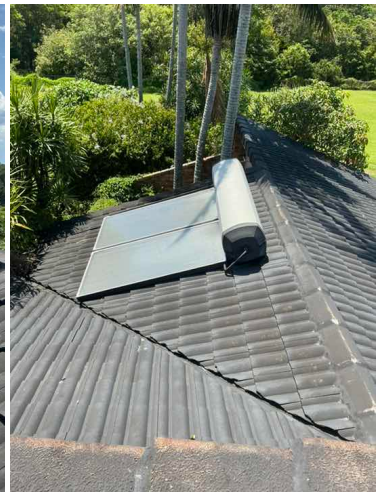
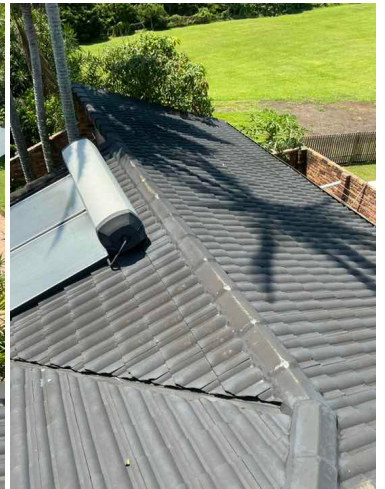
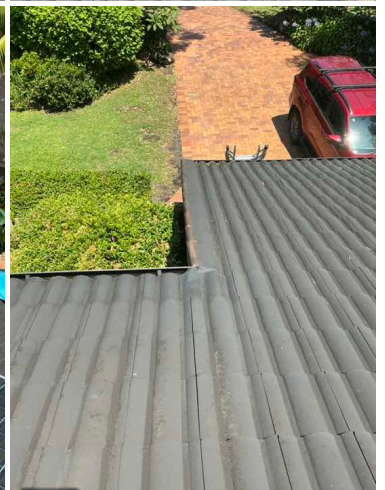
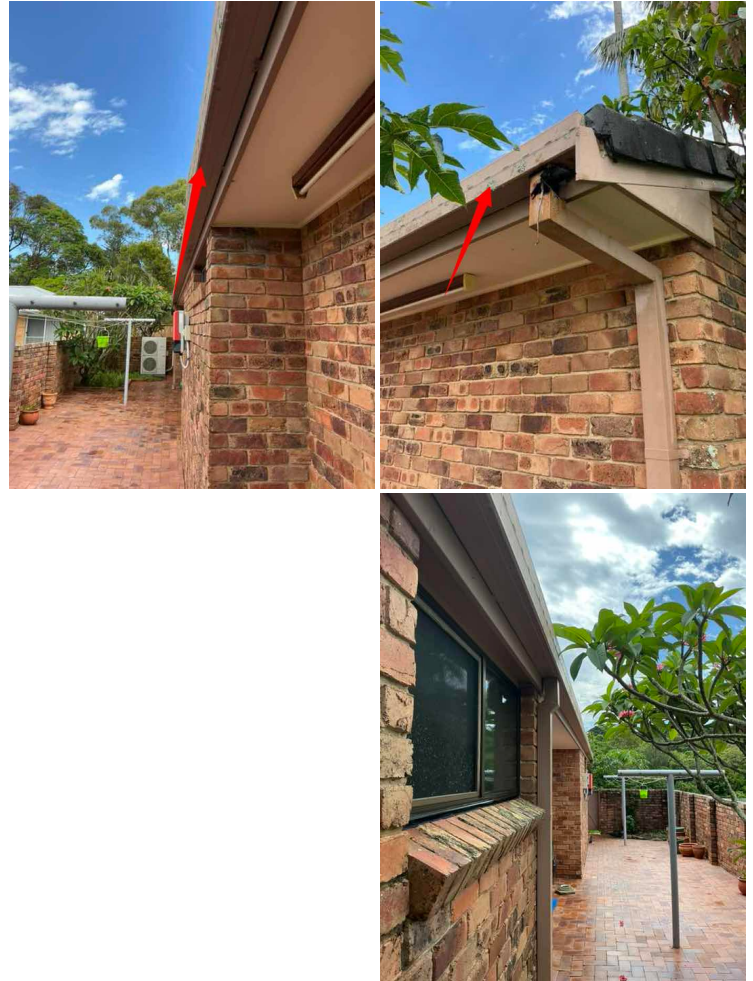
On inspection, defects were noted that may require further assessment and recommendations by licensed roofer.  
Rust located in some stretches of gutter and will require replacing

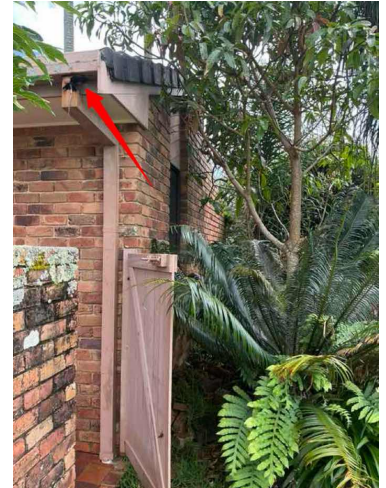
#7. Rust penetrations observed to downpipe. Over time this has potential to cause differential settlement to the footings, cause rising damp and is also conducive to termite infestation. A qualified plumber should be engaged for advice and recommendations.

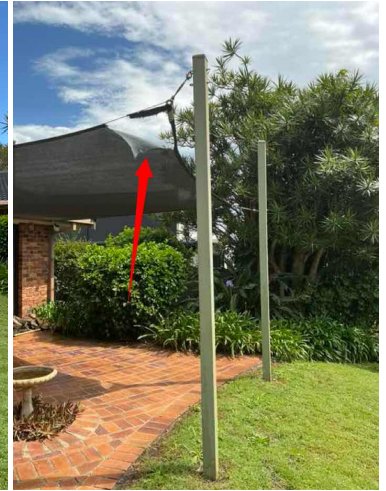
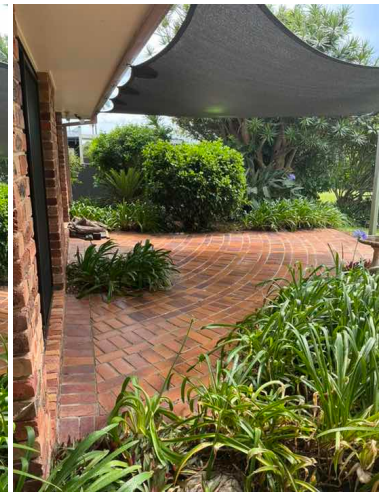
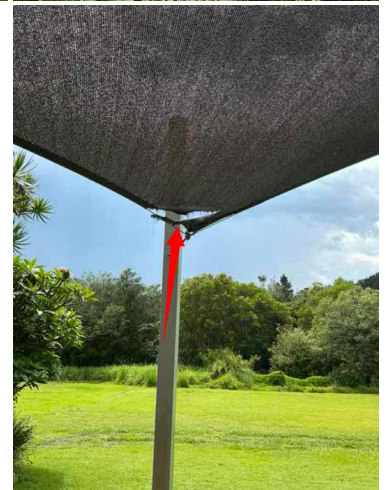
Visible sections of the Alfresco area are serviceable or in reasonable or condition for the age of this dwelling.  
Shade sail torn and requires replacing

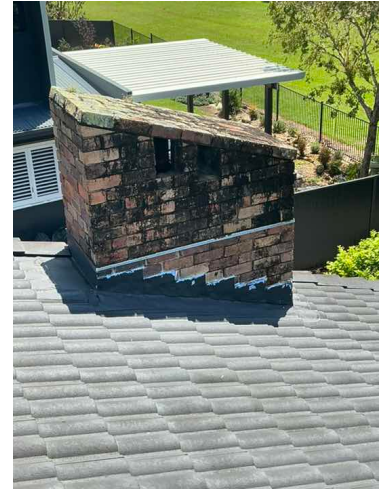
Upon visual inspection, the chimney shows signs of mortar deterioration and brick discoloration. Recommend repointing the mortar joints and cleaning the brickwork. The flashing appears worn and may require resealing to prevent water ingress. Engage a licensed roofer to assess and perform necessary repairs to ensure structural integrity and weatherproofing.

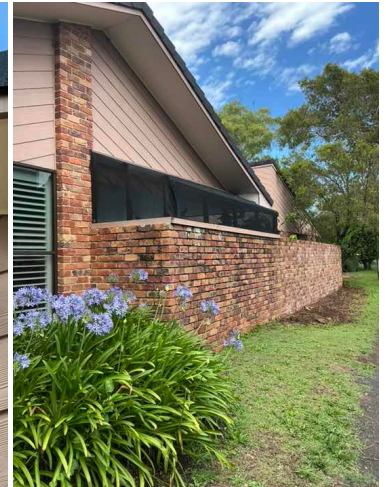
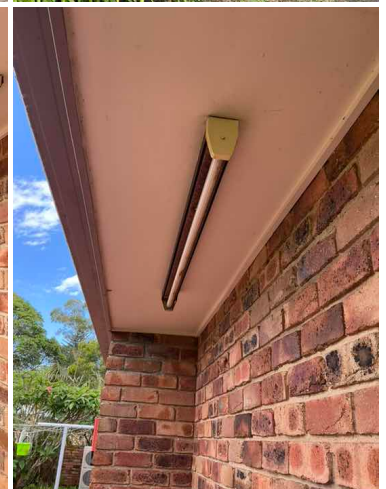
#11. Minor eave deterioration & ageing evident. Recommendations: Maintenance works, general upkeep should be carried out. Upon visual inspection, there is a noticeable gap and misalignment in the fascia and soffit area. Recommend sealing gaps and securing loose components to prevent water ingress. Engage a licensed carpenter to assess and repair structural integrity, ensuring proper alignment and weatherproofing.

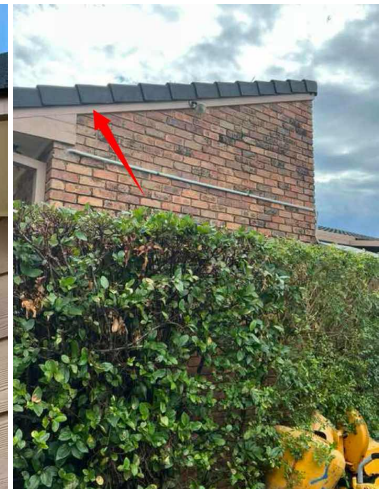
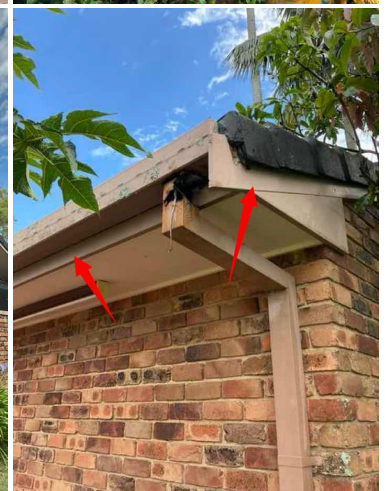
#12. Minor deterioration & ageing evident.  
 Recommendations: Maintenance works, general upkeep should be carried out.  
 Upon visual inspection, there is visible damage to the fascia board, likely due to weather exposure. Recommend a licensed carpenter replace the damaged section and apply a weather-resistant sealant to prevent future deterioration. Additionally, ensure the roof flashing is intact to avoid water ingress.  
 Upon visual inspection, the flashing around the chimney appears to be improperly sealed, which may lead to water ingress. Recommend sealing gaps with appropriate weatherproof sealant. Additionally, the roof tiles show signs of wear and may require replacement to prevent leaks. Consult a licensed roofer for repairs and further assessment.

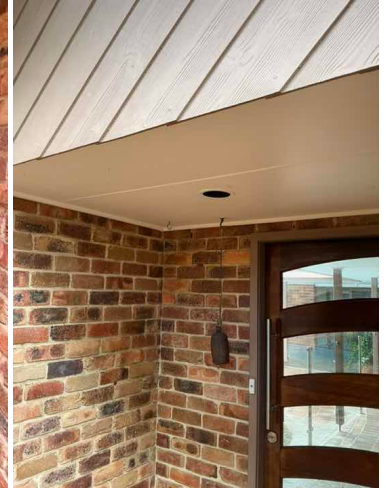
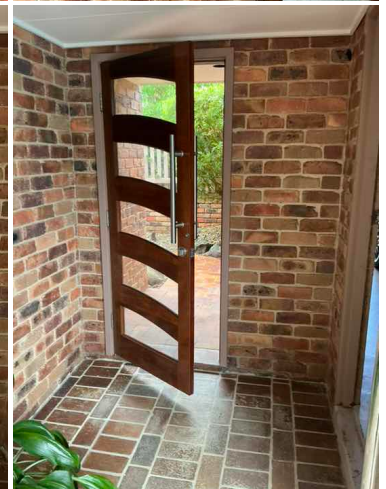
Upon visual inspection, the door appears well-fitted with no visible signs of damage or misalignment. The brickwork surrounding the door is intact, with no noticeable cracks or deterioration. It is recommended to ensure regular maintenance of the door's seal and hardware to prevent future issues. Consult a licensed tradesperson for any adjustments or repairs as needed. Door will require resealing for longevity

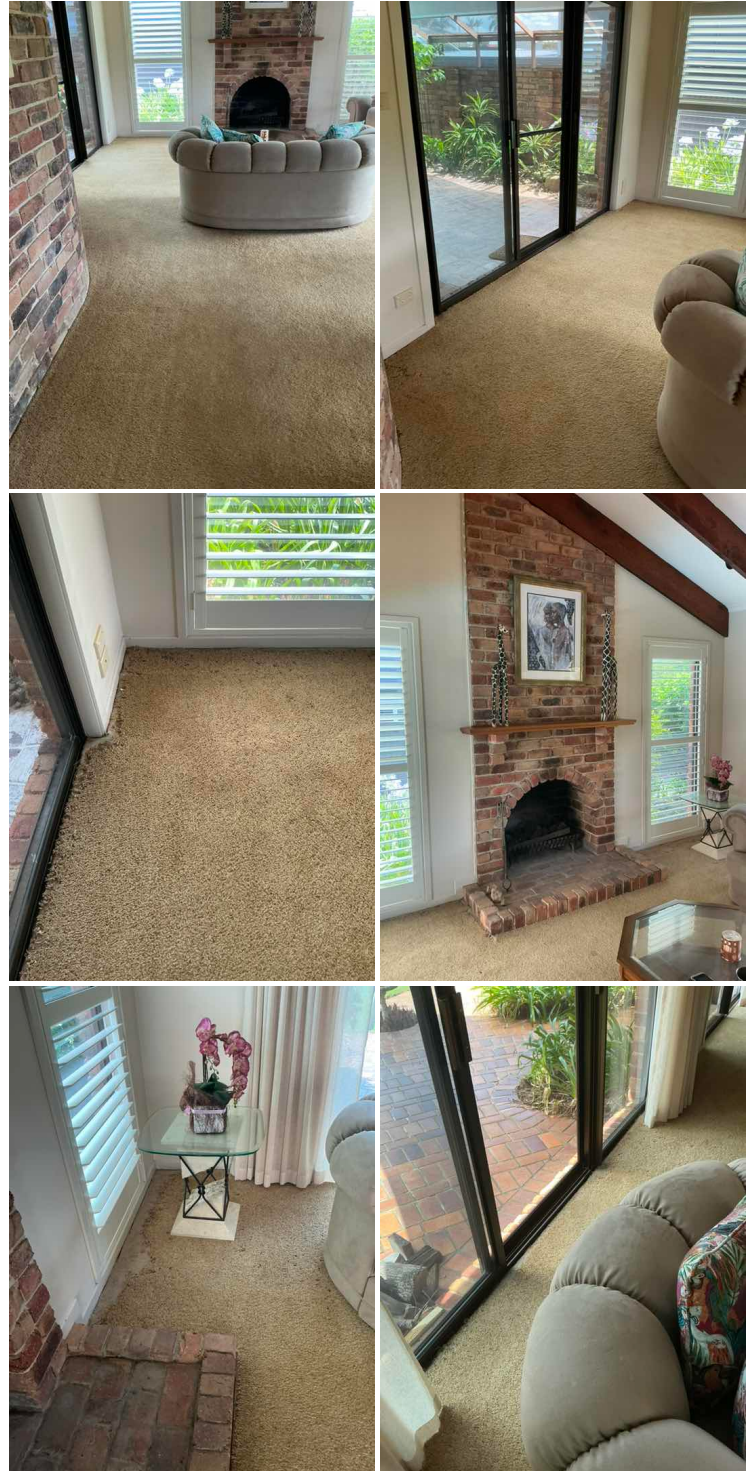
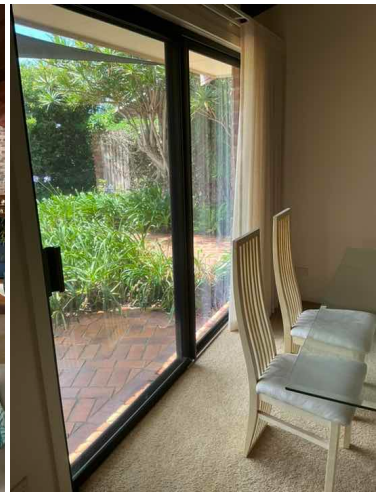
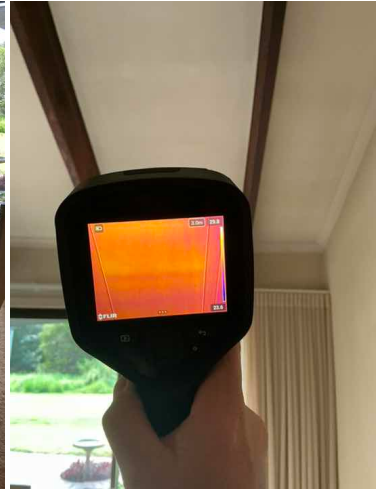
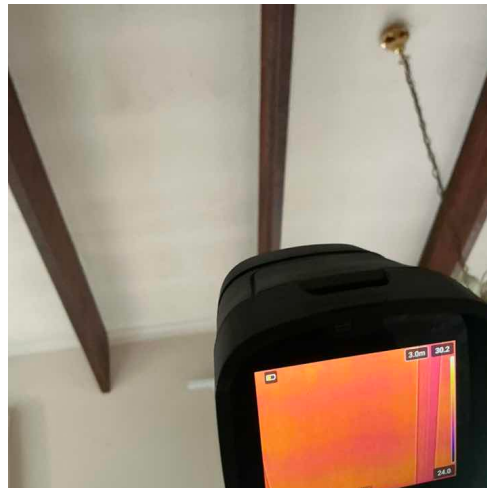
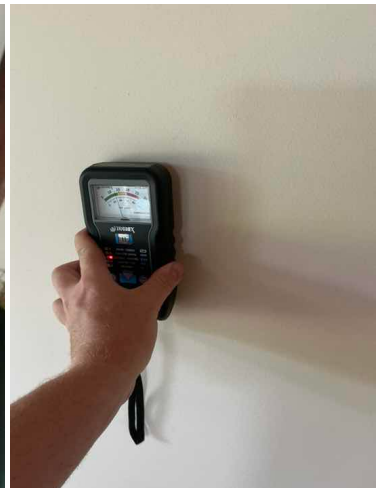
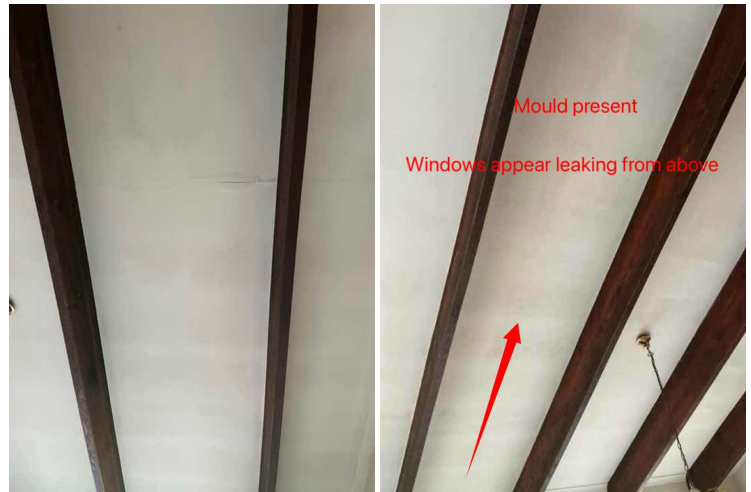
Upon visual inspection, the carpet edges appear frayed, indicating wear. Recommend engaging a licensed carpet installer to trim and secure the edges to prevent further damage. Additionally, ensure the window seals are intact to avoid moisture ingress, which could exacerbate carpet deterioration. Upon visual inspection, there is a visible crack in the ceiling. It is recommended to have a licensed tradesperson assess and repair the crack to prevent further damage. Ensure the structural integrity of the ceiling is maintained by addressing any underlying issues. Mould appears to be present in the ceiling sheets

#14. Settlement Cracks Noted. These are typical and generally patch and paint will suffice, however monitoring these cracks is advised for 12 months and if they become worse, further investigation by a suitably qualified professional is advised.

#15. Though reporting on mould does not form part of this inspection it's worth noting that mould growth is noted. Due to health risks we strongly recommend that a expert in the field of mould treatment be engaged for further advise and recommendations.

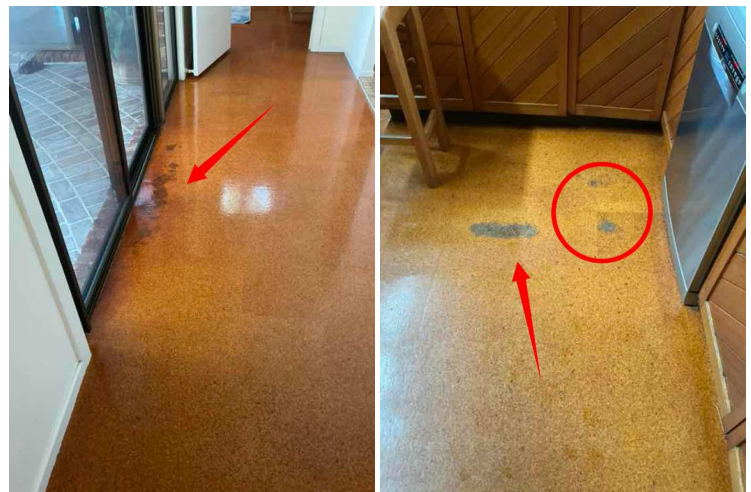
Upon visual inspection, the flooring shows signs of wear and discoloration. It is recommended to have a licensed flooring specialist assess and repair the affected areas to prevent further deterioration. Consider refinishing or replacing the damaged sections to restore the floor's appearance and functionality.

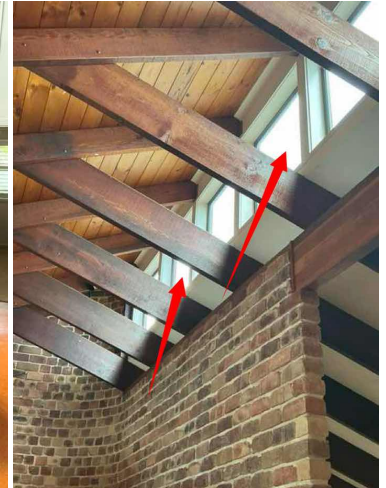
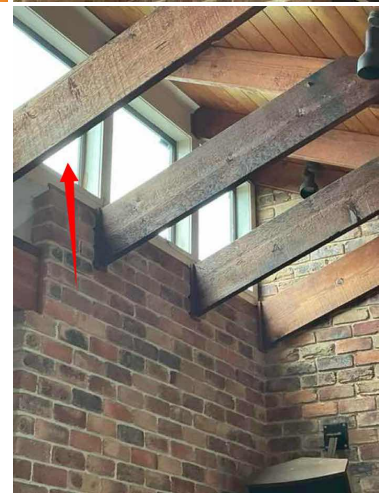
On inspection, defects were present that will require further assessing and recommendations by a qualified trades persons, please read below for details. All windows appear to be leaking during rainfall. Will require attention. Replacement windows are located at the property for installation.

#21. Decay noted to the timber floor. It is strongly recommended that all affected timbers be replaced. This presents a Safety Hazard. Contact a qualified carpenter for repairs.

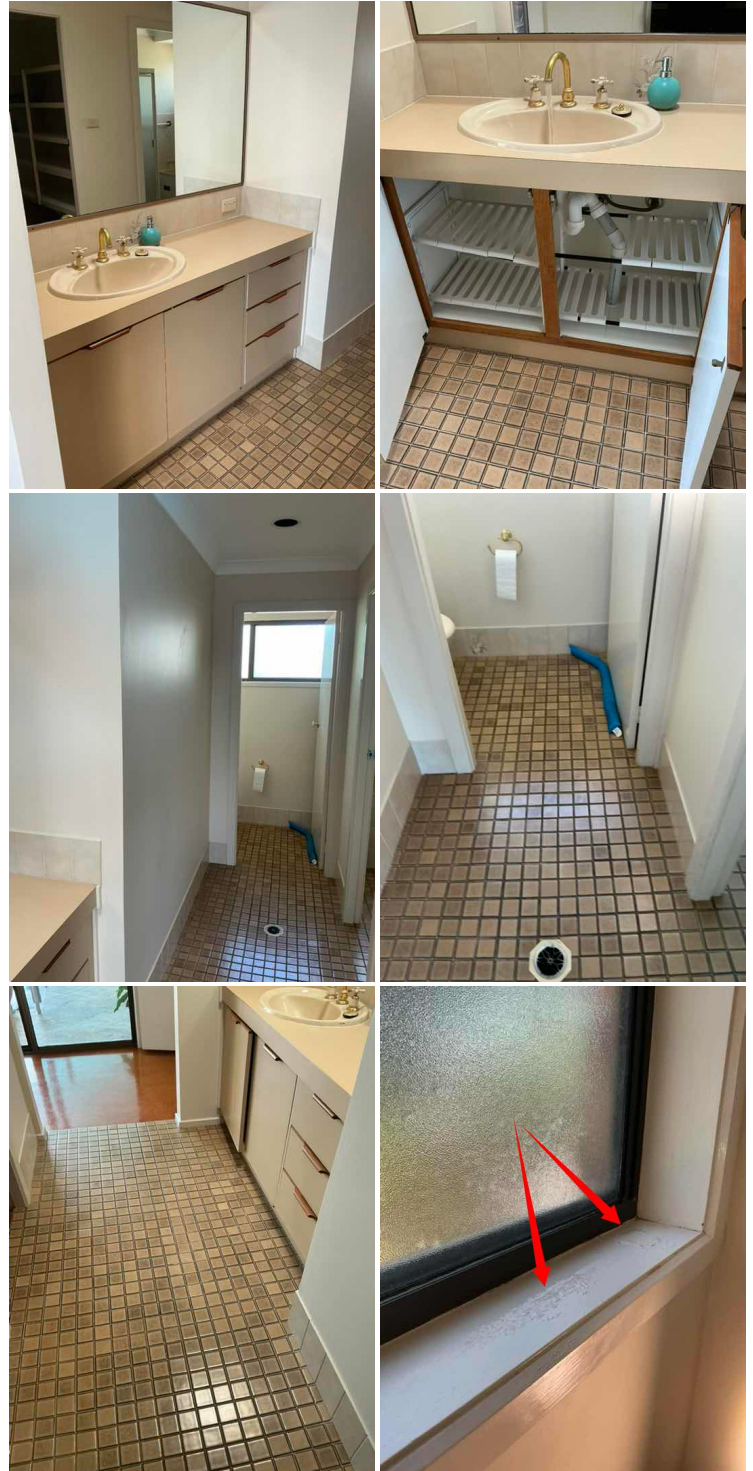
Upon visual inspection, there is evidence of moisture damage on the window sill, indicated by peeling paint. It is recommended to have a licensed painter repair the paintwork and a plumber check for any leaks or condensation issues. Ensure proper sealing around the window to prevent future moisture ingress.

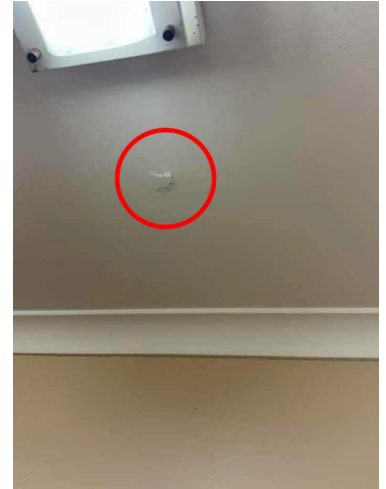
Upon visual inspection, there is a small hole in the ceiling. It is recommended to have a licensed tradesperson patch and repaint the affected area to prevent further damage. Ensure the ceiling is checked for any underlying issues that may have caused the damage.
