# Building and Pest Report

## 13 Cowrie Street Lennox Head

Report/Agreement #	040225090858188
Inspection Date:	04 Feb 2025
Inspection Time:	09:08 am

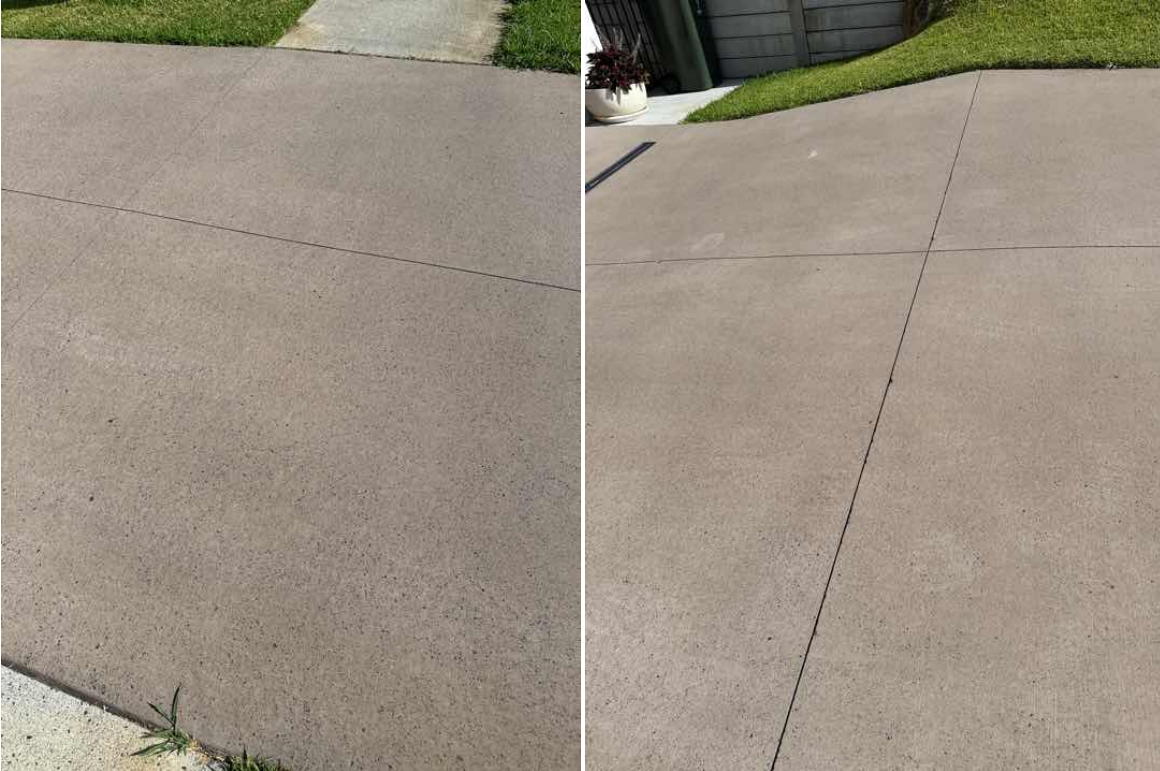
On visual inspection, the general condition of the driveway is serviceable.

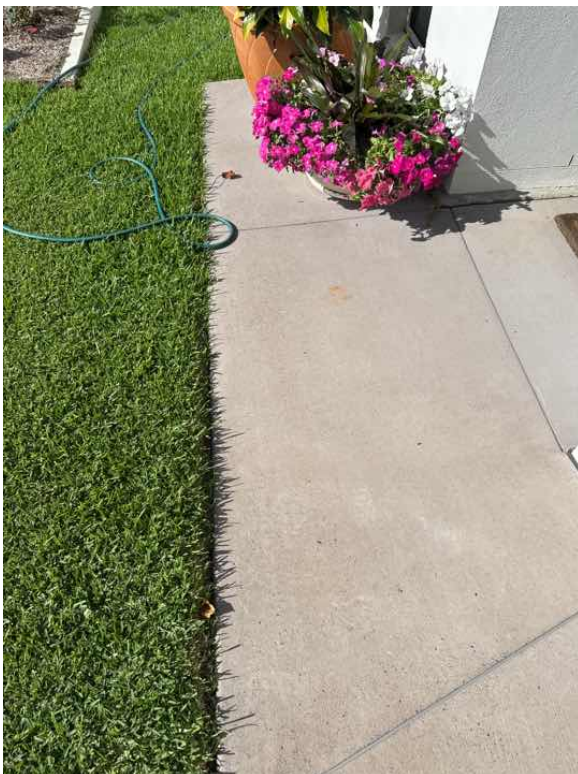
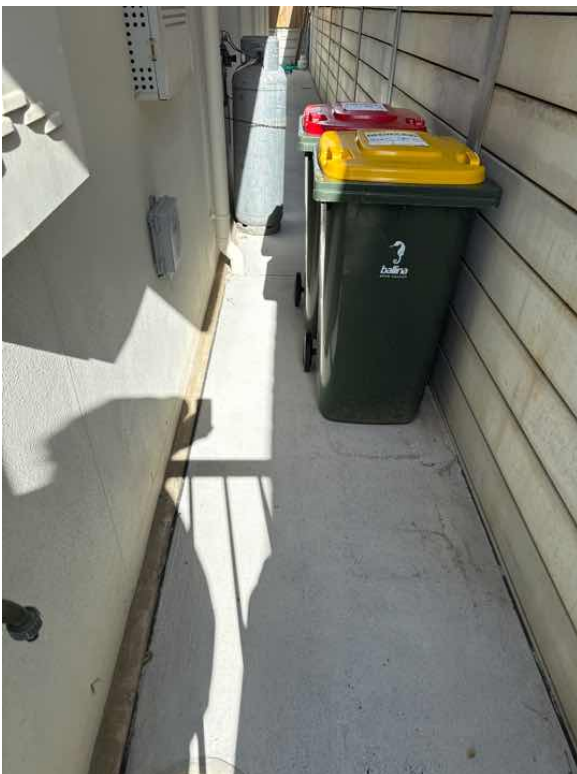
The paths around the home are in a serviceable condition for the age of this dwelling with no major defects visible.

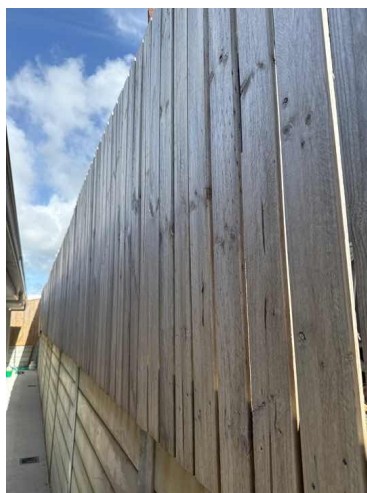
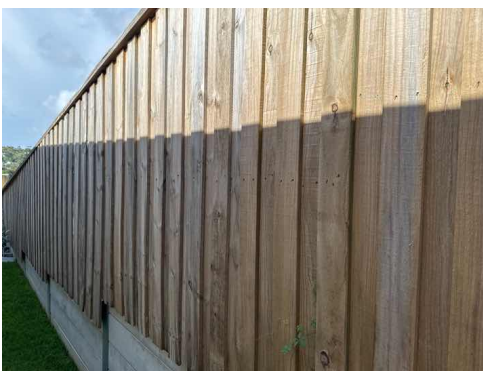
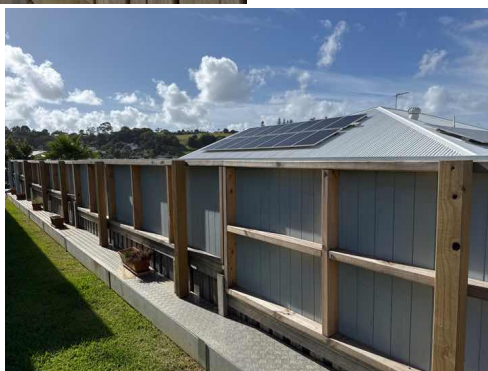
Of the visible areas, the general condition of the fences and gates is serviceable for the age of dwelling.

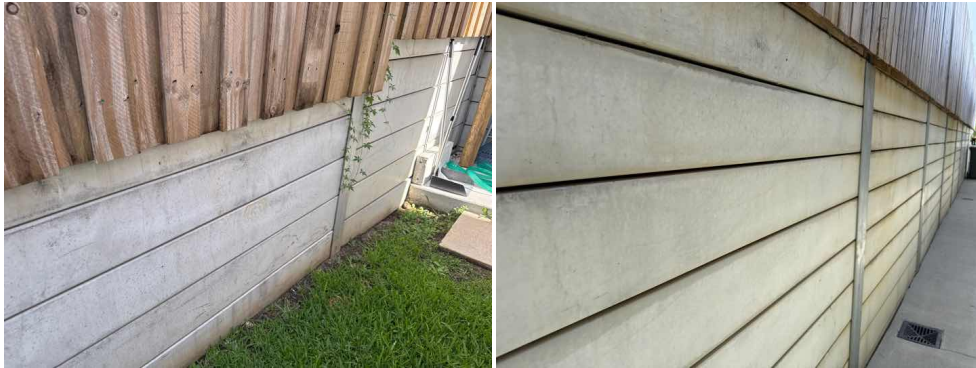
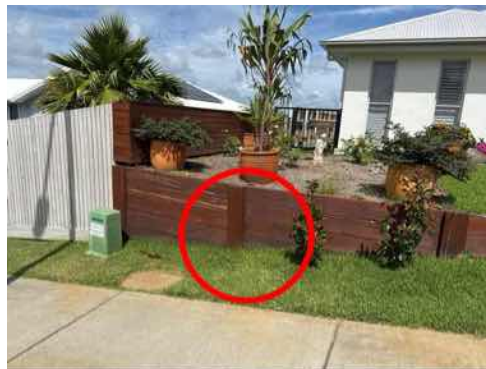
Retaining wall leaning due to deterioration and age. A qualified brick layer should be engaged for advice and recommendations.

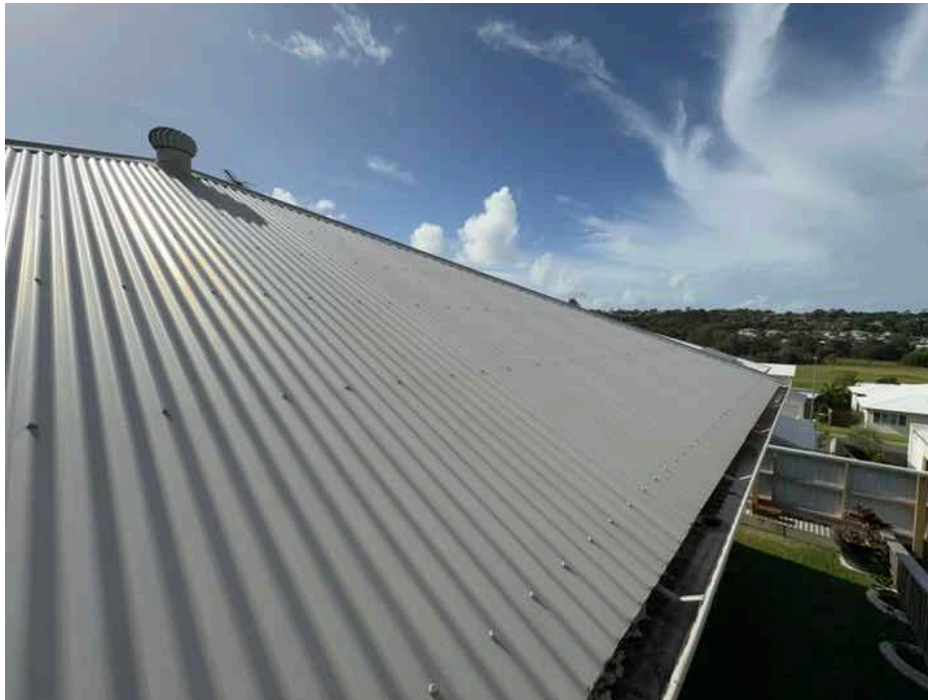
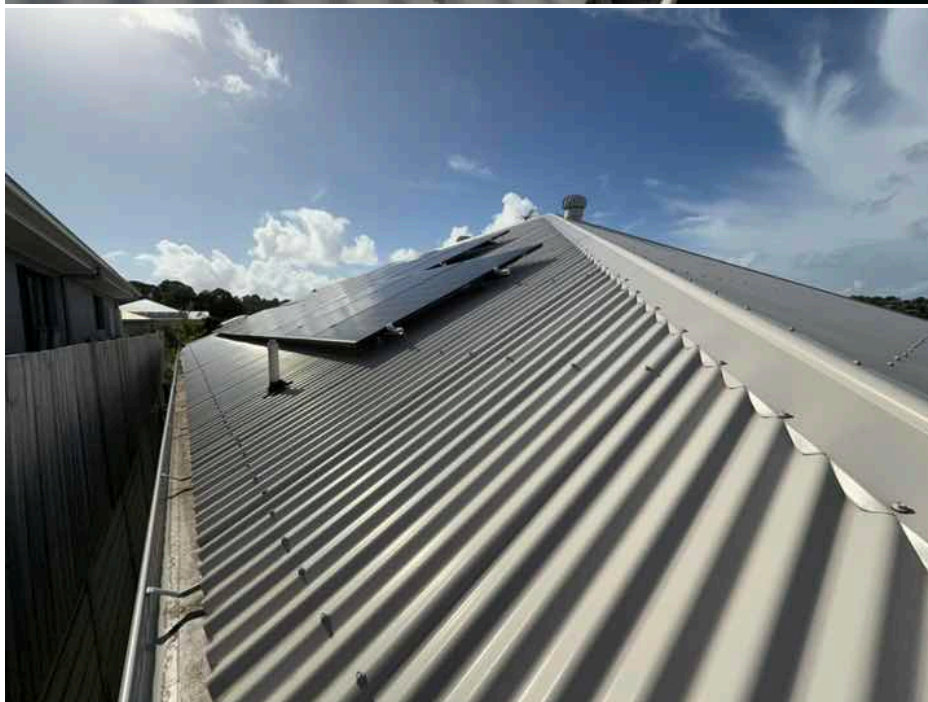
Of the visible areas, the general condition of the roof is in serviceable condition for the age.  
Note: In the absence of rainfall there is no guarantee that the roof won't leak.

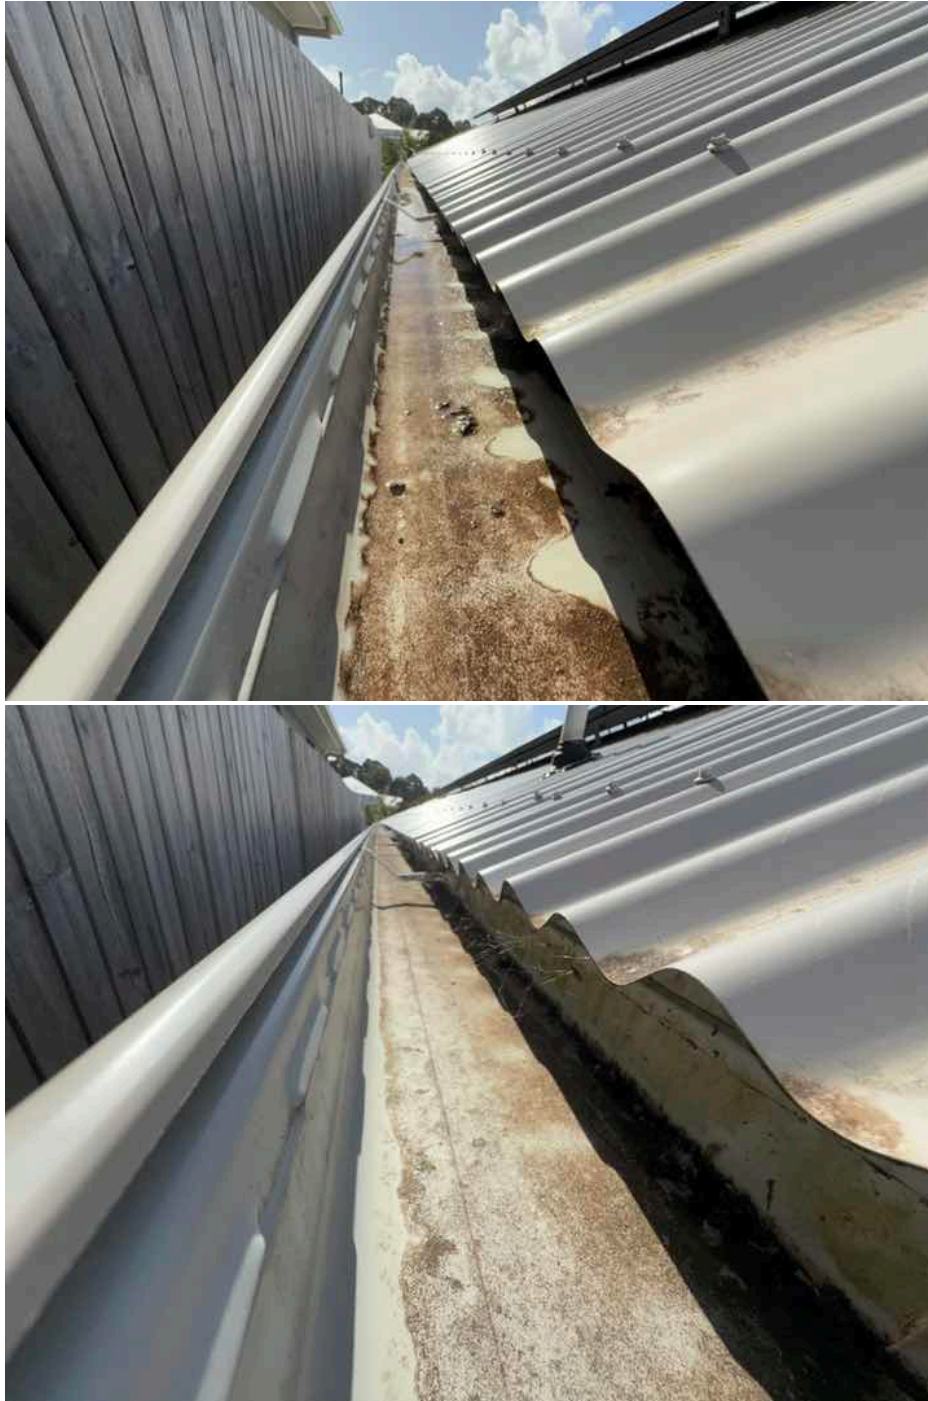
All visible and accessible of the physical nature of the guttering system appears to be in a serviceable condition with no apparent defects at the time of inspection. In the absence of prolonged rain fall efficiency of the guttering can not be assessed and you may find that further investigation or repairs maybe required. Note: Periodic maintenance checks should be carried out for rust penetrations and leaks.

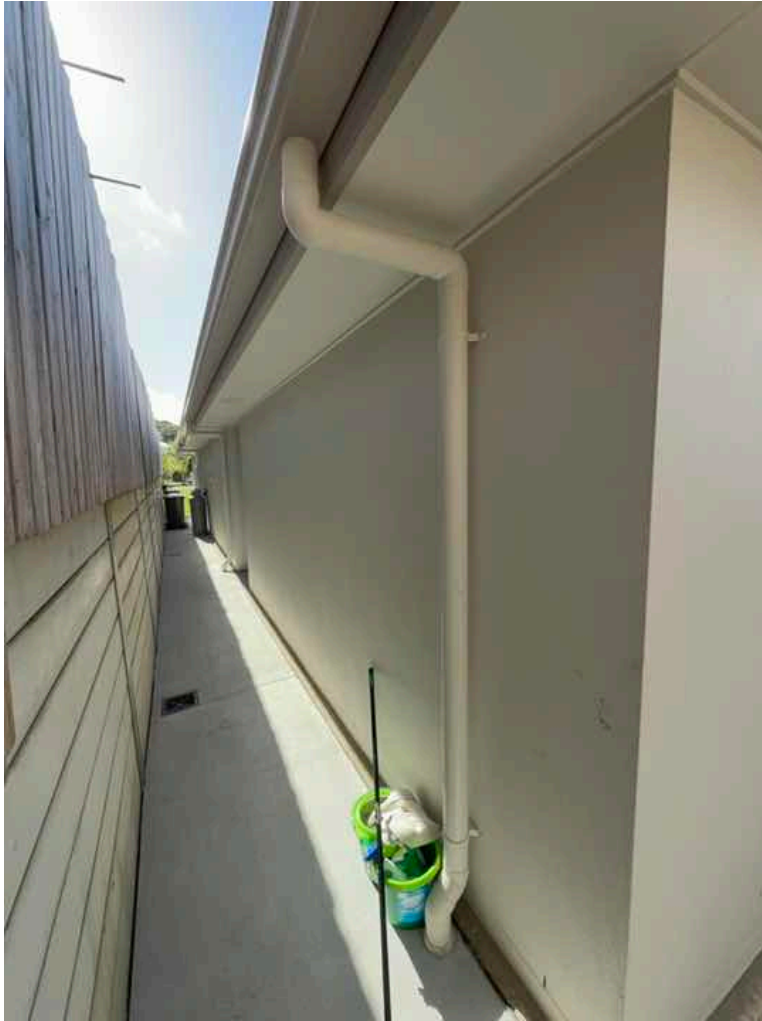
On visual inspection no apparent defects were noted to the down pipes and are considered serviceable, however no comment can be made with regard to blockages or connections to stormwater or functionality in the absence of rain. Note: Periodic maintenance checks should be carried out for rust penetrations and leaks.

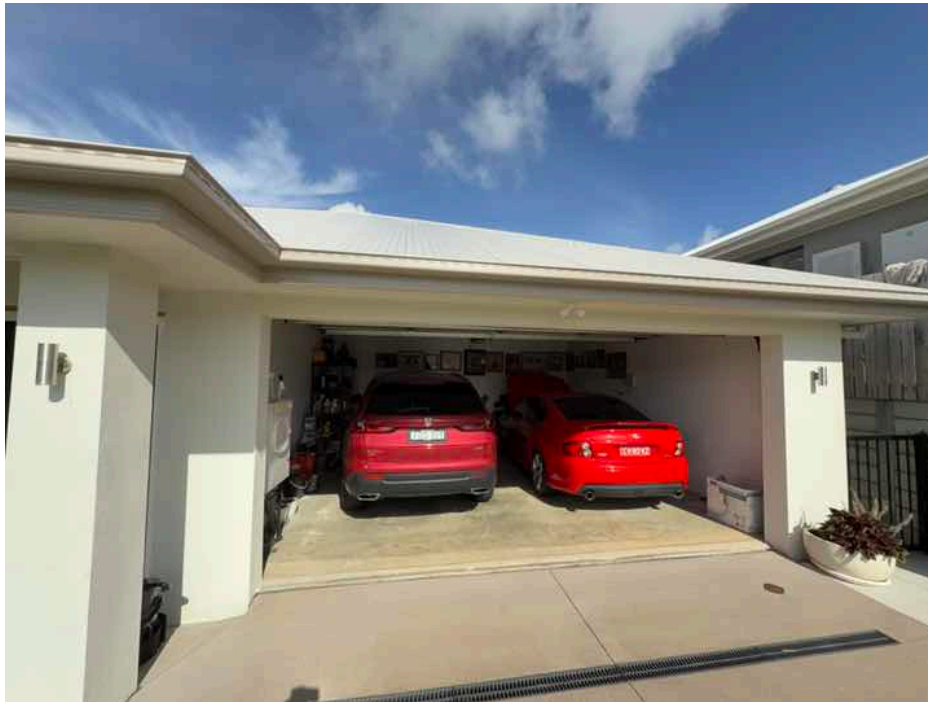
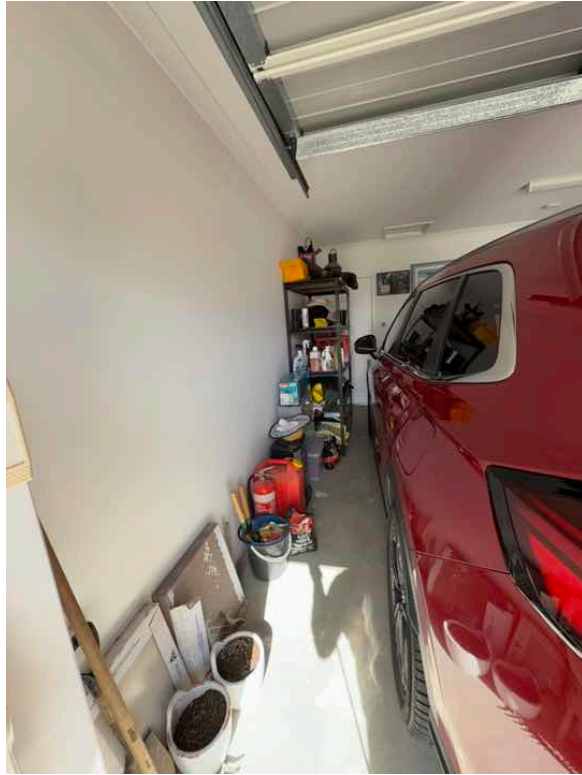
From the visible and accessible areas, the garage appears to be in a serviceable condition for the age of the property with no notable structural defects sighted.

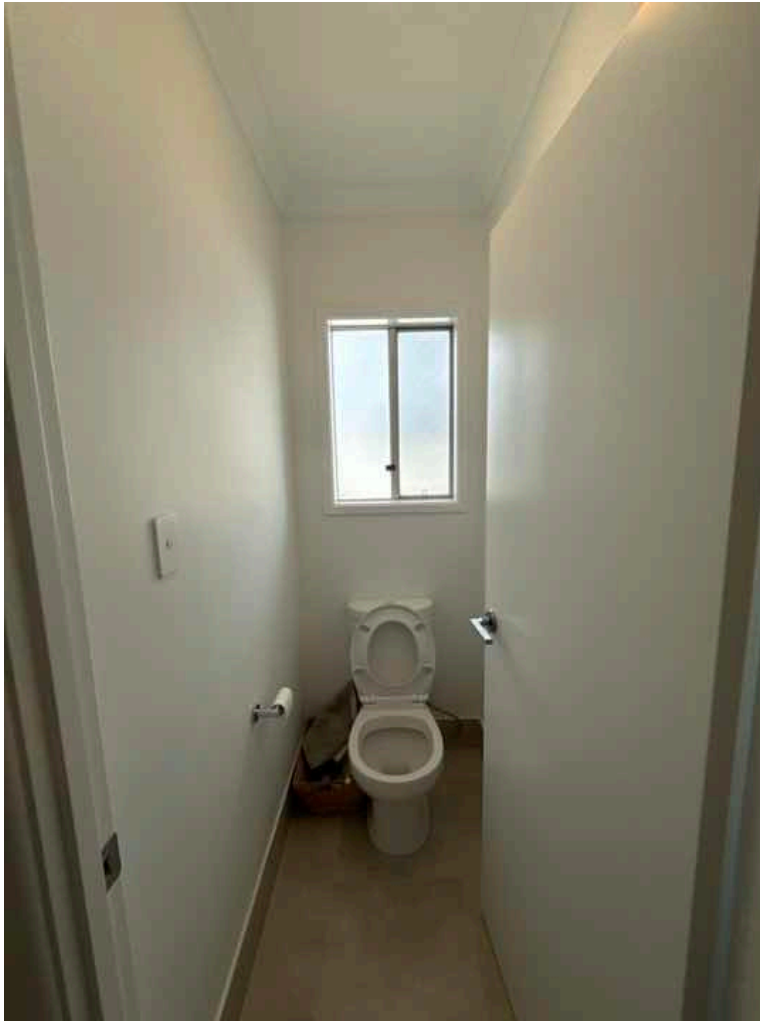
Of the visible areas, the general condition of this bathroom is serviceable or in reasonable condition for age of dwelling.

No exhaust fan is installed - Recommend having one installed.

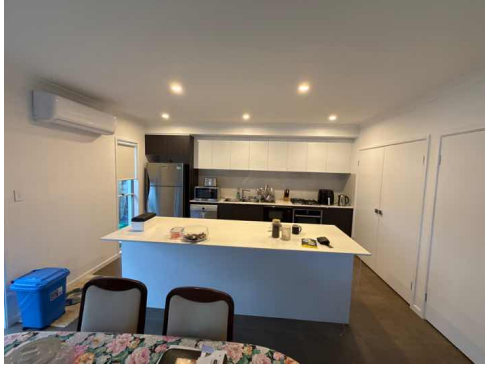
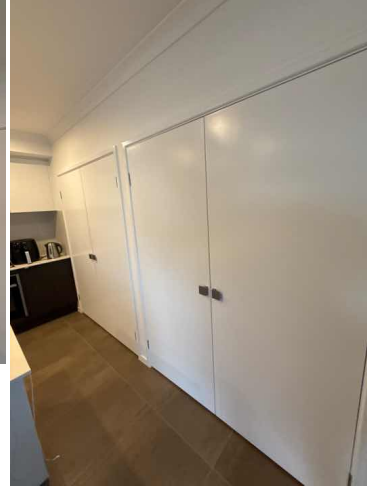
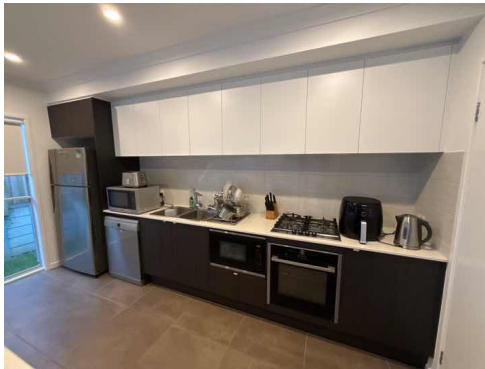
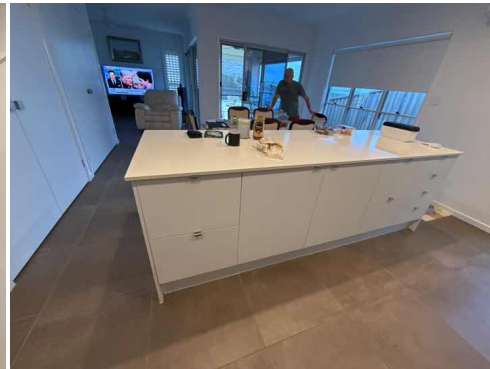
Of the visible areas, the general condition of the kitchen and pantry is serviceable or in reasonable condition for age of dwelling.

Adjustment to cabinet doors required, in some instance hinges may need to be replaced.
