# Building and Pest Report

## 37 Rainforest Wy, Lennox Head

Report/Agreement #	0403261049588
Inspection Date:	04 Mar 2026
Inspection Time:	10:00 am

**The Scope of the Inspection:** This report Complies with Australian Standards AS 4349.1-2007. Inspection of Buildings Part 1: Pre- Purchase Inspections-Residential Buildings- Appendix "C"

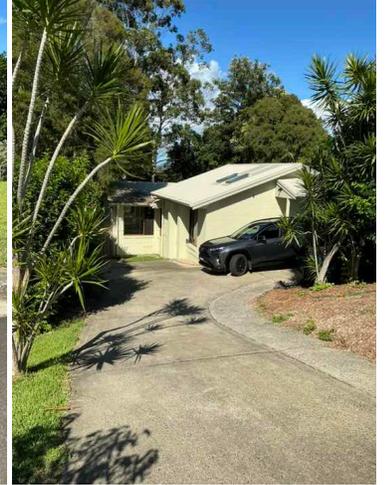
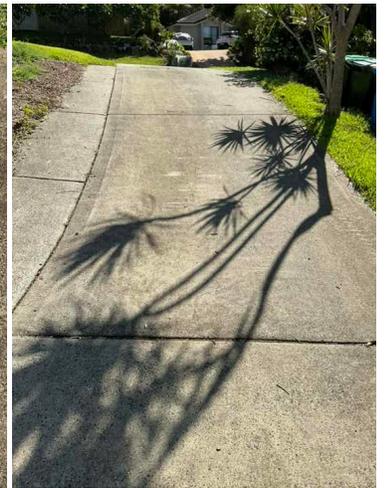
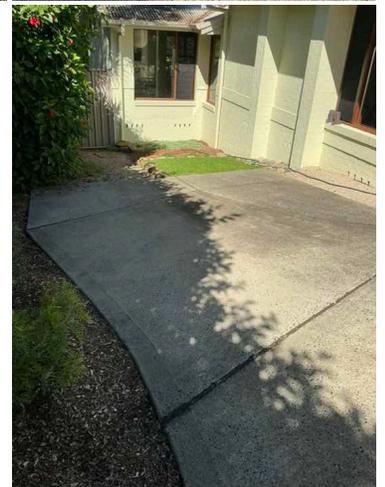
On visual inspection, the general condition of the driveway is serviceable.

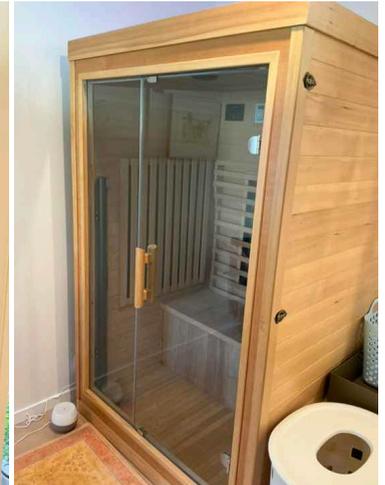
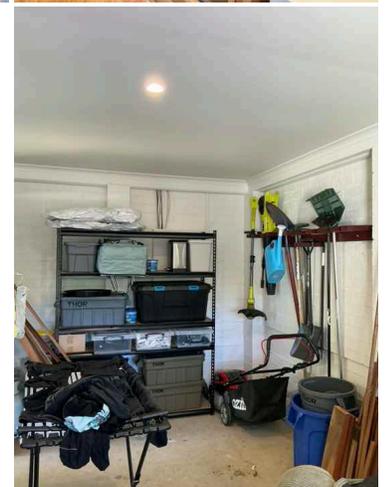
Stored items restricted a full and thorough inspection of this area. Defects may exist in the obstructed and inaccessible areas. It is strongly recommended that full access be granted to enable a thorough inspection as there may be timber pest activity, damage or defects. Note: Where vehicles and storage has restricted a full inspection it is advised that this area be cleared so a full and unobstructed inspection can be carried out.
