# Building and Pest Report

## 1 Albatross Street, Ballina

### Pest And Building Inspection

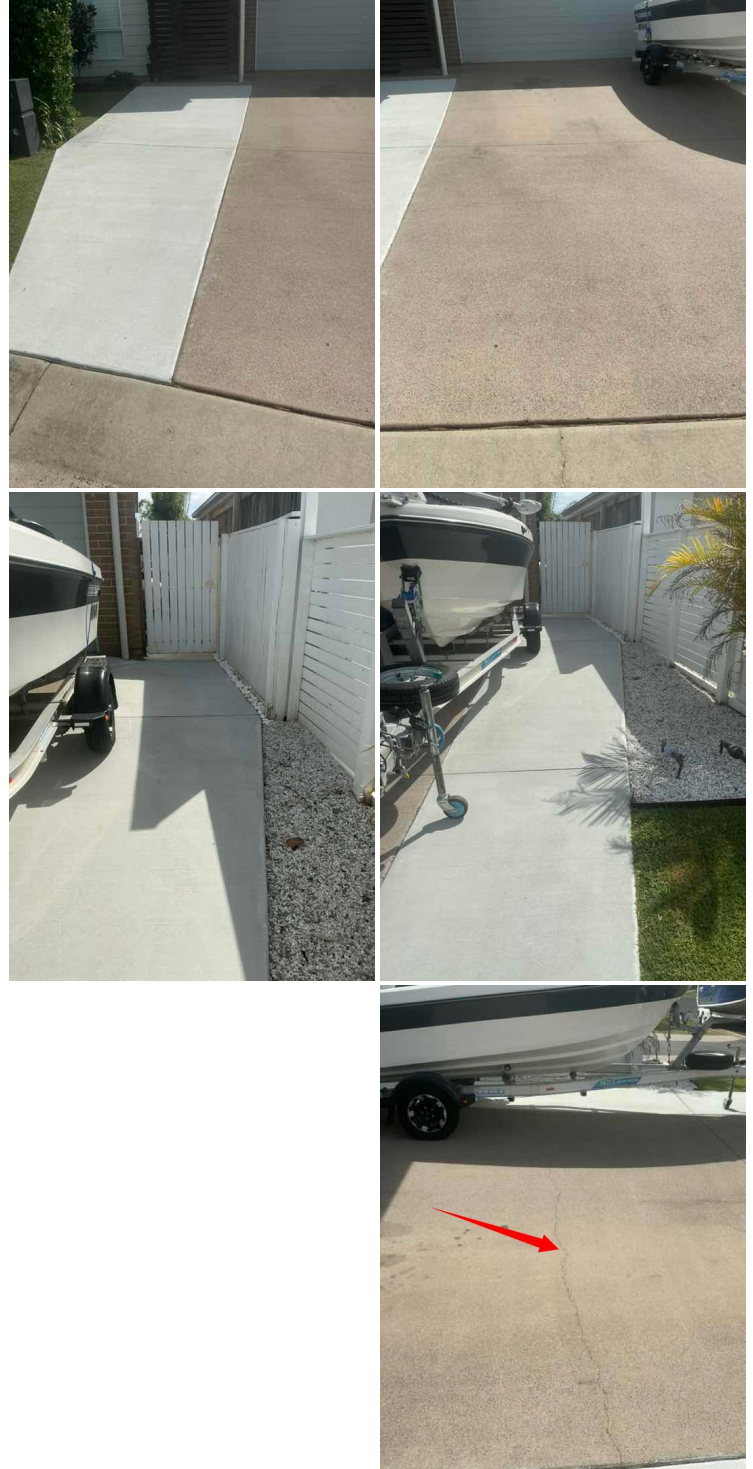
On visual inspection, the general condition of the driveway is serviceable.

Common cracks were observed on the driveway. Whilst these cracks appeared to be typical at the time of inspection, we strongly recommend you monitor these cracks and if worsening occurs contact a concreter for further advice.

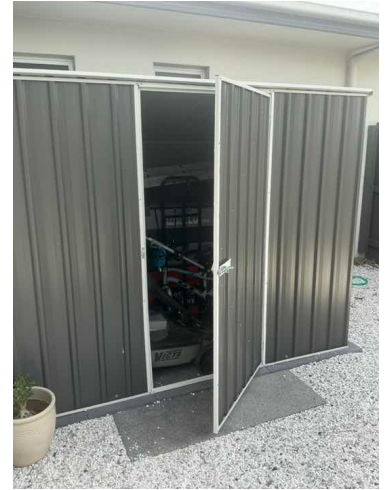
The shed is in fair usable condition.

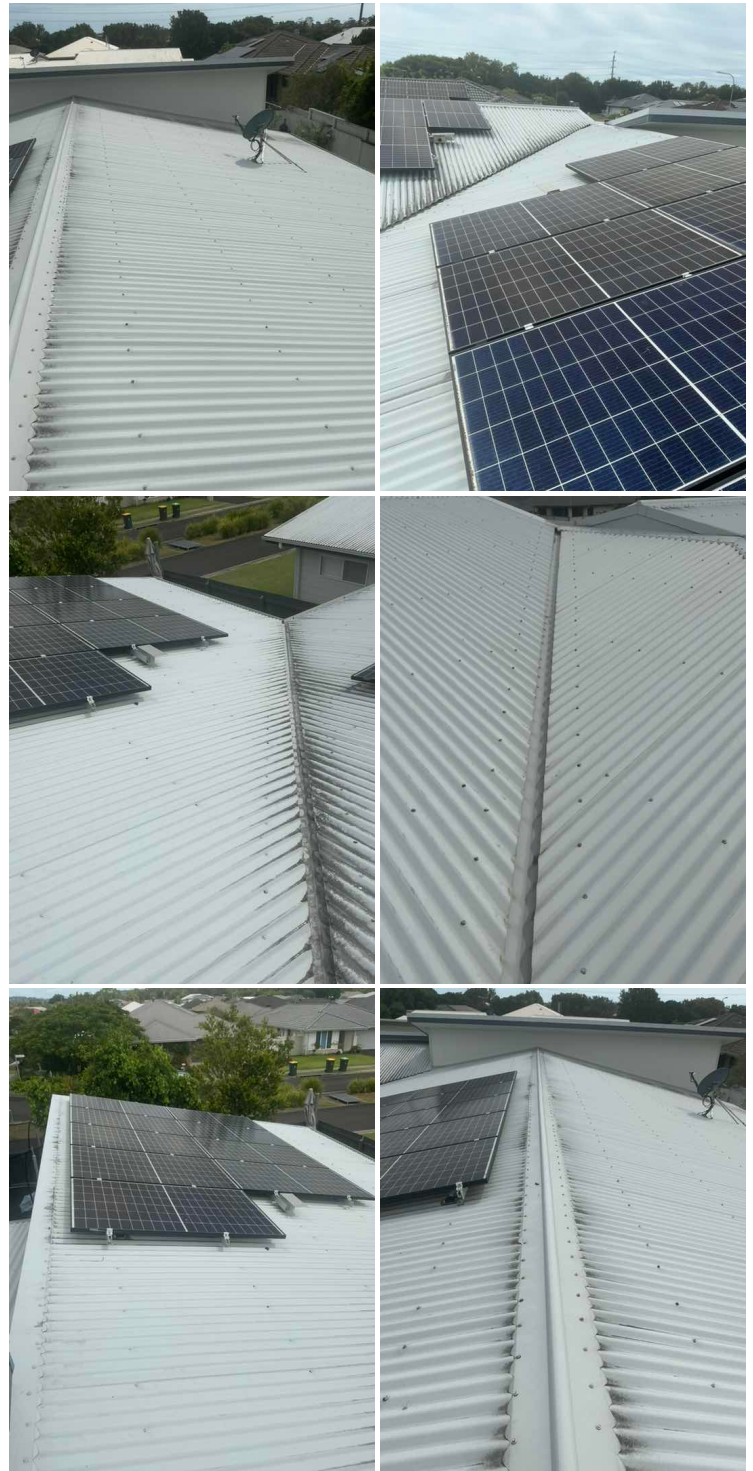
Of the visible areas, the general condition of the roof is in serviceable condition for the age.

Note: In the absence of rainfall there is no guarantee that the roof won't leak.

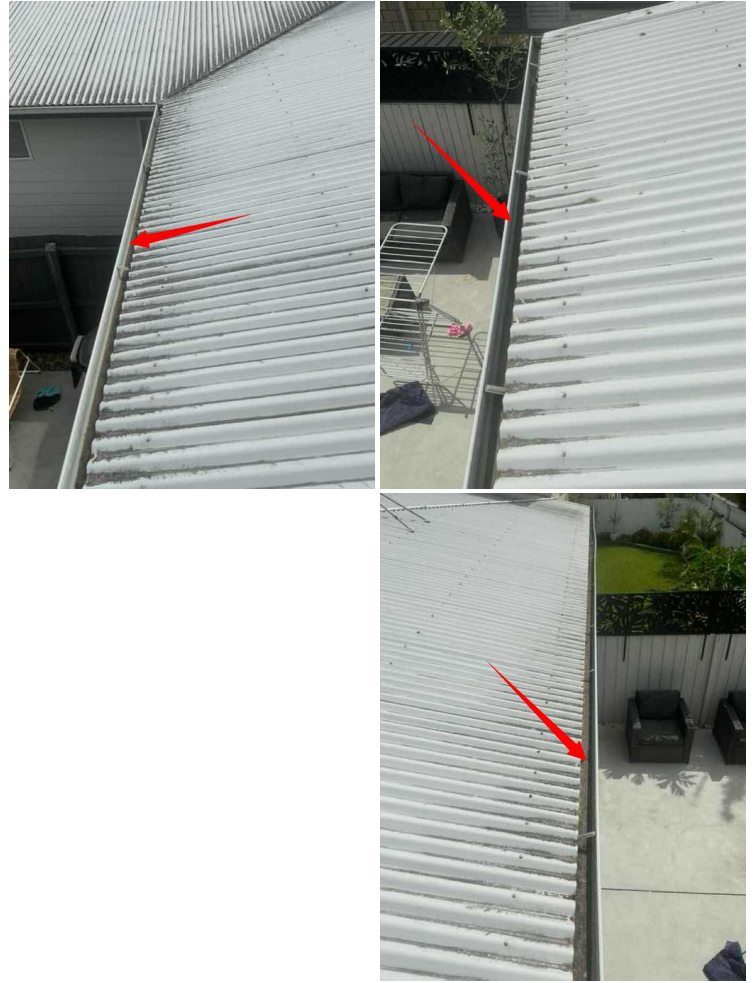
All visible and accessible of the physical nature of the guttering system appears to be in a serviceable condition with no apparent defects at the time of inspection. In the absence of prolonged rain fall efficiency of the guttering can not be assessed and you may find that further investigation or repairs maybe required. Note: Periodic maintenance checks should be carried out for rust penetrations and leaks.

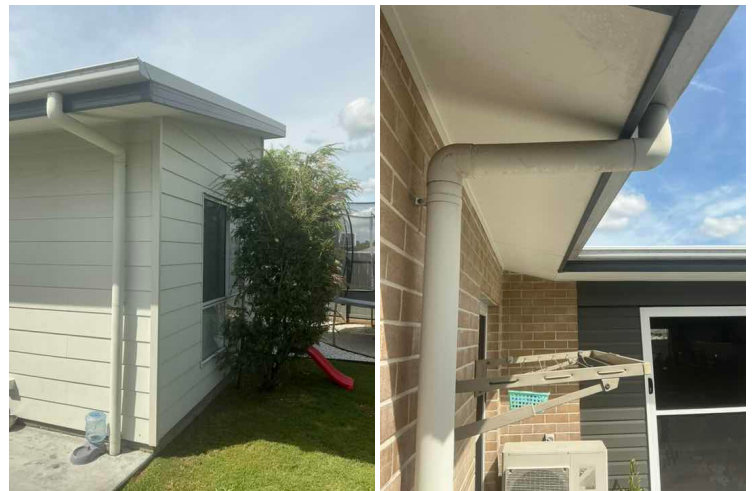
On visual inspection no apparent defects were noted to the down pipes and are considered serviceable, however no comment can be made with regard to blockages or connections to stormwater or functionality in the absence of rain. Note: Periodic maintenance checks should be carried out for rust penetrations and leaks.

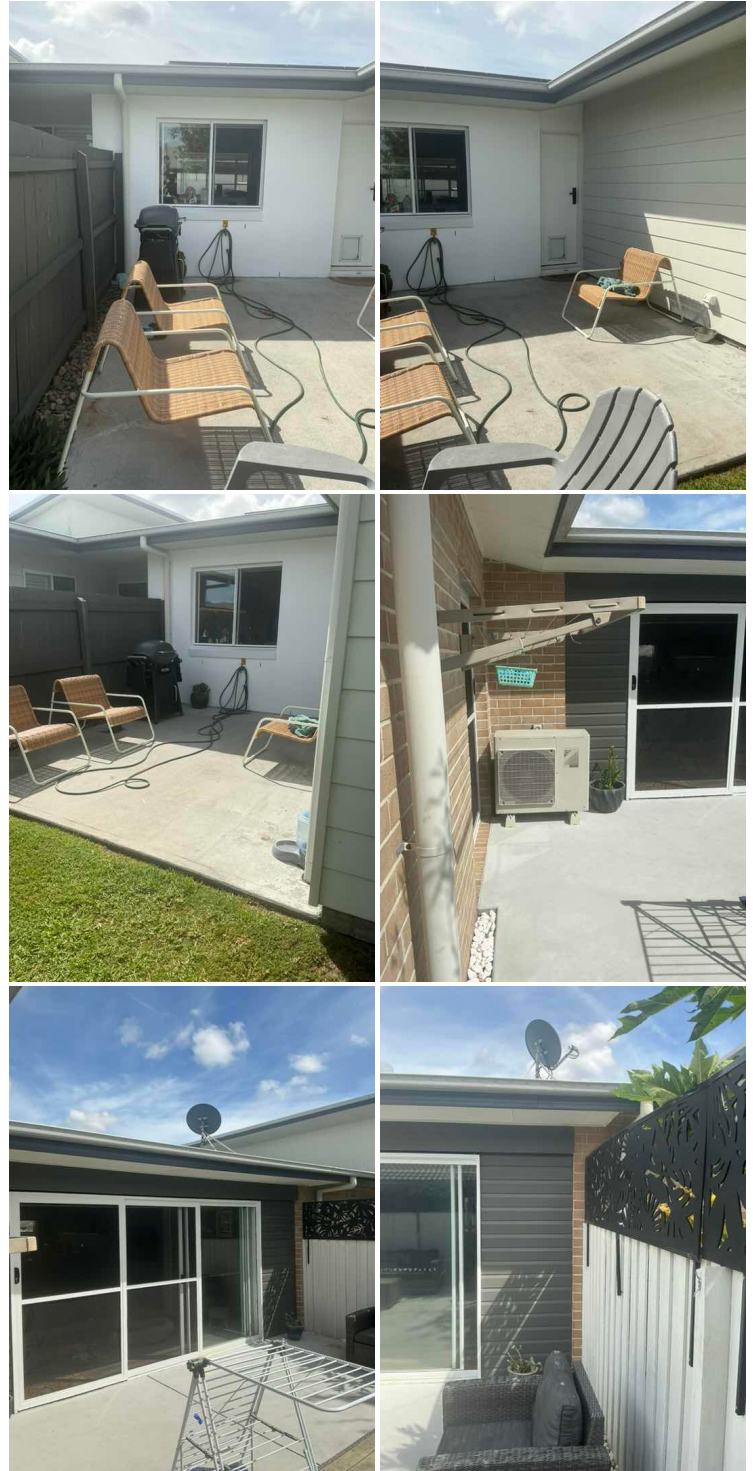
Visible sections of the Alfresco area are serviceable or in reasonable or condition for the age of this dwelling.

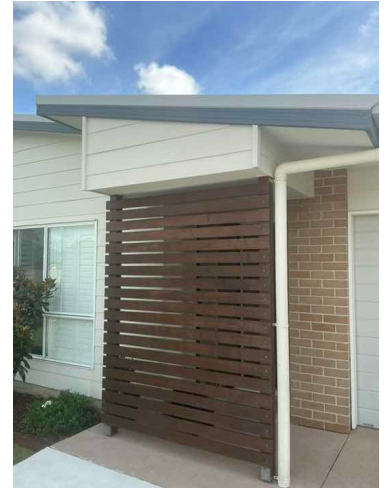
The entry porch serviceable or in reasonable or condition for the age of this dwelling.

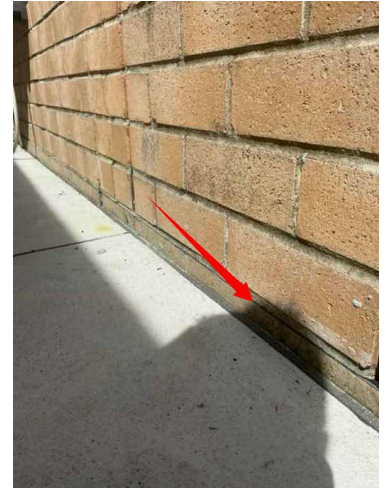
Of the visible and accessible areas, there was no visible evidence of excessive rising damp on the external walls at time of inspection.

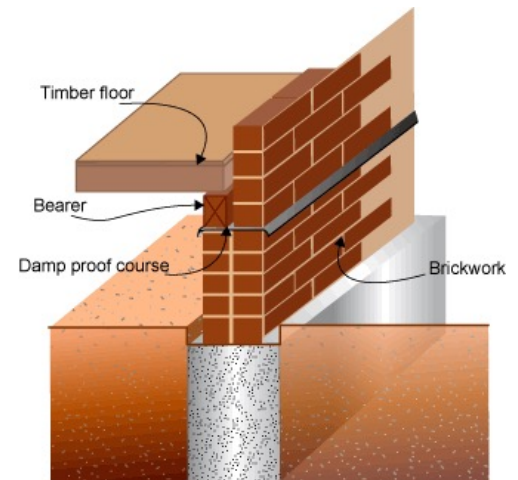
A damp proof course (DPC) was noted.

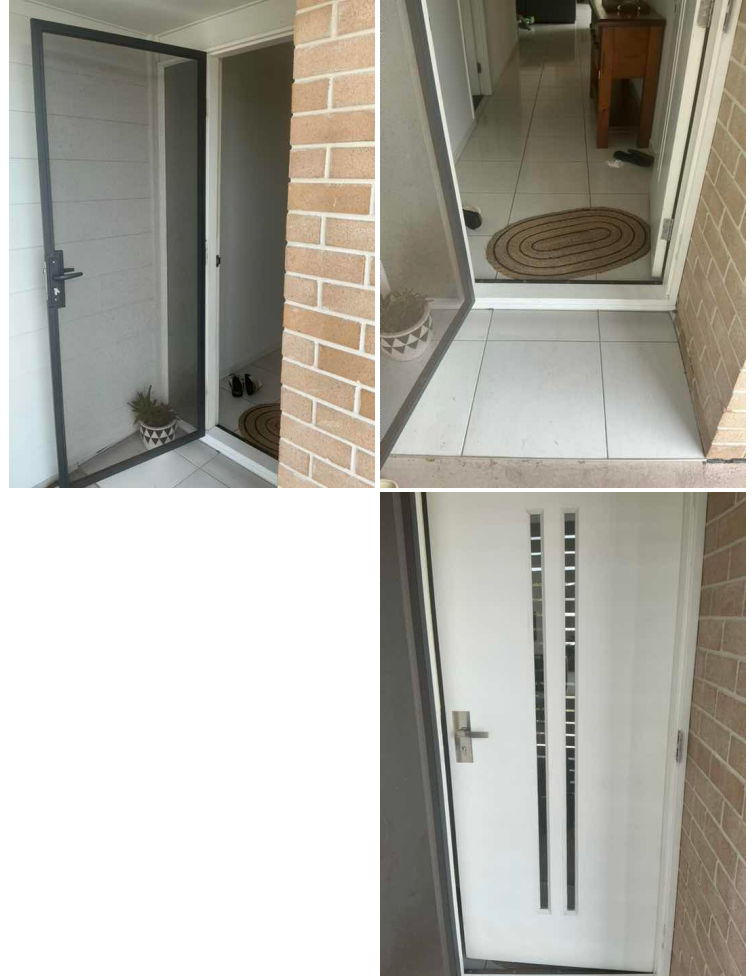
The doors are in serviceable condition with no notable defects observed.

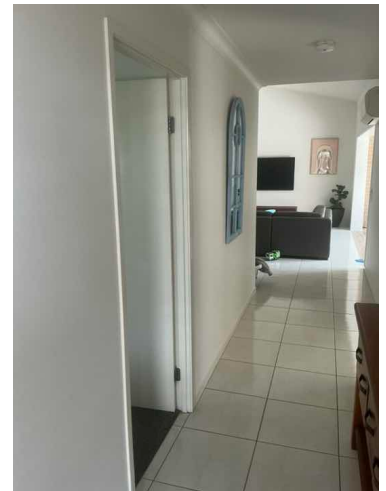
From the visible and accessible areas, the hallway/ appears to be in a serviceable condition for the age of the property with no notable structural defects sighted.

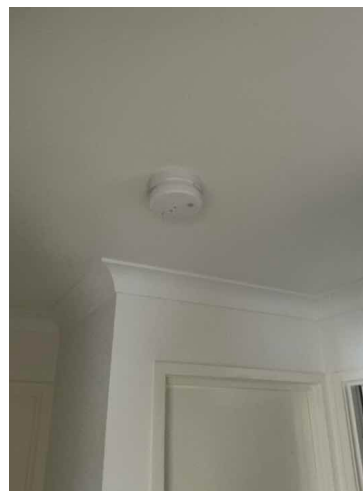
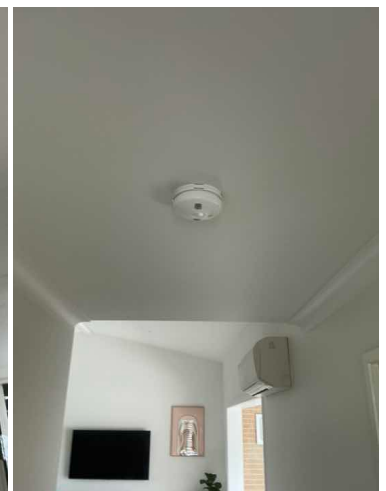
Yes 2 smoke alarms were sighted but not tested.

Legislation requires smoke Alarms to be installed.  
Check with your local council regarding type, locations  
and other related requirements.

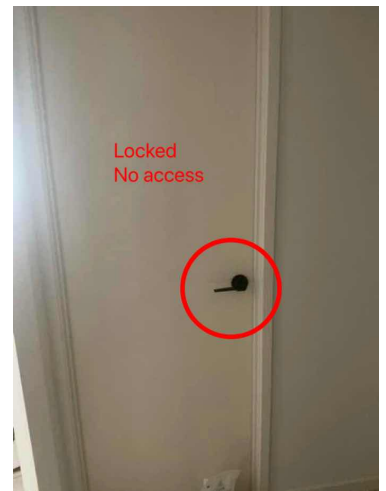
Locked no access

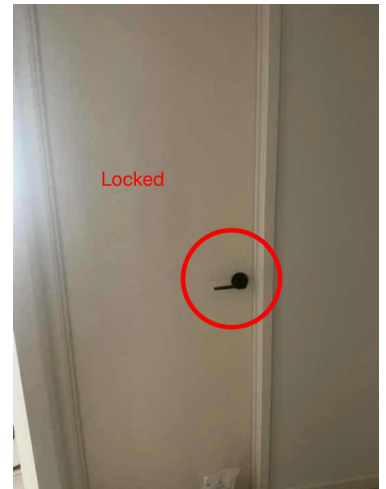
This bathroom is located in the hallway.

No access locked door

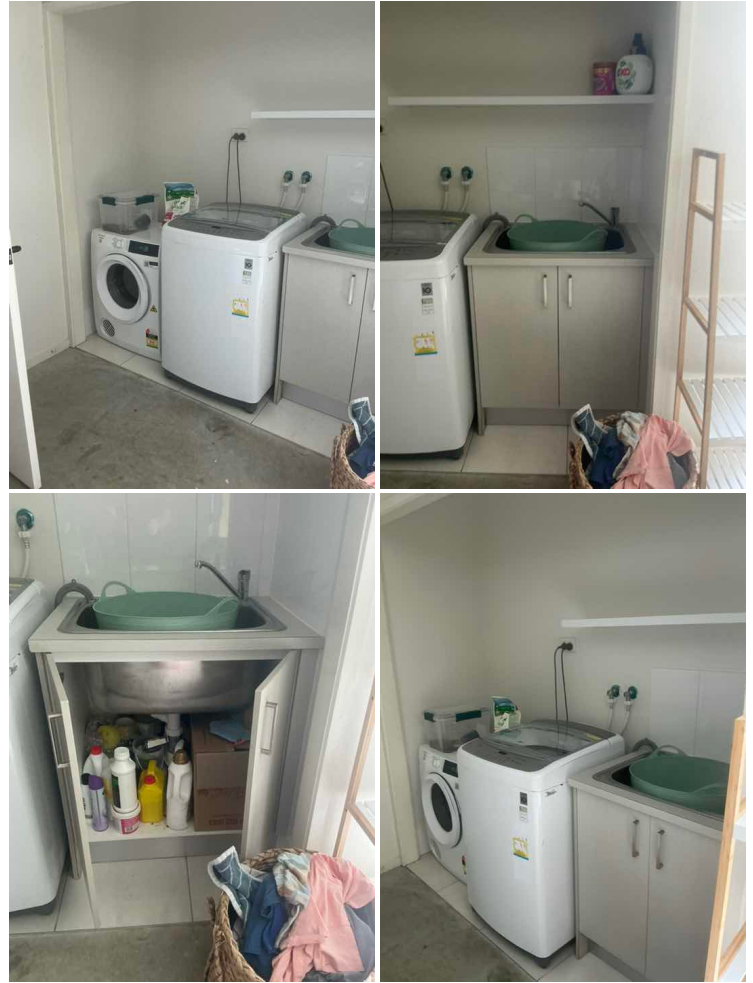
Of the visible areas, the general condition of the laundry is serviceable or in reasonable condition for age of dwelling.

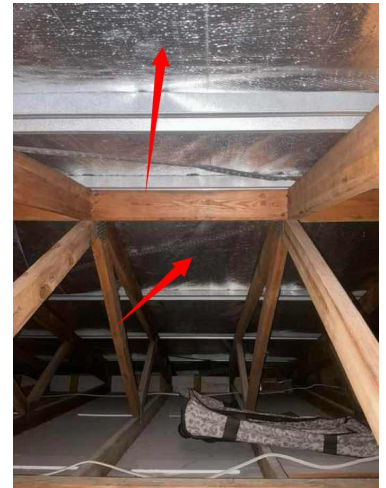
Sarking is installed.

The sarking generally is in a serviceable condition.
