PEST AND BUILDING PRE-PURCHASE REPORTS

2/40 Sunray Cres
Lennox Head

BPI - INSPECTION REPORT	3
PROPERTY DESCRIPTION	4
BPI - INSPECTION AGREEMENT	5
*BPI BUILDING REPORT - EXECUTIVE SUMMARY	6
TERMS AND CONDITIONS (Building Report)	7
INTERIOR (Building Report)	9
ROOF VOID (Building Report)	17
EXTERIOR (Building Report)	18
ROOF EXTERIOR (Building Report)	20
THE SITE (Building Report)	22
CONCLUSION (Building Report)	24
* BPI TIMBER PEST REPORT - EXECUTIVE SUMMARY	25
TERMS & CONDITIONS (Timber Pest Report)	26
INTERIOR (Timber Pest Report)	29
ROOF VOID (Timber Pest Report)	30
GARAGING (Timber Pest Report)	31
EXTERNAL (Timber Pest Report)	31
FENCES (Timber Pest Report)	31
EVIDENCE OF BARRIERS and RECOMMENDATIONS (Timber Pest Report)	32
OVERALL RISK ASSESSMENT (Timber Pest Report)	33
GENERAL REMARKS & TIMBER PEST INFORMATION	33
BUILDING & TIMBER PEST REPORT - Signed for and on behalf of:	33
APPENDICES	34

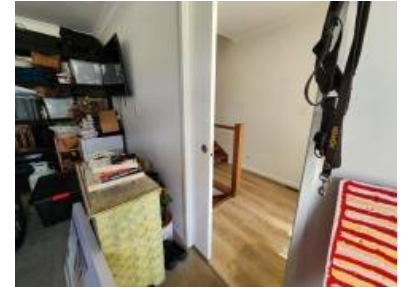
Internal sliding doors require maintenance / adjustment.

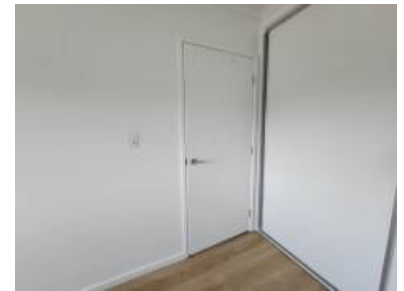
Some doors show signs of binding and require repair / easing / adjustment.

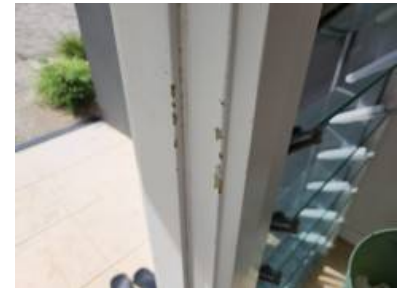
Paintwork to some door frames requires touching up / repainting.

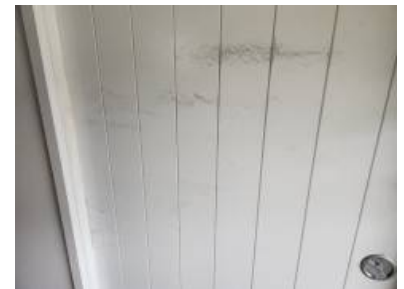
Paintwork to garage door requires touching up / repainting.

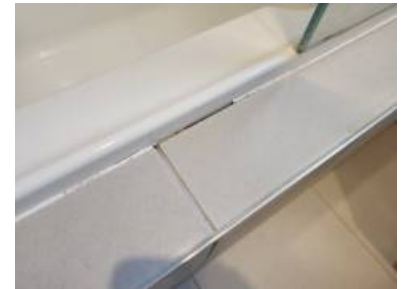
Junctions of Bathroom bath / wall tile & hob tiles require resealing with silicone.

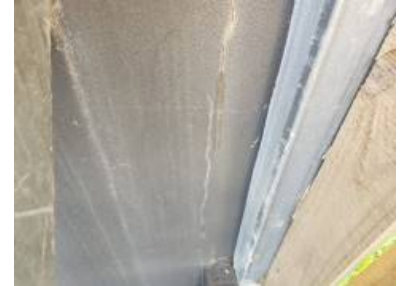
Hairline cracks to some render. *These types of cracks are normal / common and are generally due to minor settlement &/or material shrinkage consistent with the age of the building. I recommend all evident cracks be adequately sealed with a suitable sealant to aid in preventing moisture ingress.*

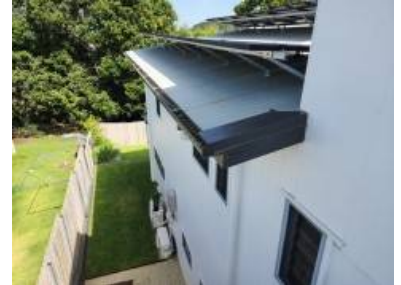
No Safe Access could be gained to the Top Level roof exterior from a 4.6m ladder.
No inspection of the Top Level roof exterior could be carried out. See Terms & Conditions: Reasonable Access.

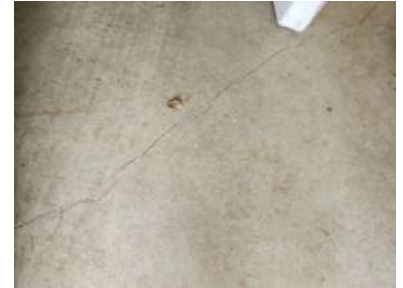
Some surface cracks to the concrete slab. These *types of minor cracks are common and generally occur when the slab surface cures.*

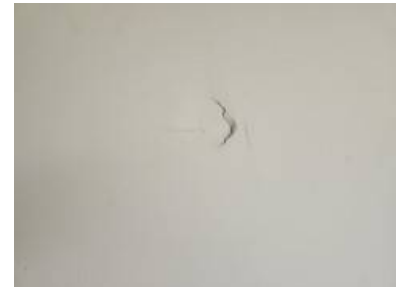
Minor damage to some walls need patching and painting.

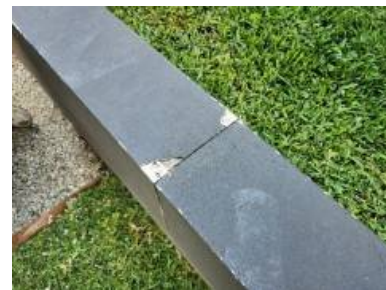
Minor damage to render on retaining wall needs patching.

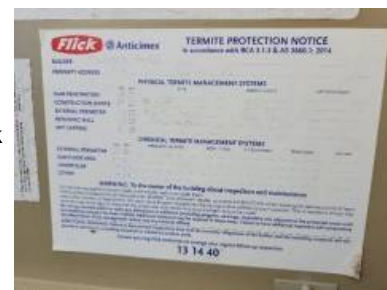
A termite barrier / treatment notice in the Meter Box / Kitchen Cupboard indicates that the slab penetrations and perimeters are protected from termite activity by Flick Guard barriers. We strongly recommend you obtain all barrier paperwork & warranty information. These barriers were installed in 2020.
