# Building and Pest Report

## 9 Cove Avenue Skennars Head

### Pest And Building Inspection

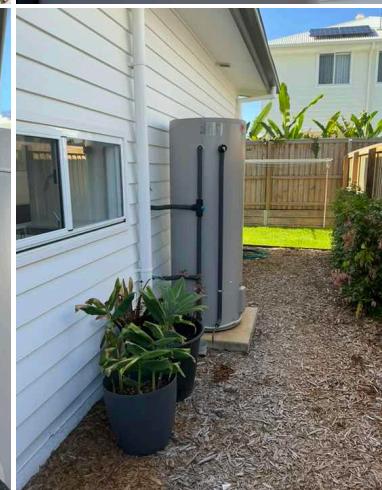
The hot water overflow requires diverting to a drain or further from the dwellings wall or footings. Excess water ponding alongside walls and into perimeter footings has the potential to cause rising damp, differential settlement and wall cracks over time. It is also conducive to termite infestation.

Recommendations: Engage a plumber to rectify.

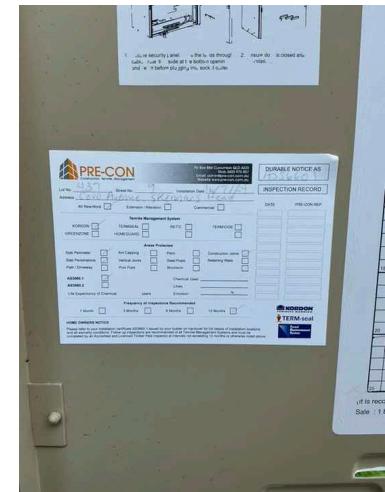
Yes, a durable notice was found in the meter-box during the inspection.

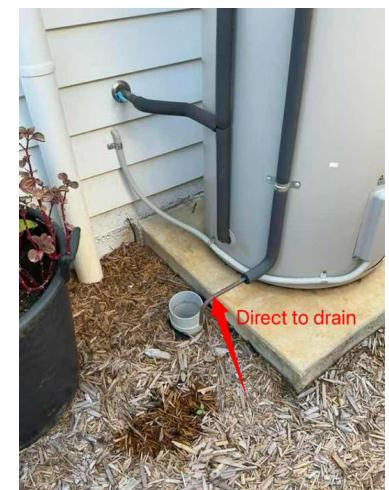
No. Divert hot water overflow away from the building perimeter.

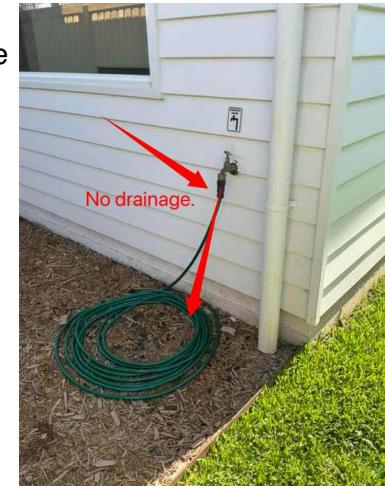
Poor drainage. There is evidence of water ponding against walls. This provides conducive conditions for termite infestation. Consult an appropriate trade for a scope of works and cost of repairs for the issue prior to contracts becoming binding.
