# Building and Pest Report

## 1/53 Gibbon St, Lennox Head

# Inspection Report

**1/53 Gibbon Street, Lennox Head , NSW, 2478**

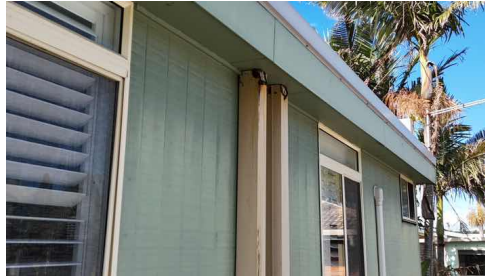
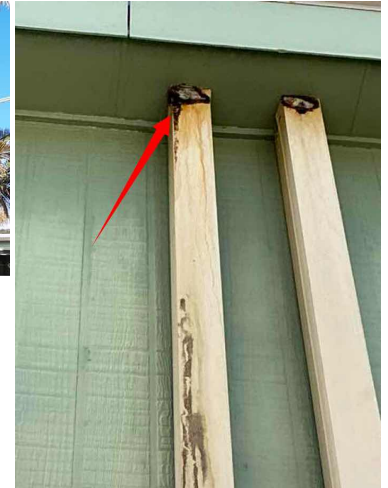
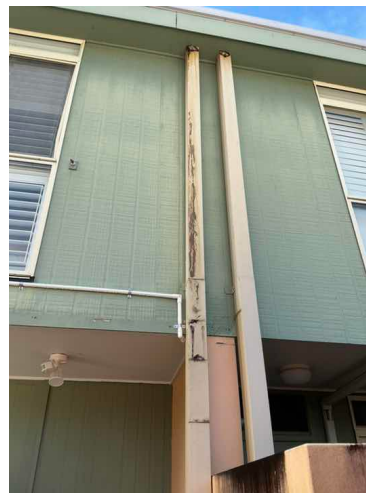
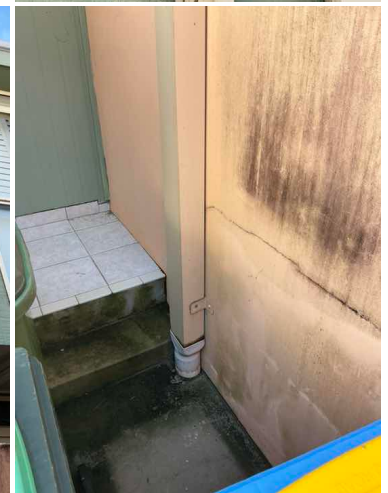
- #1. Rust penetrations observed to downpipe. Over time this has potential to cause differential settlement to the footings, cause rising damp and is also conducive to termite infestation. A qualified plumber should be engaged for advice and recommendations.
- #2. Minor downpipe rust visible. A qualified plumber should be engaged for advice and recommendations.

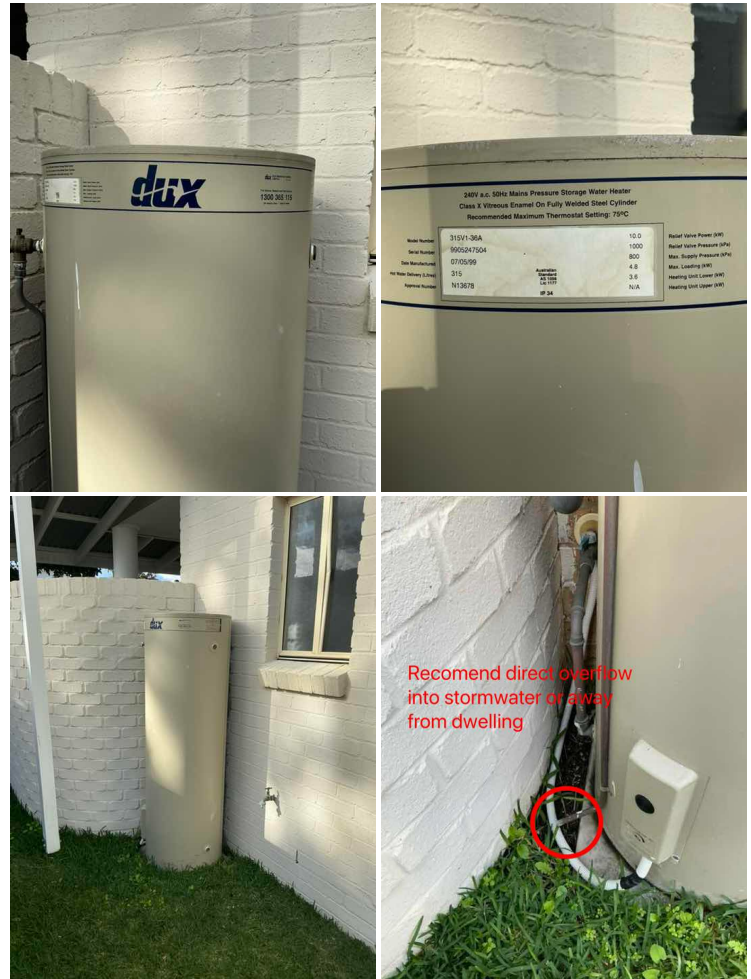
The hot water overflow requires diverting to a drain or further from the dwellings wall or footings. Excess water ponding alongside walls and into perimeter footings has the potential to cause rising damp, differential settlement and wall cracks over time. It is also conducive to termite infestation. Recommendations: Engage a plumber to rectify.

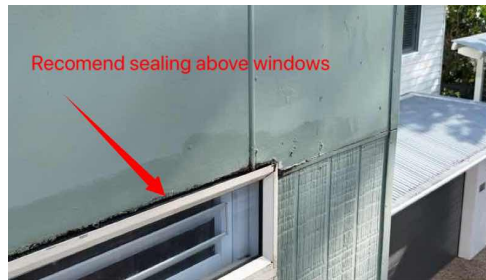
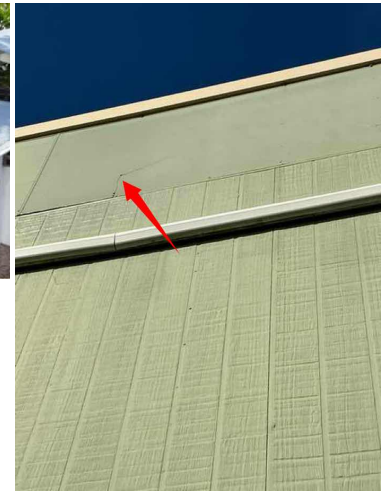
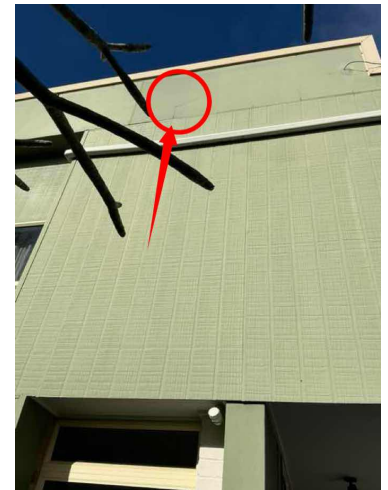
Upon visual inspection, a crack is visible on the upper wall section. Recommend sealing the crack with appropriate filler and repainting to prevent moisture ingress. Engage a licensed tradesperson to assess and repair the crack to ensure structural integrity and prevent further deterioration.

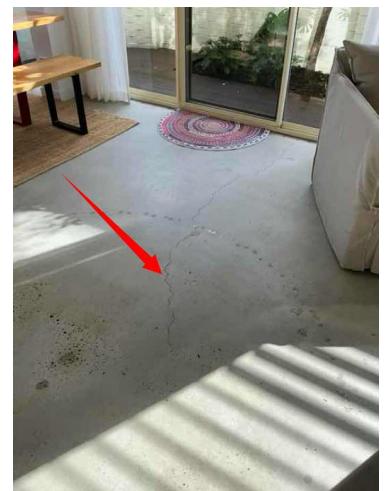
Upon visual inspection, the concrete floor exhibits noticeable cracking. It is recommended to consult a licensed contractor to assess and repair the cracks to prevent further deterioration. Consider using a suitable concrete filler or sealant to address the issue effectively. Regular monitoring is advised to ensure no additional structural concerns arise.
