# Building and Pest Report

## 1/53 Seawell Cres, Lennox Head

Report/Agreement #	160226101057122
Inspection Date:	16 Feb 2026
Inspection Time:	09:00 am

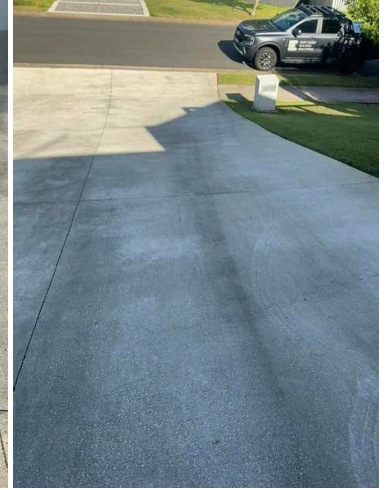
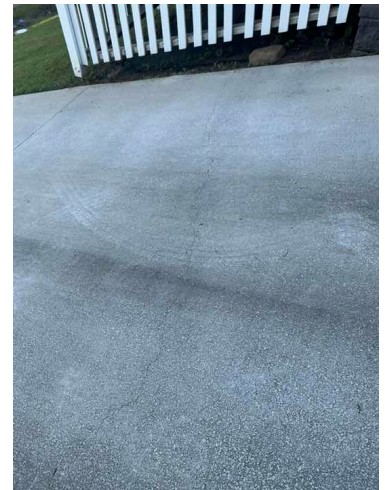
#### Driveway Condition

On visual inspection, the general condition of the driveway is serviceable.

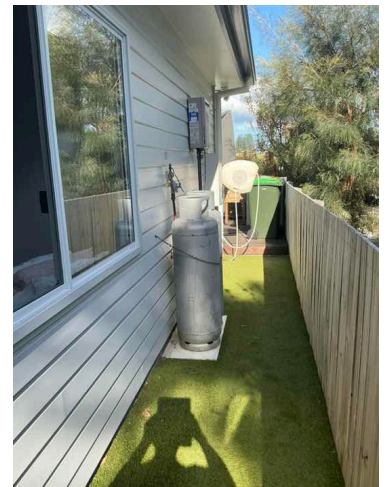
#### Pathways Condition

The paths around the home are in a serviceable condition for the age of this dwelling with no major defects visible.

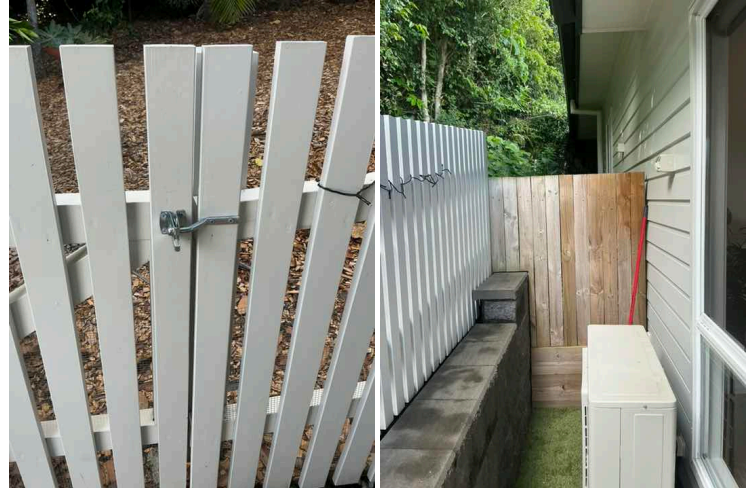
## Fences & Gates

Of the visible areas, the general condition of the fences and gates is serviceable for the age of dwelling.

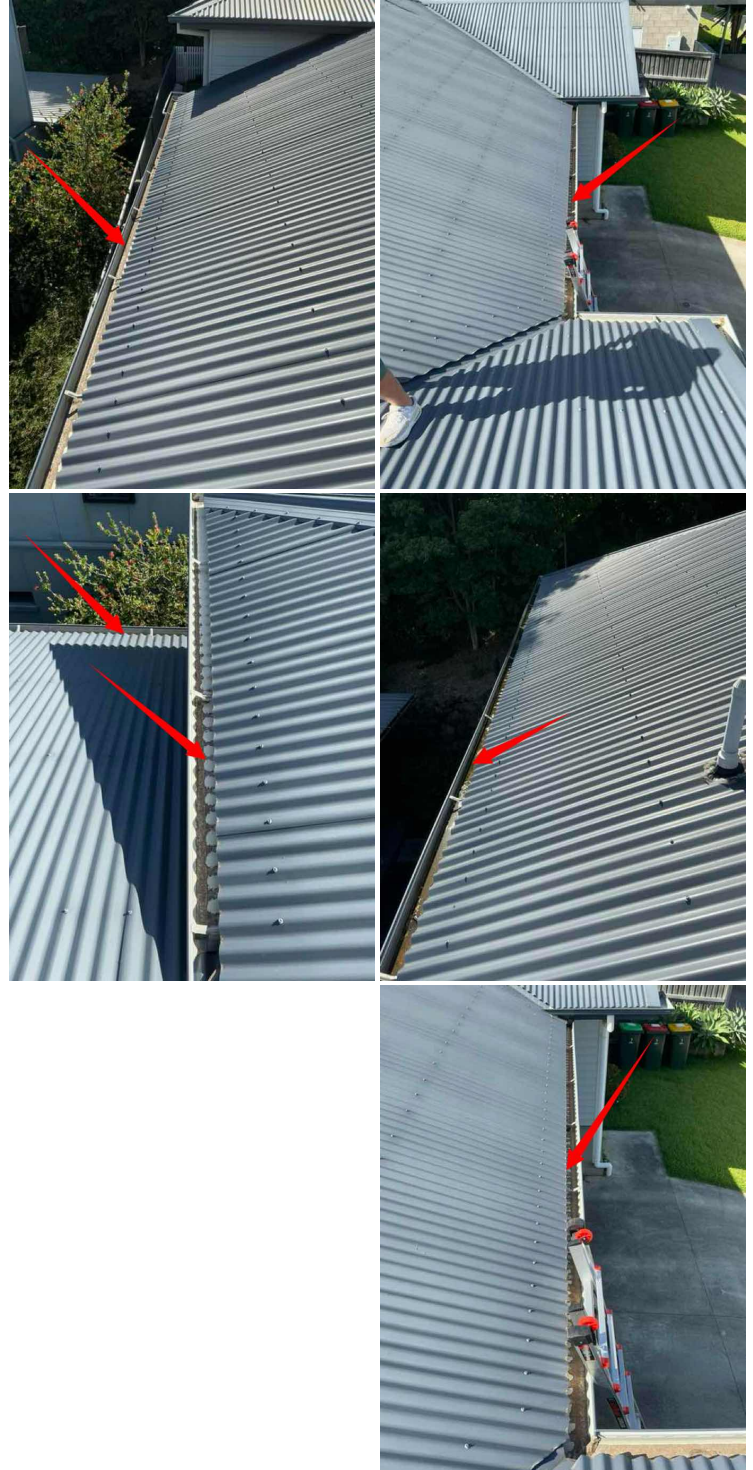
### Gutter Findings

All visible and accessible of the physical nature of the guttering system appears to be in a serviceable condition with no apparent defects at the time of inspection. In the absence of prolonged rain fall efficiency of the guttering can not be assessed and you may find that further investigation or repairs maybe required. Note: Periodic maintenance checks should be carried out for rust penetrations and leaks.

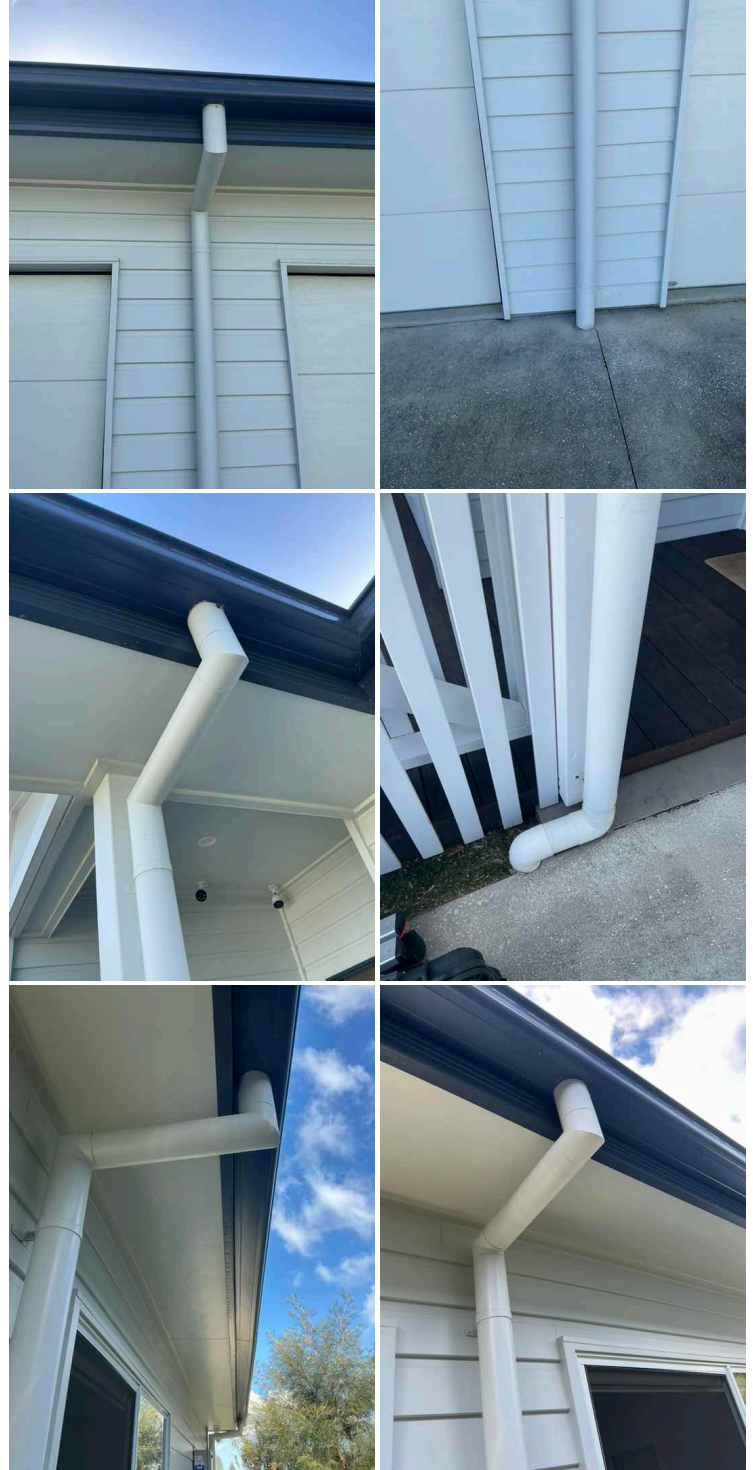
### Downpipe Findings

On visual inspection no apparent defects were noted to the down pipes and are considered serviceable, however no comment can be made with regard to blockages or connections to stormwater or functionality in the absence of rain. Note: Periodic maintenance checks should be carried out for rust penetrations and leaks.

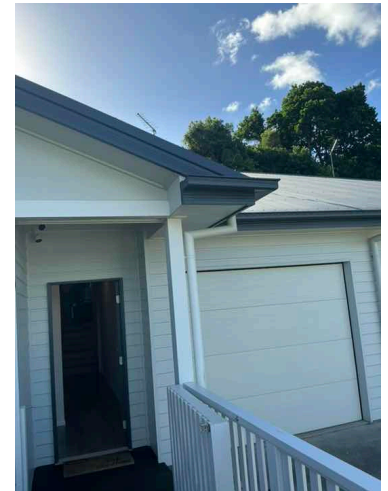
## Entry Porch Area

The entry porch serviceable or in reasonable or condition for the age of this dwelling.

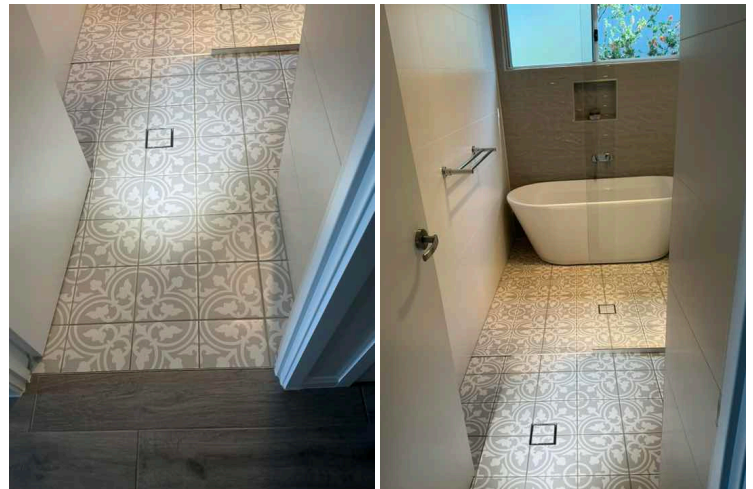
### Bathroom 1

Upon visual inspection, a crack is visible on the wall surface. It is recommended to have a licensed tiler assess and repair the crack to prevent further damage. Ensure proper sealing and to maintain the wall's integrity and appearance.

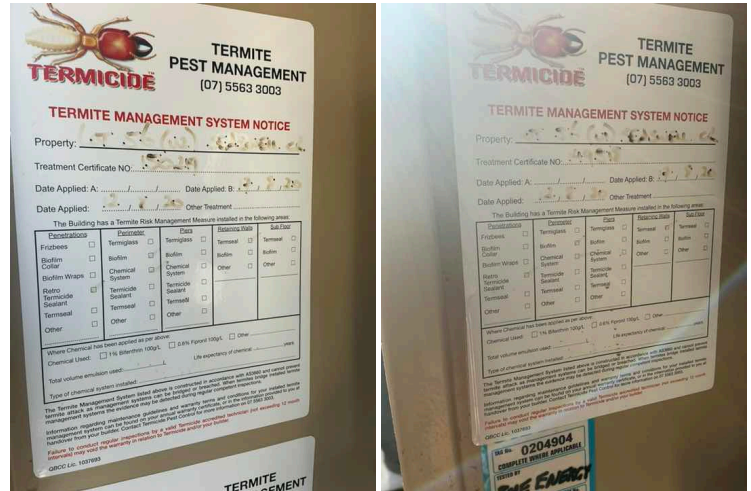
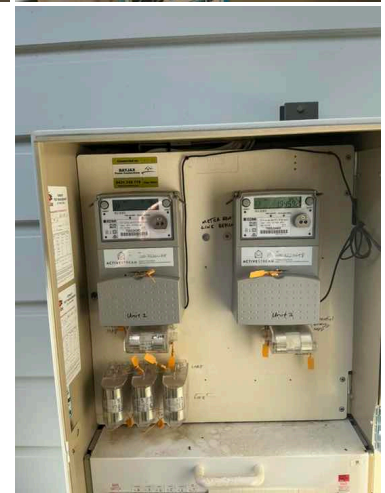
#### Was a Treatment Notice Found

Yes, a durable notice was found in the meter-box during the inspection.
