# Property Inspection Report

**31 Pearces Creek Hall Road,  
Pearces Creek , 2477, NSW**

**Date of Inspection: 14/8/2025 | Time: 9:30AM**

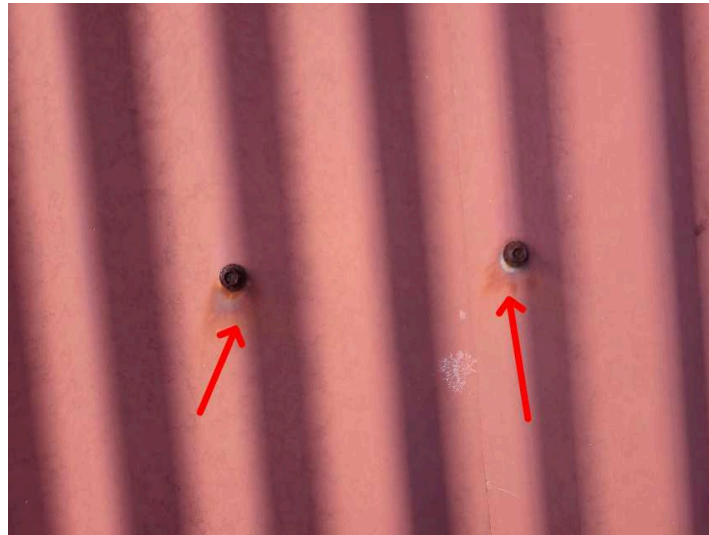
- Some of the screw fixings located on the roof sheeting are rusty and should be replaced in due course.

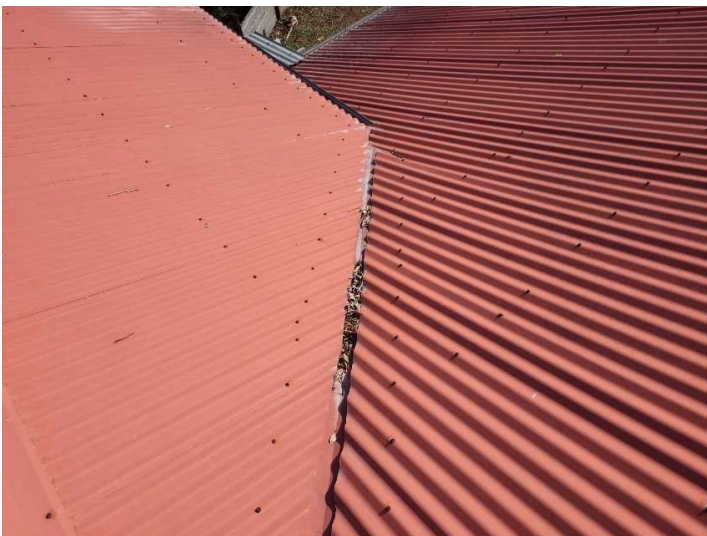
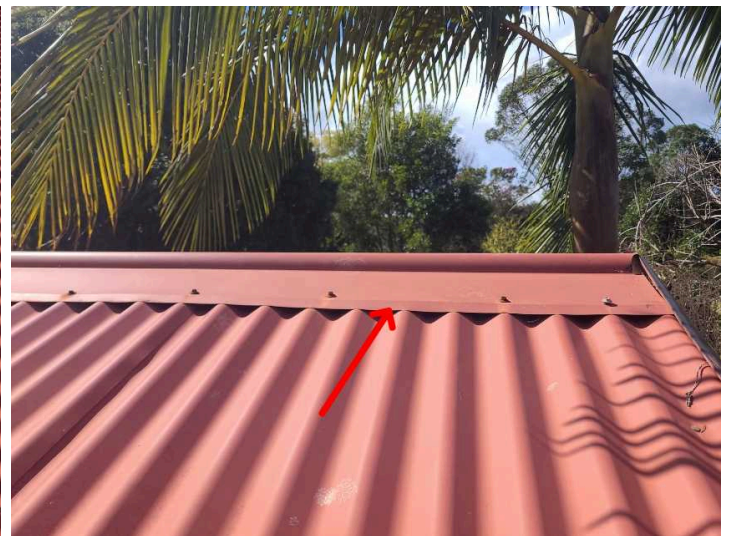
- Flashing is an impervious material (usually galvanized sheet metal) that comes in a variety of shapes and sizes and is used to cover, waterproof, and direct water away from roof penetrations and from valleys and intersections between the roof covering and other materials.
- The roof flashing, where visible, appears to be in satisfactory condition.
- Some of the valley flashings have some leaf debris which should be cleared out.

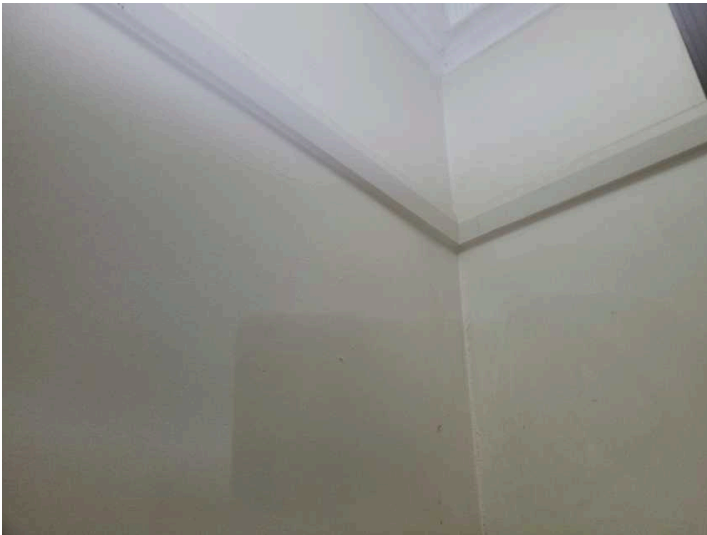
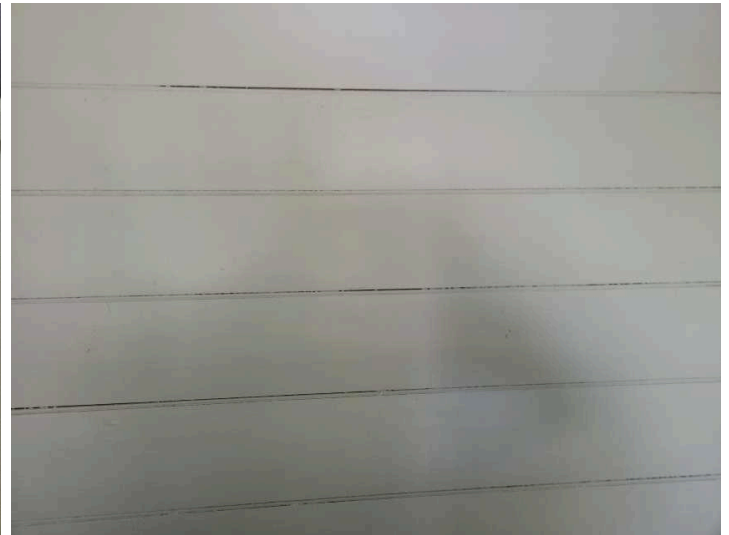
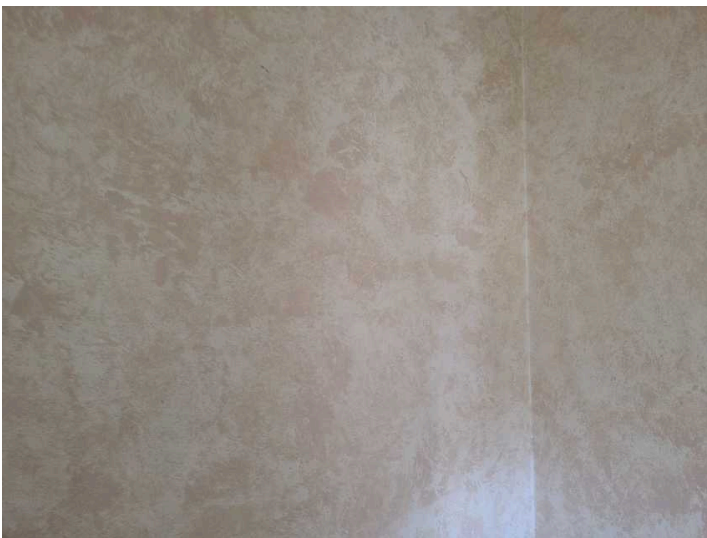
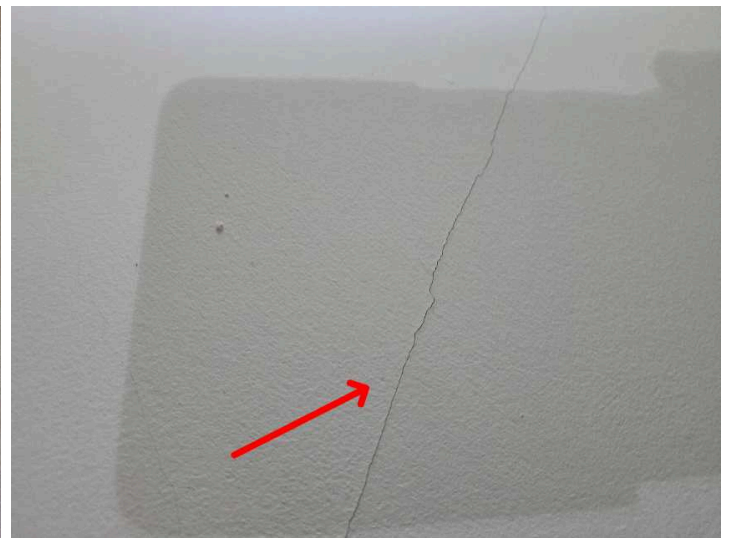
- Due to normal minor differential movement within the property or foundations, small cracks have appeared at various locations within the home. These cracks do not appear to have affected the overall structural integrity of the property and can be patched normally.

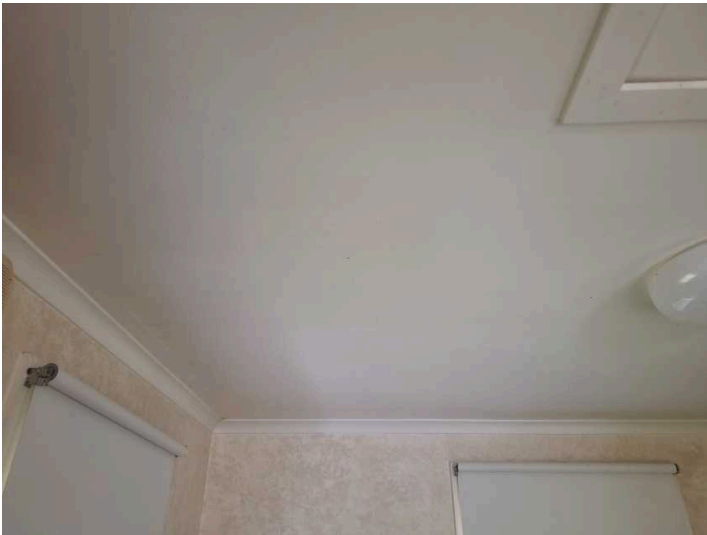
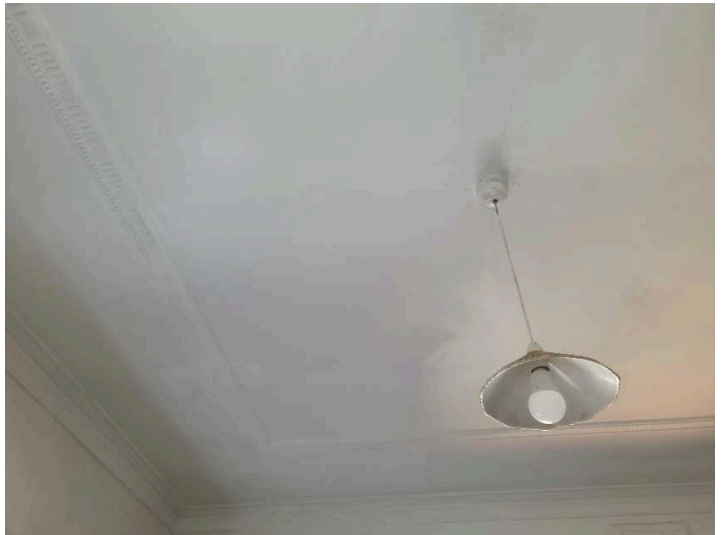
- The ceilings are original platerglass ceilings. Over time some of the plaster horse hair straps tend to break from the ceiling joists resulting in slight sagging in the ceiling and the formation of small cracks in the under surface of the ceiling. This does not appear to have affected the structural integrity of the ceilings but will require some maintenance in the future.

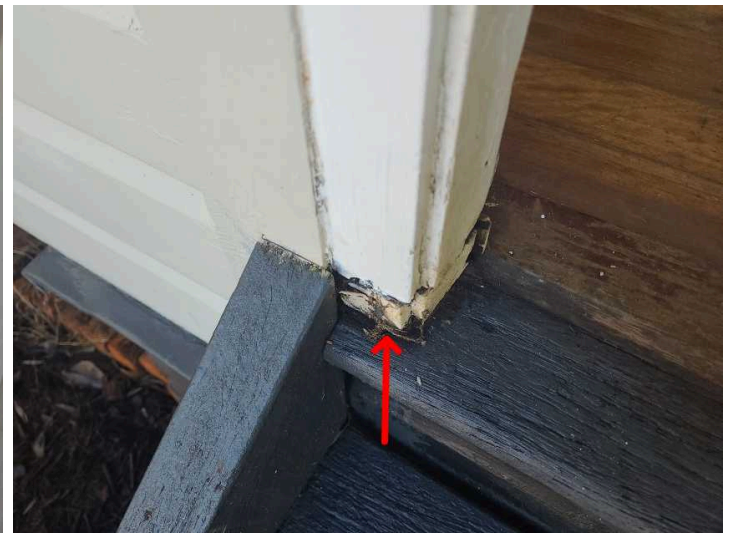
- Operated exterior doors were functional at the time of the inspection unless otherwise noted.
- Cracked glass on exterior door. Recommend repair.
- Decay noted. Maintenance in due course.

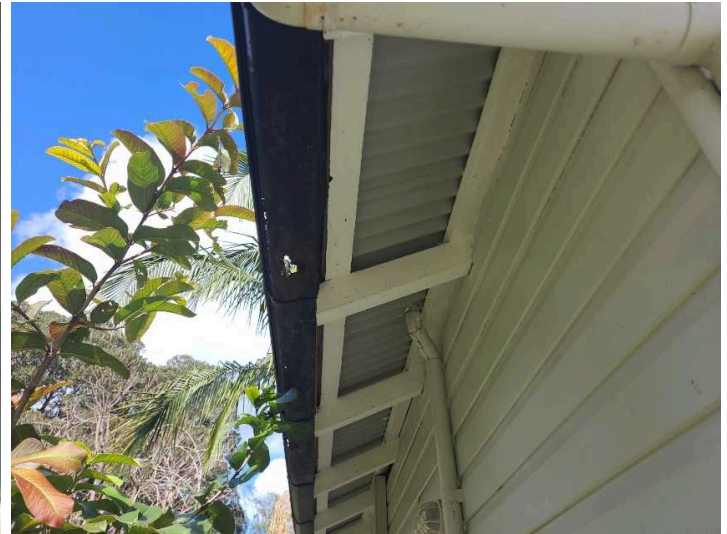
- The eaves are in satisfactory condition.
- Moisture damage, wood decay, observed. Recommend review for repair as necessary.

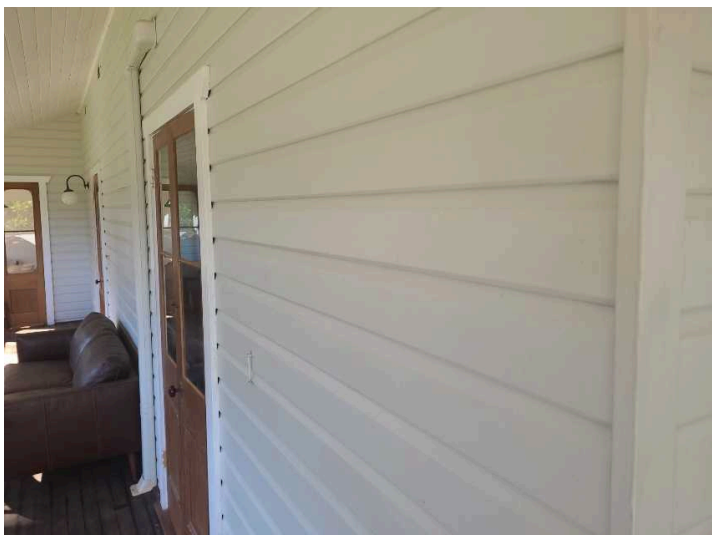
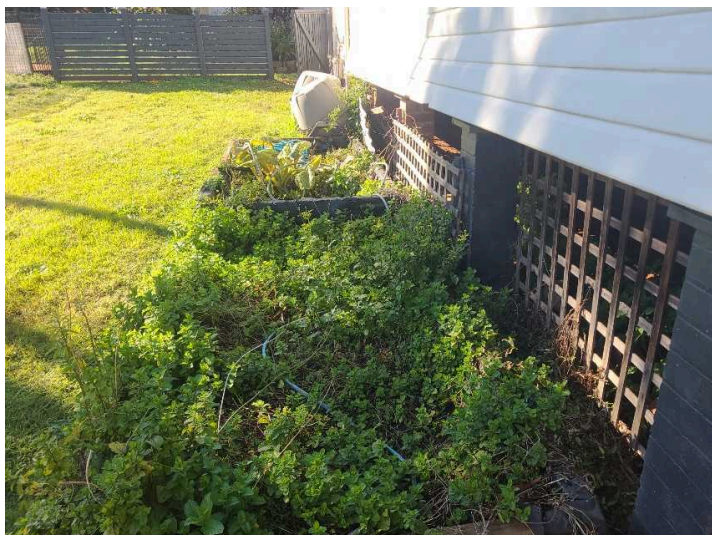
- There are a number of garden beds which are adjacent to the external walls. This can result in water moisture affecting the structure over time. It is recommended that either the beds be removed or a water barrier be placed between the garden bed and the external walls. If these beds are retained it is important that any watering is directed away from the building and kept to an absolute minimum and is controlled.

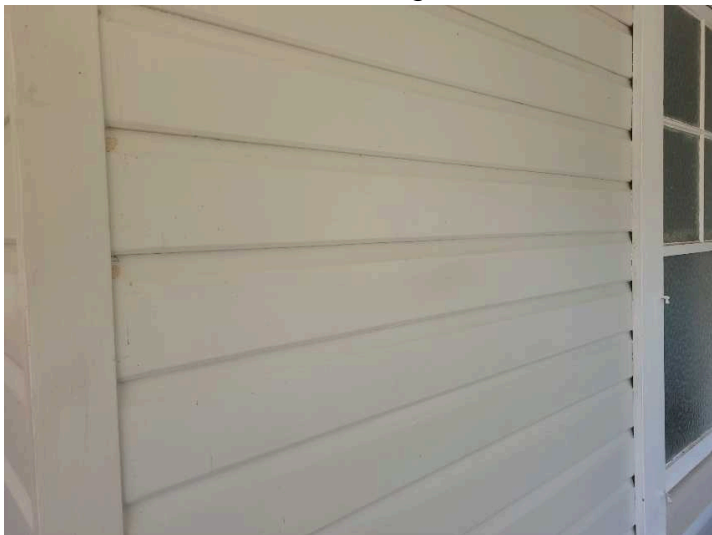
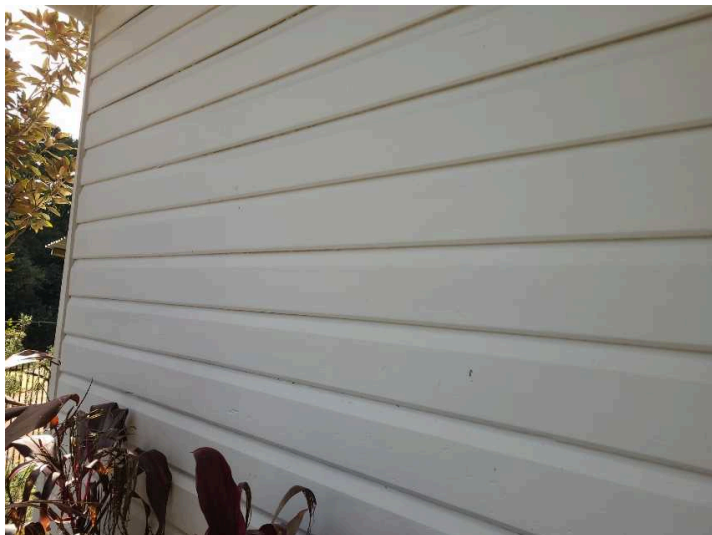
- External cladding appears to be in satisfactory condition relative to its age.
  - Some wood decay noted at the southwest side of the property.
- Recommend to have repaired and inspected for wood-destroying insect damage.

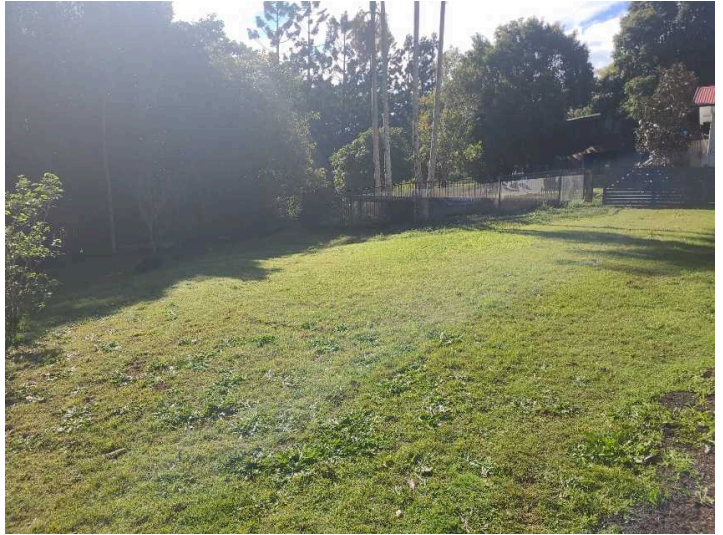
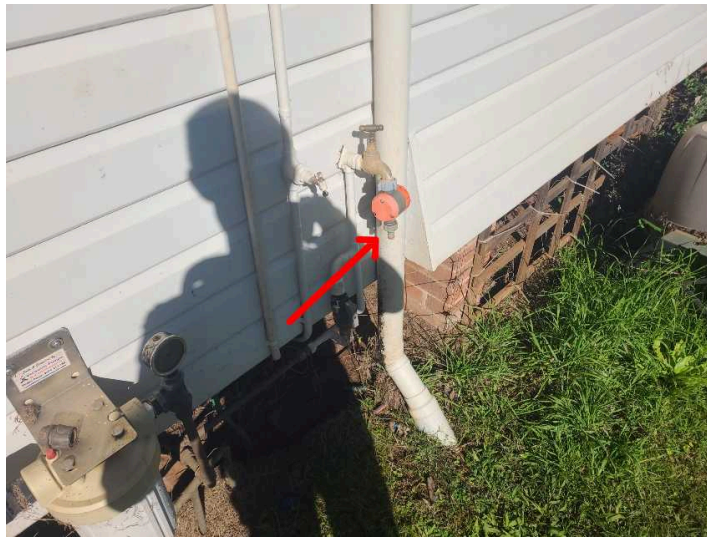
- Surface drainage conditions within 3 metres of the inspected structure appeared satisfactory.
- There are no drains located beneath the outdoor taps. This can cause water pooling if the taps were to leak. Recommend drains be installed beneath the taps. Where this is not possible it is important to ensure taps are well maintained to prevent leaks.

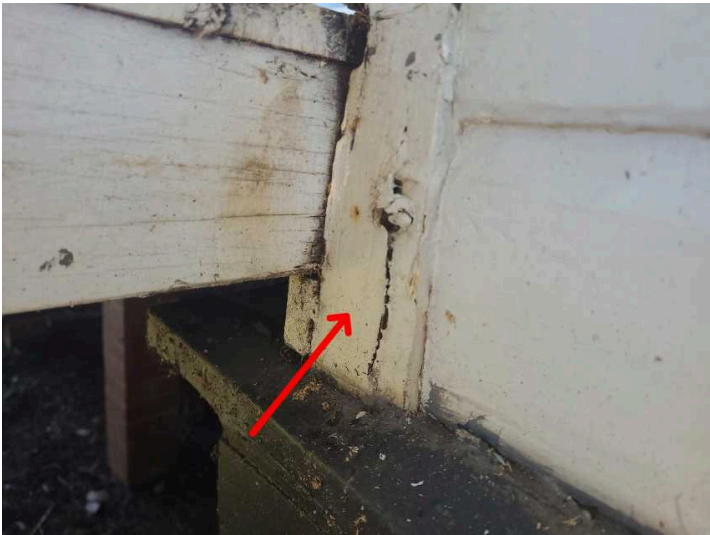
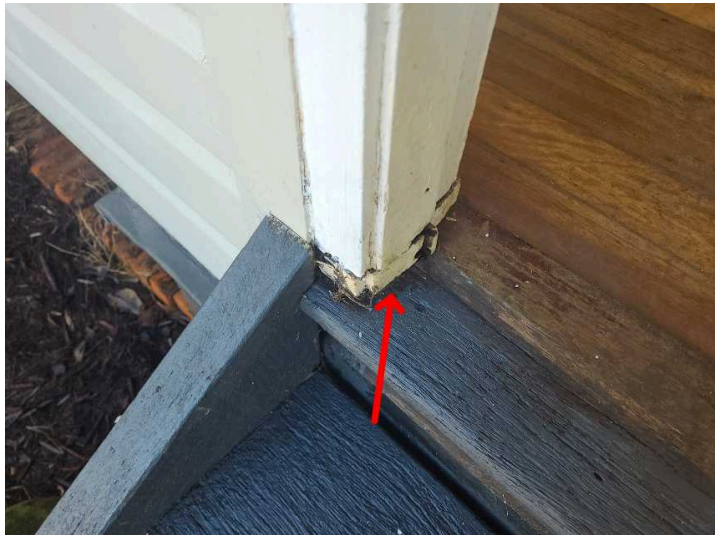
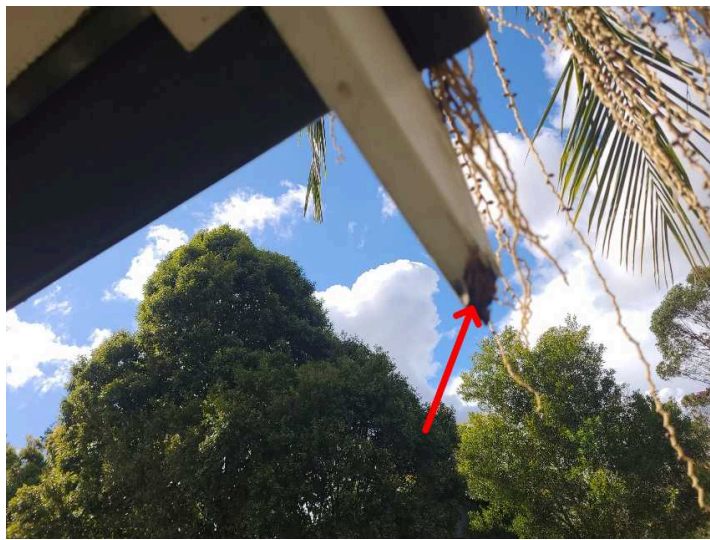
- No evidence of any wood decay/fungi present during the inspection.
- Wood decay/fungus was detected in south west cladding wall, back door frame, granny flat fascia.
- Fungal decay damage appears to be localised.
- Timber condition is decayed.

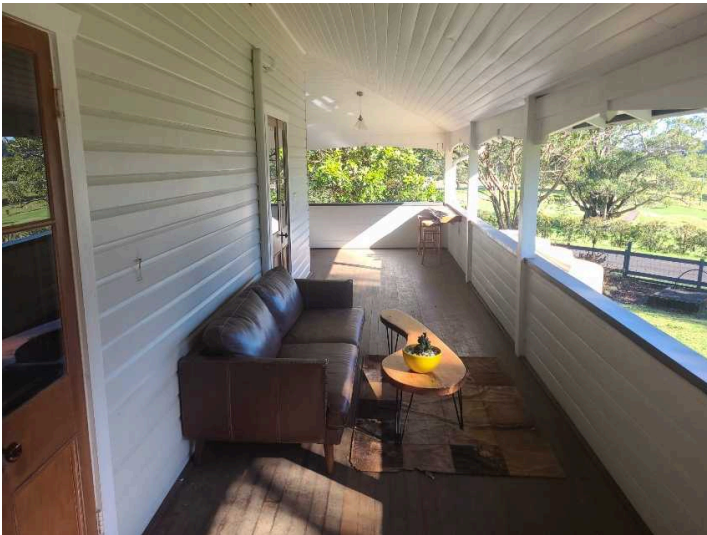
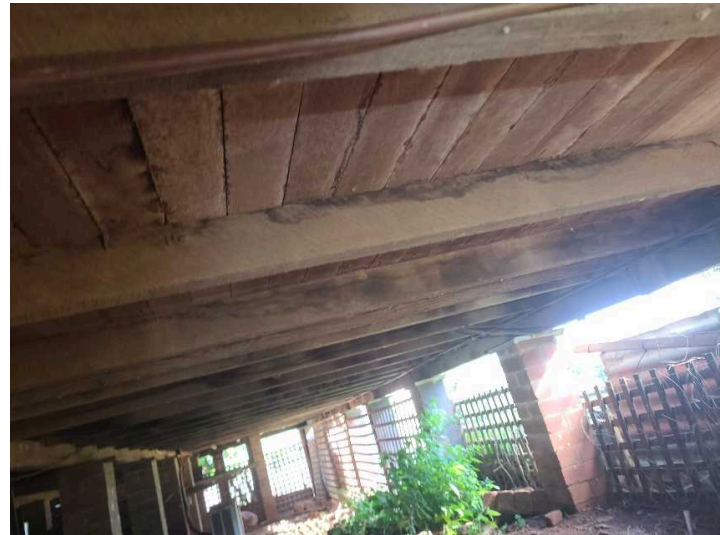
- Inspected deck was in good condition at the time of the inspection.
- Inspected deck can cause a bridge over any termite installed barriers. It is recommended that the deck should be isolated from attaching to the property, or the soil under and next to the deck should be treated.
- There is timber decking or form work in contact with the ground which may allow termite bridging over any existing termite barrier.

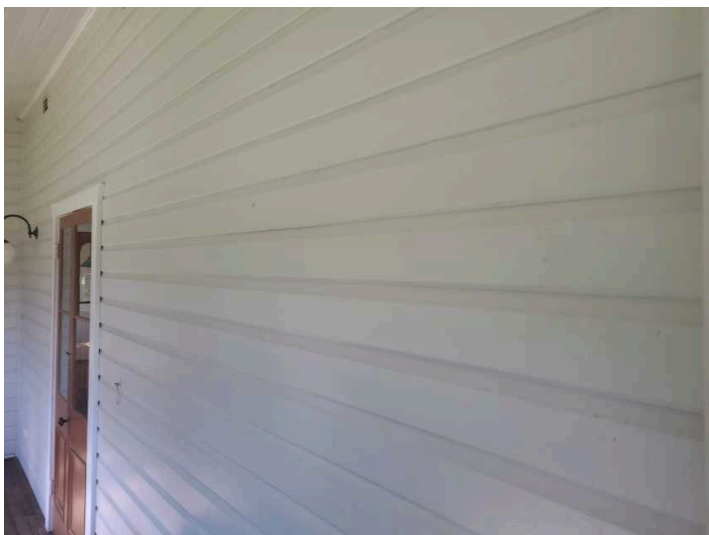
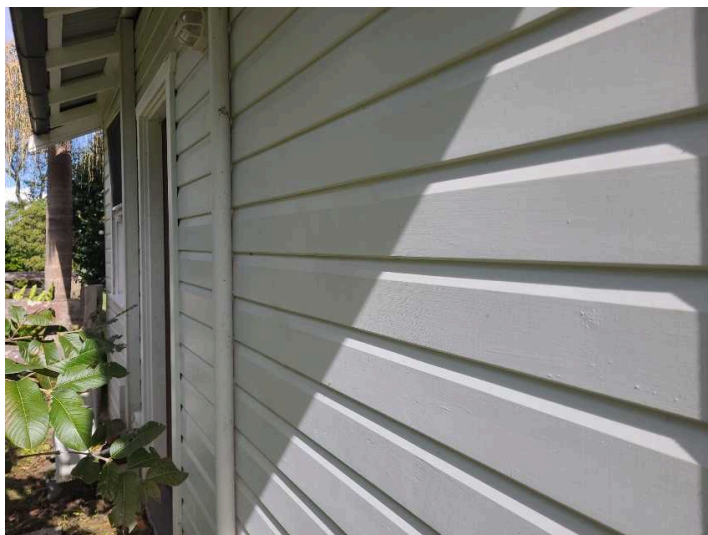
- Wood Decay damage noted in the southwest wall paneling.
- There are garden beds which are abutting external walls. This can result in water moisture affecting the structure over time. It is recommended that either the beds be removed or a water barrier be place between the garden bed and the external walls. If these beds are retained it is important that any watering is directed away from the building and kept to an absolute minimum and is controlled. These are a risk area for termite activity.

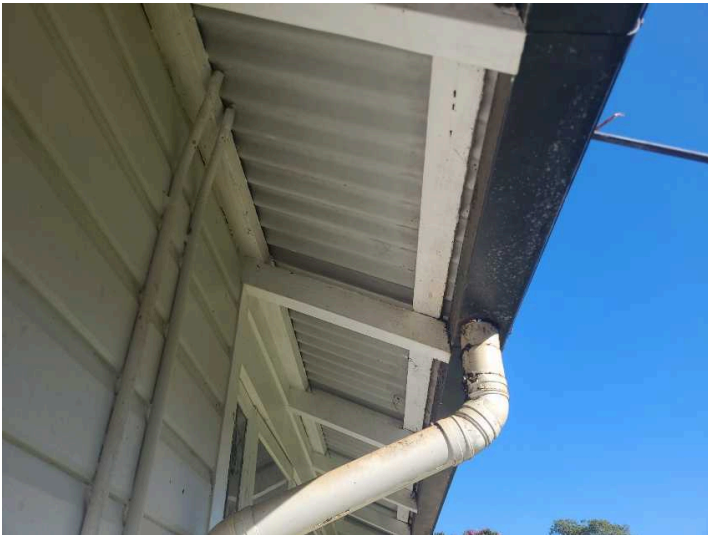
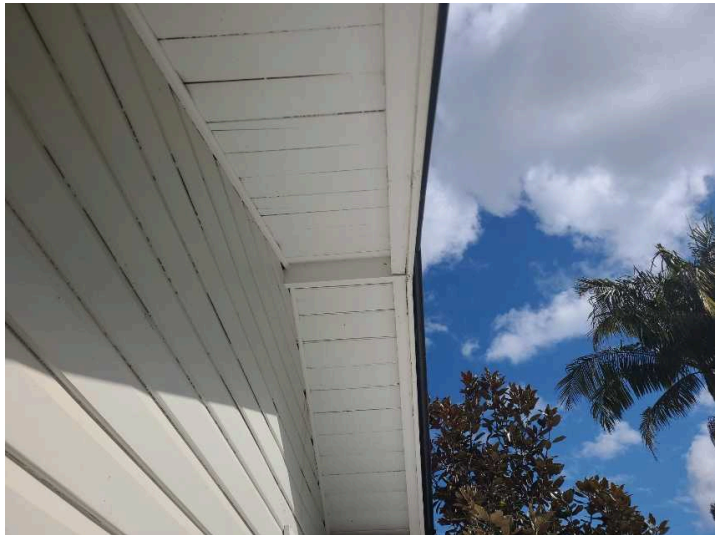
- Moisture damage, wood decay, observed. Recommend review for repair as necessary.

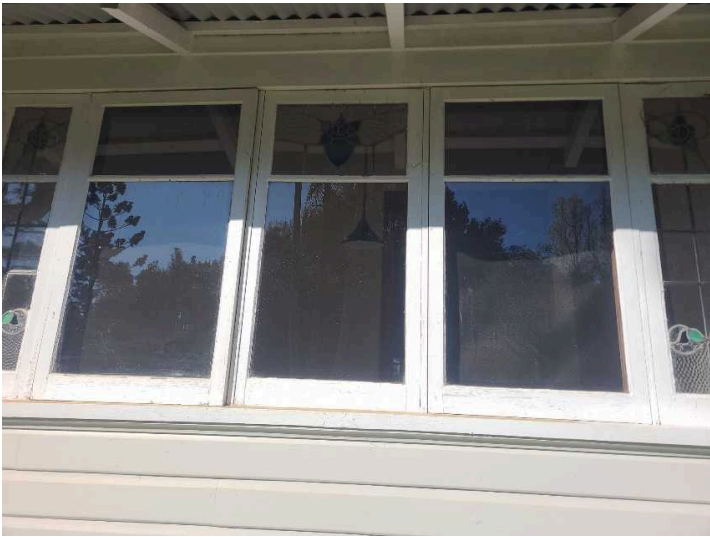
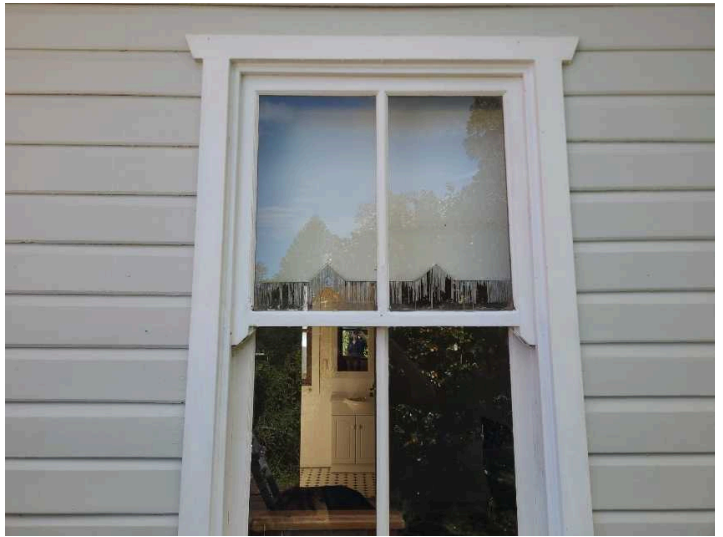
- Deterioration of wooden frames noted. While basic maintenance may prolong the life of these frames, replacement may be necessary at some point.
