Building and Pest Report

7 Fox Valley Way Lennox Head

Report/Agreement #	191125015256161
Inspection Date:	19 Nov 2025
Inspection Time:	01:52 pm

Pest And Building Inspection

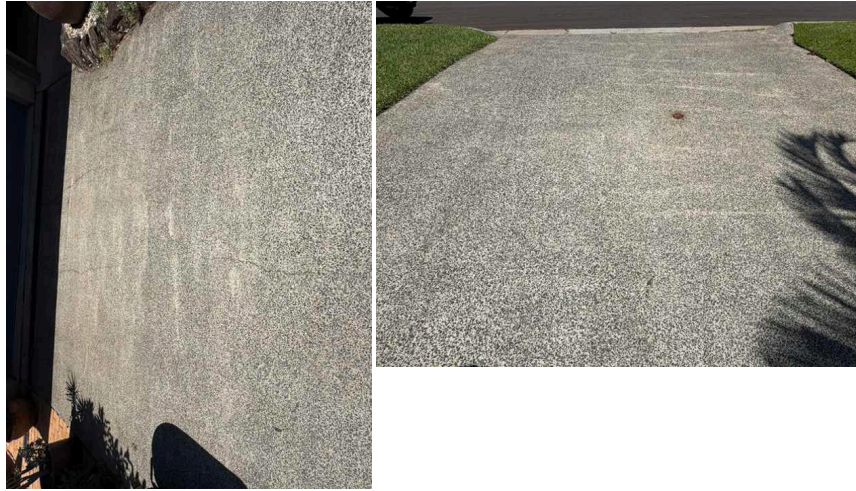
Driveway Condition

Common cracks were observed on the driveway. Whilst these cracks appeared to be typical at the time of inspection, we strongly recommend you monitor these cracks and if worsening occurs contact a concreter for further advice.

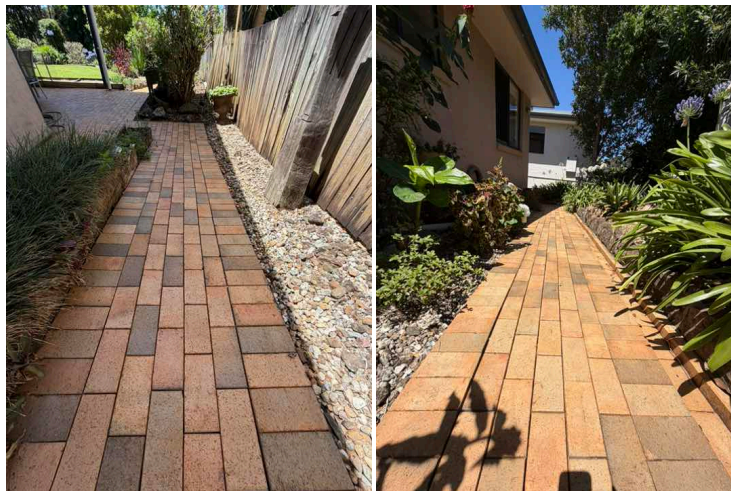
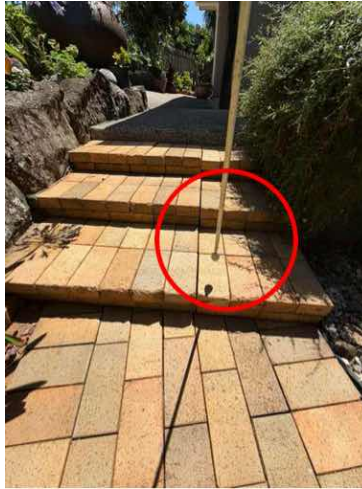
Pathways Condition

Surface raised and settled in some areas. This can cause water ponding. Relaying recommended.

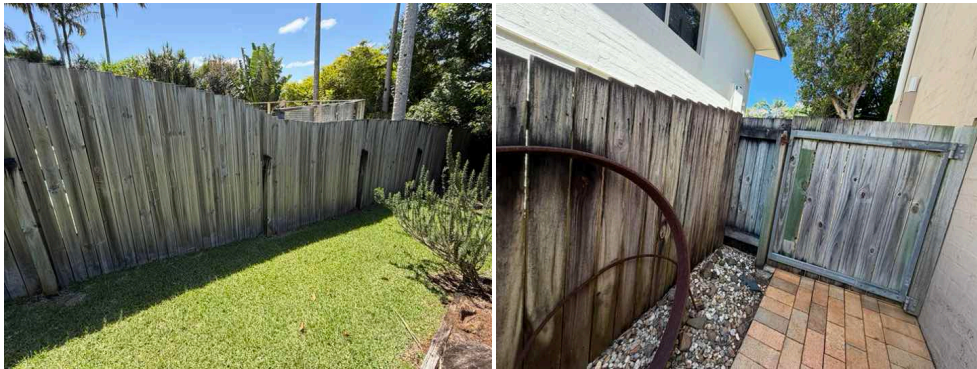
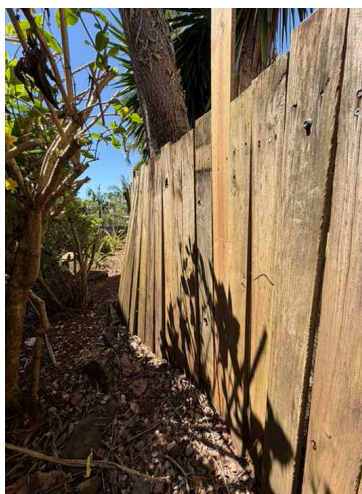
Fences & Gates

General age to fence components. General upkeep and maintenance required. A qualified fencing contractor should be engaged for repairs.

Fence rot/leaning. Repairs are required by a fencing contractor to avoid unsafe conditions.

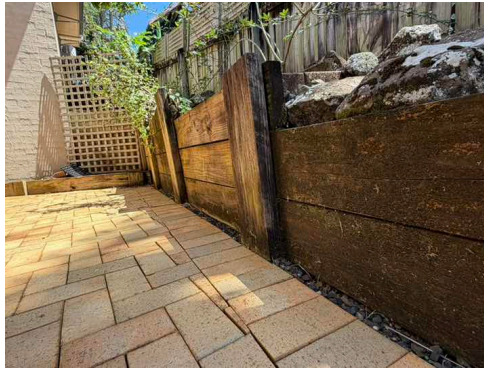
Retaining Walls

Retaining wall leaning due to deterioration and age. A qualified brick layer should be engaged for advice and recommendations.

Timber fungal decay evident. Recommendations: A qualified landscaping contractor should be engaged for repairs and recommendations.

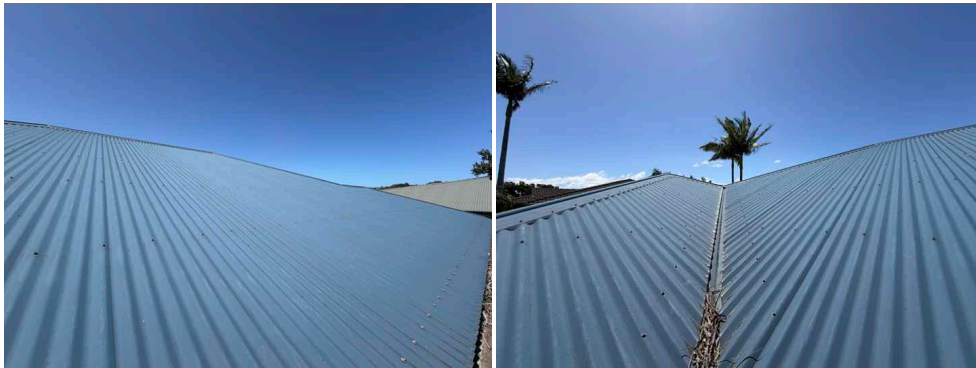
Corrosion noted to the screw fixings of the metal roof. Have these checked and replaced by qualified roofing contractor.

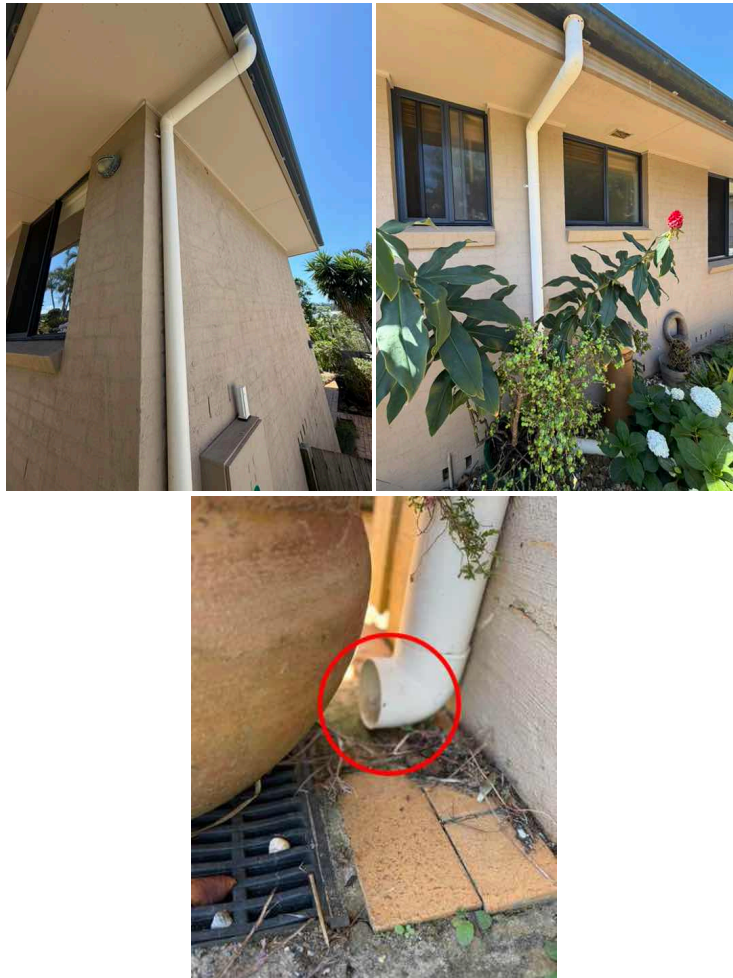
Downpipe/s not connected to storm water discharge - Downpipes not connected to storm water have the potential to cause differential settlement to the footings, cause rising damp and is also conducive to termite infestation. A qualified roof plumber should be engaged for advice and recommendations.

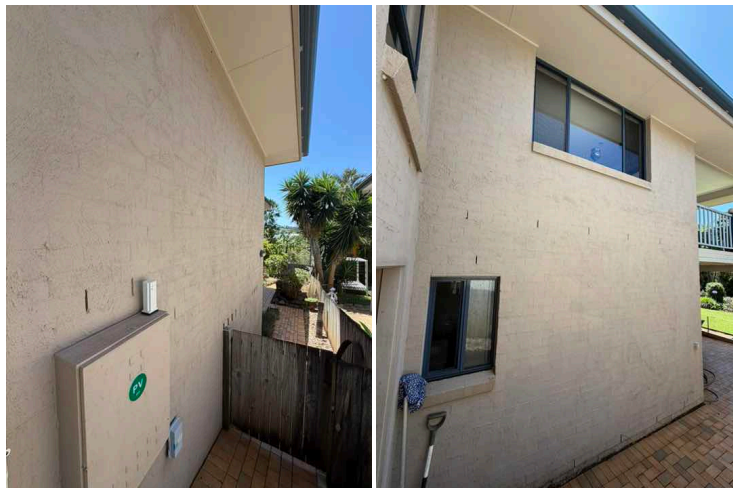
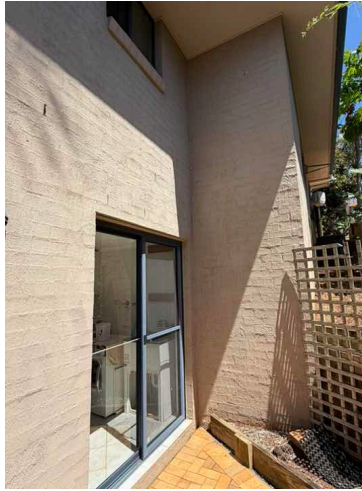
Walls

There appears to have been some settlement in the building which has caused some cracking to the walls. These cracks are categorized as 0 to 2. This can also cause some doors to bind or be out of square. In the inspectors opinion these cracks are due to settlement, usually due to ground movement and subsequent movement to building materials can be expected. Any cracks should be monitored and if cracks increase in size, further investigation should be carried out by a structural engineer.

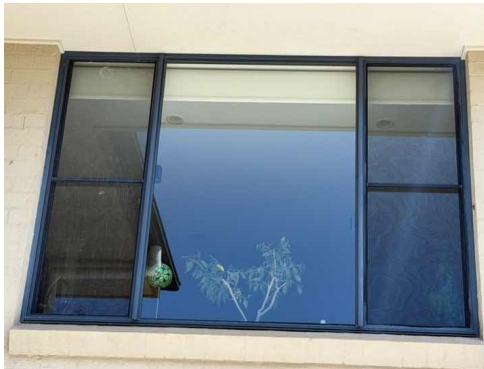
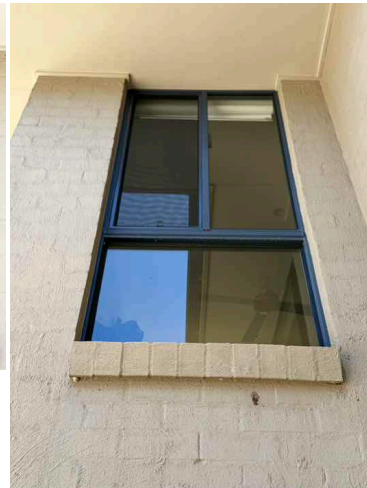
Windows

Damaged fly screen/s replace as required.

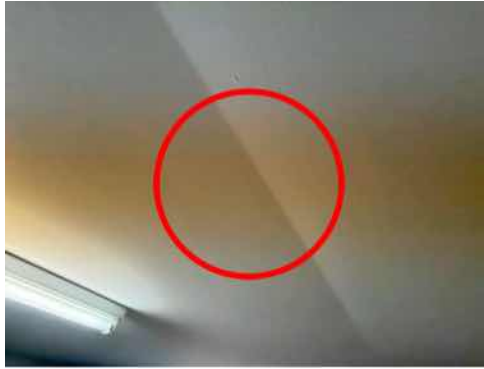
Cornice separation - I recommend you contact a qualified for repairs.

Ceiling sagging - Requires repair from a safety perspective. I recommend you contact a qualified plasterer for further advice and recommendations.

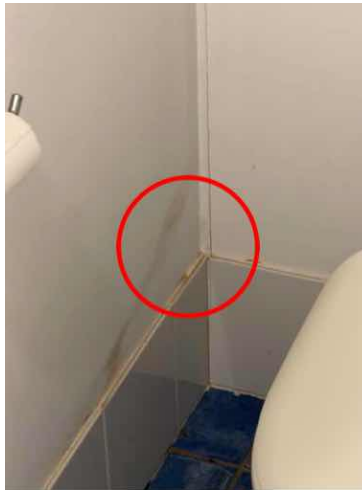
Walls

Wall appear to be out of plumb. Contact a licenced builder for further advice.

Damp stain

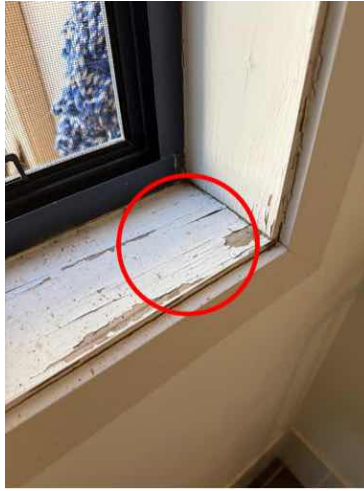
Bathroom 3

Cornice separation. I recommend you contact a licensed plasterer for repairs.

Incomplete Patch/Paint repairs noted. Call a qualified painter for repairs.

Some architraves are water damaged and require replacement. Contact a qualified fixout carpenter.

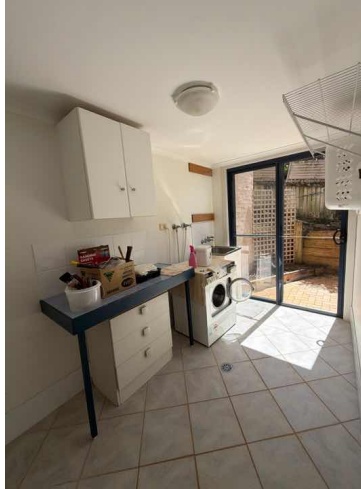
Floor

Drummy tiles noted. This needs to be repaired at the earliest as this has the potential to lead to many related issues such as damp, water ingress to other areas and cracked tiles. Contact a qualified tiler for repairs and recommendation.

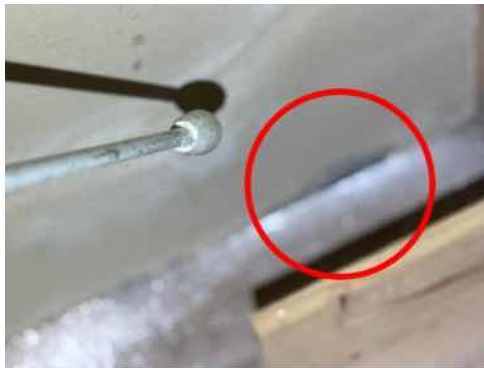
Upon visual inspection, the internal wall shows signs of moisture ingress due to ground contact. This can lead to structural damage and mold growth. It is recommended to install a proper moisture barrier and improve drainage around the foundation. Engage a licensed contractor to assess and implement necessary repairs, ensuring the wall is adequately protected from further moisture exposure.

Rusted ant capping noted. Ant capping is not designed to prevent termite entry but to force the termites to reveal themselves by means of mud packing. Rusted, missing or defective ant capping will allow the termites to enter the building undetected. Contact a qualified brick layer for further advice

Upon visual inspection, mould was detected within the basement, indicating potential moisture issues. It is recommended to address any water intrusion sources, improve ventilation, and remove existing mould. A suitably licensed or qualified tradesperson should assess and repair any structural damage, seal leaks, and install a dehumidifier to prevent recurrence. Regular monitoring and maintenance are advised to ensure a mould-free environment.

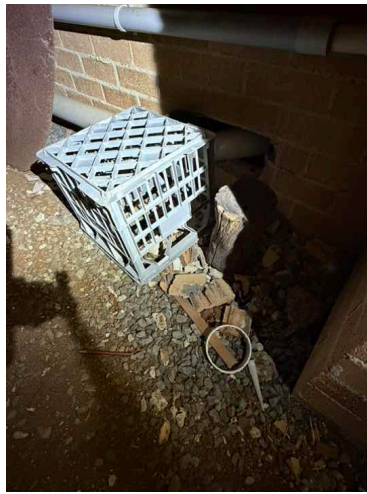
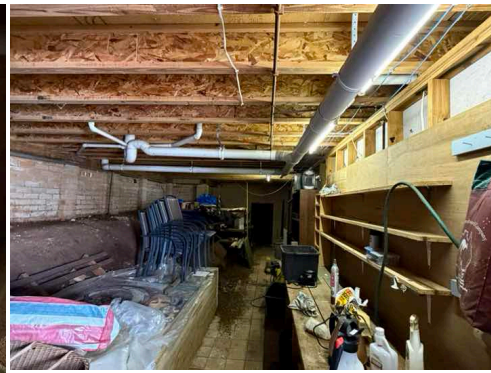
Ventilation

There was debris and other material in the subfloor, we recommend cleaning these to aid with ventilation and reduce the likely hood of rodents and pests.

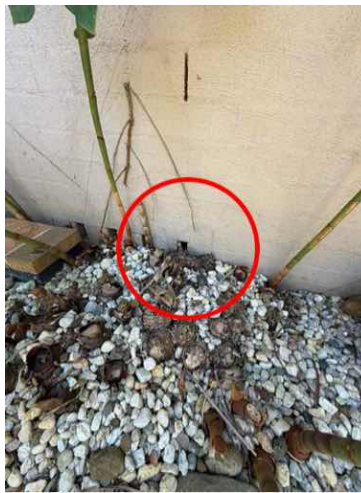
No the subfloor vents were obstructed. It is recommended that the vents be exposed.
