# Inspection Report

**105 Links Ave, East Ballina, NSW, 2478**

### Pest And Building Inspection

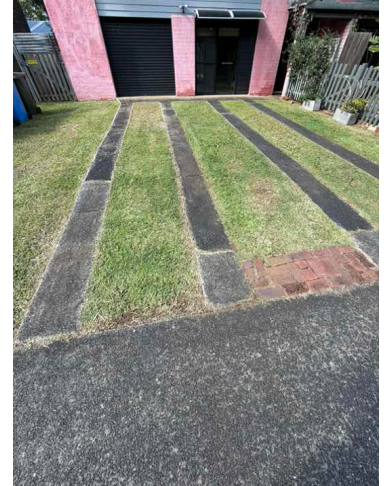
#### Driveway Condition

On visual inspection, the general condition of the driveway is serviceable. Common cracks were observed on the driveway. Whilst these cracks appeared to be typical at the time of inspection, we strongly recommend you monitor these cracks and if worsening occurs contact a concreter for further advice.

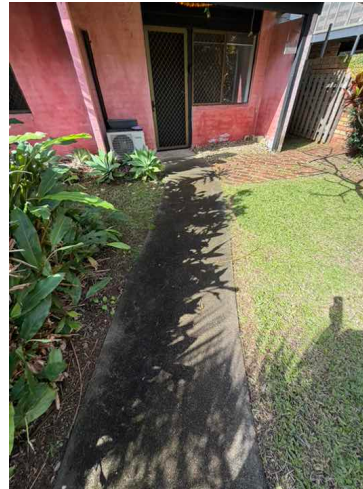
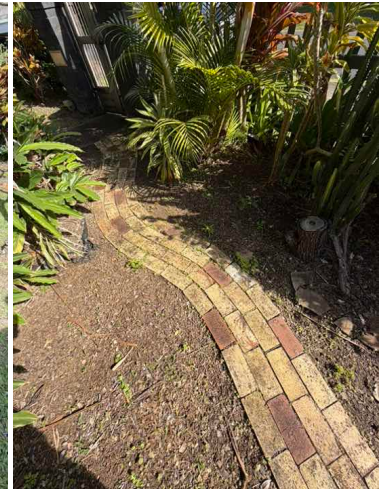
#### Pathways Condition

The paths around the home are in a serviceable condition for the age of this dwelling with no major defects visible.

Common cracks and settlement were observed on paths. Whilst these cracks appeared to be typical at the time of inspection, we strongly recommend you monitor these cracks and if worsening occurs contact a concreter for further advice.

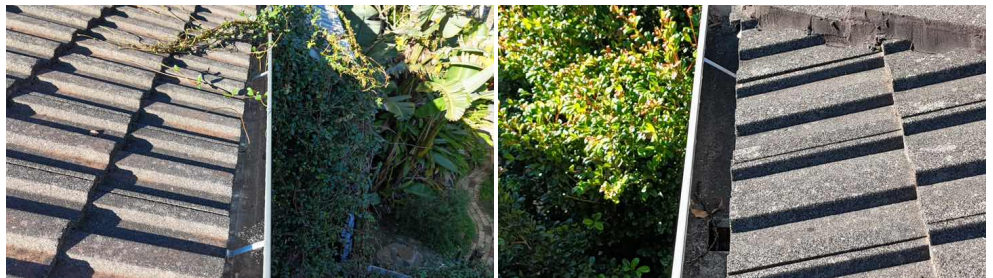
#### Gutter Findings

Debris in guttering areas- this requires cleaning out to prevent blocking of downpipes and leaking into eaves and fascia. Have gutters cleaned and assessed by a plumber for adequate fall. Regularly clean to prevent ponding. Ponding water will contribute to rust.

| Section | Location | Name | Comment |
|---|---|---|---|
| ROOF AND GUTTER | Guttering | Gutter Findings | Debris in guttering areas- this requires cleaning out to prevent blocking of downpipes and leaking into eaves and fascia. Have gutters cleaned and assessed by a plumber for adequate fall. Regularly clean to prevent ponding. Ponding water will contribute to rust. |

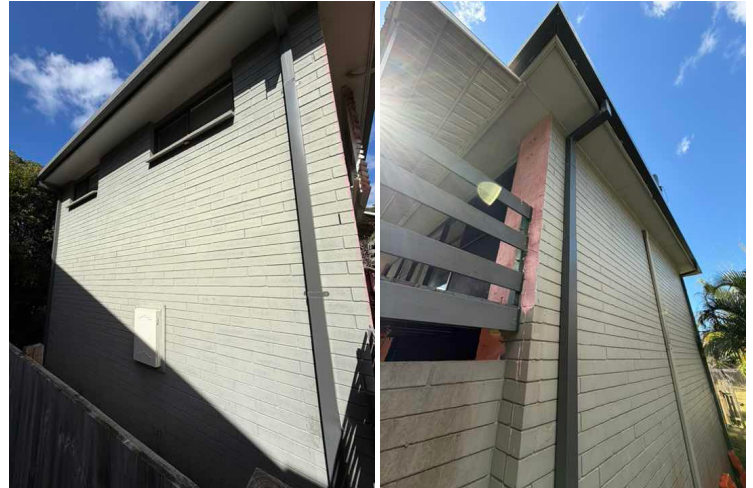
### **Downpipe Findings**

The downpipe/s wall clips is detached or missing. Although minor and easily rectifiable, we recommend a licensed roof plumber be engaged for repairs. Impact damage noted to downpipe. Contact a roof plumber for replacement as required. Minor downpipe rust visible. A qualified plumber should be engaged for advice and recommendations.

| Section | Location | Name | Comment |
|---|---|---|---|
| ROOF AND GUTTER | Downpipes | Downpipe Findings | Minor downpipe rust visible. A qualified plumber should be engaged for advice and recommendations. |

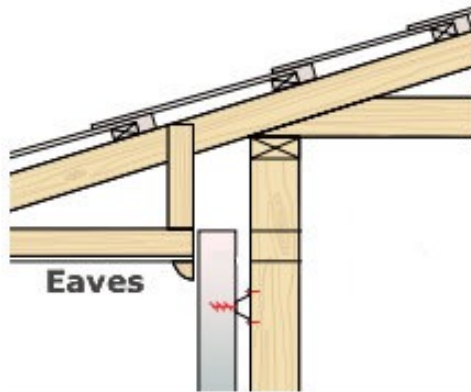
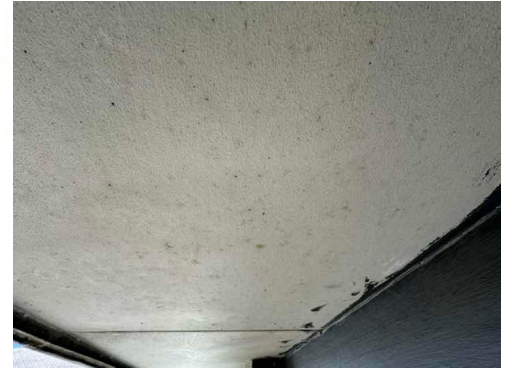
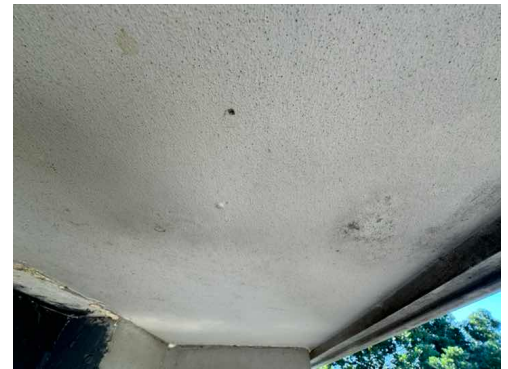
Minor eave deterioration & ageing evident. Recommendations: Maintenance works, general upkeep should be carried out.

| Section | Location | Name | Comment |
|---|---|---|---|
| EXTERIOR | Eaves | Eave Condition | Minor eave deterioration & ageing evident. Recommendations: Maintenance works, general upkeep should be carried out. |

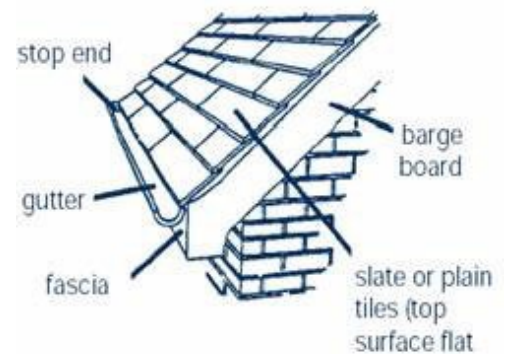
Minor deterioration & ageing evident. Recommendations: Maintenance works, general upkeep should be carried out.

| Section | Location | Name | Comment |
|---|---|---|---|
| EXTERIOR | Fascia and Barge Boards | Condition | Minor deterioration & ageing evident. Recommendations: Maintenance works, general upkeep should be carried out. |

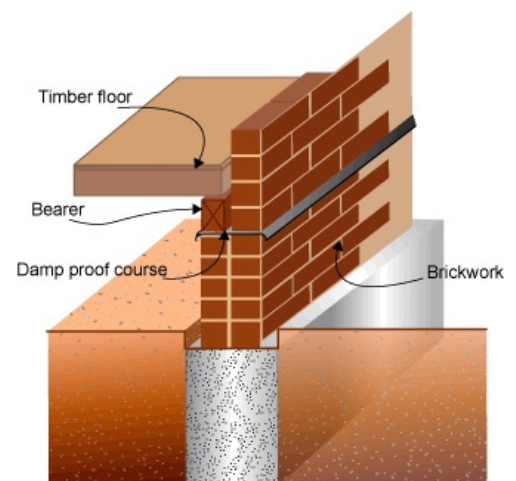
### **Damp Proof Course**

A damp proof course is not visible or could not be visually identified. This may cause rising damp issues. Contact a specialist in this field to further investigate and make recommendation.

| Section | Location | Name | Comment |
|---|---|---|---|
| EXTERIOR | Rising Damp | Damp Proof Course | A damp proof course is not visible or could not be visually identified. This may cause rising damp issues. Contact a specialist in this field to further investigate and make recommendation. |

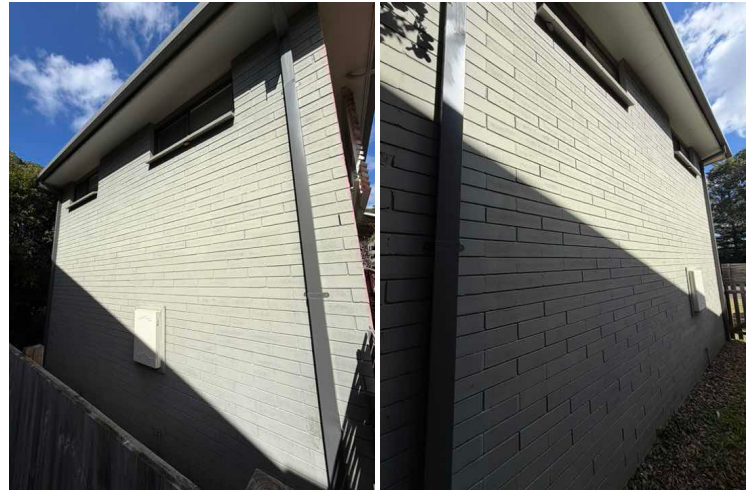
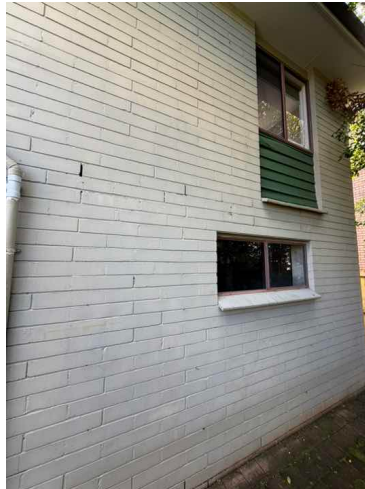
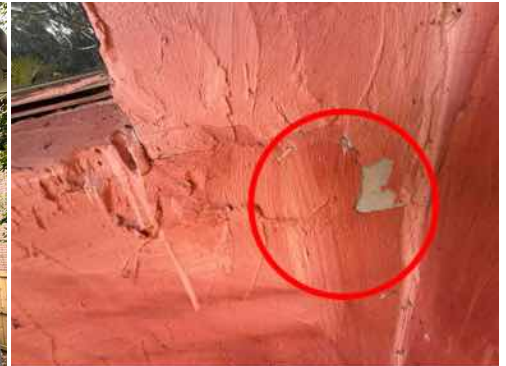
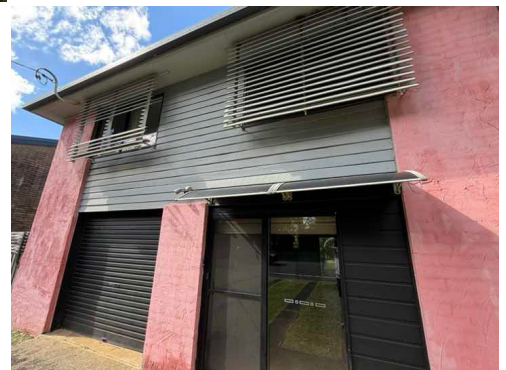
Minor cladding damage observed. This should be repaired so as to avoid moisture ingress and pests entry.

The external paint has deteriorated . External wall paint preserves and protects the building elements. Contact a qualified painter for repairs.

| Section | Location | Name | Comment |
|---|---|---|---|
| EXTERIOR | Walls | Condition | Minor cladding damage observed. This should be repaired so as to avoid moisture ingress and pests entry. |
| EXTERIOR | Walls | Condition | The external paint has deteriorated . External wall paint preserves and protects the building elements. Contact a qualified painter for repairs. |

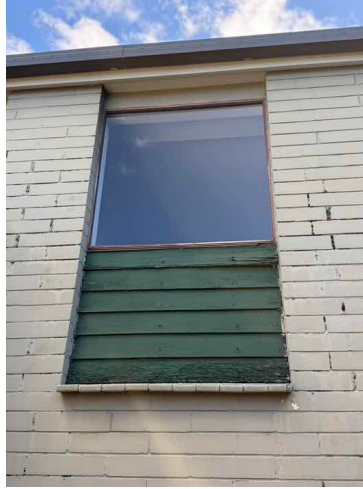
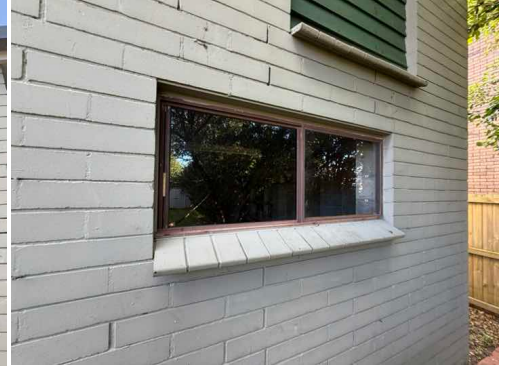
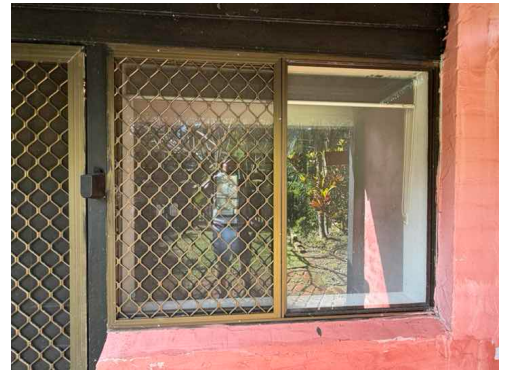
## Overall Condition

On visual inspection, the general condition of the windows is serviceable for the age. General age/damage has occurred to window components. Recommendations: Restoration work recommended. A qualified carpenter should be engaged for advice and recommendations. Damaged fly screen/s replace as required.

| Section | Location | Name | Comment |
|---|---|---|---|
| EXTERIOR | Windows | Overall Condition | General age/damage has occurred to window components. Recommendations: Restoration work recommended. A qualified carpenter should be engaged for advice and recommendations. |
| EXTERIOR | Windows | Overall Condition | Damaged fly screen/s replace as required. |

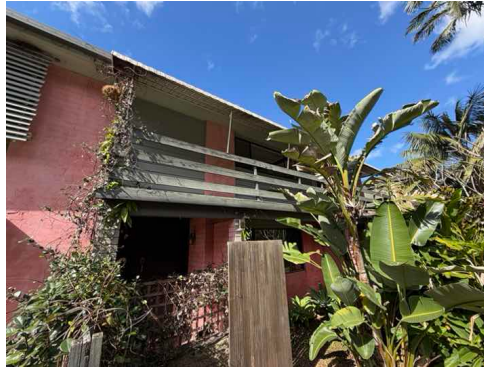
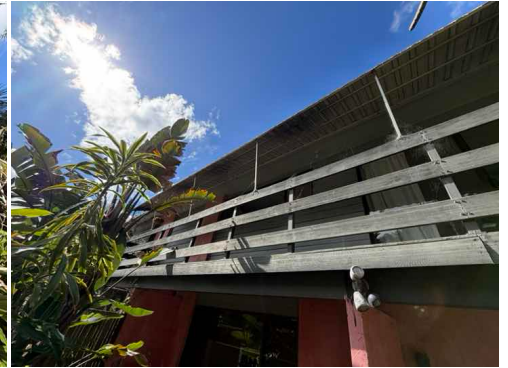
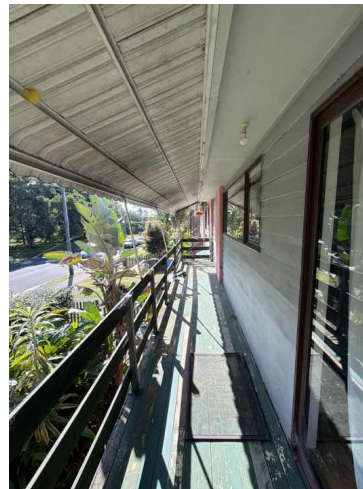
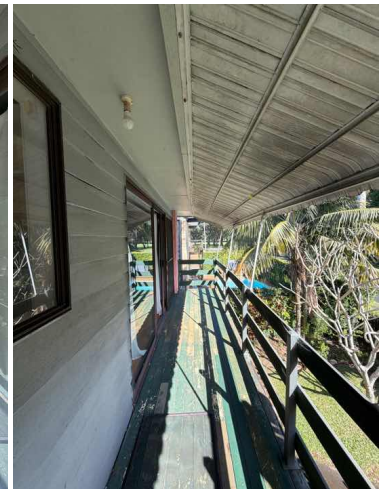
### Decking Findings

Of areas visible, minor defects and/or maintenance issues were visible. These will require assessment and subsequent repairs by a licensed tradesperson. Please read below for details. Please note that the inspector believes these to be of a minor nature relative to the age of the dwelling and or lack of proper and continual maintenance. Others, including other inspectors may differ in their opinions.

Moisture damage was observed on deck boards - Recommendations: Evaluation and repairs by a qualified decking contractor.

| STAIRS-<br>PERGOLA-<br>BALCONIES-<br>DECKS | Decking<br>Findings | Decking<br>Timber | Moisture damage was observed on deck boards -<br>Recommendations: Evaluation and repairs by a qualified decking contractor. |

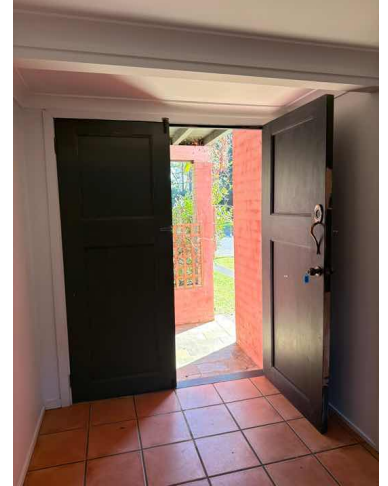
#### **Front Entry Doors**

The doors are in serviceable condition with no notable defects observed.  
Entry door / frame deterioration - General age/damage has occurred to door frame, face or components. A qualified carpenter should be engaged for advice and recommendations.

| INTERIORS | Doors | Front Entry<br>Doors | Entry door / frame deterioration - General age/damage has occurred to door frame, face or components. A qualified carpenter should be engaged for advice and recommendations. |

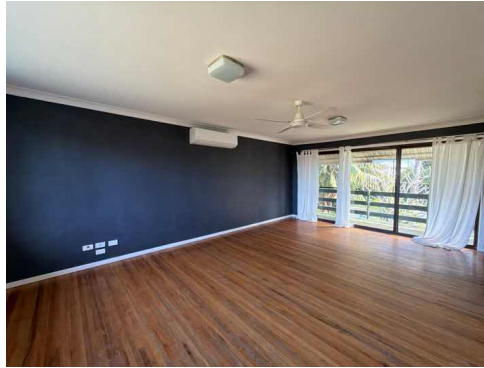
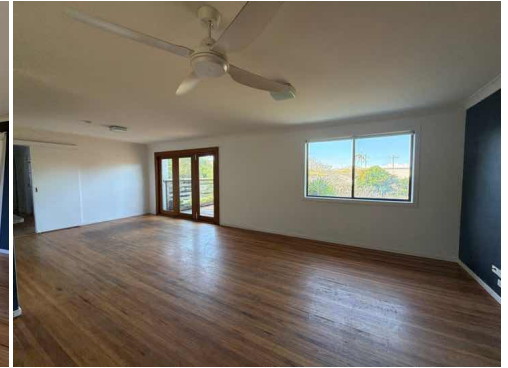
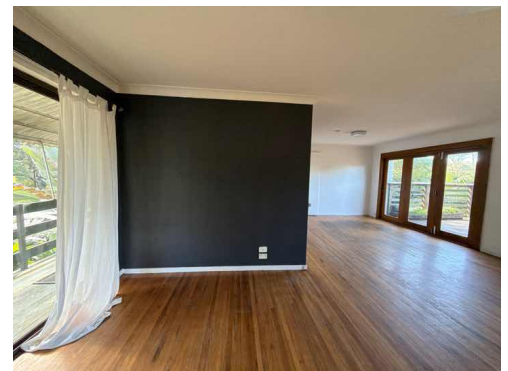
## **Combined Living & Dining**

Settlement Cracks Noted. These are typical and generally patch and paint will suffice, however monitoring these cracks is advised for 12 months and if they become worse, further investigation by a suitably qualified professional is advised.

| INTERIORS | Combined<br>Living &<br>Dining | Ceiling | Settlement Cracks Noted. These are typical and generally patch and paint will suffice, however monitoring these cracks is advised for 12 months and if they become worse, further investigation by a suitably qualified professional is advised. |

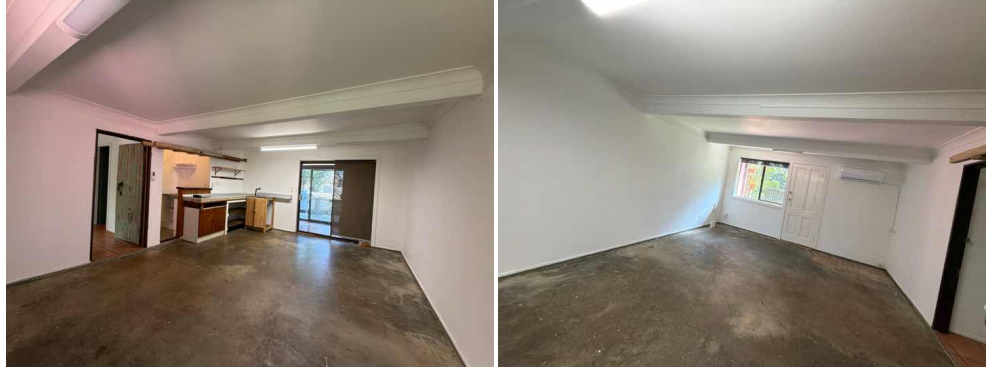
On inspection, defects were present that will require further assessing and recommendations by a qualified trades persons, please read below for details.

Settlement Cracks Noted. These are typical and generally patch and paint will suffice, however monitoring these cracks is advised for 12 months and if they become worse, further investigation by a suitably qualified professional is advised.

| INTERIORS | Games Room | Ceiling | Settlement Cracks Noted. These are typical and generally patch and paint will suffice, however monitoring these cracks is advised for 12 months and if they become worse, further investigation by a suitably qualified professional is advised. |

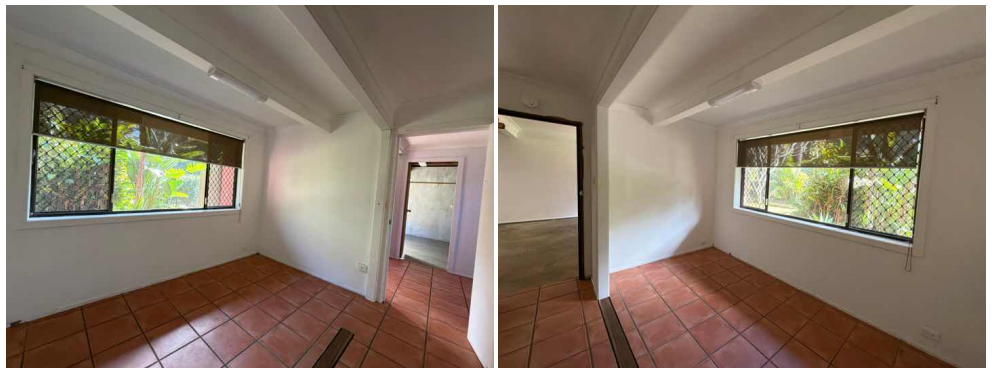
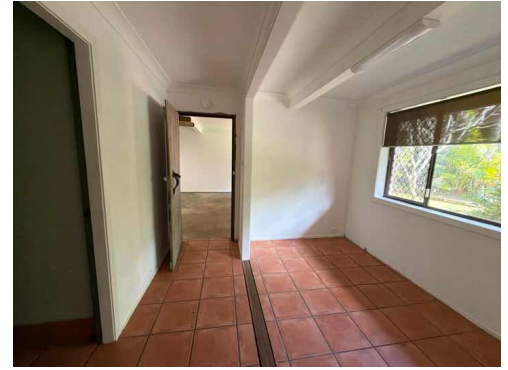
Door stop should be fitted - Wall damage from door handle impacting wall lining has occurred. I recommend you contact a qualified painter for repairs.

| INTERIORS | Study | Door | Door stop should be fitted - Wall damage from door handle impacting wall lining has occurred. I recommend you contact a qualified painter for repairs. |

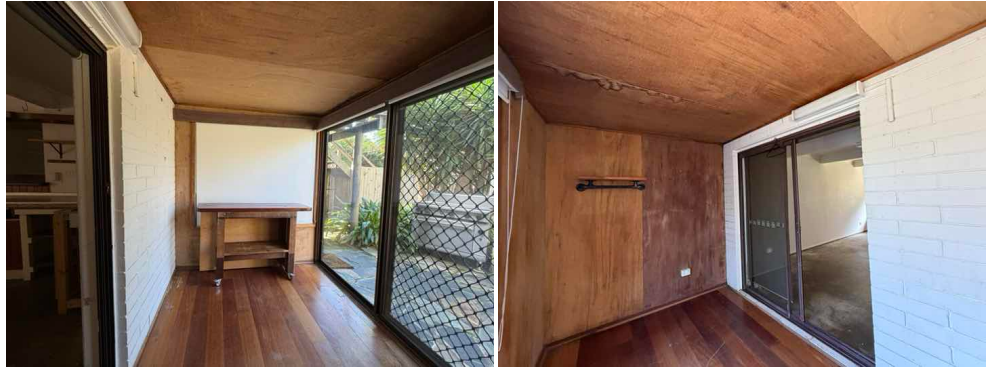
On inspection, defects were present that will require further assessing and recommendations by a qualified trades persons, please read below for details.

General ageing and/or denting and the like is evident on ceiling linings - Recommendations: A qualified painter should be engaged to assess and repair as required.

| INTERIORS | Sunroom | Ceiling | General ageing and/or denting and the like is evident on ceiling linings - Recommendations: A qualified painter should be engaged to assess and repair as required. |

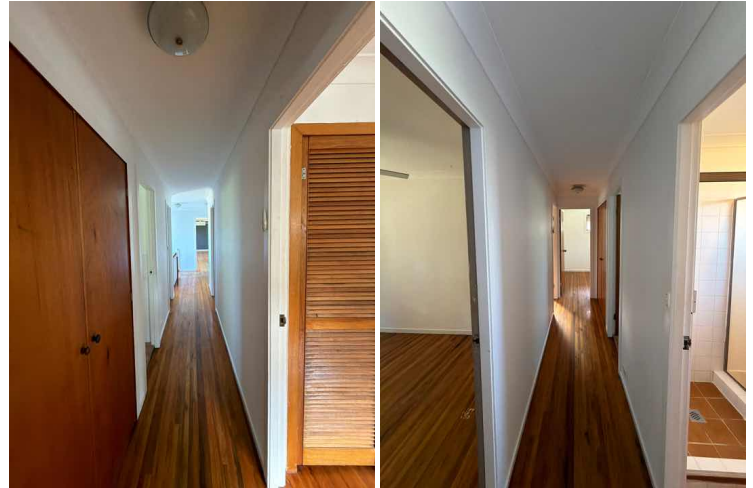
Settlement Cracks Noted. These are typical and generally patch and paint will suffice, however monitoring these cracks is advised for 12 months and if they become worse, further investigation by a suitably qualified professional is advised.

Stained timber flooring - This is normally due some water penetration. This will not be able to be removed and options include replacement, staining all the boards dark or lining same to cover. A qualified carpenter should be engaged for advice and recommendations.

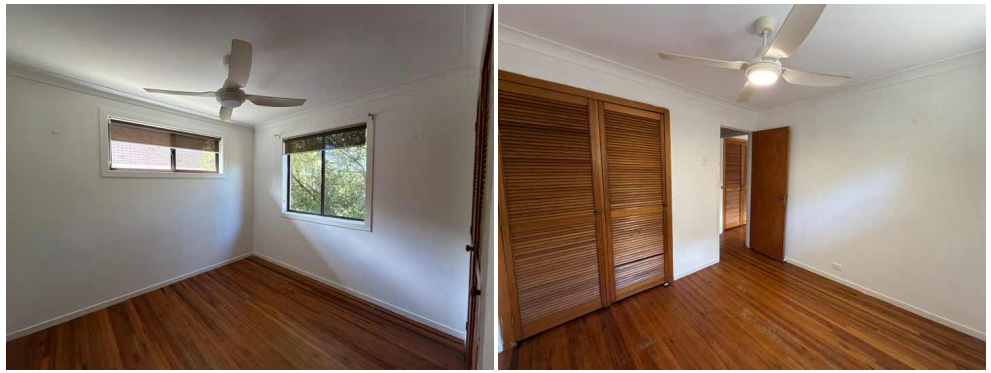
Impact damage observed. Repairs / Replacement recommended.

| INTERIORS | Bedroom 2 | Door | Impact damage observed. Repairs / Replacement recommended. |

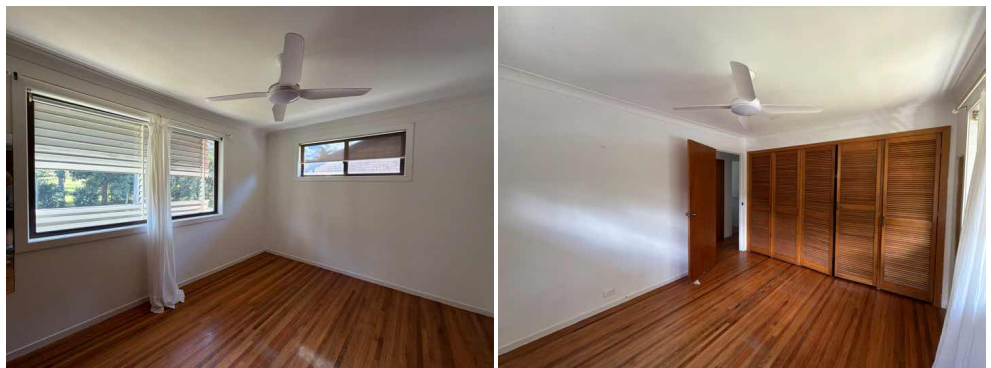
Door lock hardware is loose possibly damaged. Maintenance as required.

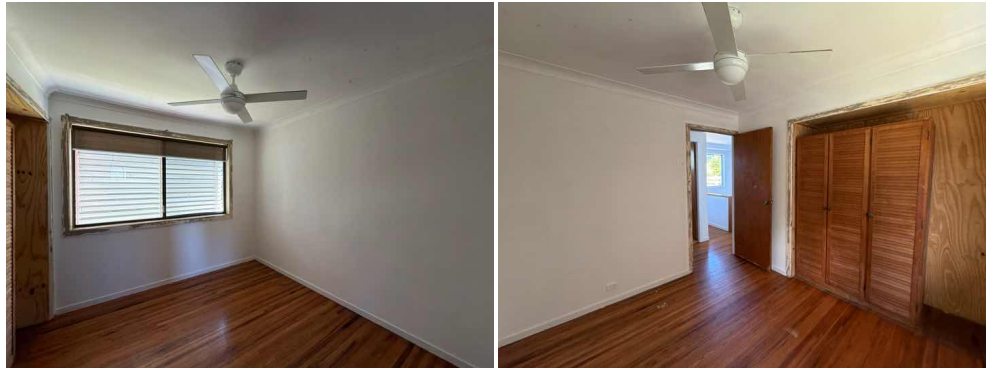
**Bedroom 4****Overall Condition**

The door to the built-in door is missing. Contact a joinery company for repairs.

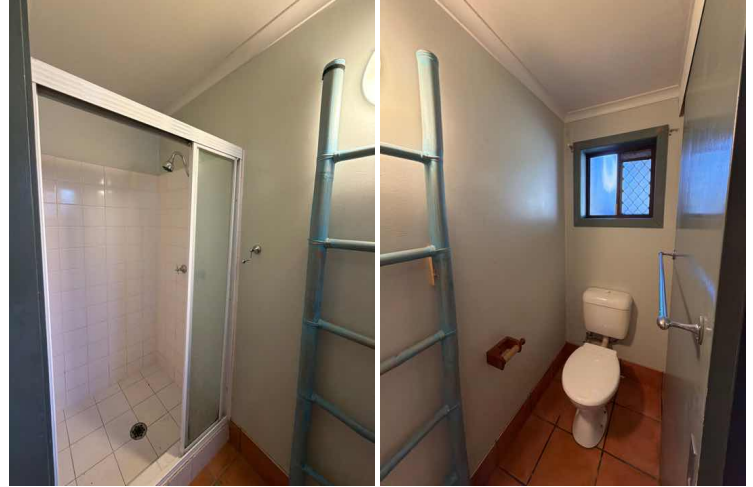
Cornice separation. I recommend you contact a licensed plasterer for repairs.

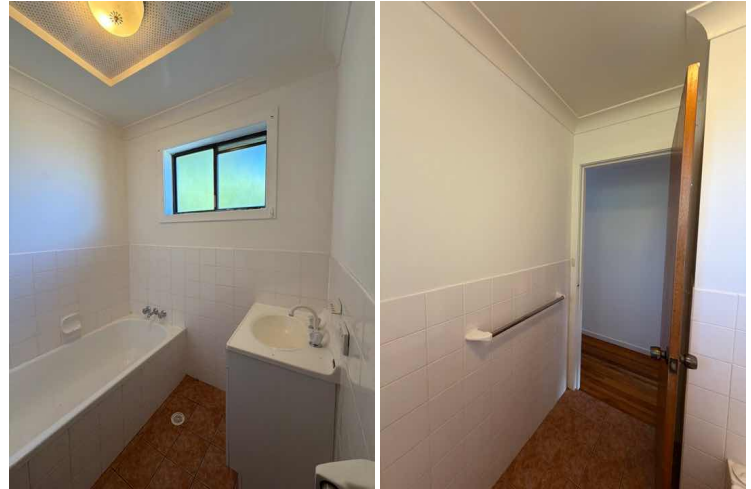
Door / frame deterioration - General age/damage has occurred to door frame, face or components.  
Recommendations: A qualified carpenter should be engaged for advice and recommendations.

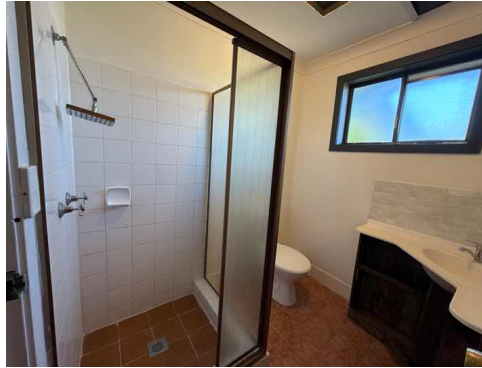
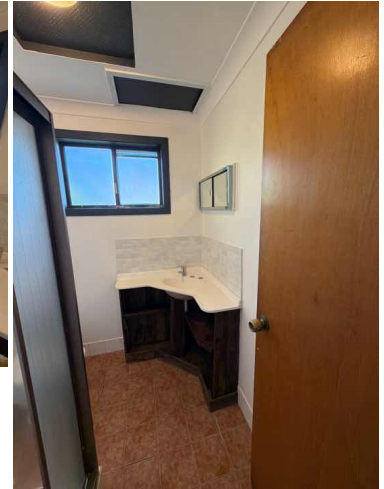
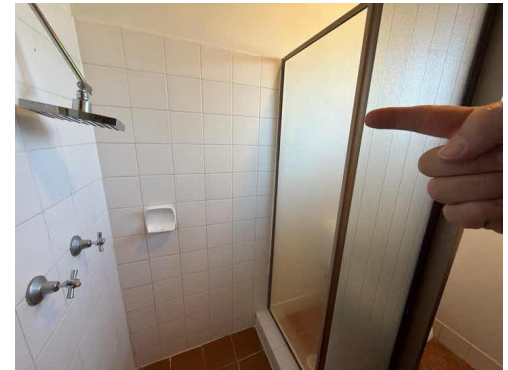
Door / frame deterioration - General age/damage has occurred to door frame, face or components.

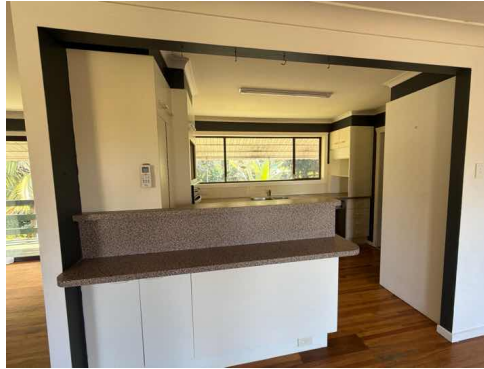
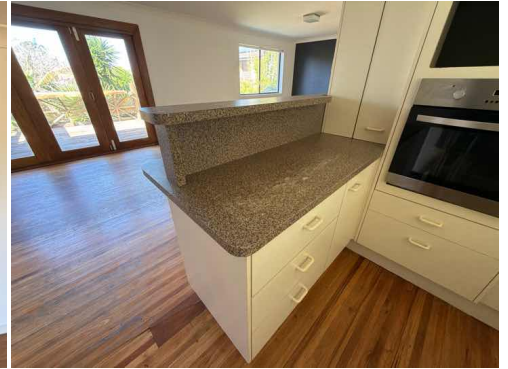
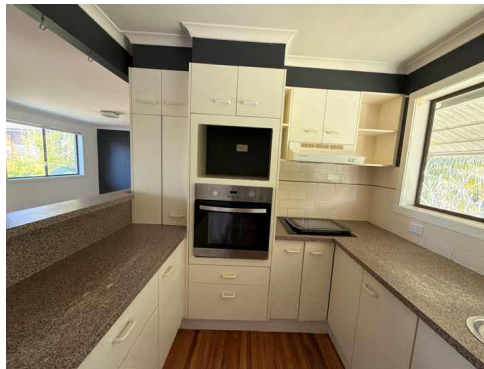
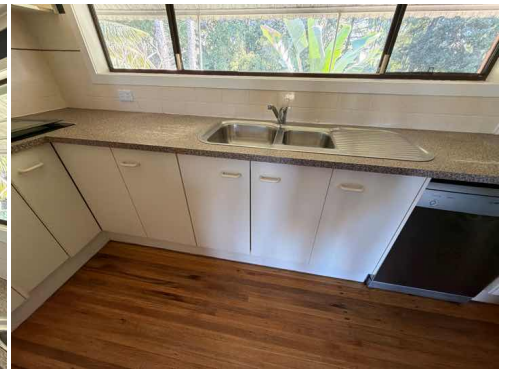
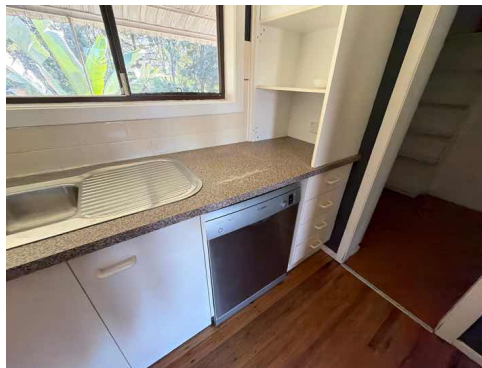
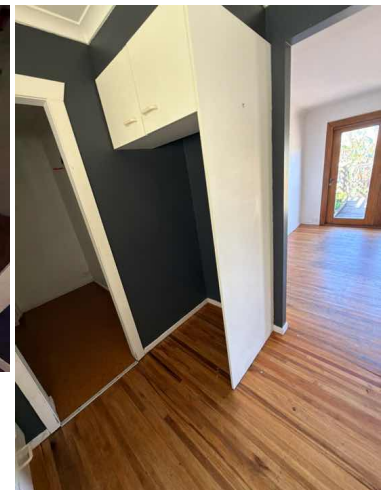
Cornice separation. I recommend you contact a licensed painter for repairs.

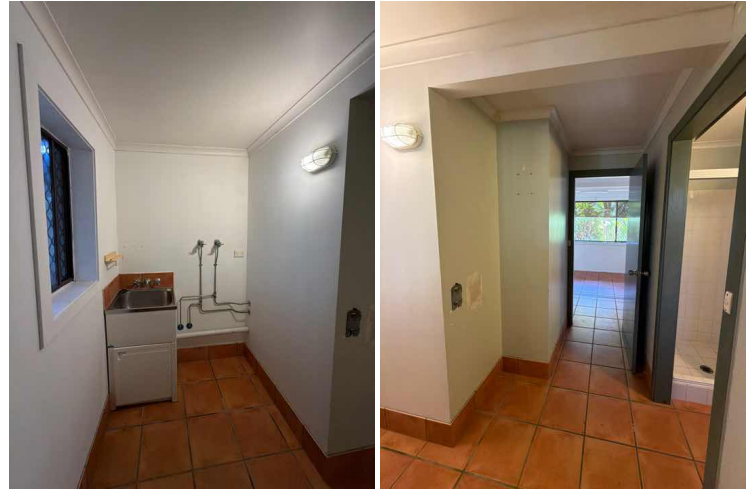
Door / frame deterioration - General age/damage has occurred to door frame, face or components.  
Recommendations: A qualified carpenter should be engaged for advice and recommendations.
