Building and Pest Report

5 Morton Way Skennars Head

Pest And Building Inspection

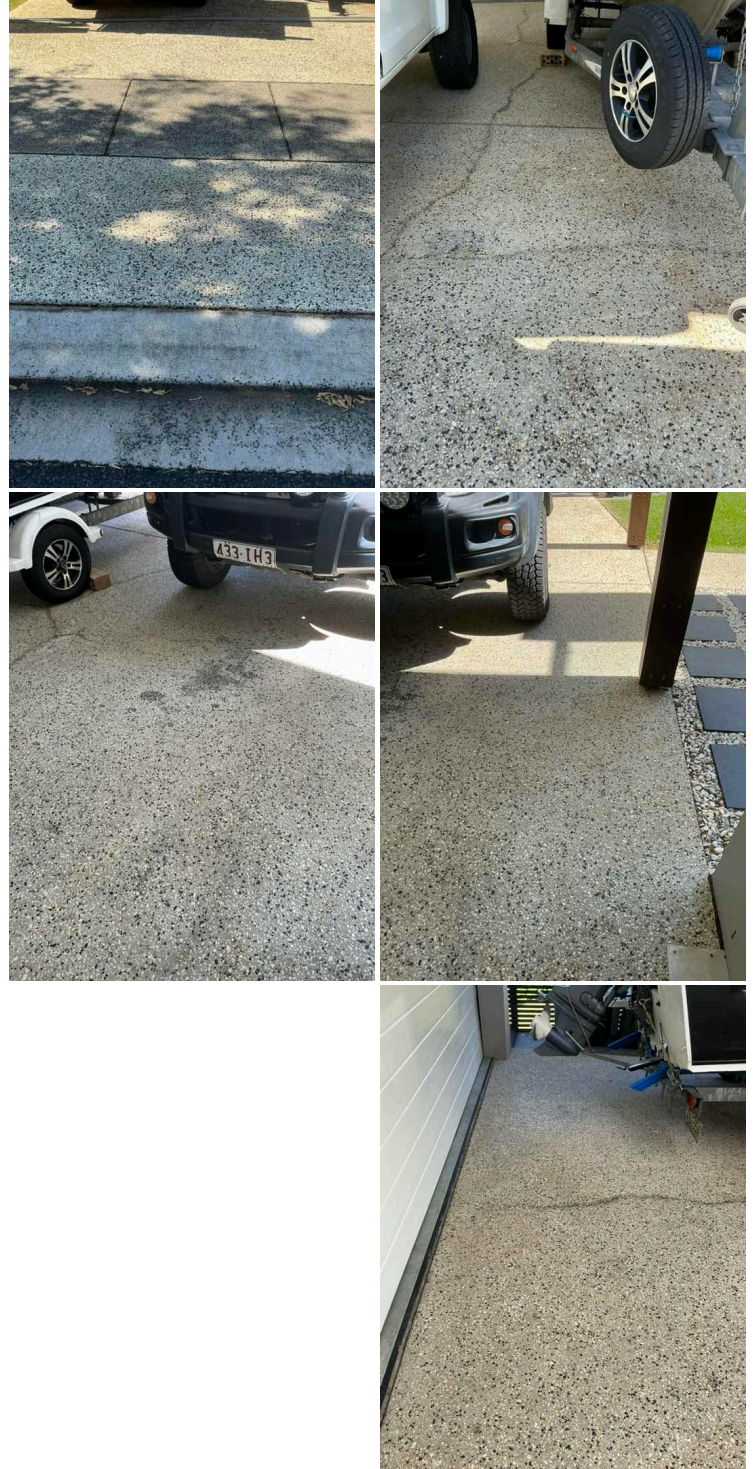
Driveway Condition

On visual inspection, the general condition of the driveway is serviceable.

Common cracks were observed on the driveway. Whilst these cracks appeared to be typical at the time of inspection, we strongly recommend you monitor these cracks and if worsening occurs contact a concreter for further advice.

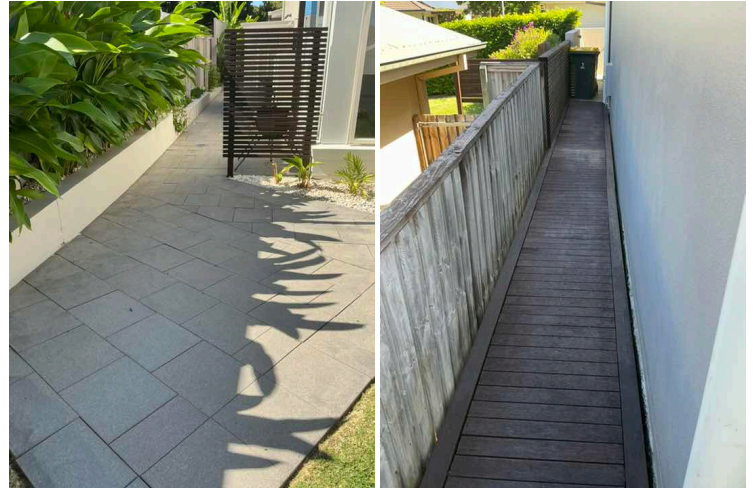
Pathways Condition

The paths around the home are in a serviceable condition for the age of this dwelling with no major defects visible.

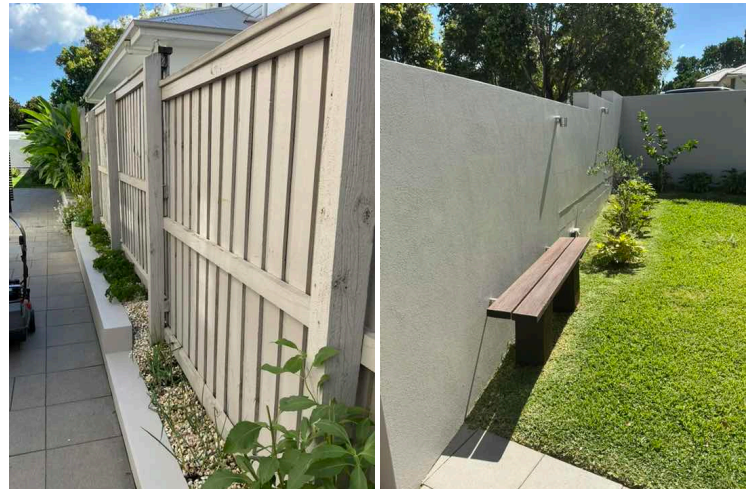
Fences & Gates

Of the visible areas, the general condition of the fences and gates is serviceable for the age of dwelling.

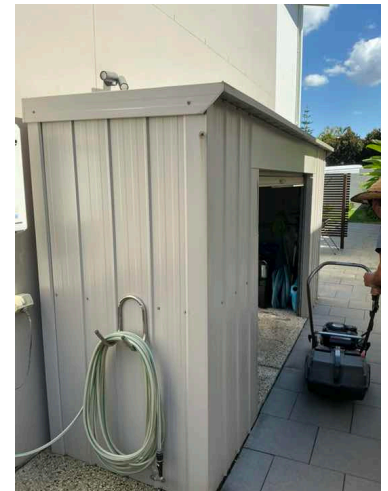
Shed Condition

The shed is in fair usable condition.
