# Building and Pest Report

## 1 Henderson Place Lennox Head

# **BPI BUILDING & PEST INSPECTIONS**

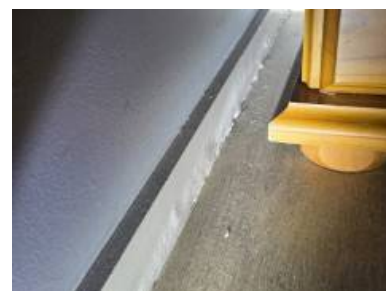
**Skirtings and Architraves**  
1 Skirting shows signs of swelling to bedroom.

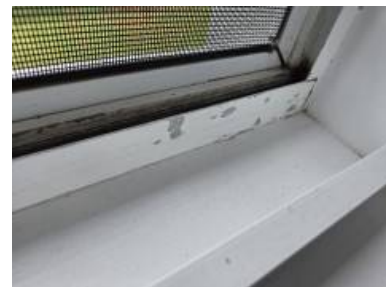
Some windows show evidence of corrosion and require maintenance / repair.

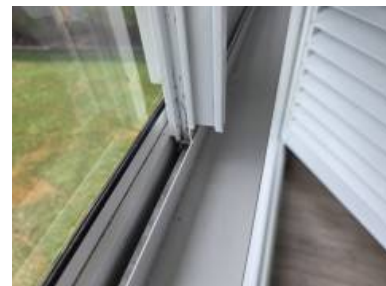
Some window slider rollers show signs of wear or are worn and require lubrication / replacement.

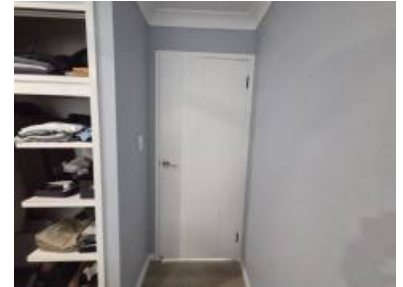
Door is binding and requires repair / easing / adjustment.

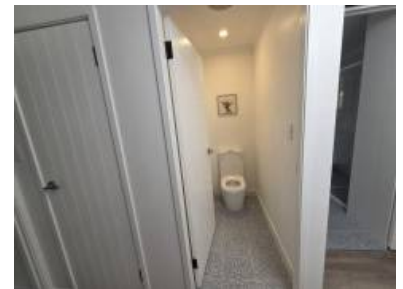
No lift off hinges present to the toilet door. This may comply with the date of construction however, this is a safety issue and therefore was included in this report. We recommend the installation of lift off hinges.

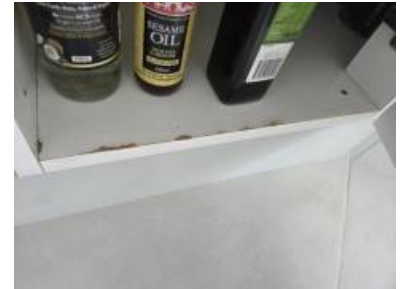
The Kitchen cabinetry / bench tops / laminate show evidence of general wear & scratches.

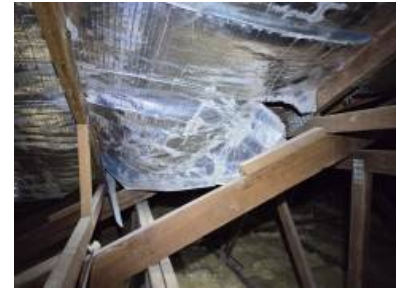
Sarking paper is present in the roof cavity to the underside of the roof tiles.

Some sarking paper requires refixing.

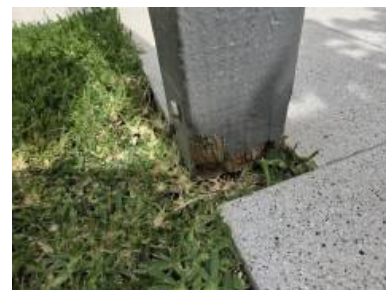
Timber post bases.

Some timber(s) require sealing and painting as there are signs of the beginning of wood decay present. Read the report.

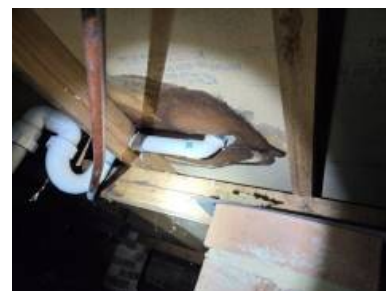
Some flooring shows signs of past water penetration to Bathroom shower. The leak has been repaired.

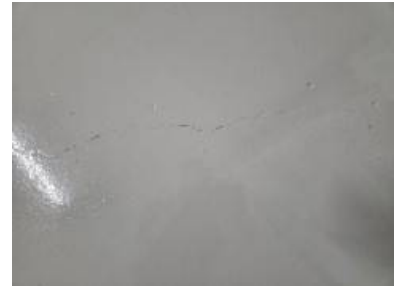
**Condition:**  
Some surface cracks to the concrete slab. *These types of minor cracks are common and generally occur when the slab surface cures.*

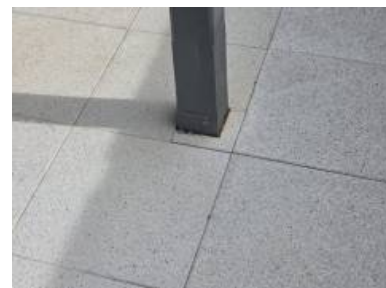
- Some Verandah / Patio timber support post bases are in contact with the ground / concrete / soil. This may allow concealed termite entry. The situation should be modified so that timber to soil contact does not occur (by creating a 75mm visual barrier) or have them treated with termiticide.
