# Building and Pest Report

## 55B Habitat Way Lennox Head

Report/Agreement #	240425085605395
Inspection Date:	24 Apr 2025
Inspection Time:	08:56 am

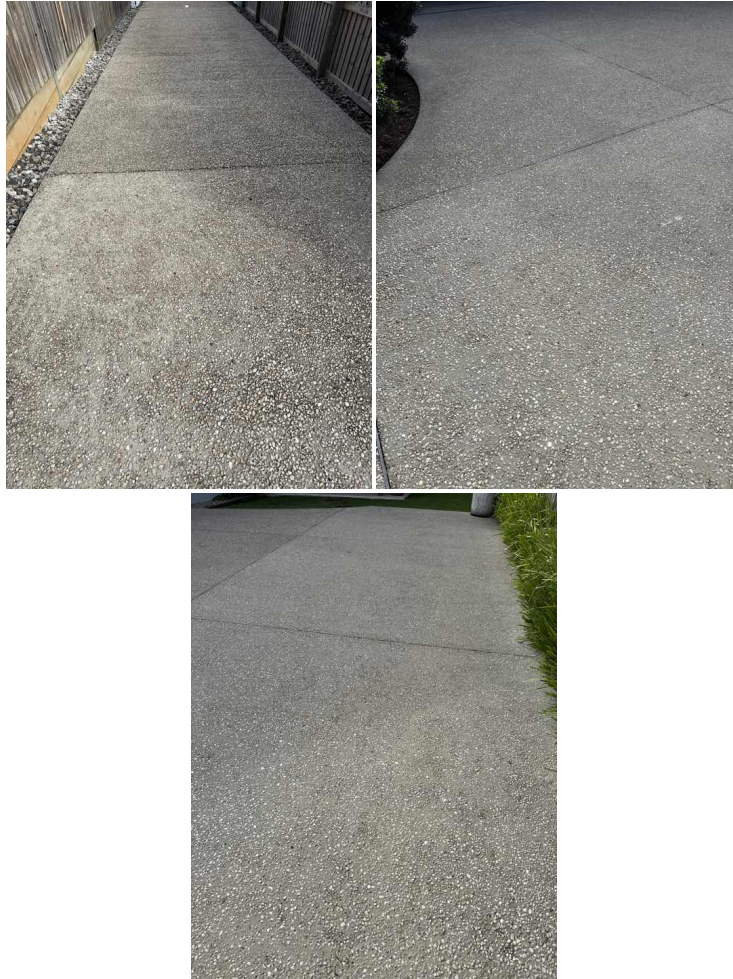
On visual inspection, the general condition of the driveway is serviceable.

Common cracks were observed on the driveway. Whilst these cracks appeared to be typical at the time of inspection, we strongly recommend you monitor these cracks and if worsening occurs contact a concreter for further advice.

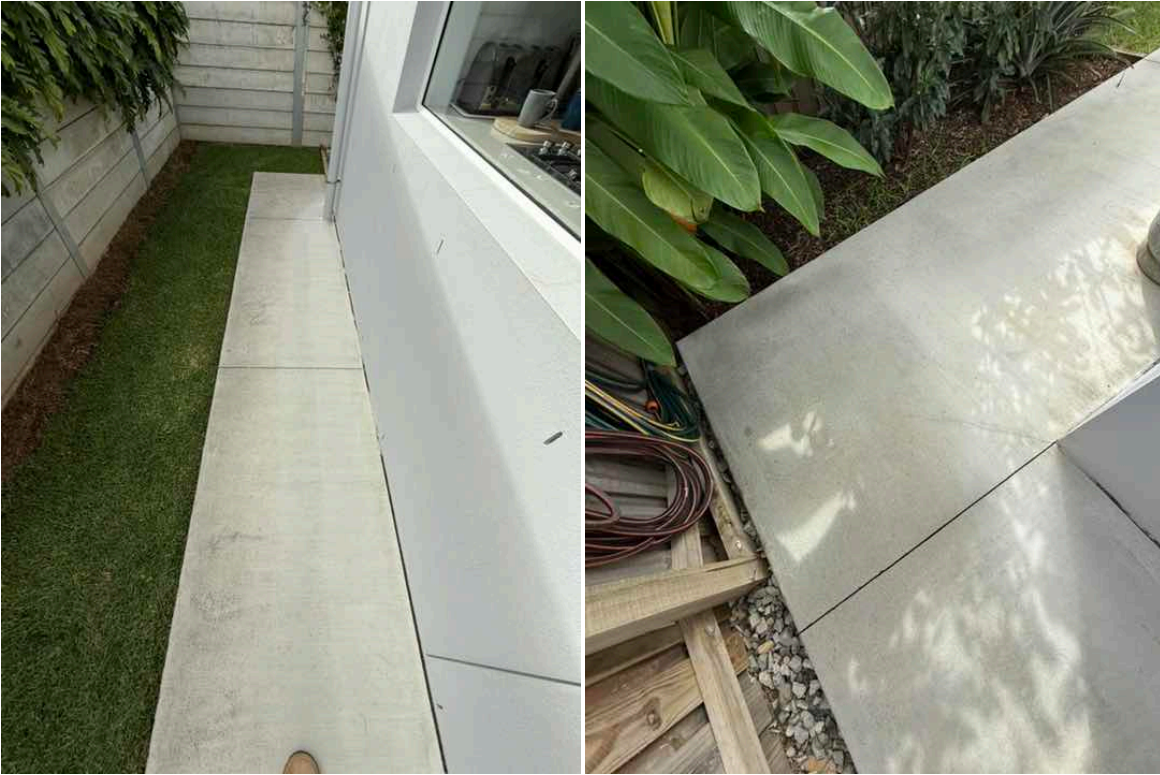
The paths around the home are in a serviceable condition for the age of this dwelling with no major defects visible.

Common cracks and settlement were observed on paths. Whilst these cracks appeared to be typical at the time of inspection, we strongly recommend you monitor these cracks and if worsening occurs contact a concreter for further advice.

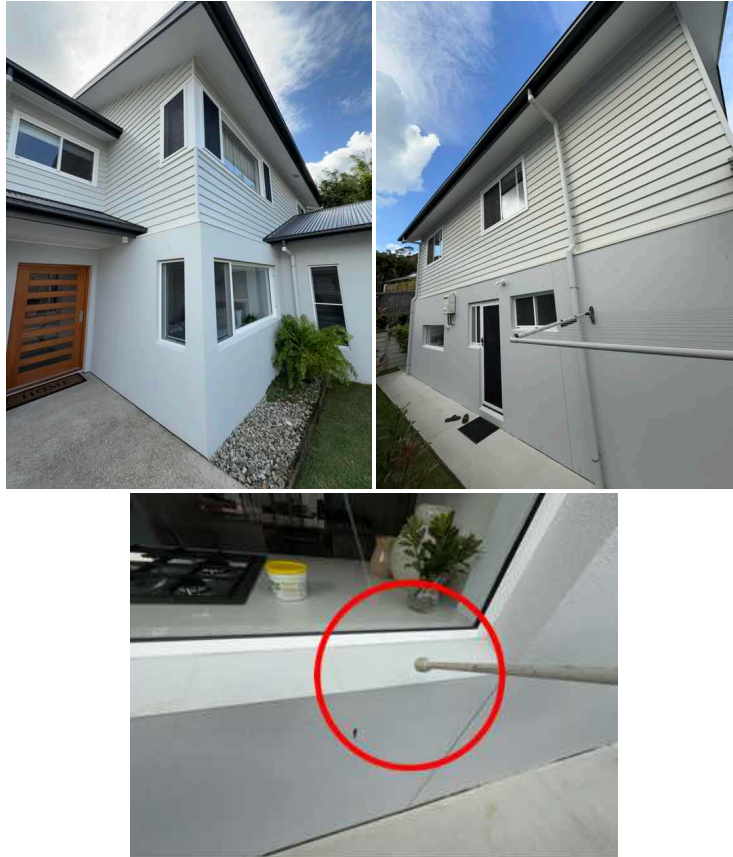
On visual inspection, the general condition of the exterior walls is serviceable for the age.

Drummy render

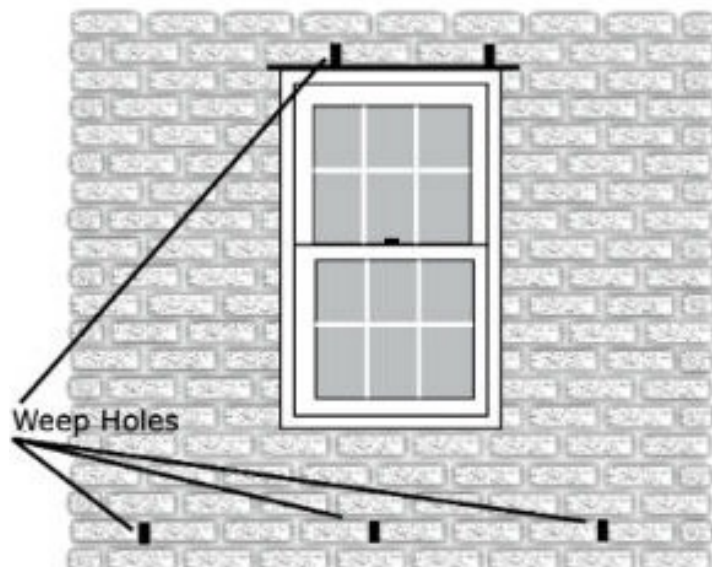
The weep holes are unobstructed .

Some weep holes partially are covered - Recommendations: Lower finished ground levels to fully expose all weep holes on the lower brick courses around the dwelling.

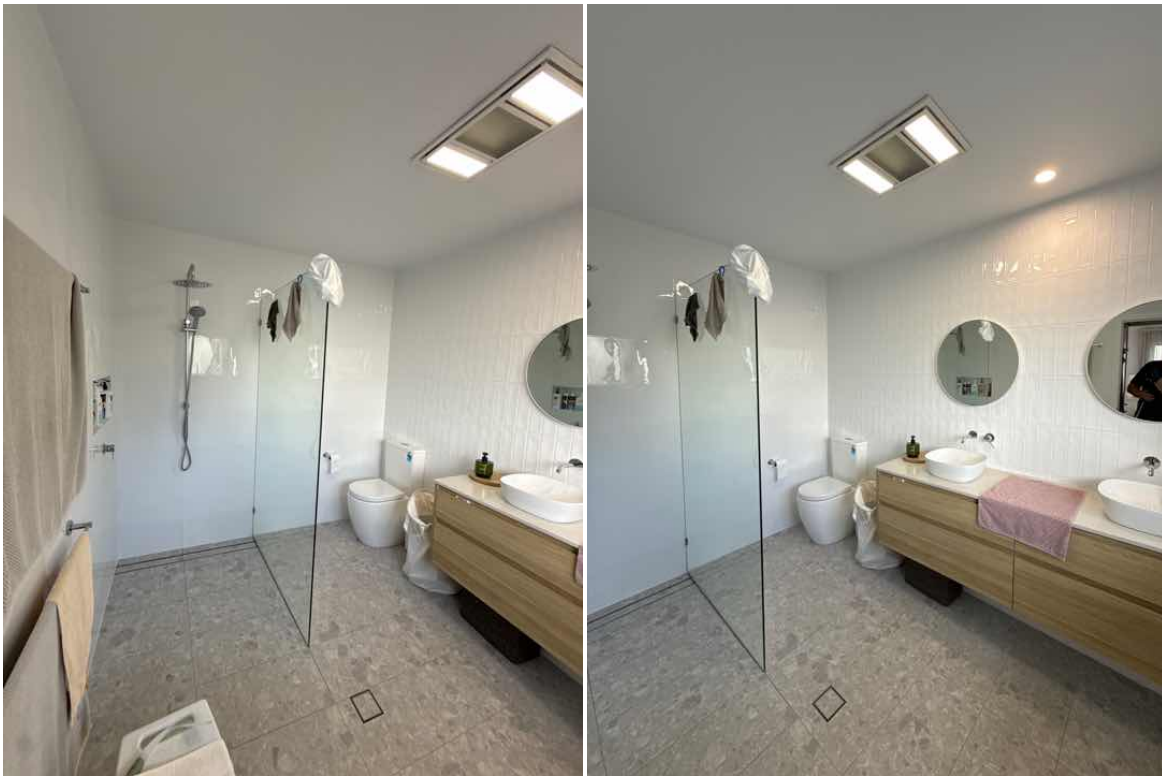
Bath spout is loose
