# Building and Pest Report

## 5 Castle Drive Lennox Head

# Inspection Report

**5 Castle Drive , Lennox Head , NSW, 2478**

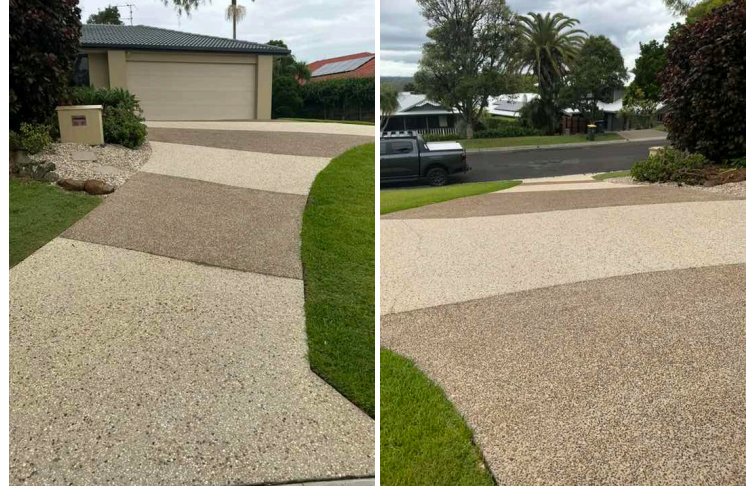
On visual inspection, the general condition of the driveway is serviceable.

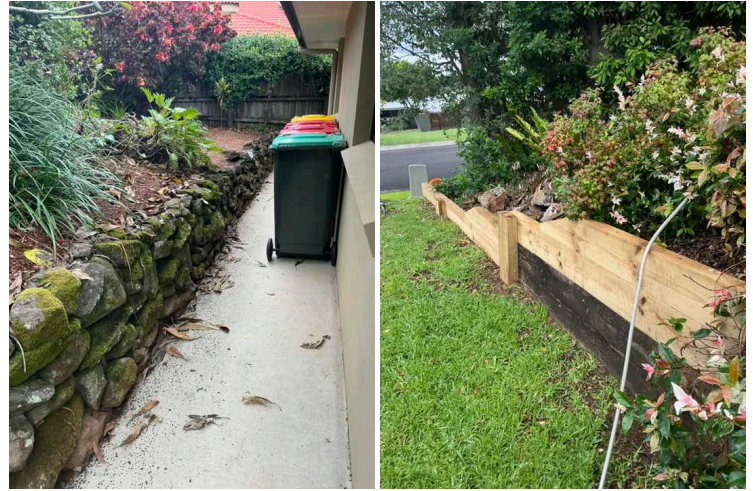
The retaining wall material is stone.

The retaining wall material is wood / timber.

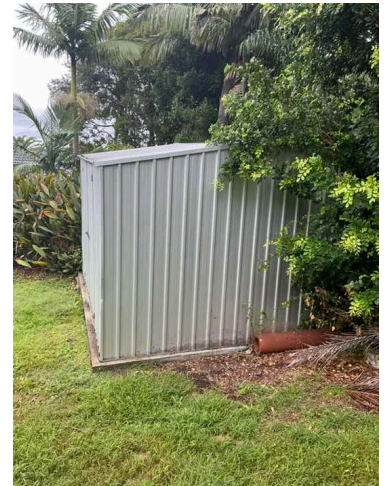
The shed is in fair usable condition.

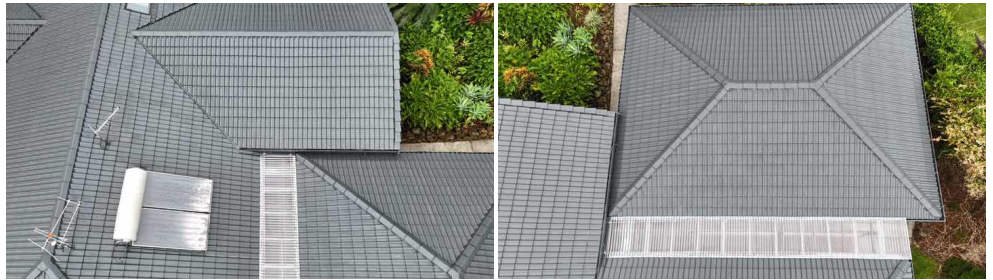
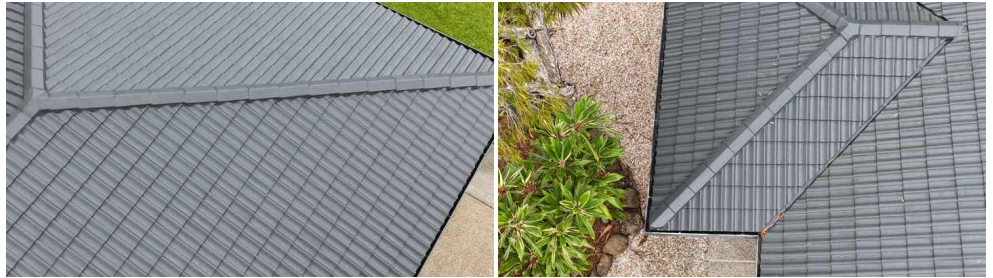
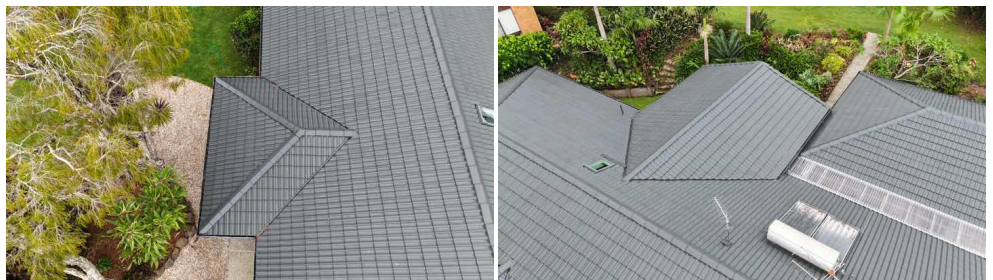
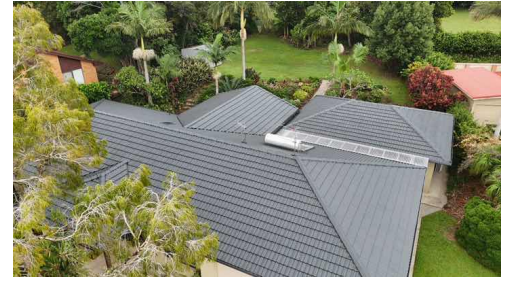
Of the visible areas, the general condition of the roof is in serviceable condition for the age.

Note: In the absence of rainfall there is no guarantee that the roof won't leak.

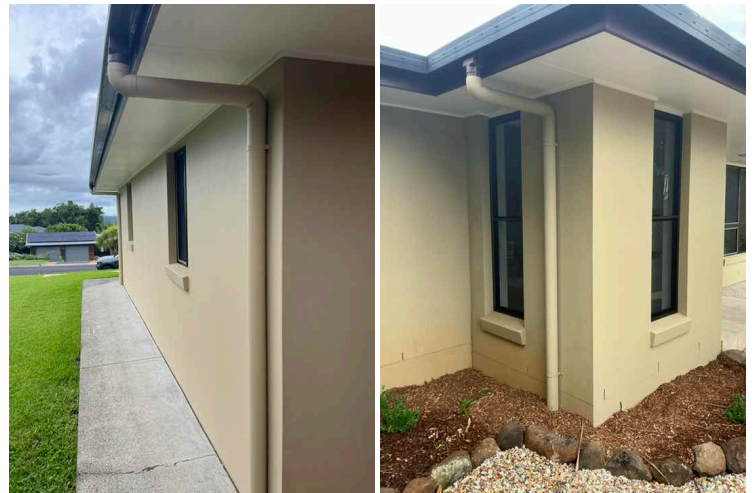
On visual inspection no apparent defects were noted to the down pipes and are considered serviceable, however no comment can be made with regard to blockages or connections to stormwater or functionality in the absence of rain. Note: Periodic maintenance checks should be carried out for rust penetrations and leaks.

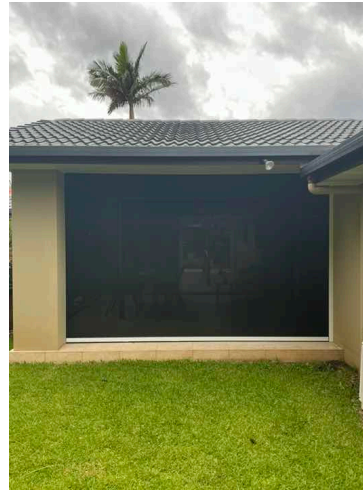
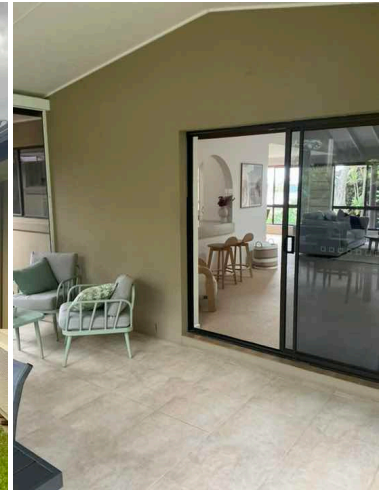
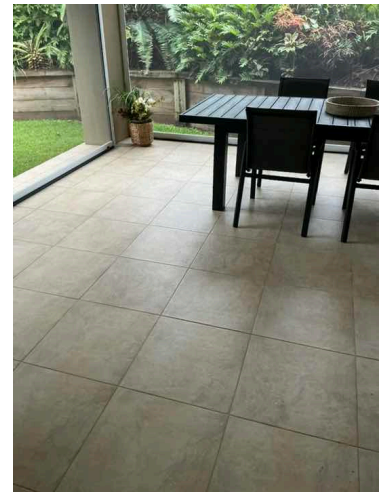
Visible sections of the Alfresco area are serviceable or in reasonable or condition for the age of this dwelling.

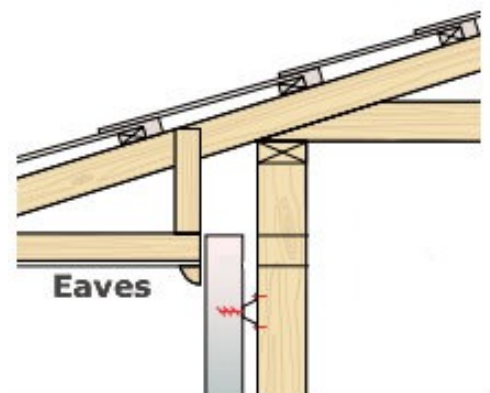
The soffit lining (eaves) are in a serviceable condition with no notable defects.

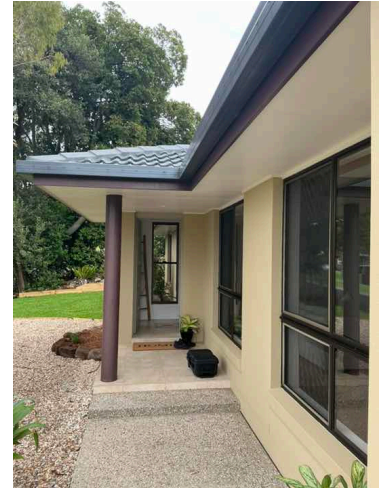
The entry porch serviceable or in reasonable or condition for the age of this dwelling.

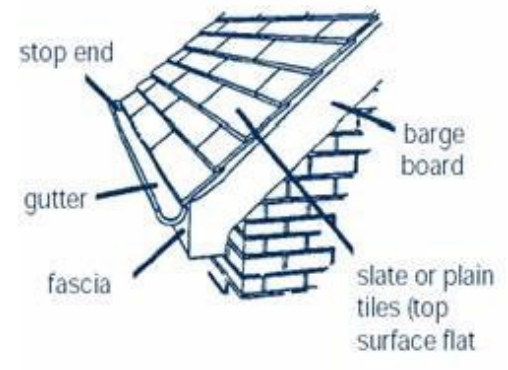
On visual inspection, the general condition of the fascia/barge boards is serviceable.

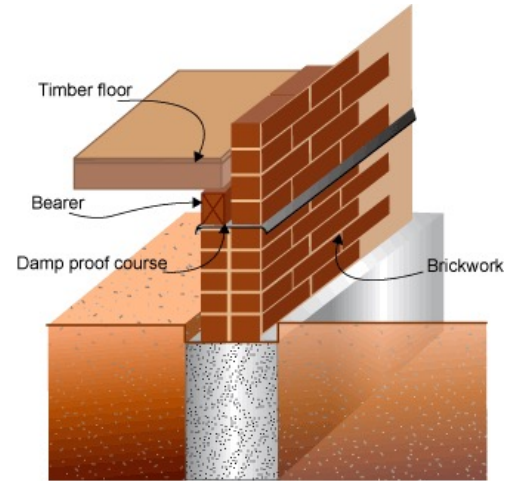
A damp proof course (DPC) was noted.

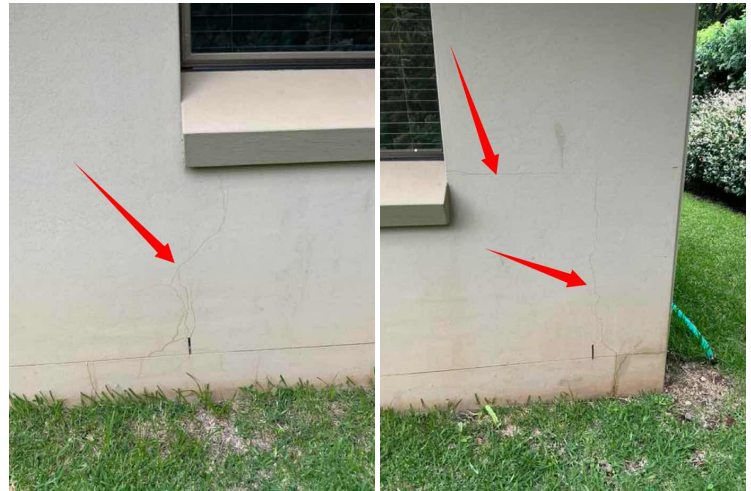
| Section | Location | Name | Comment |
|---|---|---|---|
| EXTERIOR | Walls | Condition | <p>#1. There appears to have been some settlement in the building which has caused some cracking to the walls. These crack are catergorized as 0 to 2. This can also cause some doors to bind or be out of square. In the inspectors opinion these cracks are due to settlement, usually due to ground movement and subsequent movement to building materials can be expected. Any cracks should be monitored and if cracks increase in size, further investigation should be carried out by a structural engineer.</p> <p>For clarification on the catergory of cracks please refer to Cracking of Building Elements in Section 2D of the Terms and Conditions contained in this report.</p> |

#1. There appears to have been some settlement in the building which has caused some cracking to the walls. These cracks are categorized as 0 to 2. This can also cause some doors to bind or be out of square. In the inspectors opinion these cracks are due to settlement, usually due to ground movement and subsequent movement to building materials can be expected. Any cracks should be monitored and if cracks increase in size, further investigation should be carried out by a structural engineer.

*For clarification on the category of cracks please refer to Cracking of Building Elements in Section 2D of the Terms and Conditions contained in this report.*

**IMPORTANT:** Regardless of location or size If cracks have been identified then a structural engineer is required to determine the significance of the cracking prior to a decision to purchase.

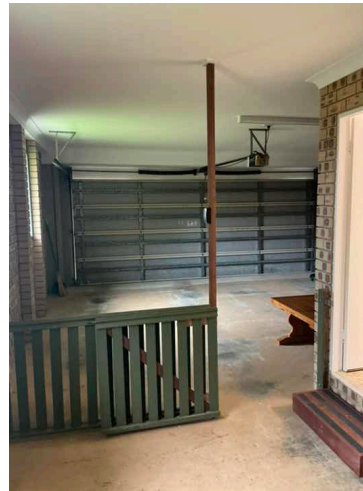
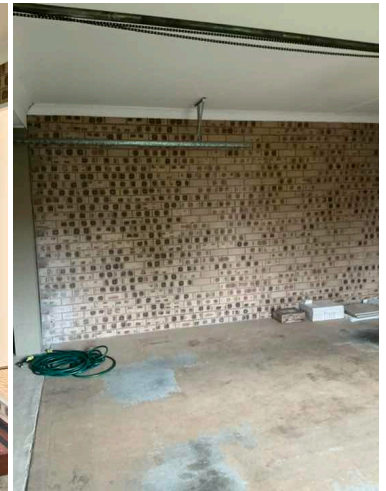
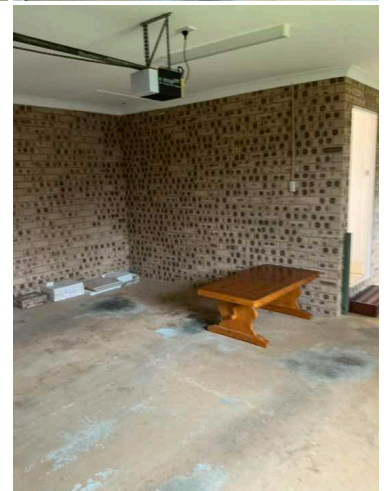
From the visible and accessible areas, the garage appears to be in a serviceable condition for the age of the property with no notable structural defects sighted.

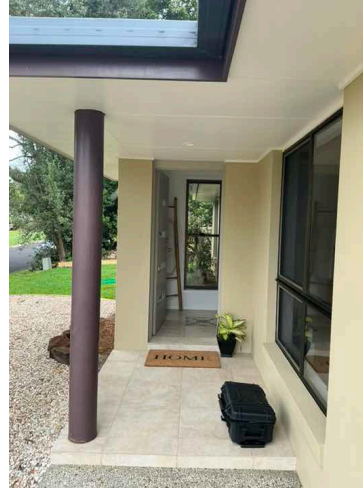
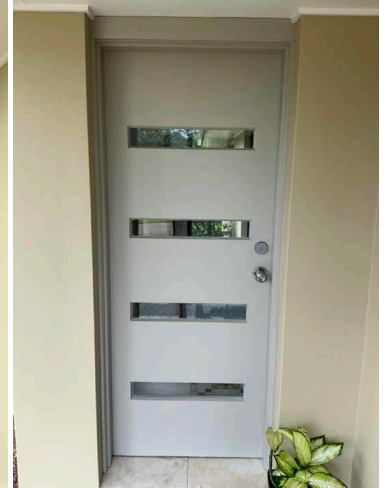
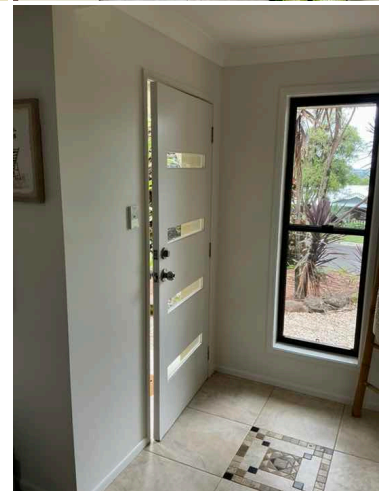
The doors are in serviceable condition with no notable defects observed.

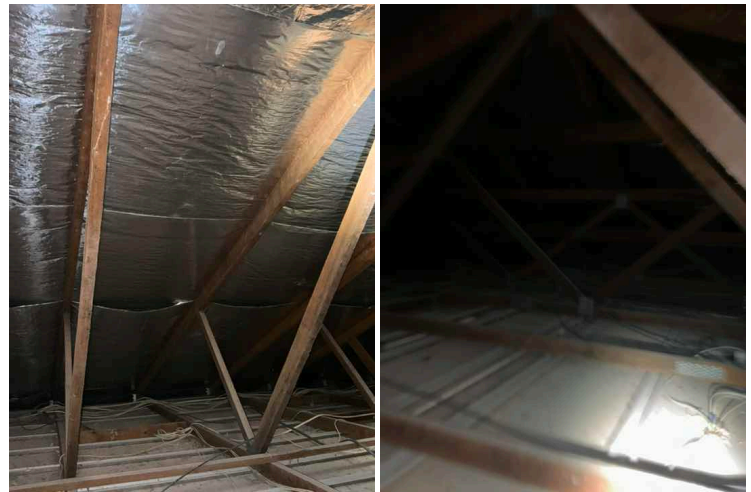
Visible sections of the roof void is in a serviceable condition for age of this dwelling.

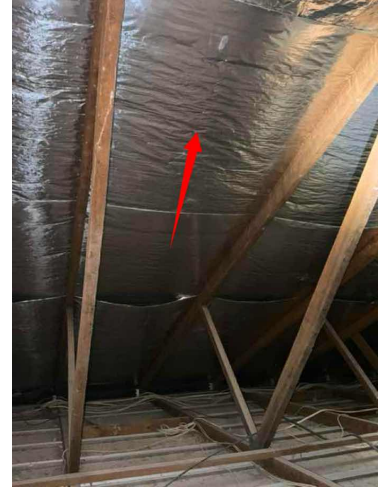
Sarking is installed.

The sarking generally is in a serviceable condition.
