Property and Timber Pest Report

Inspection Date: 5 Sep 2025

Property Address: 24 Pinnacle Row Lennox Head 2478

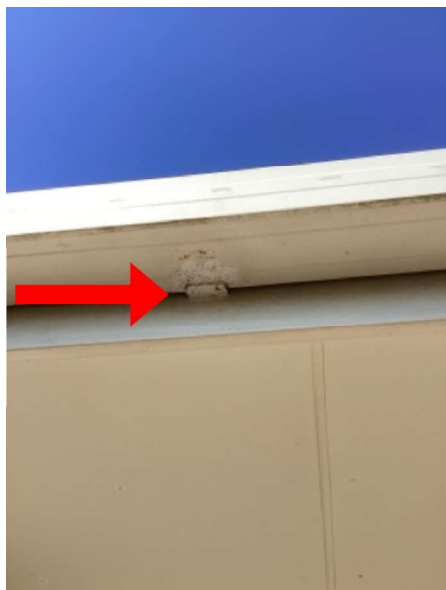
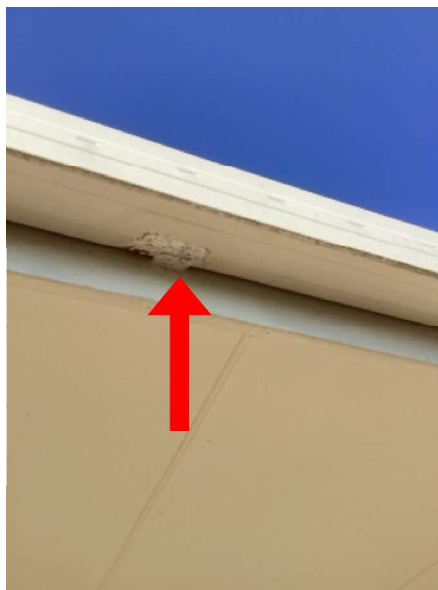
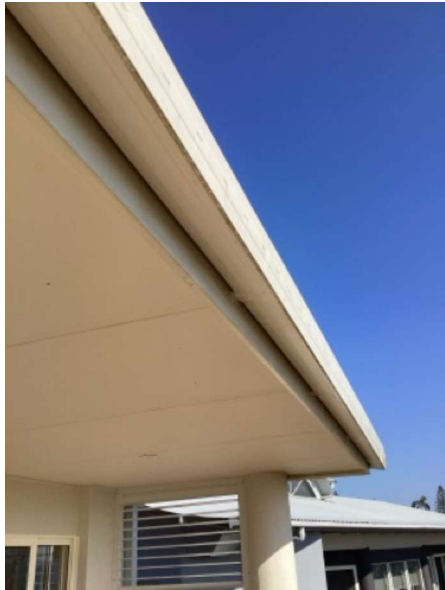
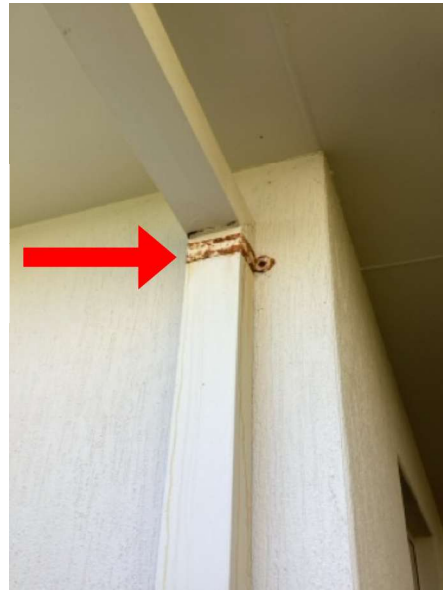
Minor Defect 1.01

Location: All External Areas

Finding: The inspection of the external areas has identified a significant defect involving the gutter brackets and metal downpipes, which are displaying substantial signs of rust deterioration. This corrosion is evident throughout all external regions, indicative of prolonged exposure to moisture and inadequate maintenance. The integrity of these components is compromised, potentially affecting the property's drainage efficiency and posing a risk of further structural damage if left unaddressed. Immediate remedial action is recommended to prevent escalation, which may include the replacement or repair of the affected elements to ensure the functionality and safety of the drainage system.

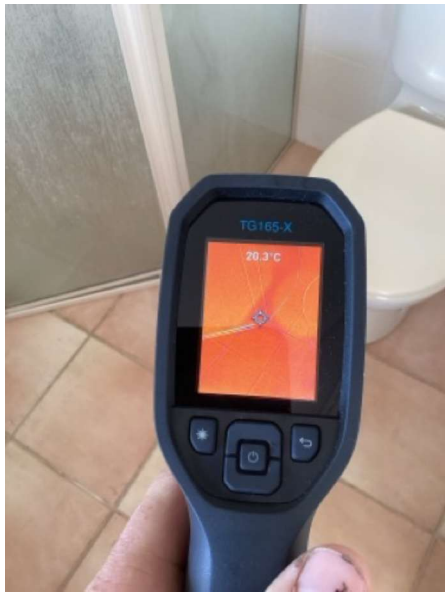
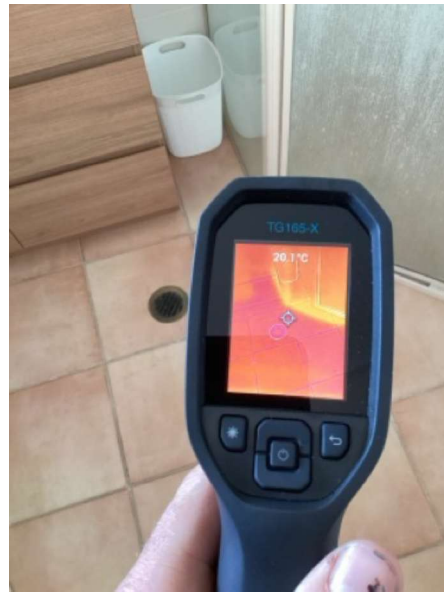
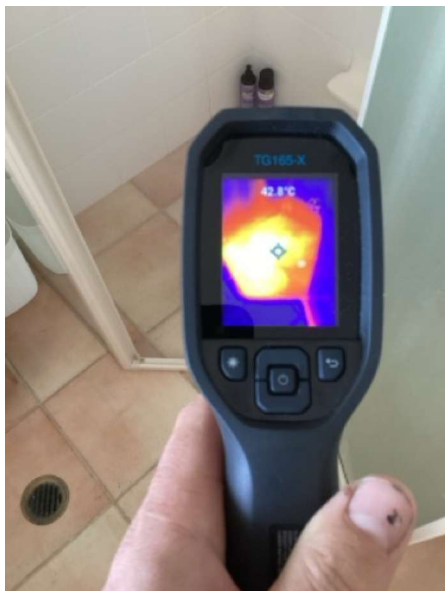
Location: Bathroom

Finding: Upon conducting a thermal imaging assessment of the downstairs bathroom, the analysis indicates that all water stops are functioning correctly, and no issues were detected in terms of water intrusion or temperature irregularities. The thermal images consistently demonstrate normal temperature readings throughout the bathroom area, including around the shower, toilet, and sink fixtures. The bathroom construction and installation appear to be in good working order, with no evidence of thermal anomalies typically associated with leaks or moisture accumulation. Therefore, based on the current thermal imaging data, no defects or issues have been identified in the bathroom area.

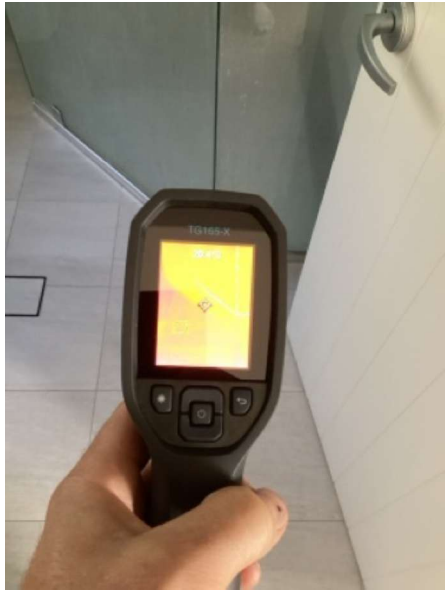
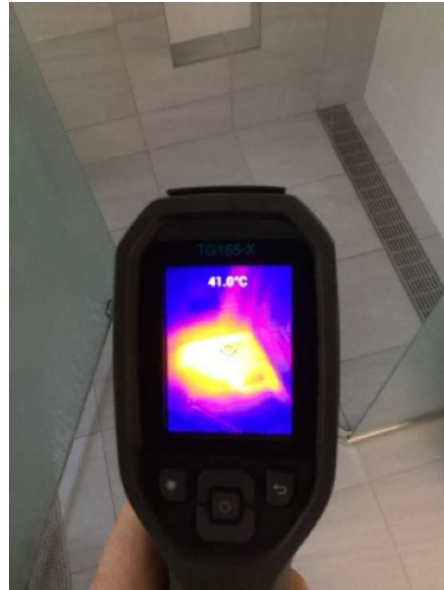
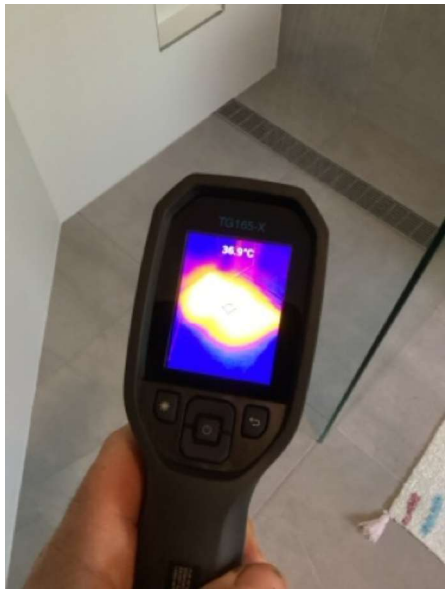
For your information 2.02

Location: Bathroom

Finding: The thermal imaging assessment of the upstairs bathroom has revealed that the area is in excellent condition, with no detectable inconsistencies or thermal anomalies present. The images provided indicate uniform temperature distribution across the surfaces, suggesting that the infrastructure is intact and functioning properly. There are no signs of moisture intrusion, leaks, or other potential defects in the bathroom. This confirms that the bathroom's current condition aligns with expected standards, and no further action is required at this time.

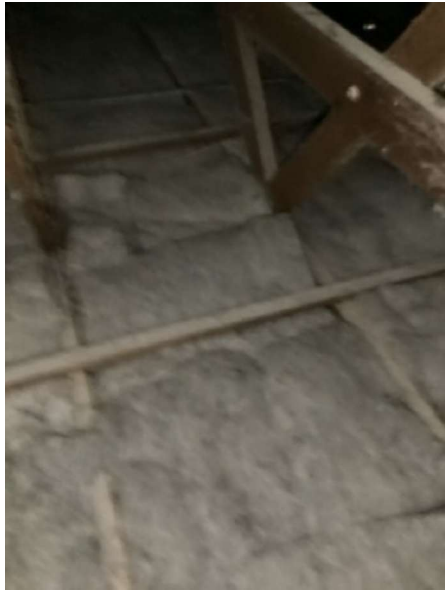
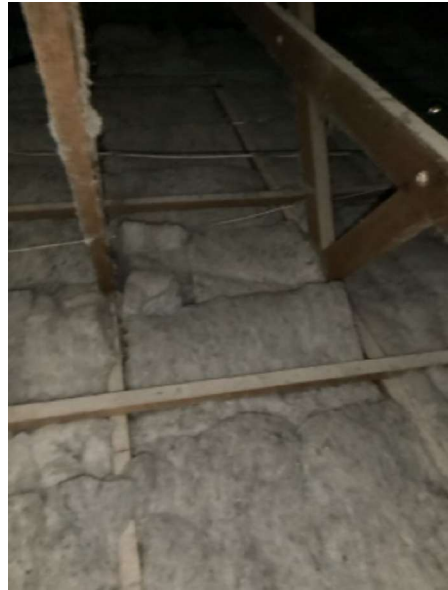
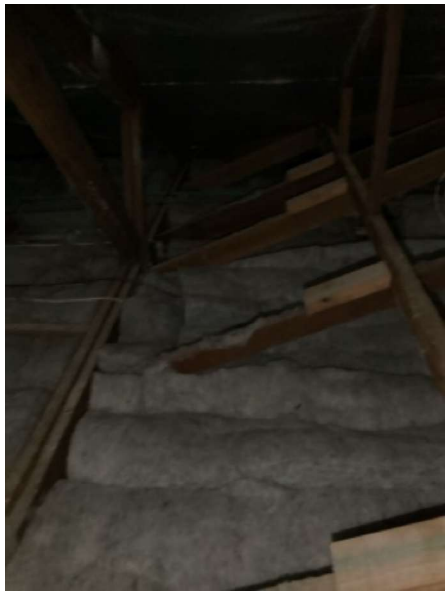
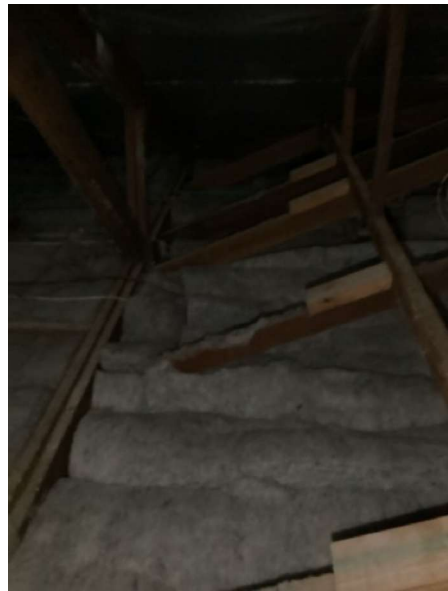
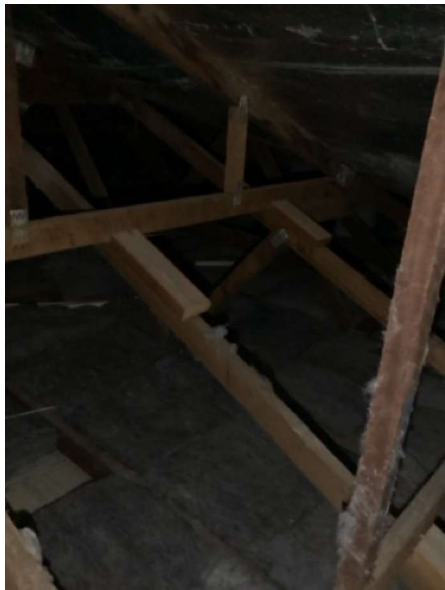
For your information 2.03

Location: Roofspace

Finding: During the inspection of the roofspace, it was observed that the roof framing is in commendable condition. The installation appears to be executed with precision, with no identifiable defects or issues throughout the structure. The timber components are well-aligned, and there is no visible evidence of deterioration, damage, or poor construction practices. This promising condition suggests that the roof framing should continue to perform its function effectively, providing structural support and stability. Overall, no remedial actions are required regarding the current state of the roof framing in this area.
