# PEST AND BUILDING PRE-PURCHASE REPORTS

# Inspection Report

**141 North Creek Rd , Lennox Head, NSW, 2478**

| Report/Agreement # | 100924025635423 |

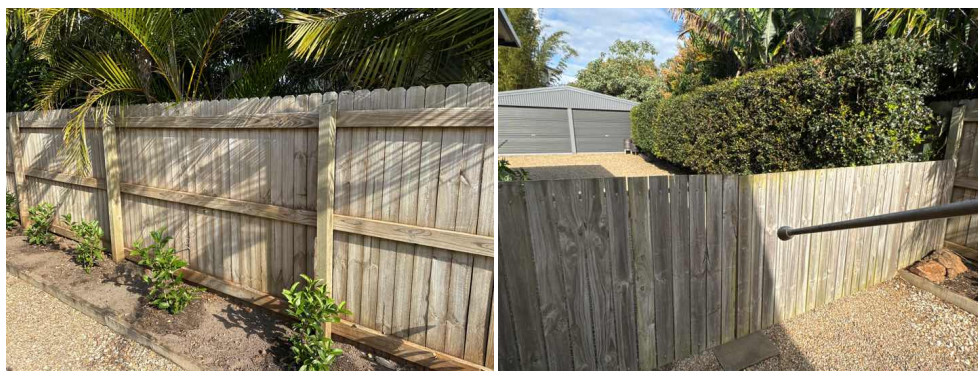
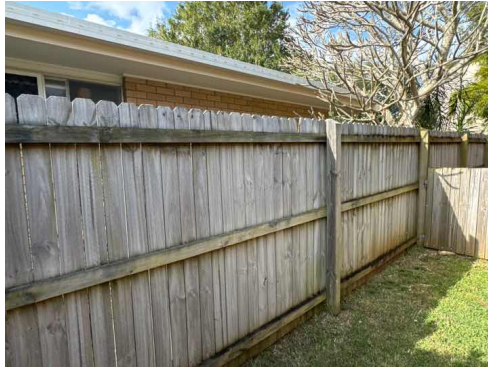
The gate does not latch. Have repaired by a qualified fencer.

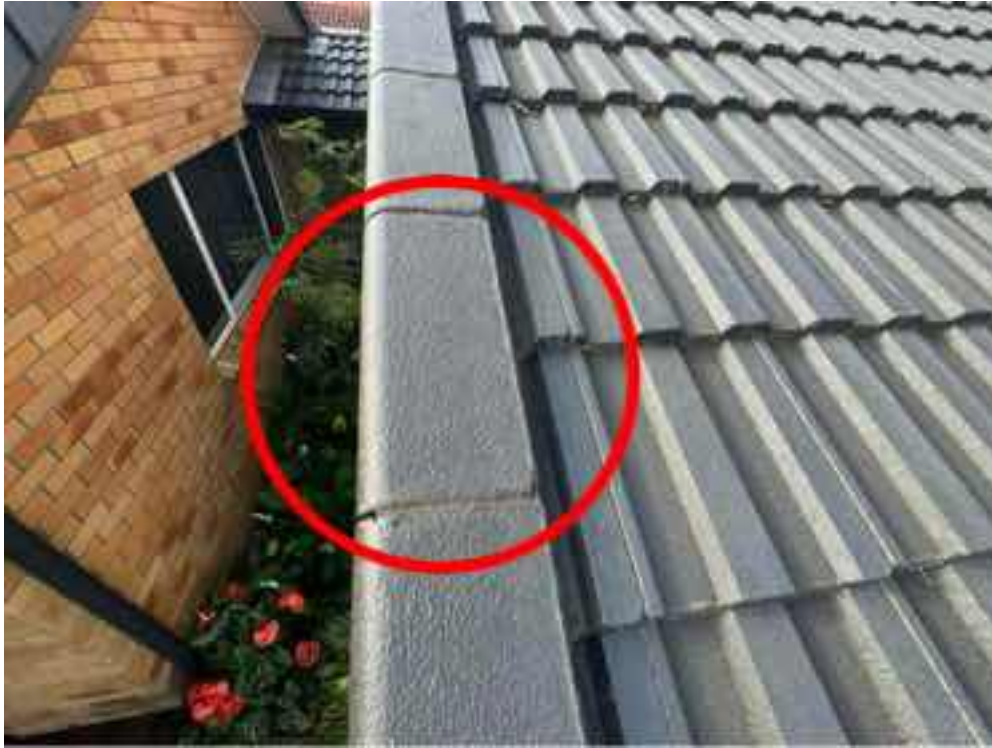
Mortar cracks visible. We recommend having these repaired by a qualified roofer as they may contribute to water ingress.

Tile lift/unevenness visible - Recommendations: Have roofer re-fix. Considered a minor defect but has the potential to become a Major defect if repairs aren't carried out immediately due to water ingress into the roof cavity.

The barge tiles on the granny flat have been installed incorrectly.

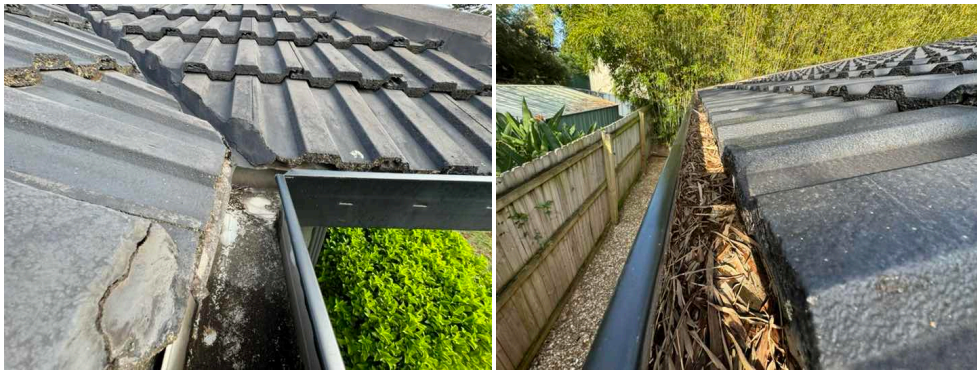
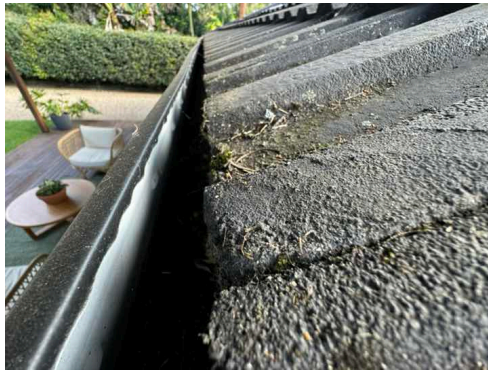
Debris in guttering areas- this requires cleaning out to prevent blocking of downpipes and leaking into eaves and fascia. Have gutters cleaned and assessed by a plumber for adequate fall. Regularly clean to prevent ponding. Ponding water will contribute to rust.

Gutter ponding - This can relate to poor fall, inadequate down pipes, gutter or debris build up. If debris presence has been noted above clean same out and re-assess for any ponding. If clean guttering is ponding it can be a blocked down pipe or the guttering fall is inadequate. A qualified roof plumber should be engaged for advice and recommendations.

There is evidence of leaking gutters. Contact a roof plumber for advice and repairs.

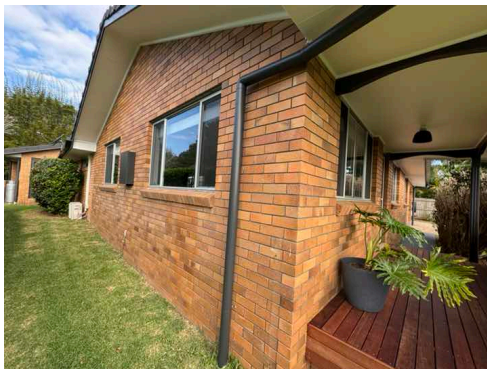
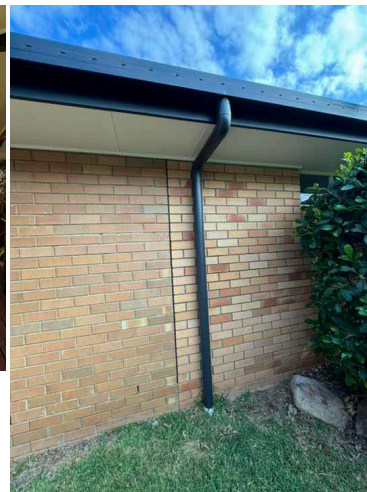
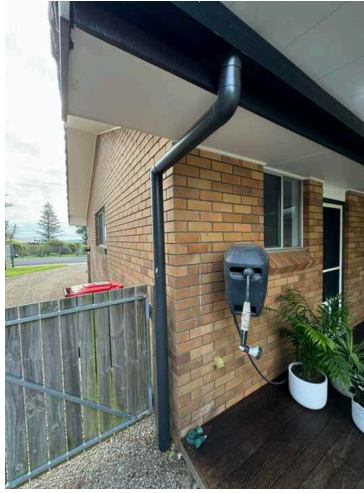
The downpipe base is damaged/cracked. This has the potential to cause leaking. Recommendations: A qualified plumber should be engaged for repairs.

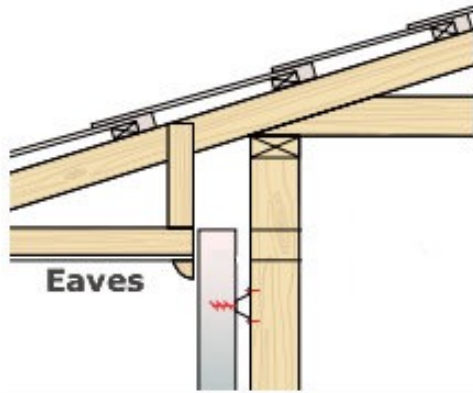
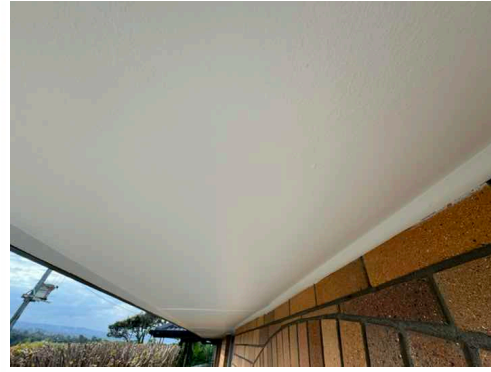
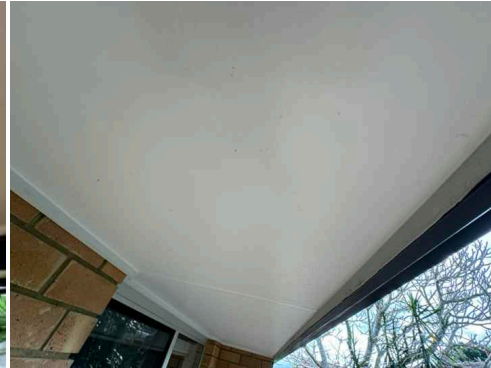
Eave lining damage visible. Recommendations: A qualified carpenter should be engaged for repairs.

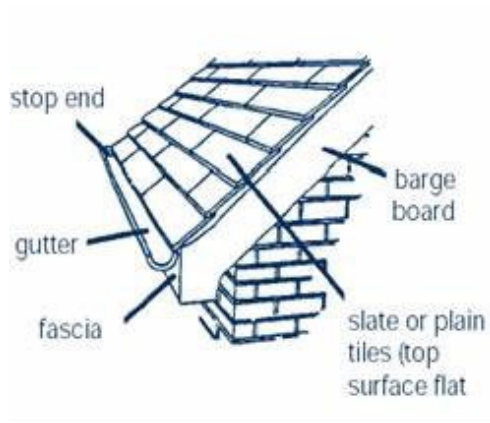
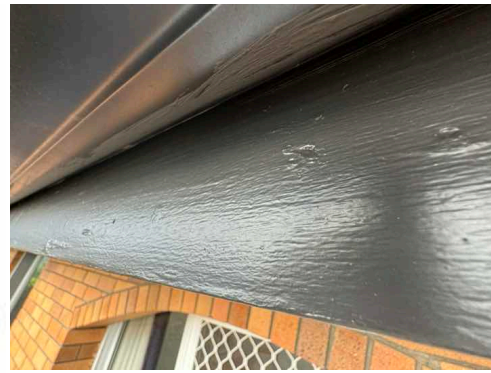
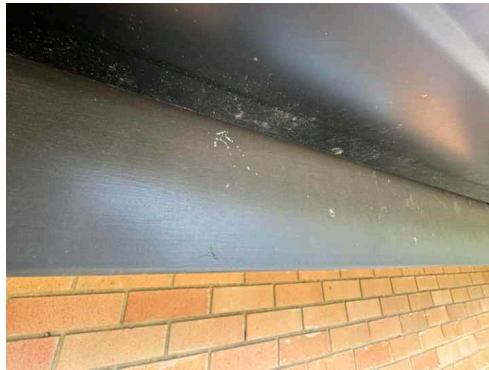
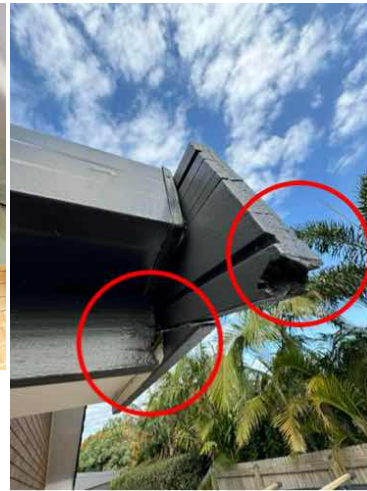
Paint / finish was deteriorated in areas and is in need of maintenance - Sanding back affected areas and painting required.

Timber fungal decay (rot) visible. Recommendations: A qualified carpenter should be engaged to replace all affected timbers.

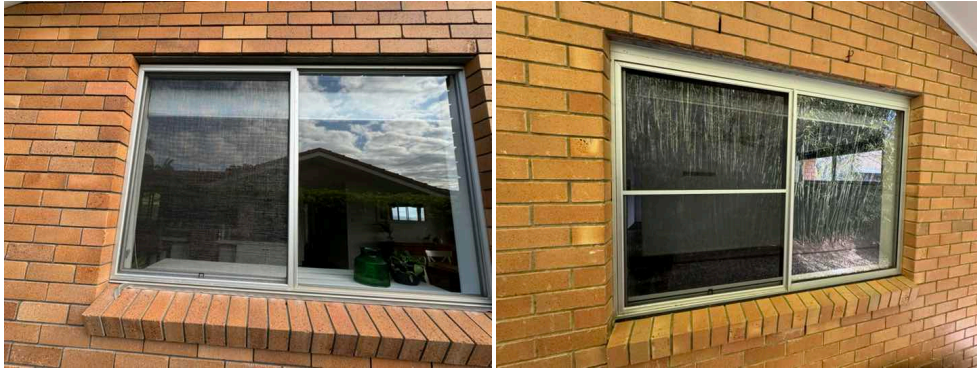
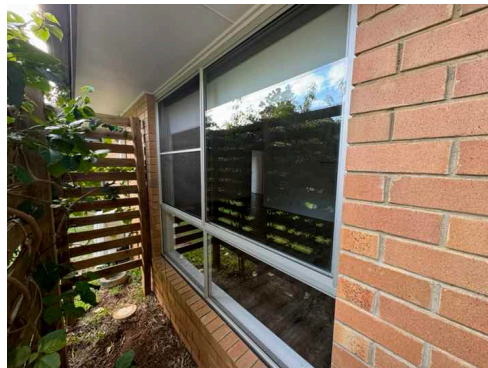
General age/damage has occurred to window components. Recommendations: Restoration work recommended. A qualified carpenter should be engaged for advice and recommendations.

Deterioration of sections of window rubber seals was observed. A qualified glazier should be engaged for advice and recommendations.
