# Property Inspection Report

**94 Tanamera Drive ,  
Alstonville , 2477, NSW**

**Date of Inspection: 6/8/2026 | Time: 8:45AM**

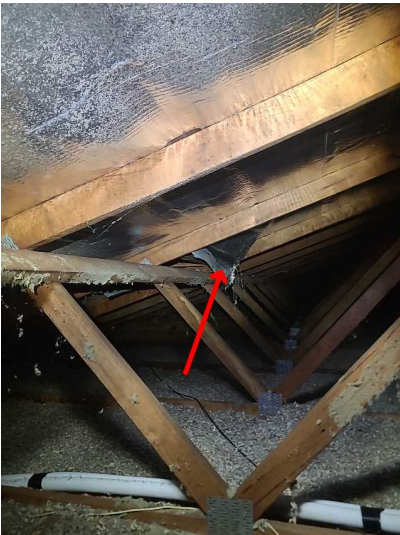
- The sarking (optional material under roof tiles to provide additional protection against water ingress) is perished/torn in areas. Recommend review for repair or replacement as required.

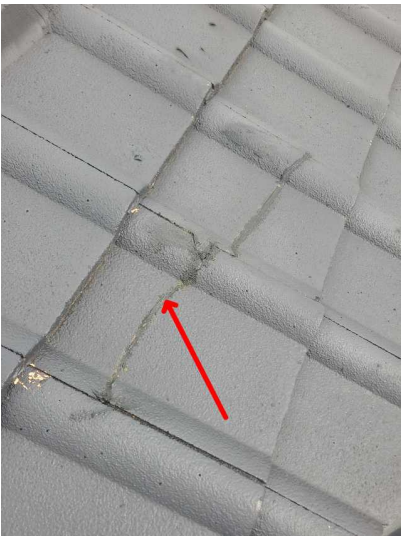
- There are previous silicone repairs noted. These tiles should be monitored, and ideally at some stage replaced as silicone can deteriorate over time.

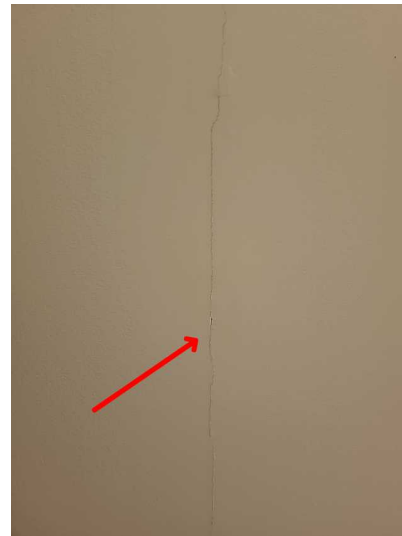
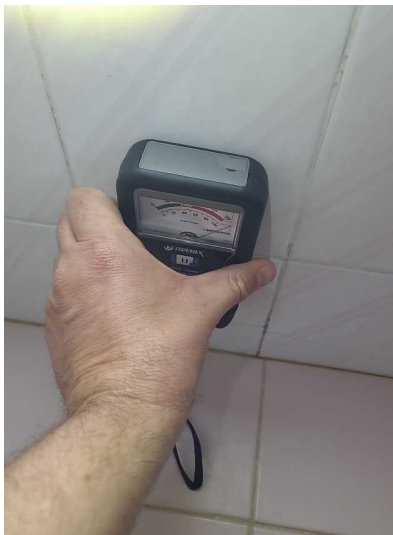
- Due to normal minor differential movement within the property or foundations, small cracks have appeared at various locations within the home. These cracks do not appear to have affected the overall structural integrity of the property and can be patched normally.
- Excessive moisture was present to the main shower walls which appear to require resealing.

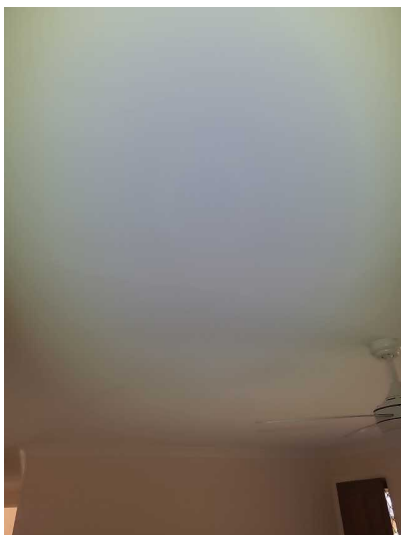
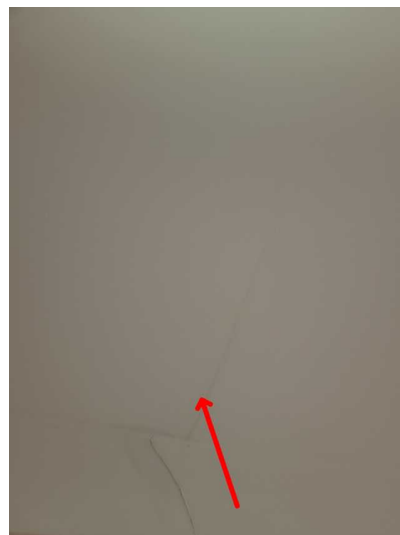
- The ceiling has minor hairline joint cracks between the joints of the sheets. This is normally due to minor movement in the roof structure and can be repaired normally. This does not appear to have affected the structural integrity of the ceilings but may require some maintenance in the future.

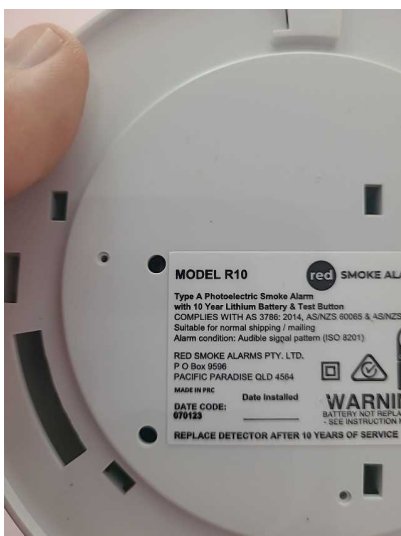
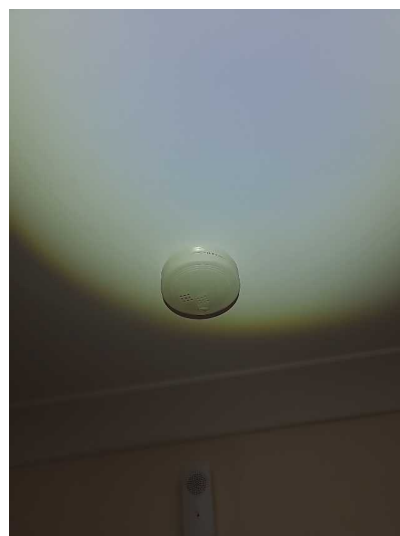
| Interior Areas | | |
|---|---|---|
| Page 16 Item: 3 | Smoke Alarms | • The smoke alarm is beyond the expiry date and needs to be replaced. |

- Testing of smoke alarms is not included in this inspection. Pushing the "Test" button only verifies that there is power at the alarm--either a battery or hardwired to the house power--and not the operational workings of the alarm. The operational check is done by filling the sensor with smoke and is beyond the scope of this inspection. Battery operated smoke alarms should be checked routinely and the batteries changed frequently.
- There is a long-life-battery operated smoke alarm installed in the property. Expiry 2033.
- The smoke alarm is beyond the expiry date and needs to be replaced.

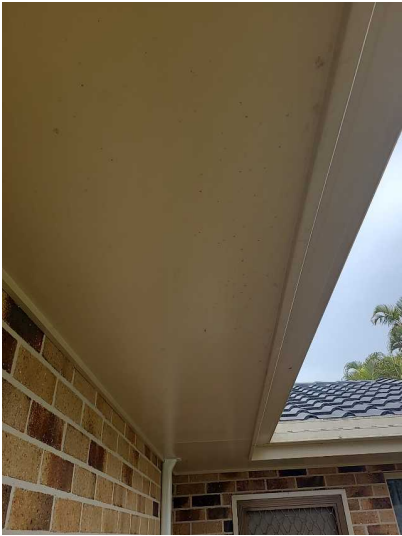
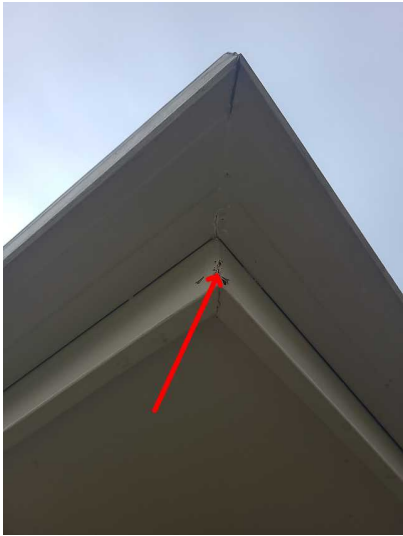
- Observations:
- The eaves are in satisfactory condition.
  - Moisture damage, wood decay, observed. Recommend review for repair as necessary.

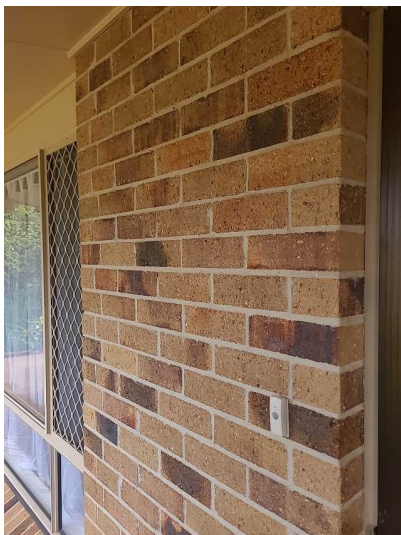
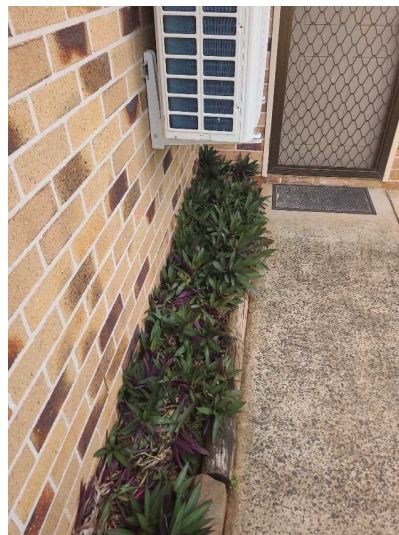
- There are a number of garden beds which are adjacent to the external walls. This can result in water moisture affecting the structure over time. It is recommended that either the beds be removed or a water barrier be placed between the garden bed and the external walls. If these beds are retained it is important that any watering is directed away from the building and kept to an absolute minimum and is controlled.

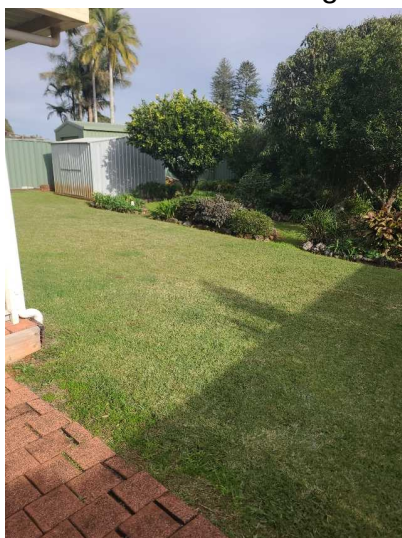
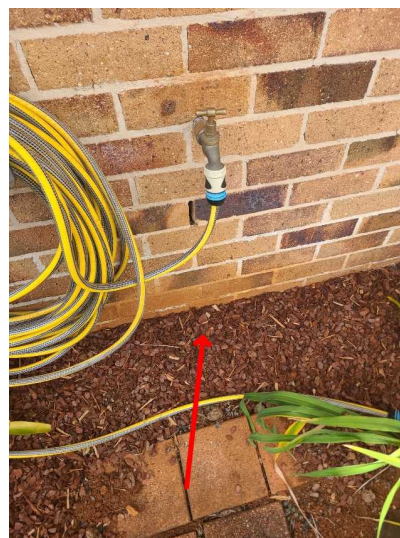
- Surface drainage conditions within 3 metres of the inspected structure appeared satisfactory.
- There are no drains located beneath the outdoor taps. This can cause water pooling if the taps were to leak. Recommend drains be installed beneath the taps. Where this is not possible it is important to ensure taps are well maintained to prevent leaks.
- The hot water system overflow pipe discharges on the foundations. This should ideally be directed into the stormwater or at least 3 metres away from the building.

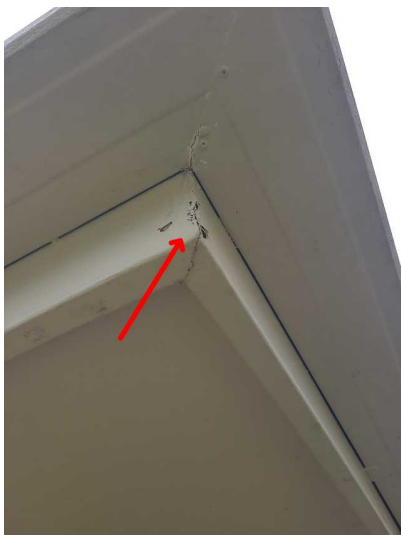
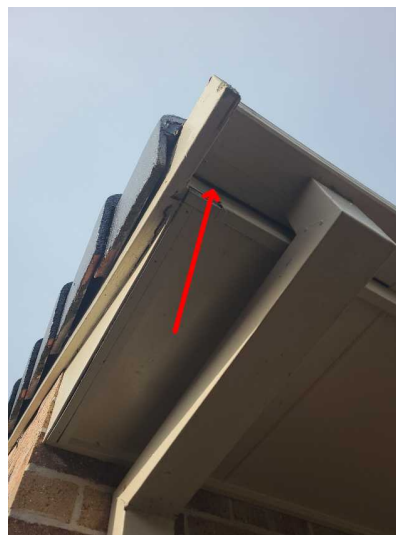
- Wood decay/fungus was detected in the west fascia.
- Fungal decay damage appears to be localised.
- Timber condition is decaying.

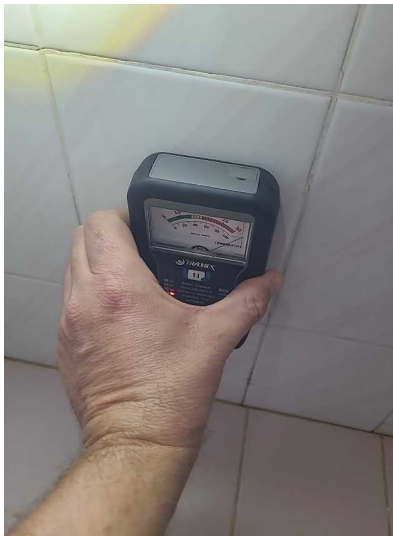
Observations: Excessive moisture conditions were present during the inspection.

Excessive moisture was present to the main shower walls that appear to require resealing.

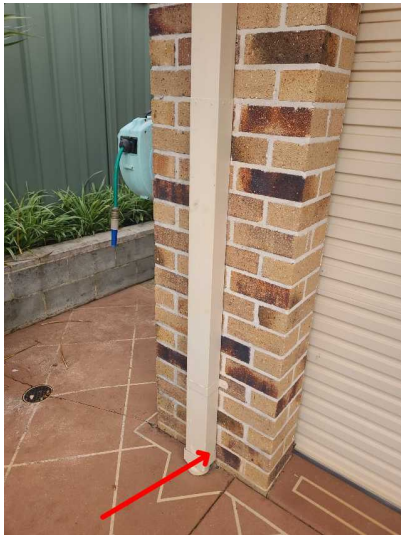
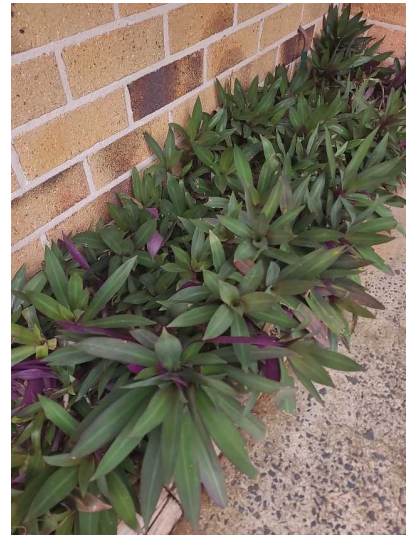
The downpipes are located close to the external wall of the home and could provide concealed access for timber pests, these should be monitored as part of an effective termite management plan.

Prune or remove any plants that are in contact or proximity to home to eliminate pathways of wood destroying insects.

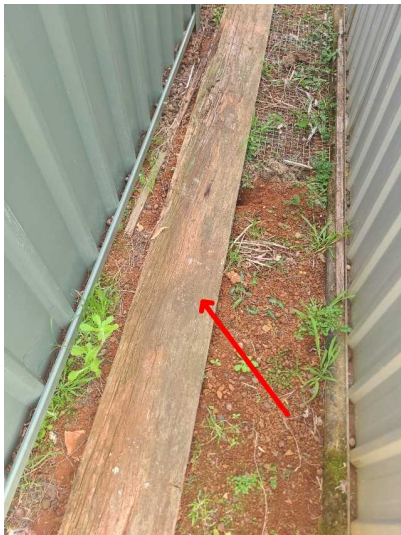
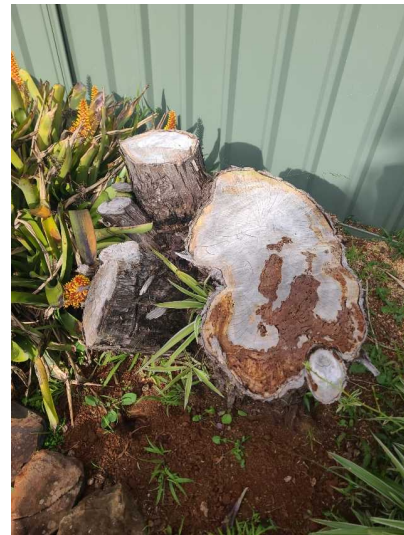
- There is landscaping/stored timber, or old tree stumps in contact with the ground that provides possible breeding grounds for subterranean termites. These should be removed.

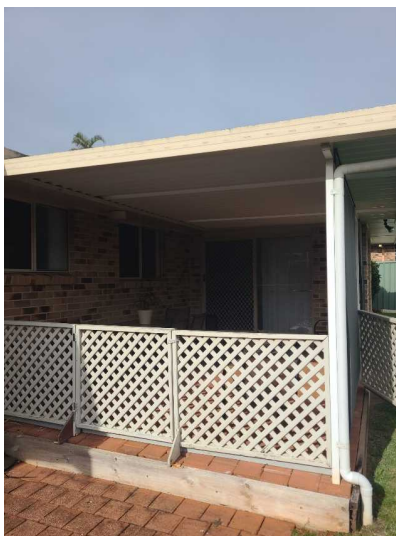
- The patio is in contact with the ground which may allow concealed termite access to the structure. Patio in satisfactory condition.

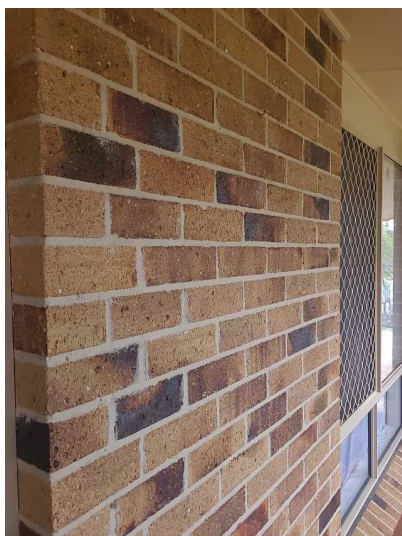
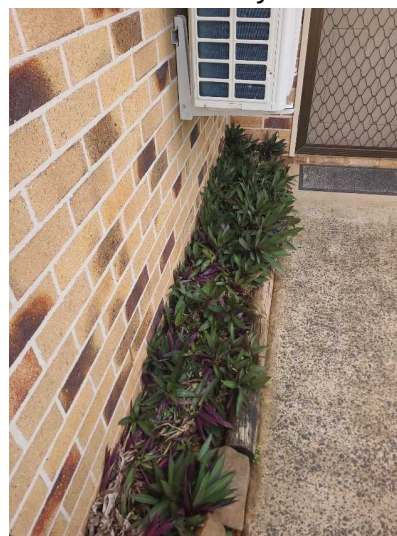
- There are garden beds which are abutting external walls. This can result in water moisture affecting the structure over time. It is recommended that either the beds be removed or a water barrier be place between the garden bed and the external walls. If these beds are retained it is important that any watering is directed away from the building and kept to an absolute minimum and is controlled. These are a risk area for termite activity.

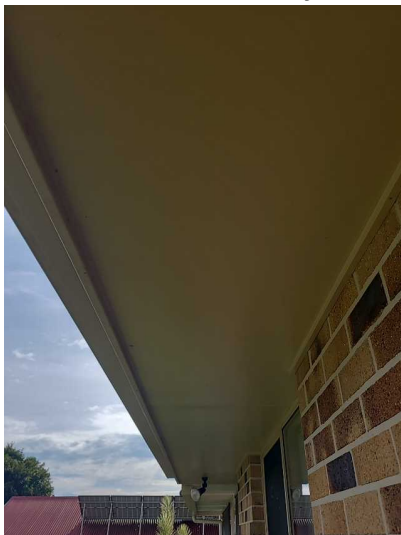
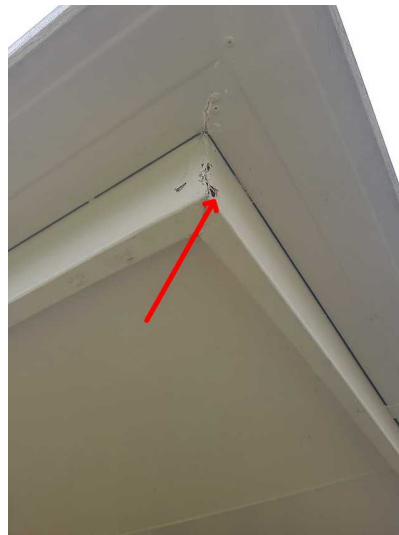
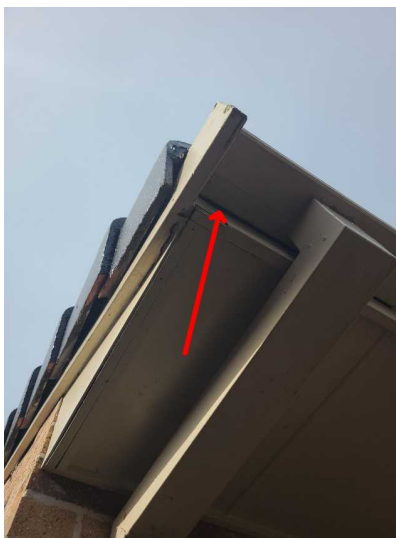
- Wood Decay damage noted in the eaves along the west wall.
- Moisture damage, wood decay, observed. Recommend review for repair as necessary.
