Building and Pest Report

17 Megan Cres Lennox Head

BPI - INSPECTION REPORT

1/17 Megan Crescent Lennox Head.

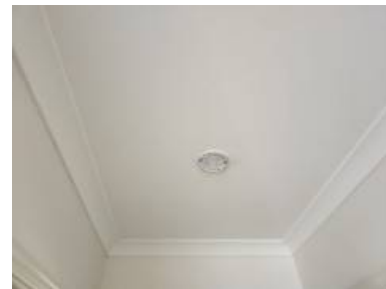
Present - Lounge.

Additional smoke detector(s) should be located to ceiling(s) at Within 3 meters of bedroom entrances.

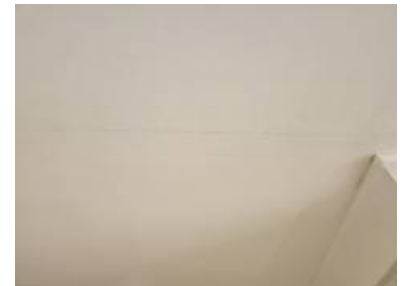
Cracking / Sagging / Defective Lining

Minor cracks to some ceiling sheet join to hallway. *The installation of an expansion join may be required.*

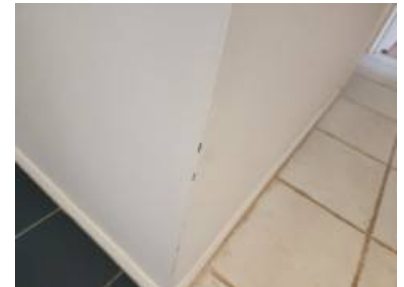
Some paintwork / walls require minor touching up.

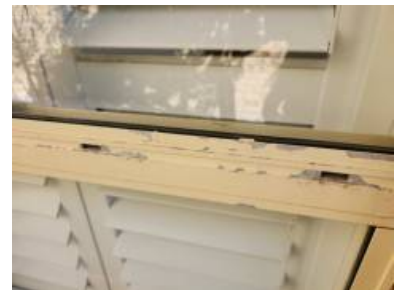
Frames / Sashes / Reveals
Various windows show evidence of corrosion and require maintenance / repair.

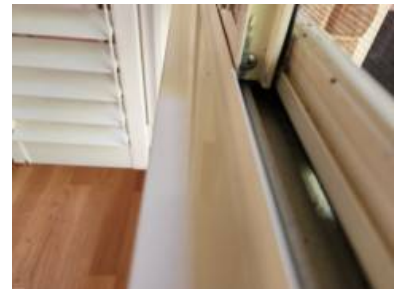
Sash Operation / Fittings / Hardware
Some window slider rollers show signs of wear or are worn and require lubrication.

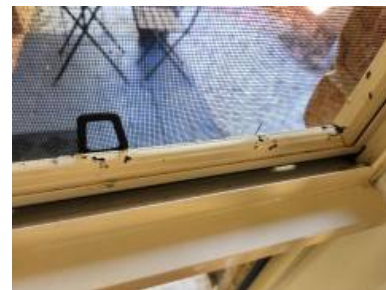
Present, Corrosion to fly screens.

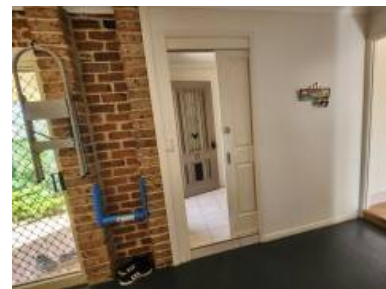
Some slider rollers show signs of wear or are worn and require lubrication / replacement.

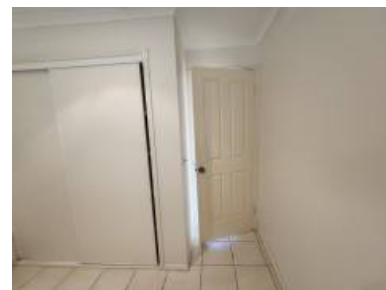
Bedroom door is binding and requires repair / easing / adjustment.

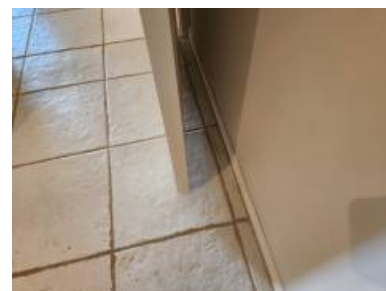
Some doors require new door stops / catches fitted to avoid damage / further damage to interior linings.

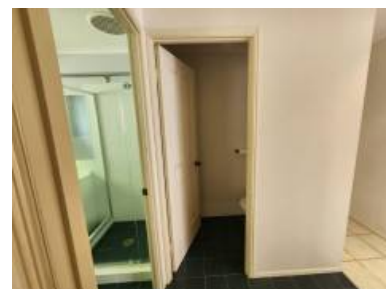
No lift off hinges present to the toilet door. This may comply with the date of construction however, this is a safety issue and therefore was included in this report. We recommend the installation of lift off hinges.

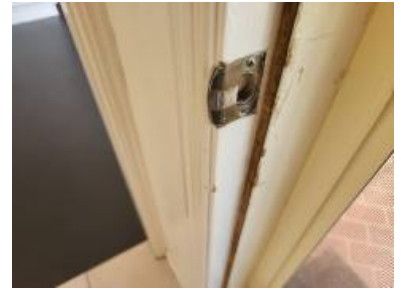
Paintwork to some door frames requires touching up / repainting.

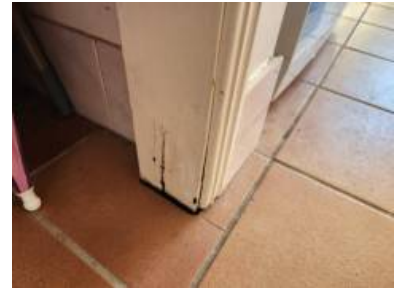
Base of the laundry cupboard door frame shows signs of past water penetration / damage and requires repair / repainting.

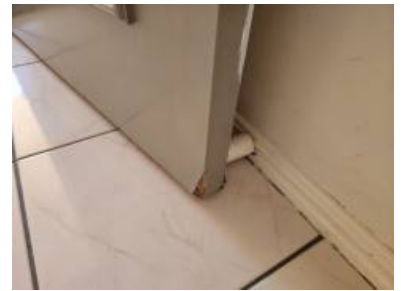
Damage to front door requires repair / sealing / painting.

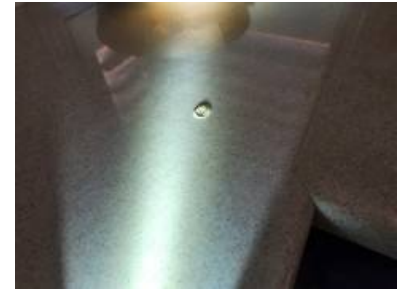
Burn mark to bench top.

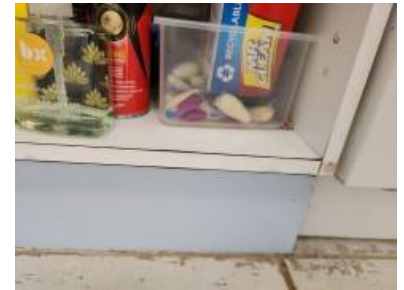
Evidence of past water penetration to sink cupboard.

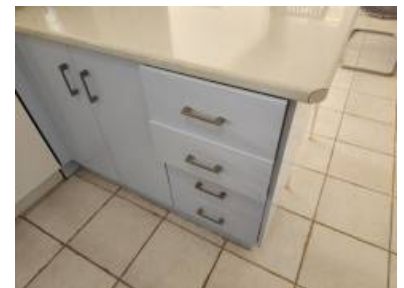
Some doors and drawers require adjustment.

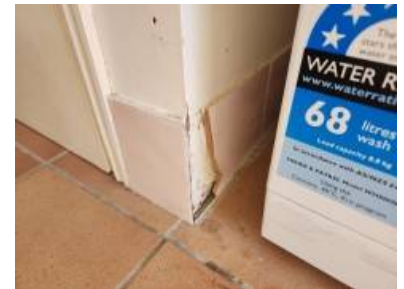
- Drummy / Cracked / Loose**
Broken skirting tile to laundry.

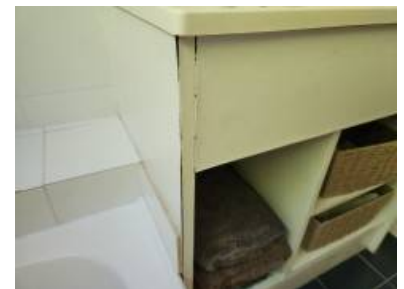
- Damage**
Signs of past water damage to Bathroom vanity cabinet.

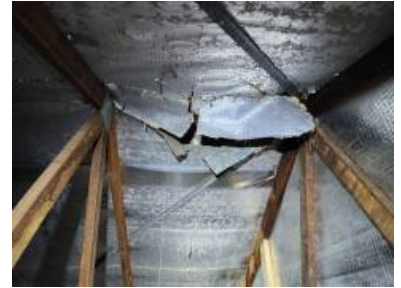
Some sarking paper requires refixing.

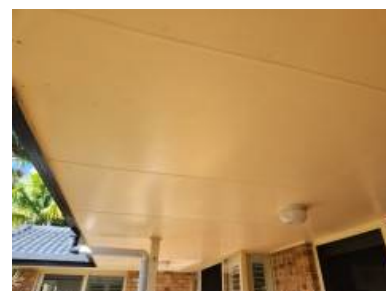
The external paintwork / finish to the external surfaces and timberwork is generally satisfactory. There are some sections / areas that require touching up / repainting.

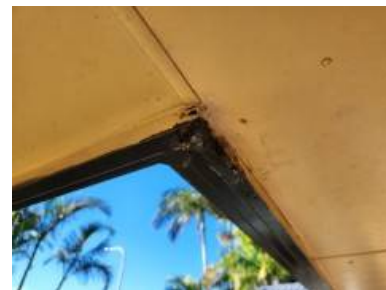
Some fascia joins show signs of weather damage and require repair.

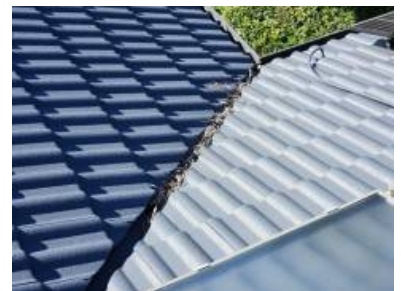
Condition:
Some sections of valleys are full of debris and require cleaning. Failure to do so may allow water to become blocked and back flow into the roof void causing water damage.

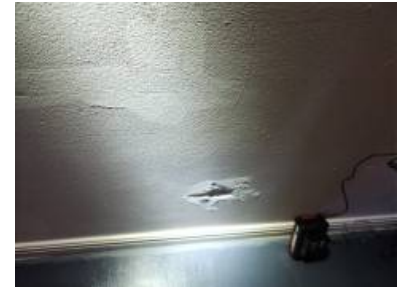
Some walls and ceilings require patching and painting.

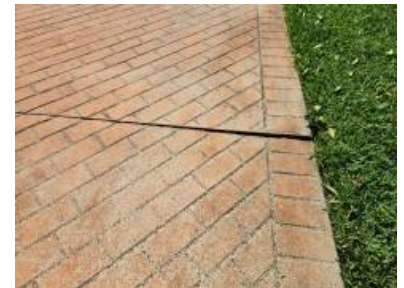
Driveway shows small signs of movement.

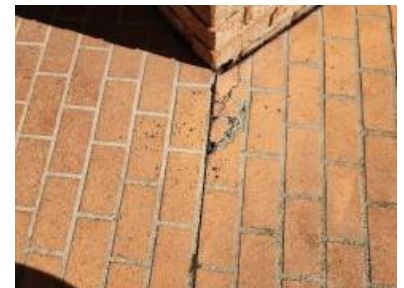
Some cracks to concrete slabs.
