# Building and Pest Report

## 5/24-26 Sunrise Cres Lennox Head

Report/Agreement #	150525091549445
Inspection Date:	15 May 2025
Inspection Time:	09:15 am

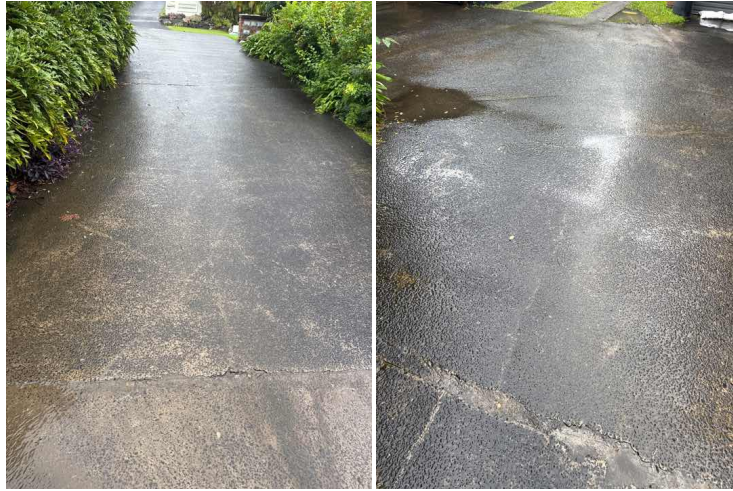
Common cracks were observed on the driveway. Whilst these cracks appeared to be typical at the time of inspection, we strongly recommend you monitor these cracks and if worsening occurs contact a concreter for further advice.

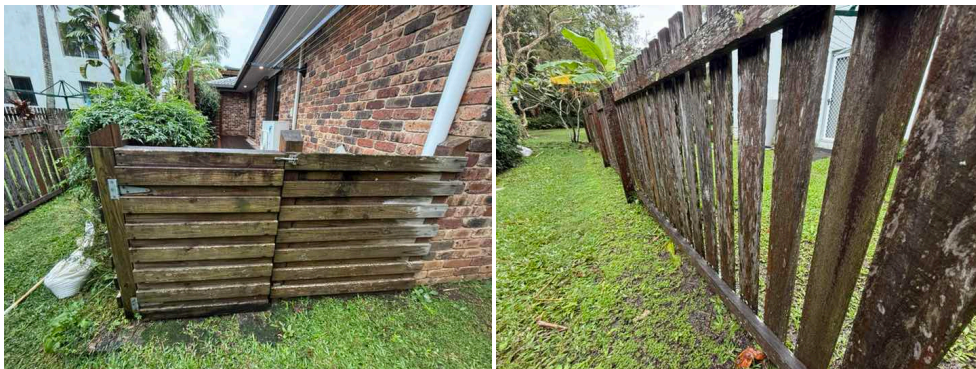
General age to fence components. General upkeep and maintenance required. A qualified fencing contractor should be engaged for repairs.

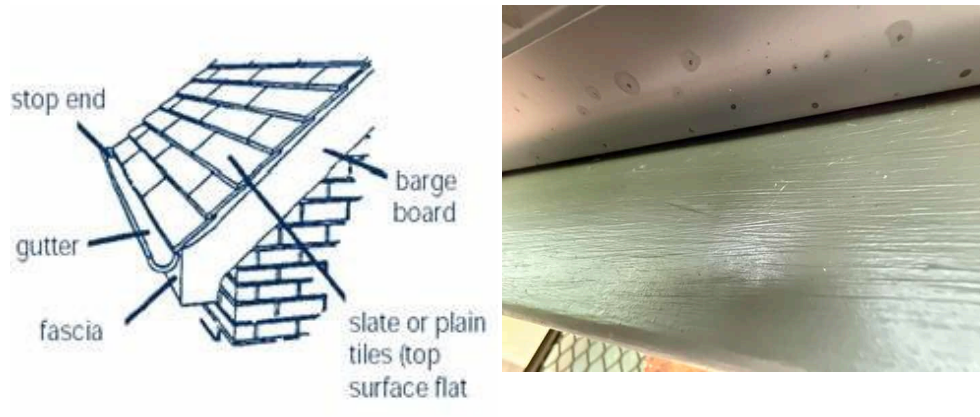
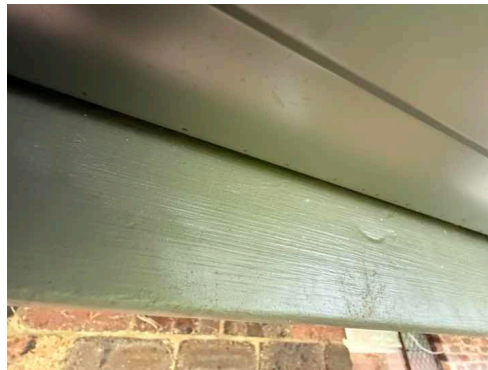
Timber fungal decay (rot) visible. Recommendations: A qualified carpenter should be engaged to replace all affected timbers.

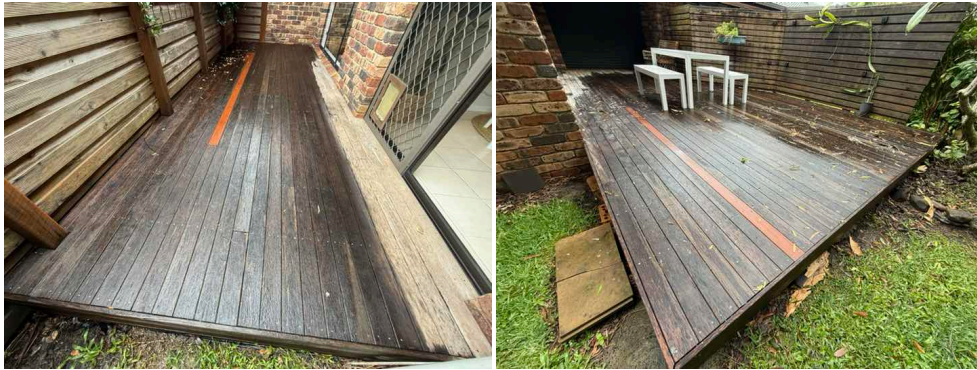
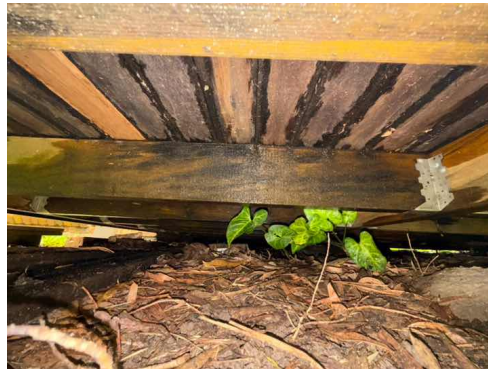
Of areas visible, minor defects and/or maintenance issues were visible. These will require assessment and subsequent repairs by a licensed tradesperson. Please read below for details. Please note that the inspector believes these to be of a minor nature relative to the age of the dwelling and or lack of proper and continual maintenance. Others, including other inspectors may differ in their opinions.

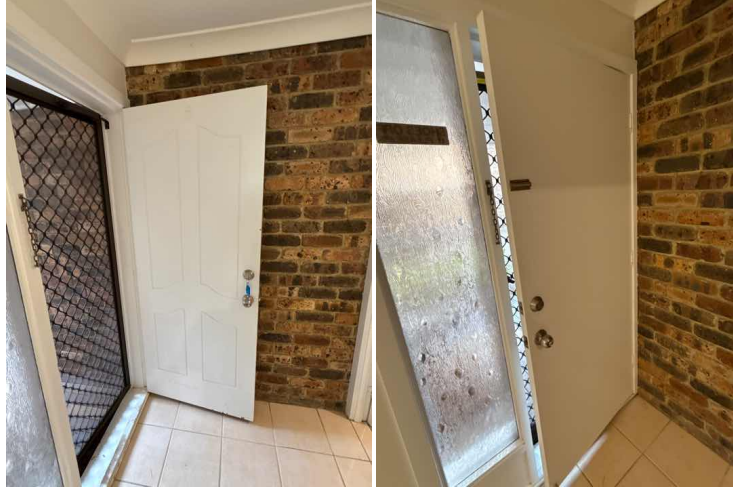
Binding entry door - Doors that bind on the frame can relate to some differential settlement, frame movement, age, expansion, shrinkage or poor hanging. A qualified carpenter should be engaged for repairs.

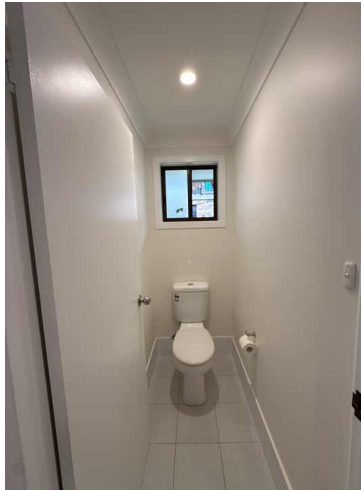
Door stop should be fitted - Wall damage from door handle impacting wall lining has occurred.  
Recommendations: A qualified carpenter should be engaged for advice and recommendations.

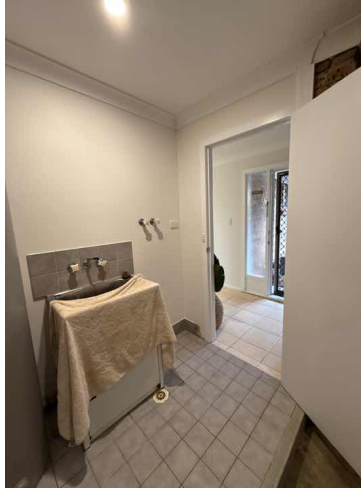
Damaged tile/s observed. Have repaired by a licensed tiler.
