Building and Pest Report

14 Gardenia
Street
Ballina

Inspection Report

14 Gardenia Street , Ballina, NSW, 2478

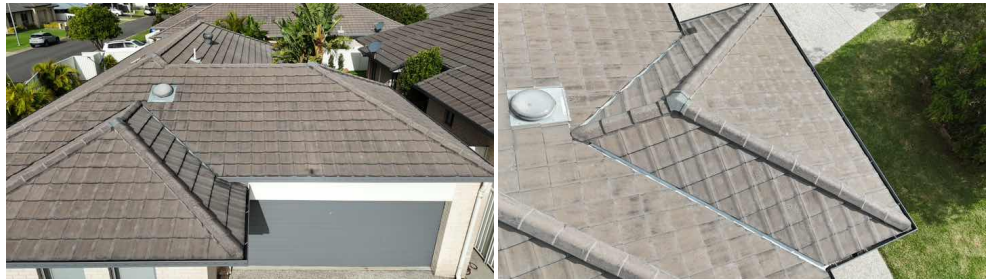
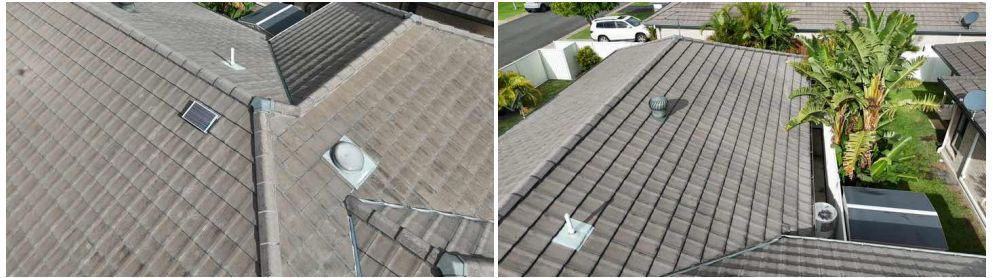
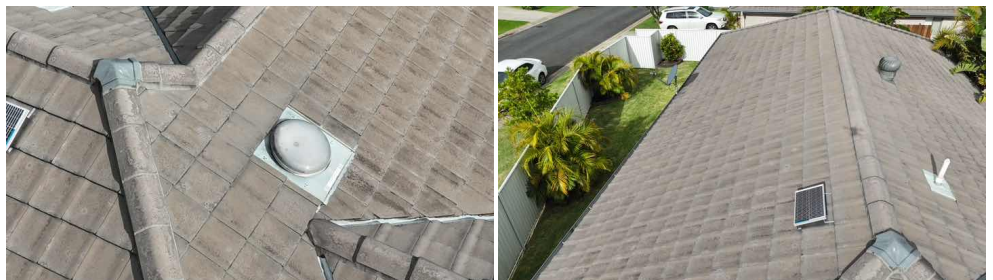
Of the visible areas, the general condition of the roof is in serviceable condition for the age.

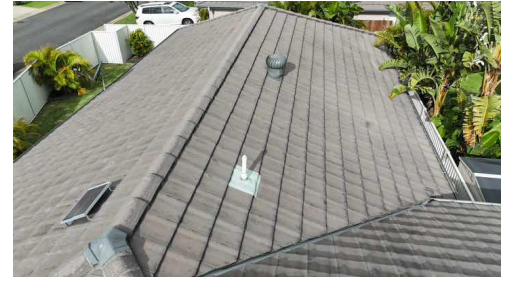
Guttering

All visible and accessible of the physical nature of the guttering system appears to be in a serviceable condition with no apparent defects at the time of inspection. In the absence of prolonged rain fall efficiency of the guttering can not be assessed and you may find that further investigation or repairs maybe required. Note: Periodic maintenance checks should be carried out for rust penetrations and leaks.

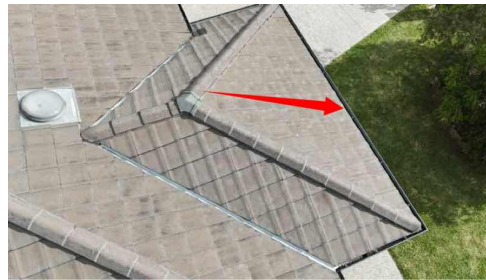
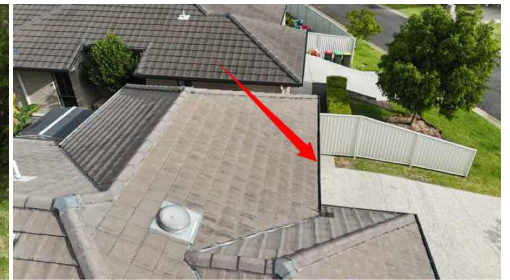
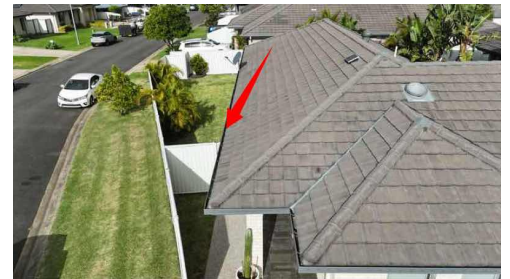
Downpipes

On visual inspection no apparent defects were noted to the down pipes and are considered serviceable, however no comment can be made with regard to blockages or connections to stormwater or functionality in the absence of rain. Note: Periodic maintenance checks should be carried out for rust penetrations and leaks.

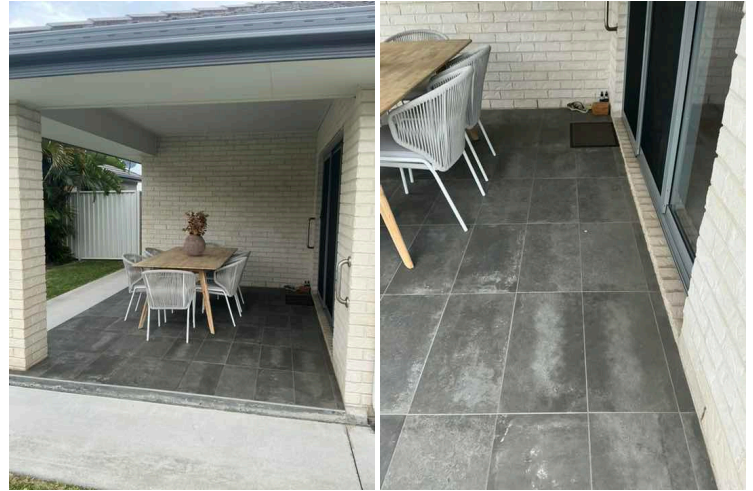
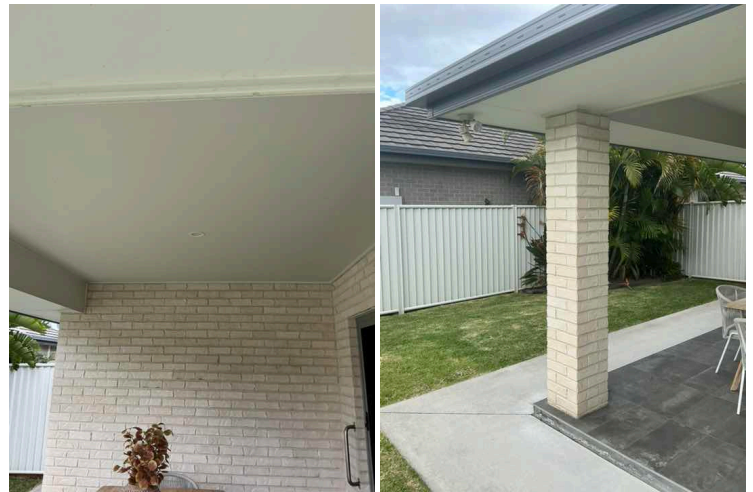
Visible sections of the Alfresco area are serviceable or in reasonable or condition for the age of this dwelling.

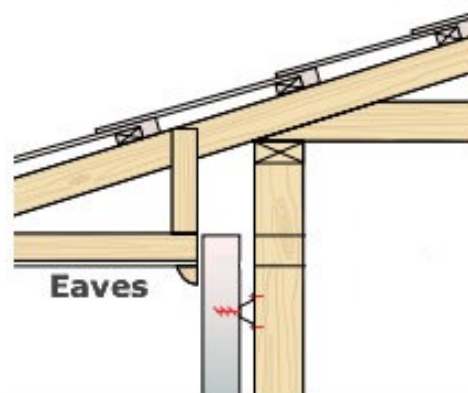
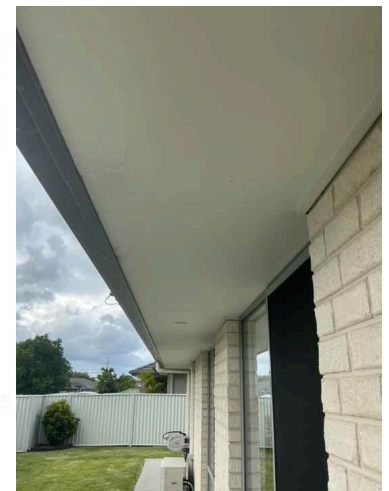
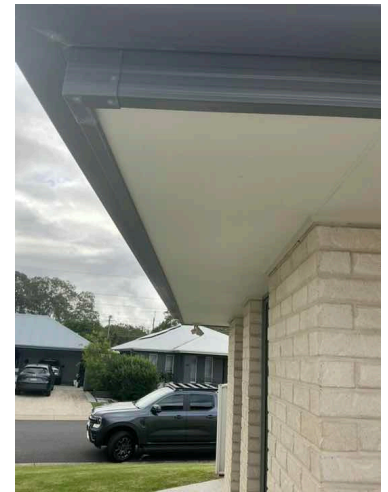
Eaves

The soffit lining (eaves) are in a serviceable condition with no notable defects.

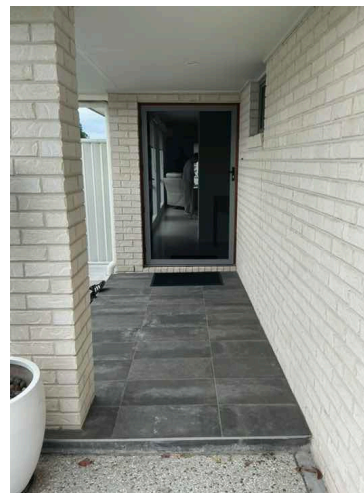
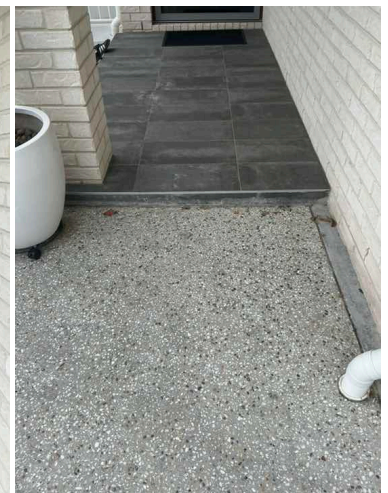
Entry Porch Area

The entry porch serviceable or in reasonable or condition for the age of this dwelling.

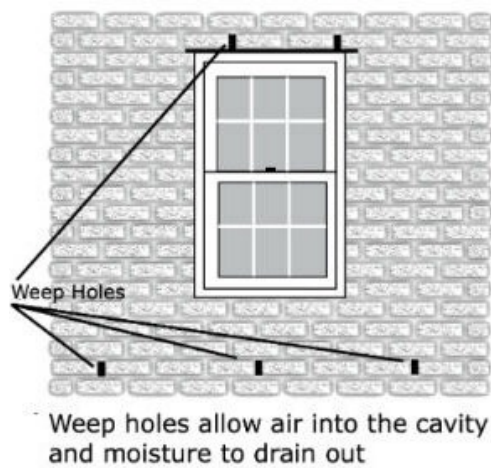
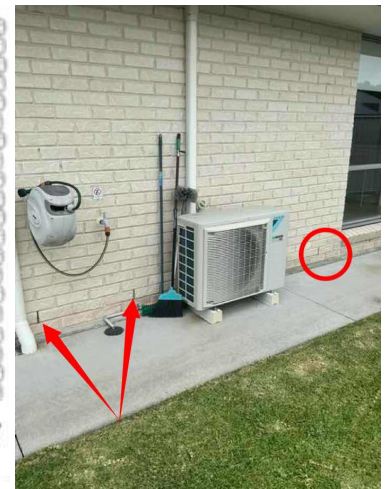
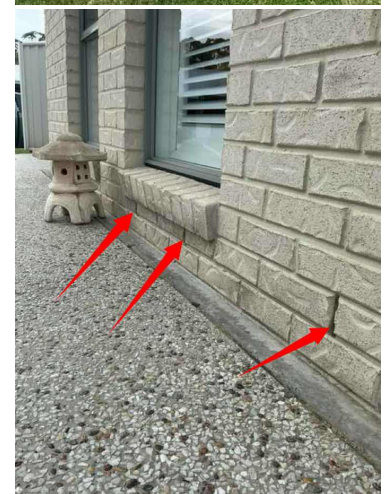
The weep holes are unobstructed .

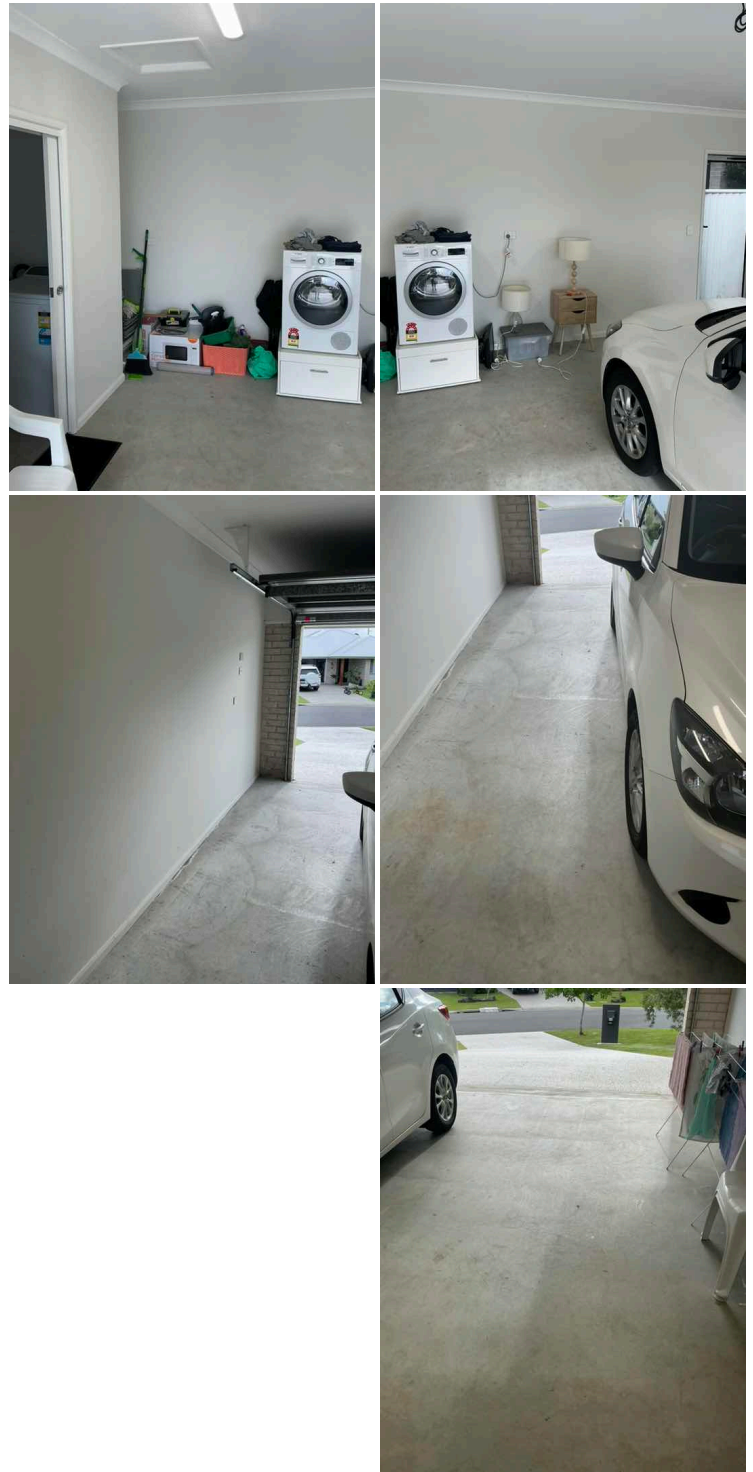
From the visible and accessible areas, the garage appears to be in a serviceable condition for the age of the property with no notable structural defects sighted.

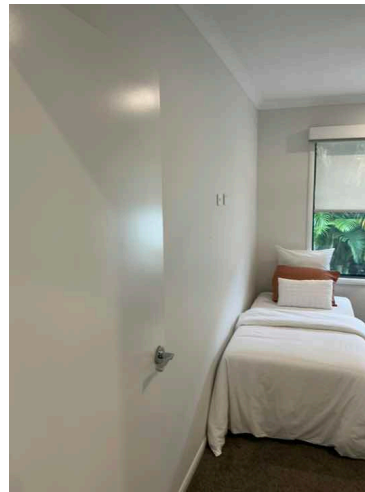
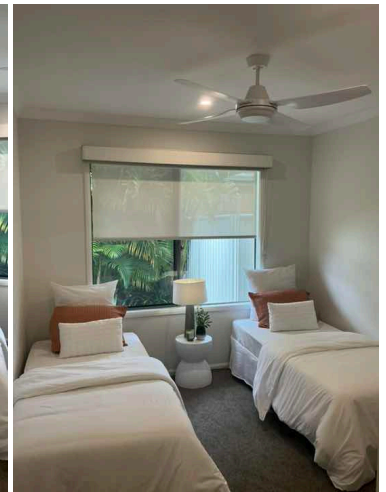
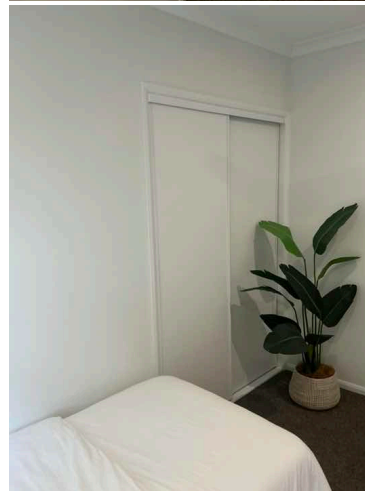
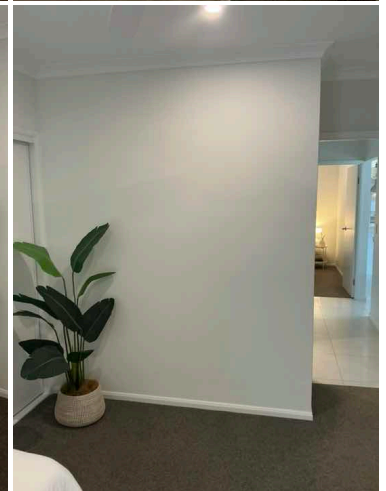
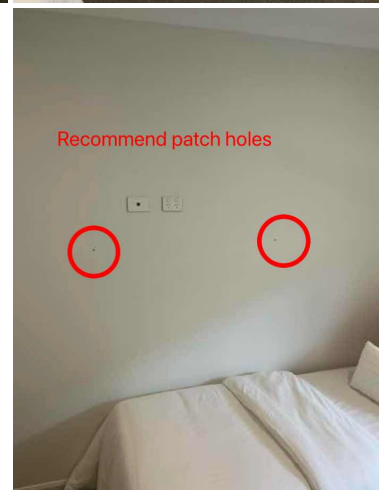
Bedroom 1

From the visible and accessible areas, this bedroom appears to be in a serviceable condition for the age of the property with no notable structural defects sighted.

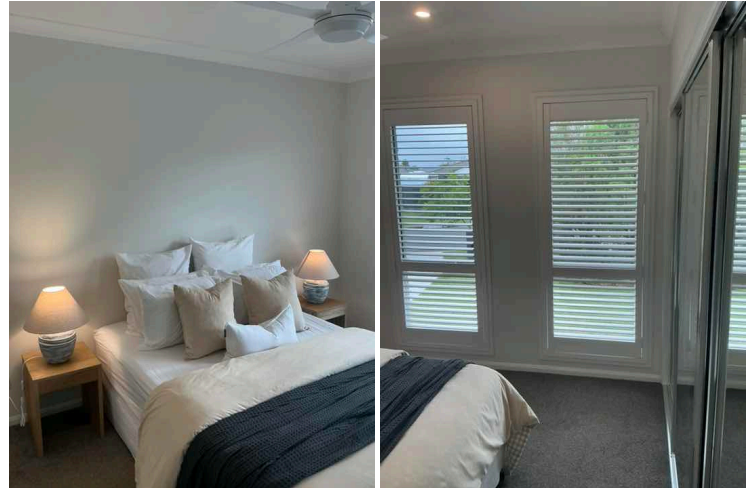
Bedroom 2

From the visible and accessible areas, this bedroom appears to be in a serviceable condition for the age of the property with no notable structural defects sighted.

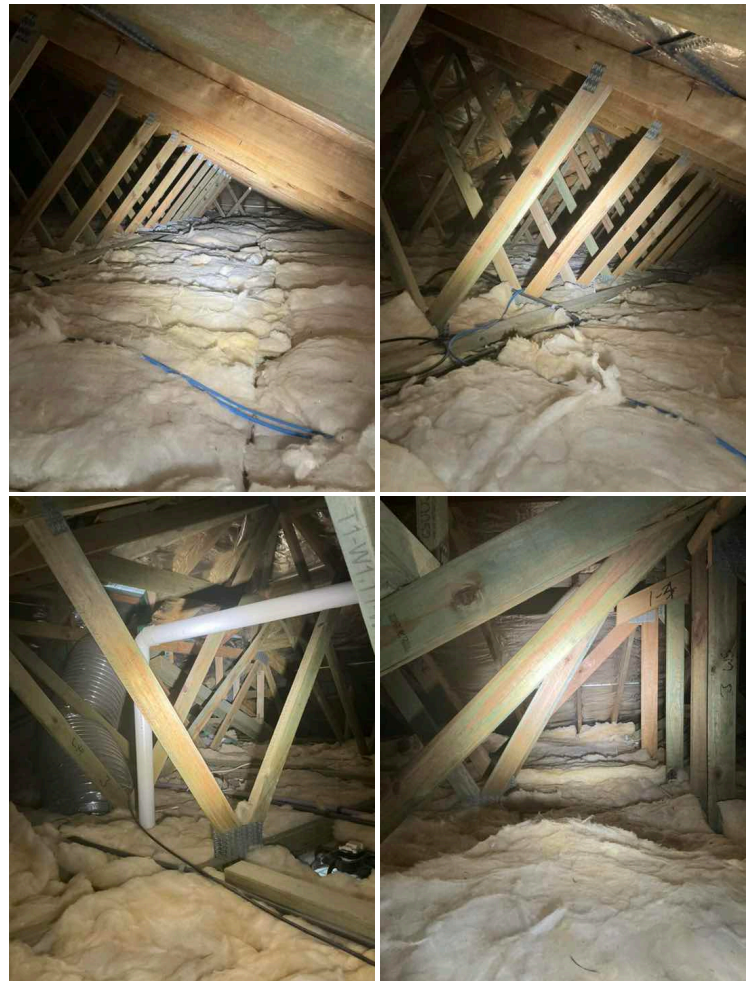
Visible sections of the roof void is in a serviceable condition for age of this dwelling.

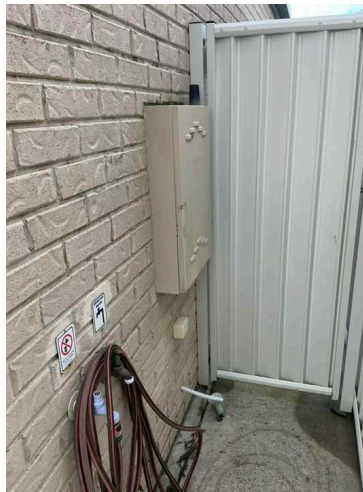
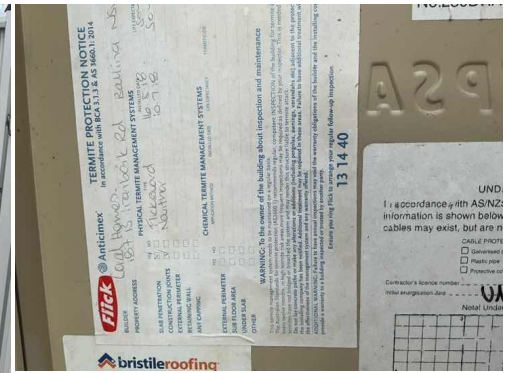
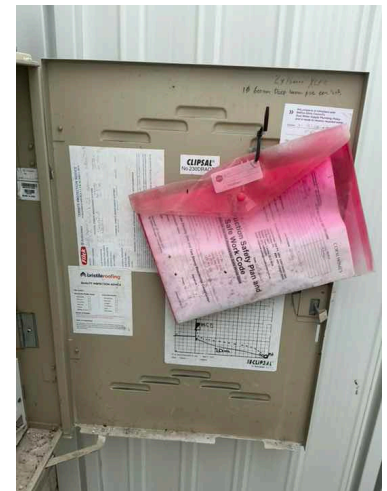
Yes, a durable notice was found in the meter-box during the inspection.
