# Building and Pest Report

## 8 Angus Kennedy Close, Lennox Head

# Inspection Report

**8 Angus Kennedy Close, Lennox Head, NSW, 2478**

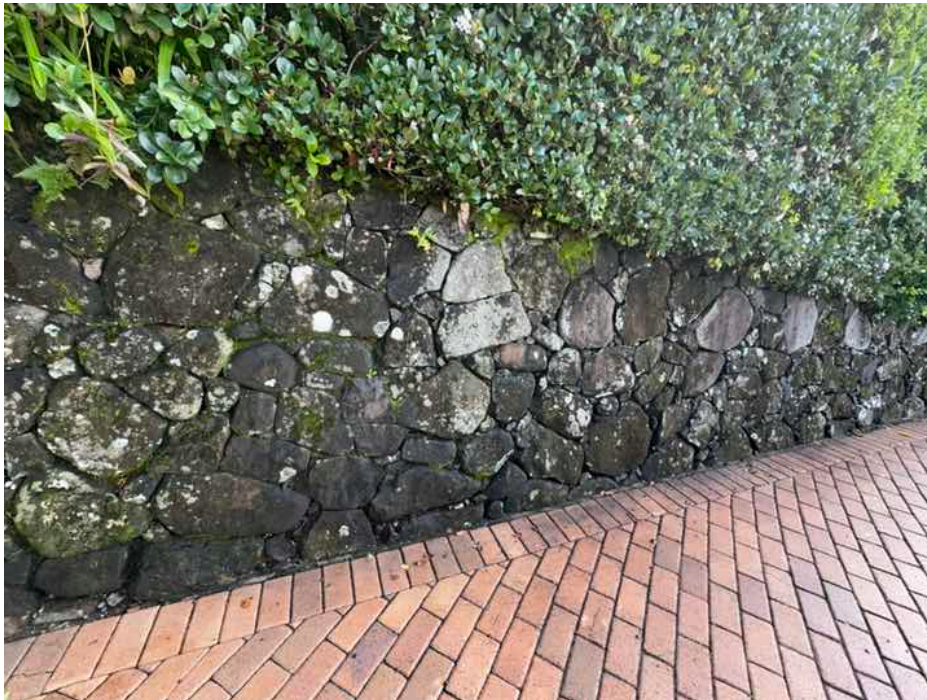
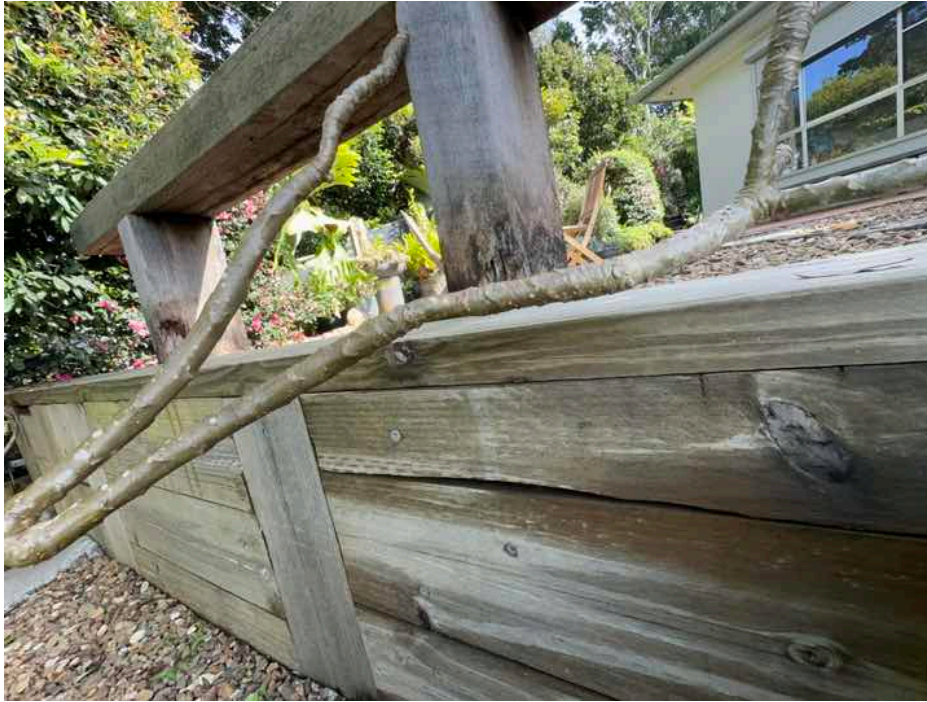
There was no visible evidence of excess ponding or fall towards the property walls at the time of the inspection. Regardless, it is difficult to ascertain in dry conditions and it is therefore recommended that you assess same after a rainfall period to be able to sufficiently ascertain if any problems exist in this regard. If water is ponding around perimeter walls and paths or appears to be flowing into the footings/foundations you must have assessed by a qualified plumber or landscaper.

Recommend installing a drainage point under the tap to assist with drainage.

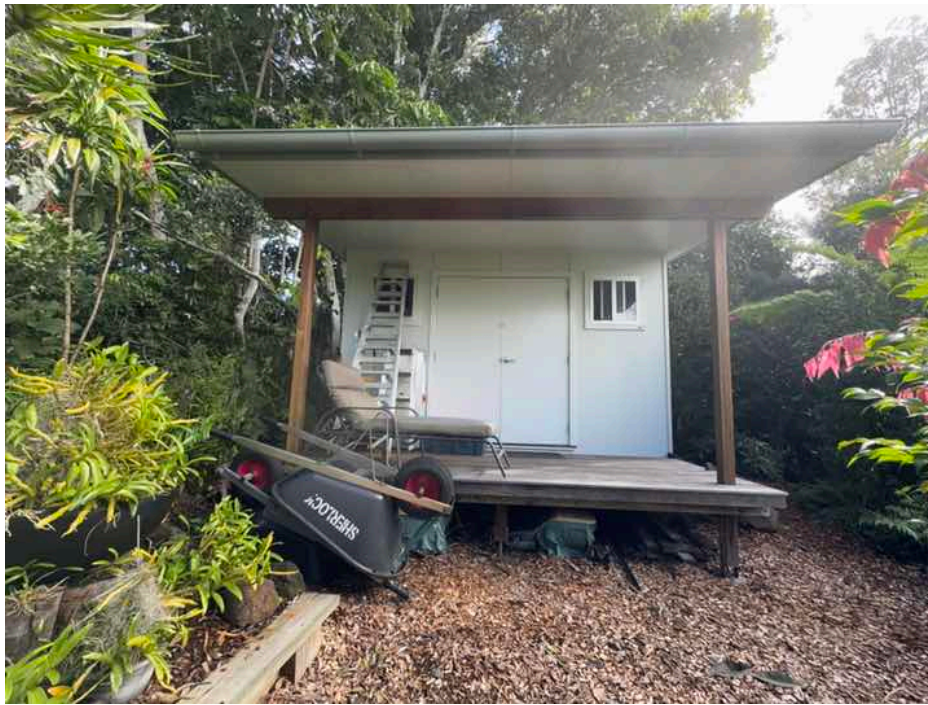
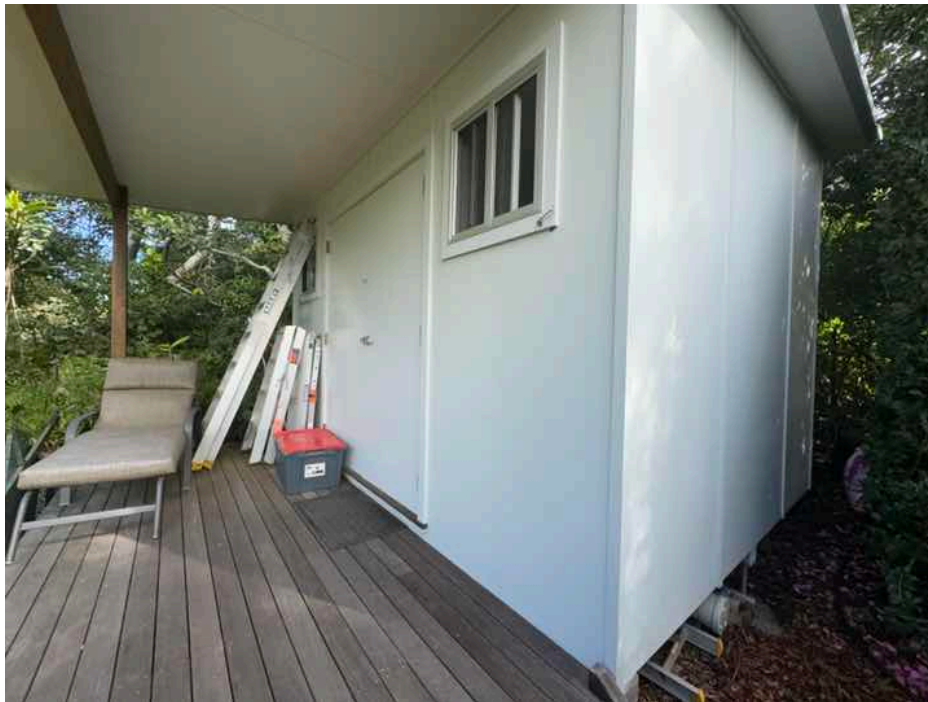
The shed is in fair usable condition.

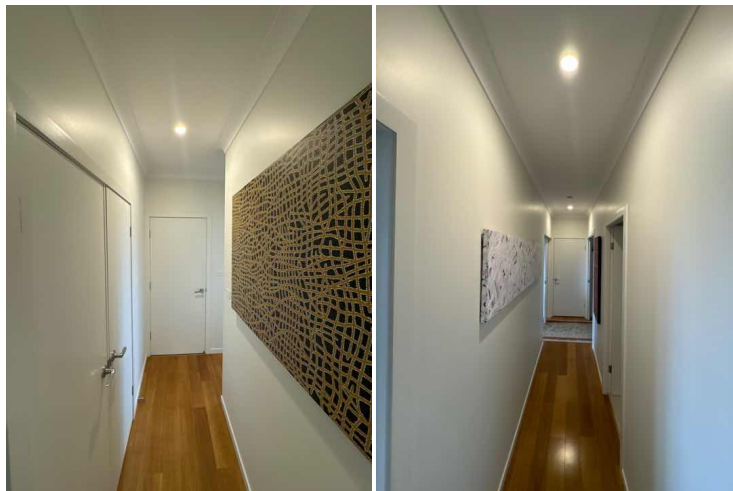
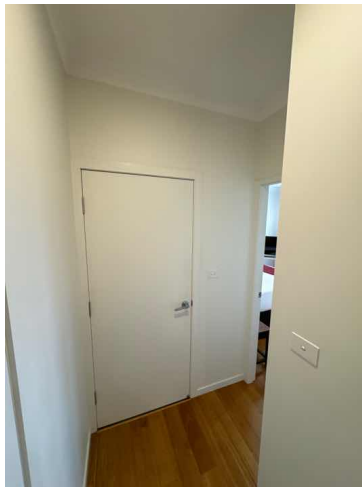
Typical cornice separation/detachment observed. I recommend you contact a qualified painter for repairs.
