# Building and Pest Report

## 1/28 Kell Mather Drive Lennox Head

### Pest And Building Inspection

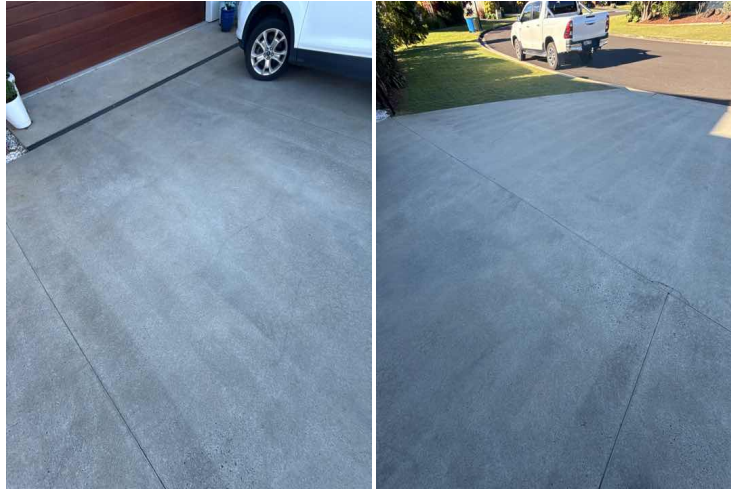
Common cracks were observed on the driveway. Whilst these cracks appeared to be typical at the time of inspection, we strongly recommend you monitor these cracks and if worsening occurs contact a concreter for further advice.

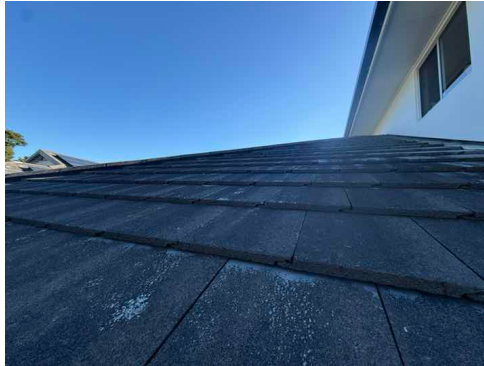
Of the visible areas, the general condition of the roof is in serviceable condition for the age.

Note: In the absence of rainfall there is no guarantee that the roof won't leak.

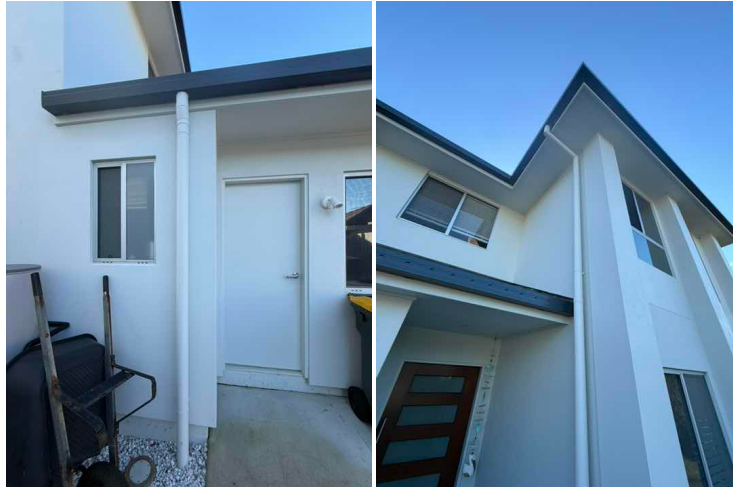
On visual inspection no apparent defects were noted to the down pipes and are considered serviceable, however no comment can be made with regard to blockages or connections to stormwater or functionality in the absence of rain. Note: Periodic maintenance checks should be carried out for rust penetrations and leaks.

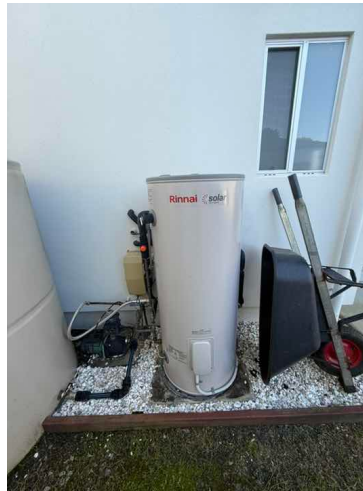
The hot water system appears to be in a serviceable condition. No specific tests other than running the hot water from a tap was carried out. No determination has been made as to the suitability or adequacy of the hot water system in relation to capacity or otherwise.

The make of the hot water unit is rinnai.

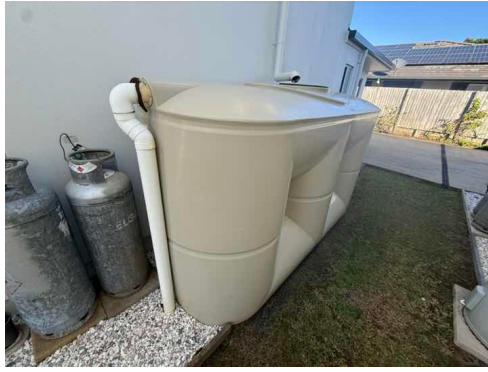
On Visual Inspection the water tank appears serviceable, but should be checked by a qualified plumber.

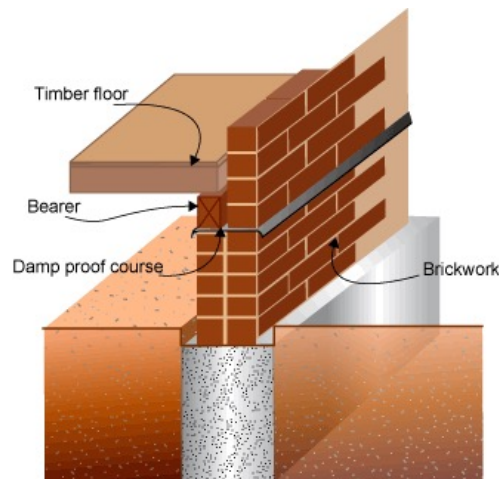
A damp proof course is not visible or could not be visually identified. This may cause rising damp issues. Contact a specialist in this field to further investigate and make recommendation.

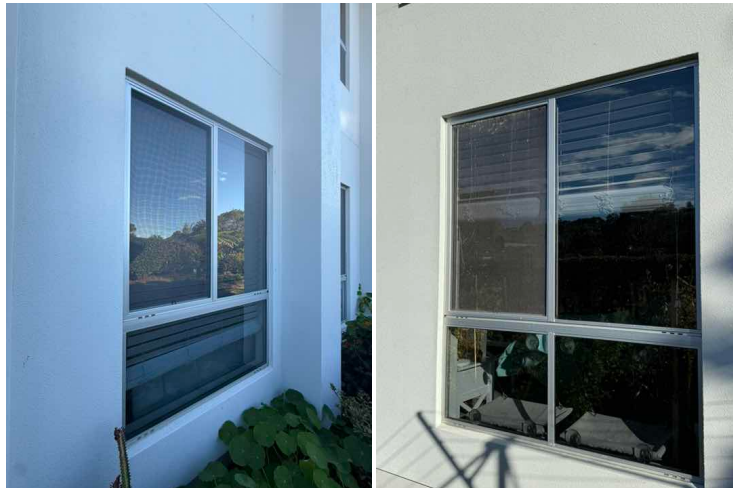
On visual inspection, the general condition of the windows is serviceable for the age.

Damaged fly screen/s replace as required.

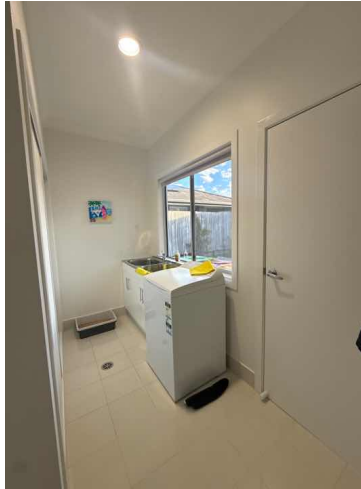
Of the visible areas, the general condition of the laundry is serviceable or in reasonable condition for age of dwelling.

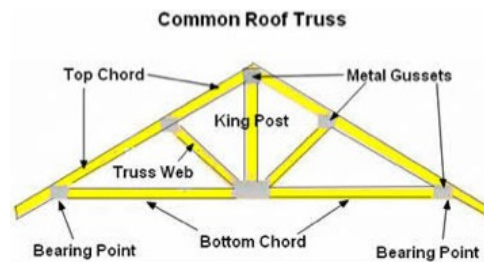
There is insulation present in the roof space/void. This is preventing a full inspection of ceiling joists from being undertaken. It is strongly recommended that full access be gained as it could be harbouring timber pest activity, damage or defects.

There is low clearance in areas throughout the roof void which is preventing a full/thorough visual inspection taking place. It is strongly recommended that full access be granted to enable a thorough inspection to take place as it could be harbouring timber pest activity, damage or defects.

There is sarking present in the roof space/void. This is preventing a full inspection from being undertaken. It is strongly recommended that full access be gained as it could be harbouring timber pest activity, damage or defects.

The roof frame is a truss timber frame.
