PEST AND BUILDING PRE-PURCHASE REPORTS

BPI BUILDING & PEST INSPECTIONS

31 Linderman Street
West Ballina

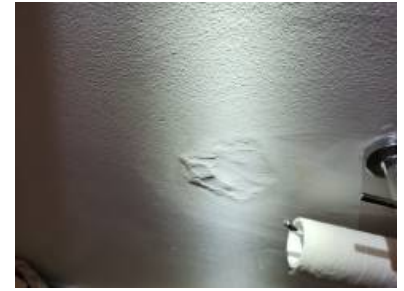
Some wall sheeting shows evidence of past patching to toilet.

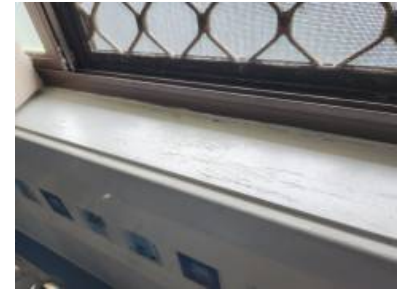
Kitchen window reveal require repainting.

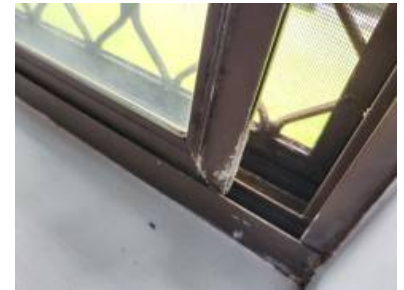
Some windows show evidence of minor corrosion beginning.

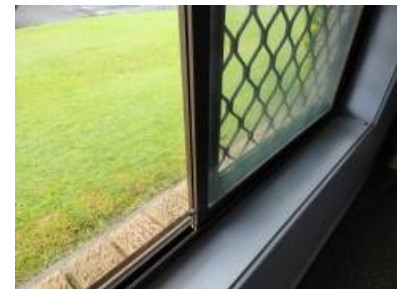
Some window slider rollers show signs of wear or are worn and require lubrication / replacement. New slider cliplocks required to some windows.

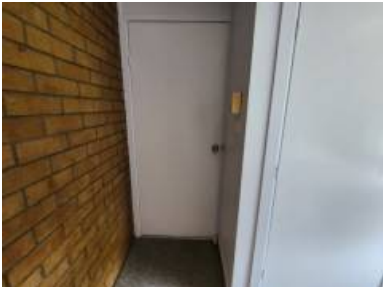
Some doors show signs of binding and require repair / easing / adjustment.

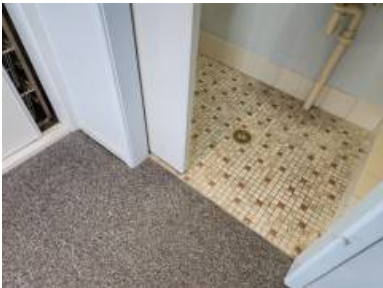
Door guide required to the bottom of the sliding door.

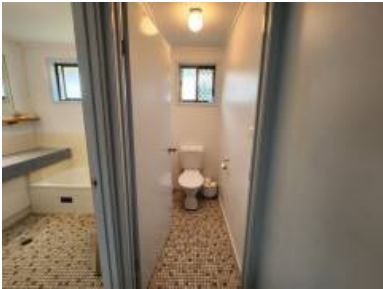
No lift off hinges present to the toilet door. This may comply with the date of construction however, this is a safety issue and therefore was included in this report. We recommend the installation of lift off hinges.

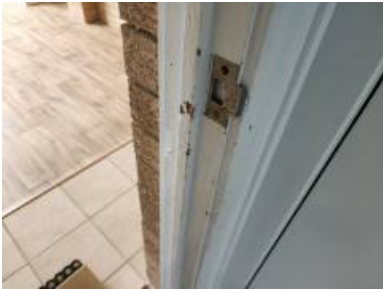
Paintwork to some door frames requires touching up / repainting.

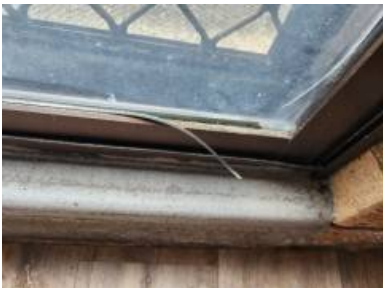
External glass sliding door glazing seals have hardened / perished / shrunk and require repair / replacement to old garage sliding door.

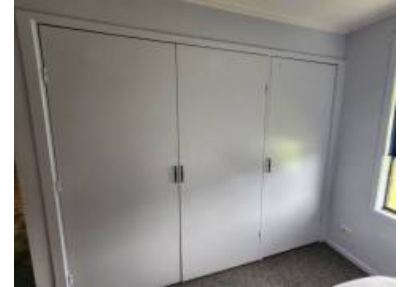
Some doors show signs of binding and require repair / adjustment.

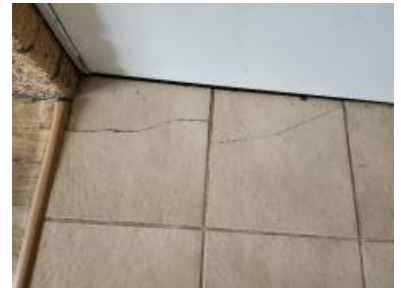
Cracks to some floor tiles to Back door and front door.

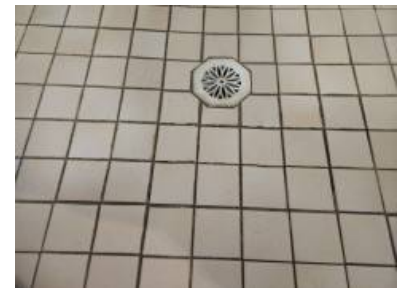
Some Ensuite floor tiles require regrouting & resealing.

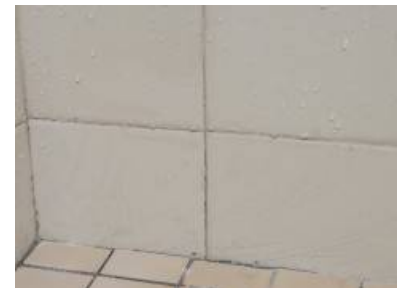
Some hairline cracks to some wall tiles at the base of the ensuite shower.

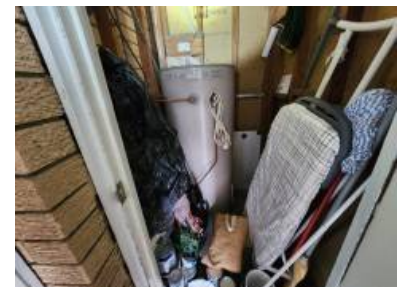
The hot water system is located inside and no overflow tray is present. I recommend the installation of an overflow tray to the base of the hot water system or have the system relocated outside. This is to aid in preventing potential water leaks / damage.

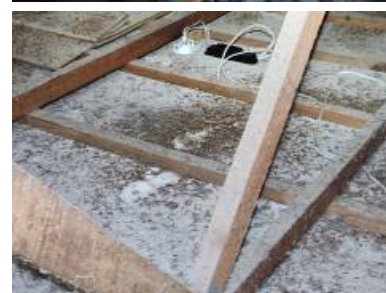
There is evidence of past water penetration within the Roof Void.

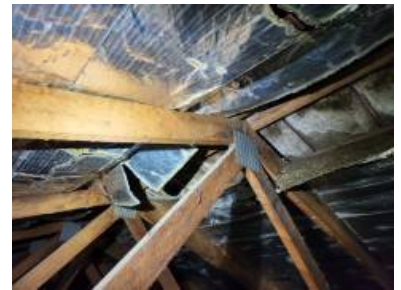
Sarking paper is showing signs of deterioration and requires repair or replacement.

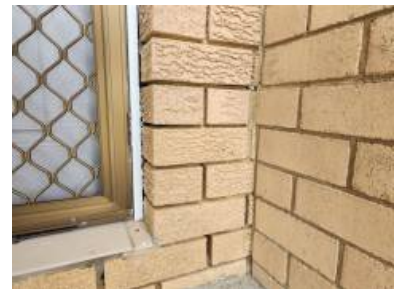
Some mortar to some brickwork next to front door shows signs of erosion and requires repair / patching. I recommend that a qualified bricklayer be engaged for further investigation / rectification.

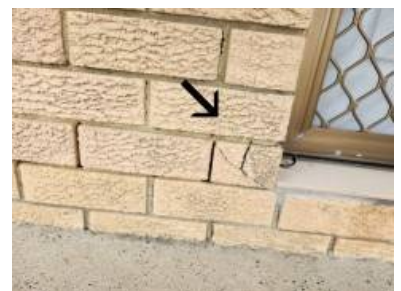
1 cracked brick to front entrance needs replacing.

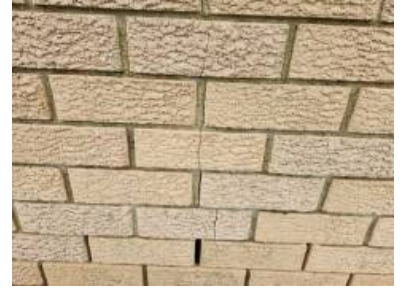
Cracks to brickwork at Kitchen eastern side.

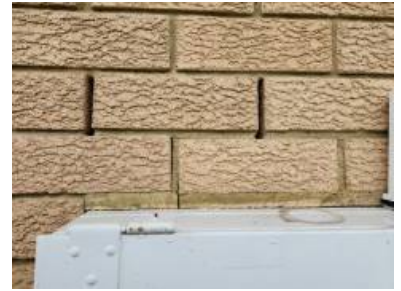
Mortar cracks to brickwork above meter box.

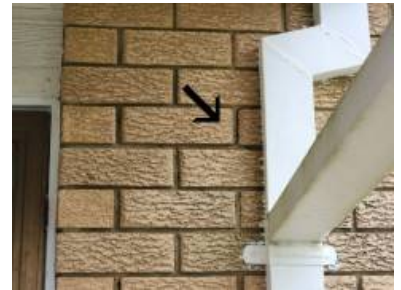
Mortar cracks to brickwork at southern side of front door.

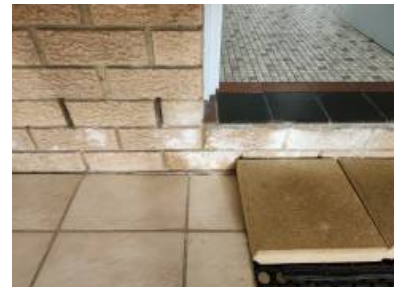
The bases of some brickwork shows signs of efflorescence. Efflorescence is caused when the brickwork absorbs soil moisture and dries out leaving mineral / salt deposits behind (white powder). That the efflorescence is confined to the brickwork below the damp proof course indicates that the damp proof course is doing its job.

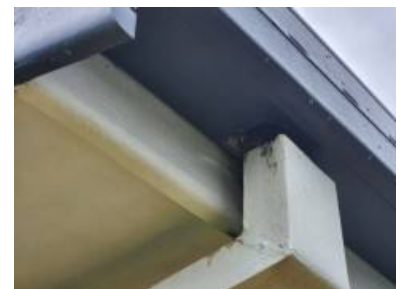
Condition:
Gutter needs new downpipe out let.

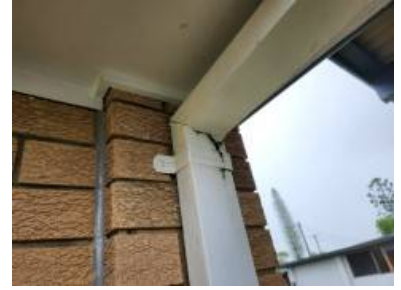
Some gutter and downpipe joins are leaking and require re-sealing.

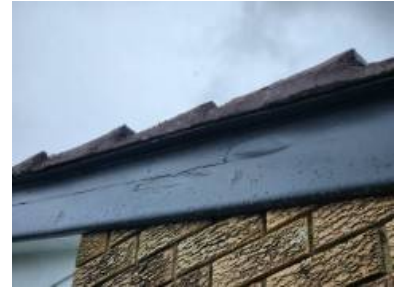
Some fascia timbers show signs of weather damage and require repair.

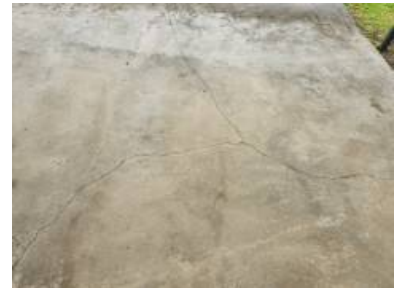
Some surface cracks to concrete slabs.

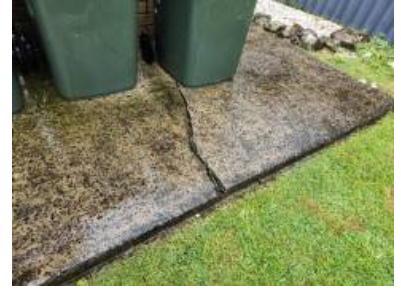
Some concrete slabs show signs of cracking & movement.

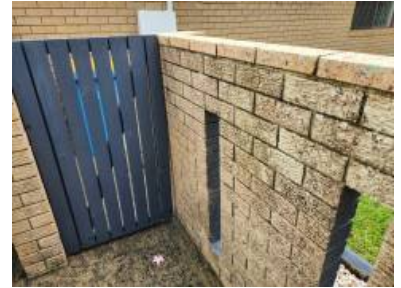
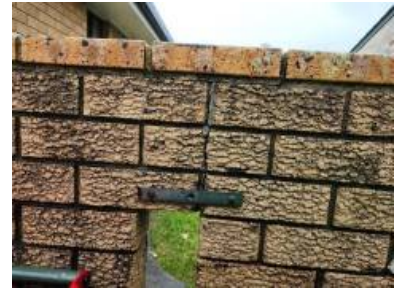
Some fencing shows signs of movement.

Crack to top of brick fence.
