# PEST AND BUILDING PRE-PURCHASE REPORTS

# BPI BUILDING & PEST INSPECTIONS

57 Survey Street  
Lennox Head

### **REPORT TABLE OF CONTENTS**

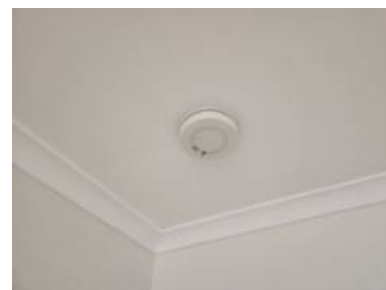
Present - Lounge, Additional smoke detector(s) should be located to ceiling(s) at Within 3 meters of bedroom entrances.

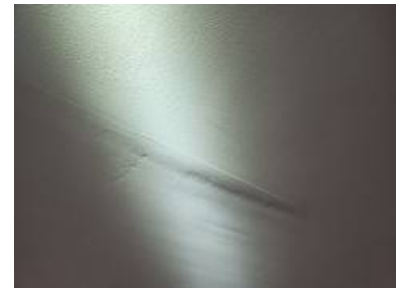
Minor cracks to some ceiling sheet joins.

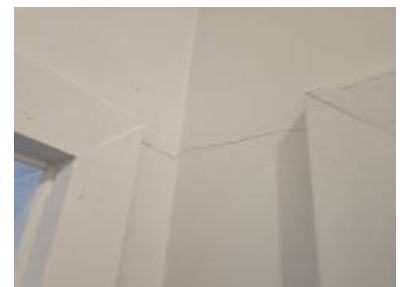
Minor crack to wall sheet join to Hallway.

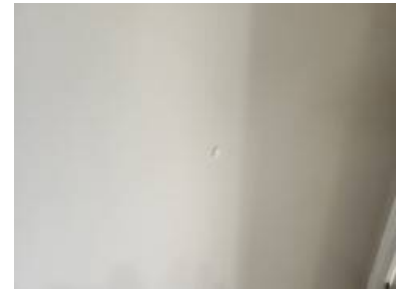
Hole behind door handle requires patching / painting. I recommend that a door stop / catch be installed to protect the wall sheeting from further damage.

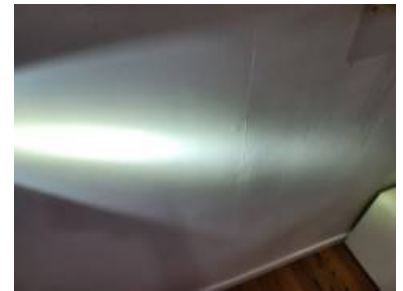
Minor crack to wall sheeting to under stairs.

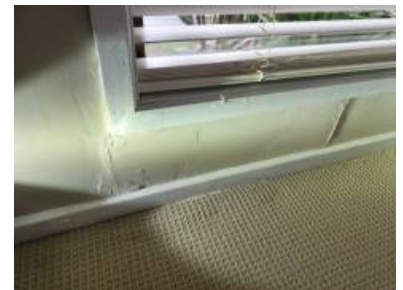
Undulations to some sheet joins under bedroom window need repair.

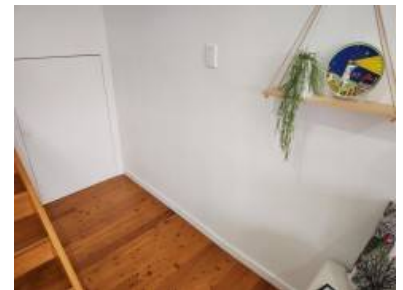
Some walls show signs of bulging to under stairs.

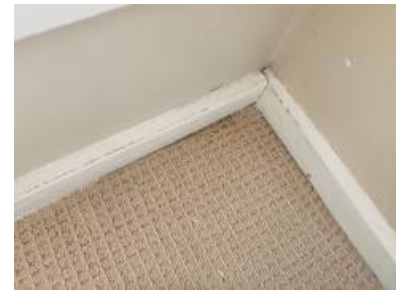
Some architraves require patch and Paint.

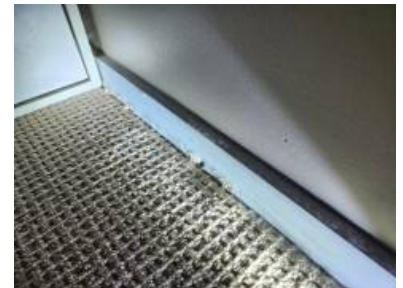
Signs of past water penetration to skirtings at Walk in robe behind bathroom.

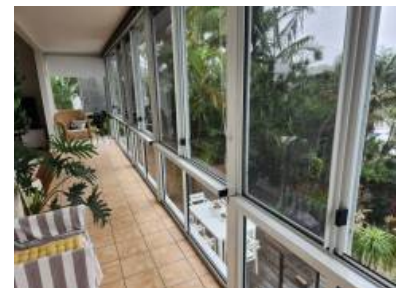
We recommend that all openable Bedroom windows over 2m above the external ground level have safety devices fitted that limit the window opening to a maximum of 125mm or have security grills installed. This is a safety hazard.

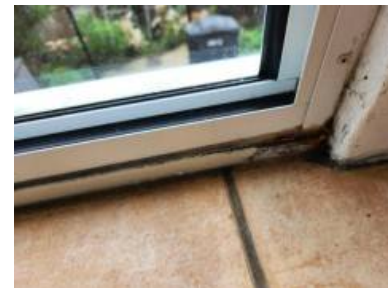
Some windows show evidence of minor corrosion and require maintenance / repair.

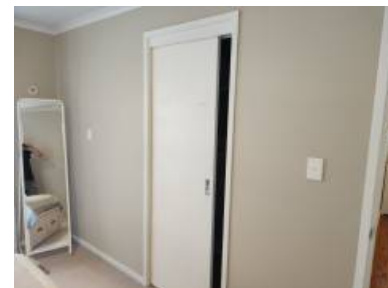
Internal sliding door requires maintenance / adjustment.

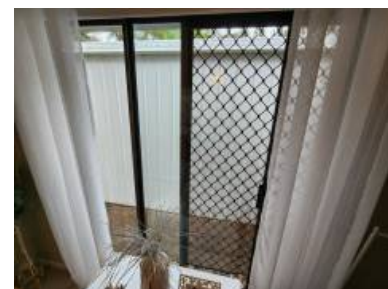
Some external slider rollers require repair / maintenance / lubrication.

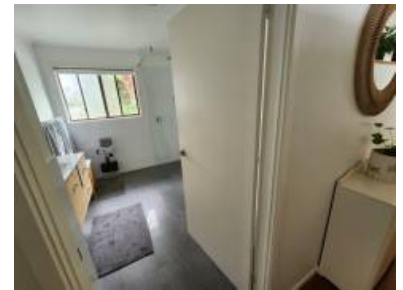
No lift off hinges present to the toilet door. This may comply with the date of construction however, this is a safety issue and therefore was included in this report. We recommend the installation of lift off hinges.

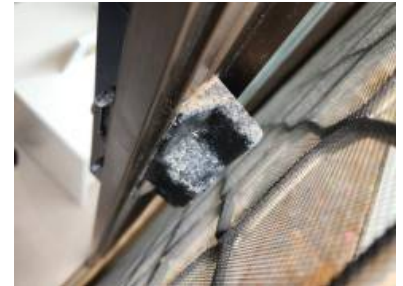
Signs of corrosion to some external door handles.

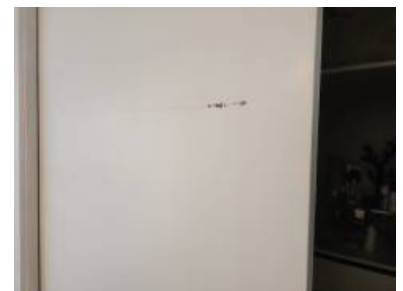
Paintwork to ensuite door requires touching up / repainting.

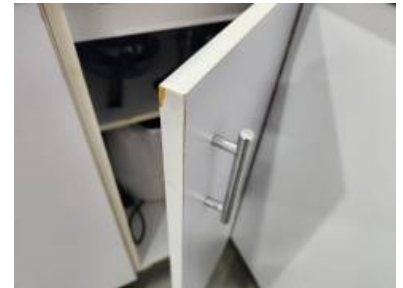
The Kitchen cabinetry / bench tops / laminate show evidence of general wear & scratches.

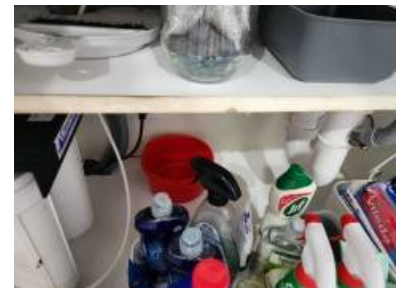
Evidence of minor water penetration to sink cupboard & shelving below sink.

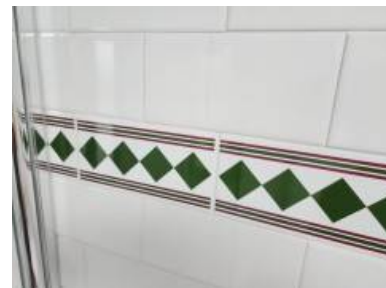
Cracks to some wall tiles to Bathroom lower level.

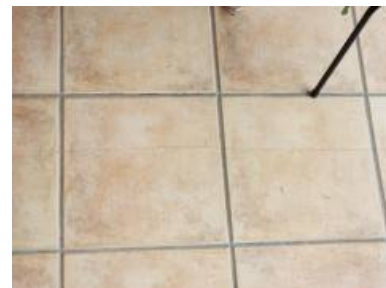
Cracks to some floor tiles to Top floor.

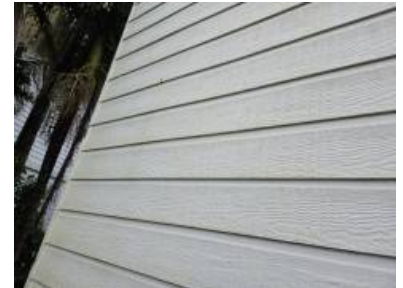
Condition:  
The external paintwork / finish to the external surfaces and timberwork is generally satisfactory. There are some sections / areas that require touching up / repainting.

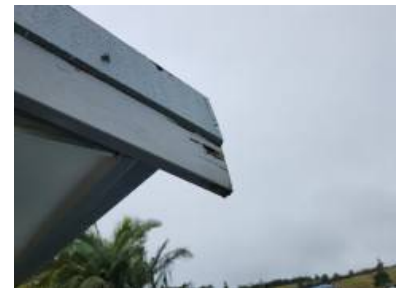
Condition:  
Some fascia timbers show signs of weather damage and require repair.

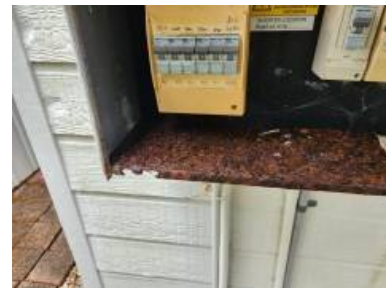
Meter box is showing signs of rust and requires replacement.

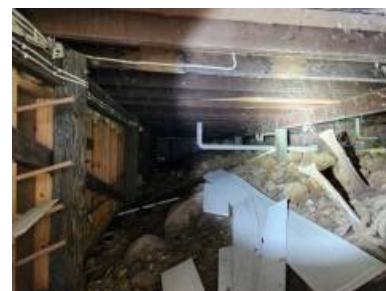
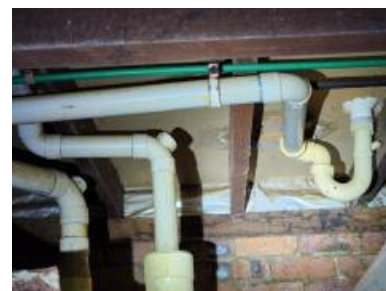
Some flooring shows signs of past water penetration to Bathroom.

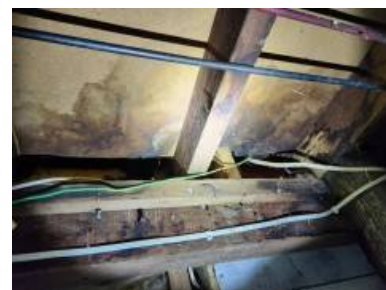
Some flooring shows signs of water damage to hallway middle floor near end bedroom and end bedroom under window.

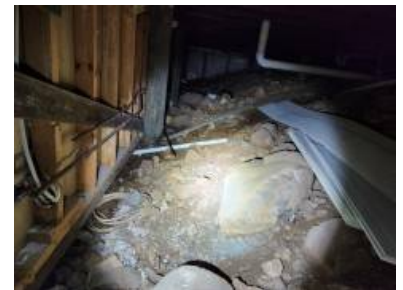
There are signs of past water ponding within the subfloor area.

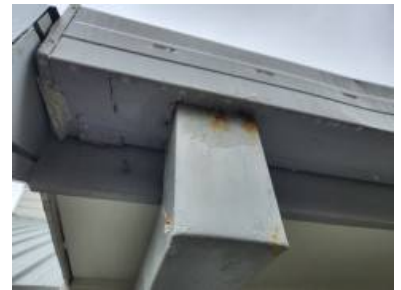
Some gutters and downpipes show signs of rust and require repair / painting with Killrust or better.

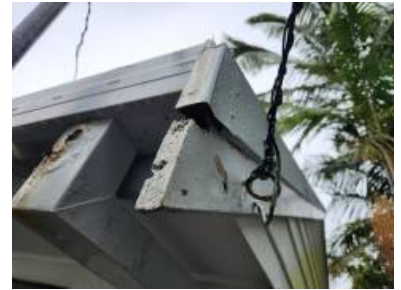
Some fascia timbers show signs of weather damage and require repair.

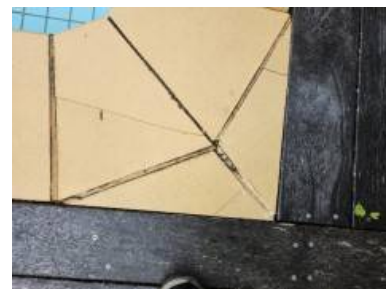
I recommend a qualified swimming pool builder / specialist be engaged for further inspection of the swimming pool. Cracks to some coping tiles.

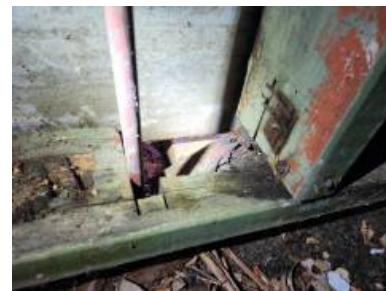
Some framing timbers. Some flooring timbers.

The visible damage to the timbers appears to be moderate. Further damage may exist in concealed areas. Please refer to the definitions section of this report - Section 1.2 - Timber Damage.

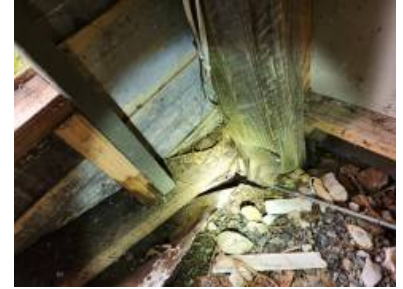
- Some underfloor timbers are in contact with soil. These should be modified so that timber to soil contact does not occur as timbers in contact with soil are highly attractive to termite attack.

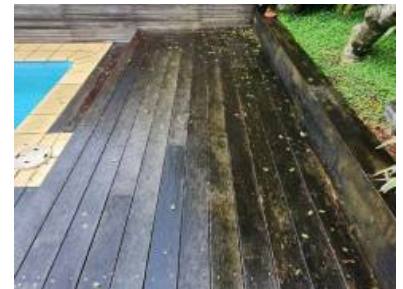
There is insufficient crawl space below decking timbers due to the method of construction. See Section 2.0 - Reasonable Access.

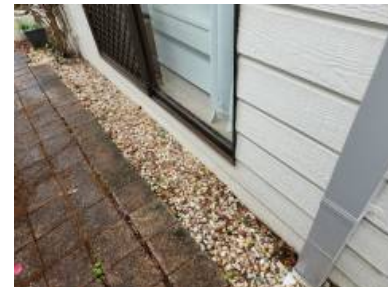
- The bases of some external cladding is in contact with ground / soil. This may allow concealed termite entry. We recommend modifications be made so that the base of the cladding is not in contact with the ground / soil (by creating a 75mm visual barrier) or have them treated with termiticide.
