Building and Pest Report

100 Phoenix Drive, Tintenbar

Inspection Report

100 Phoenix Dr, Tintenbar, NSW, 2487

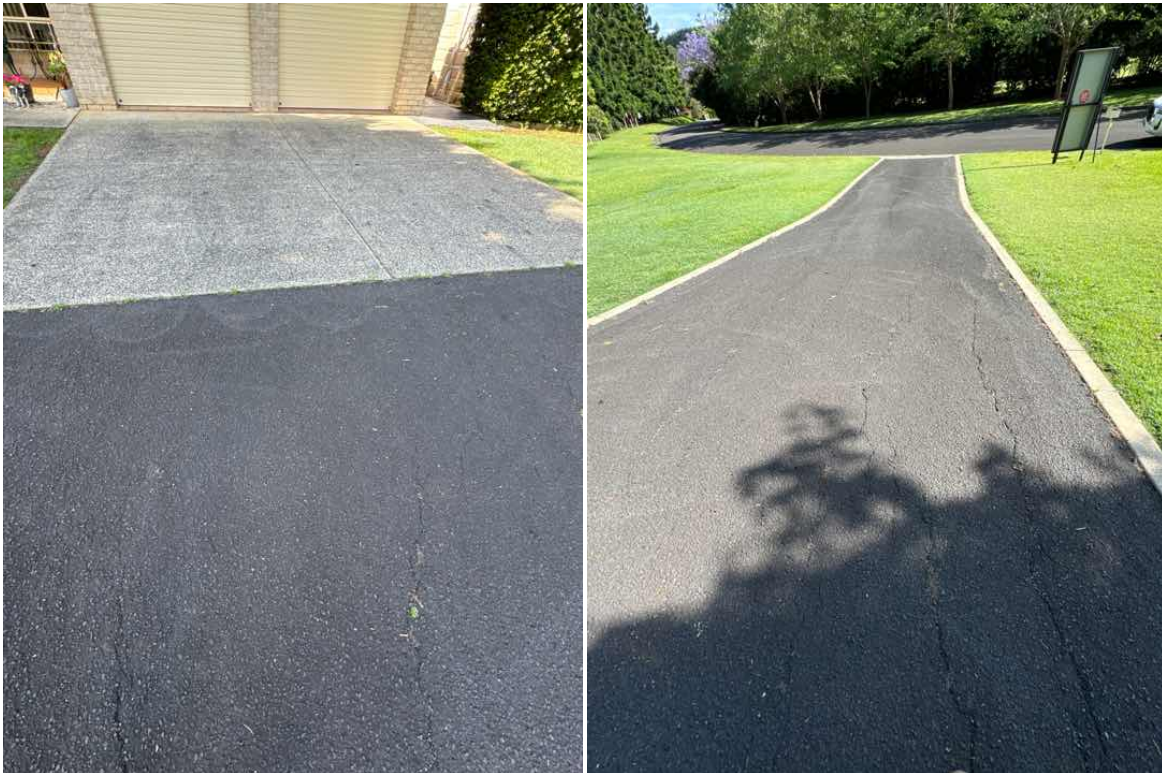
On visual inspection, the general condition of the driveway is serviceable.

Common cracks were observed on the driveway. Whilst these cracks appeared to be typical at the time of inspection, we strongly recommend you monitor these cracks and if worsening occurs contact a concreter for further advice.

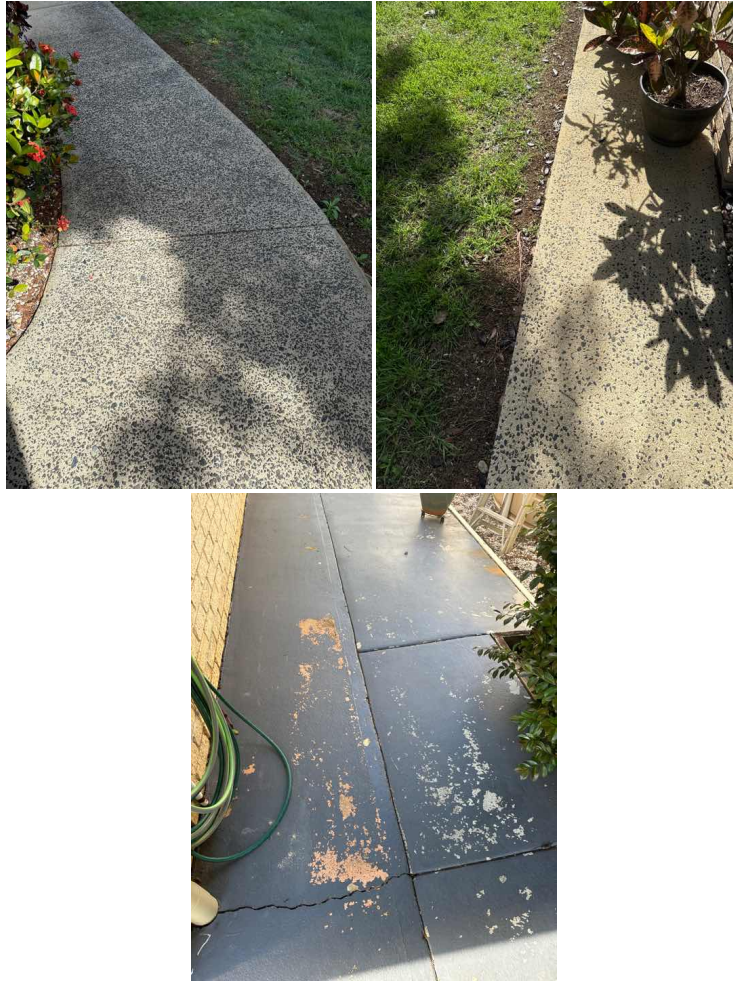
The paths around the home are in a serviceable condition for the age of this dwelling with no major defects visible.

Common cracks and settlement were observed on paths. Whilst these cracks appeared to be typical at the time of inspection, we strongly recommend you monitor these cracks and if worsening occurs contact a concreter for further advice.

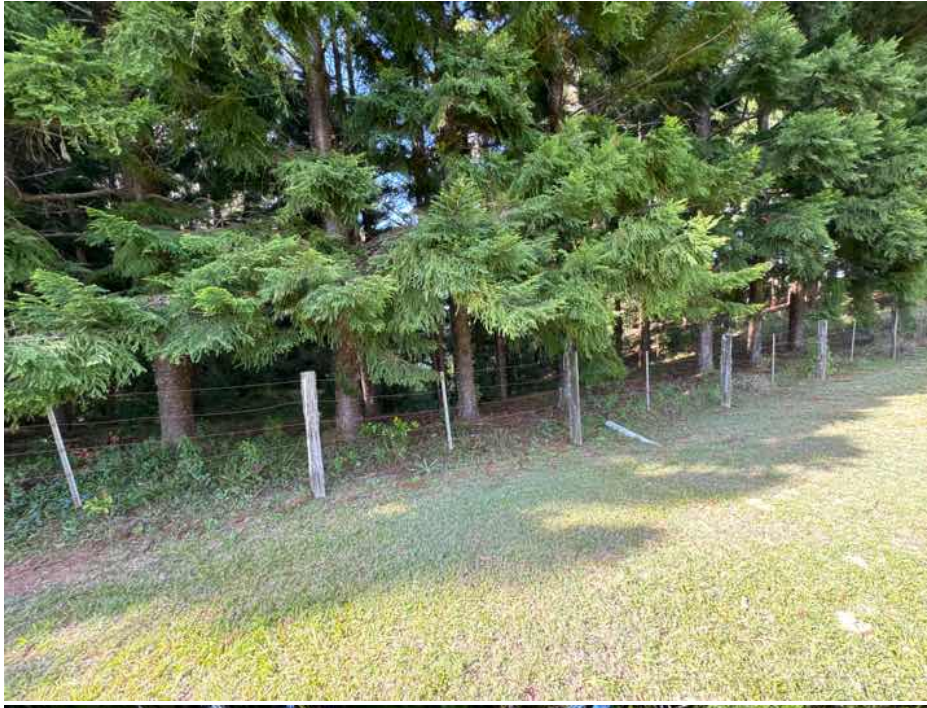
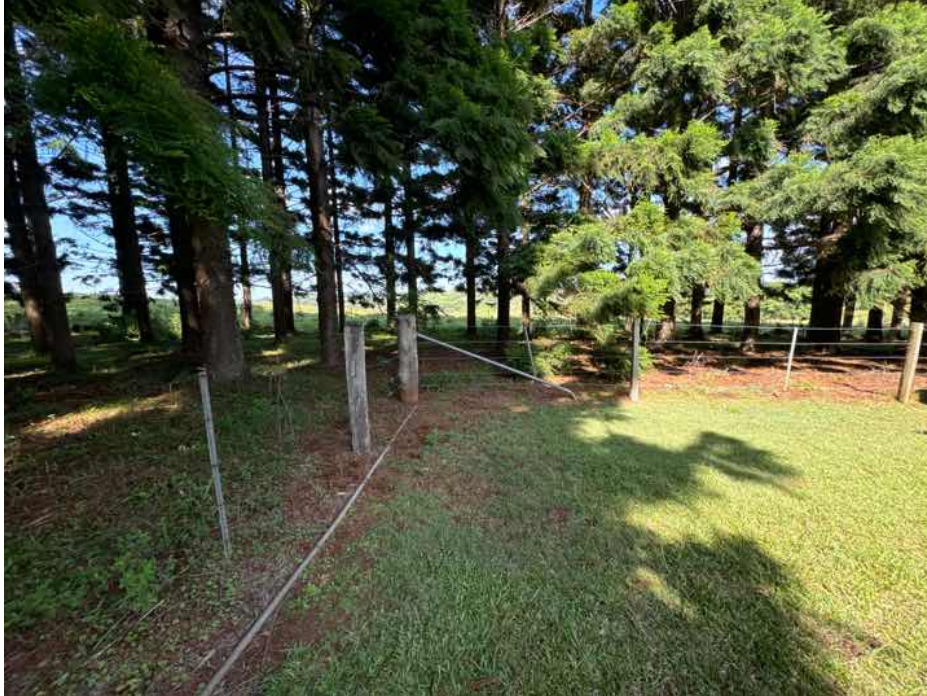
Of the visible areas, the general condition of the fences and gates is serviceable for the age of dwelling.

General age to fence components. General upkeep and maintenance required. A qualified fencing contractor should be engaged for repairs.

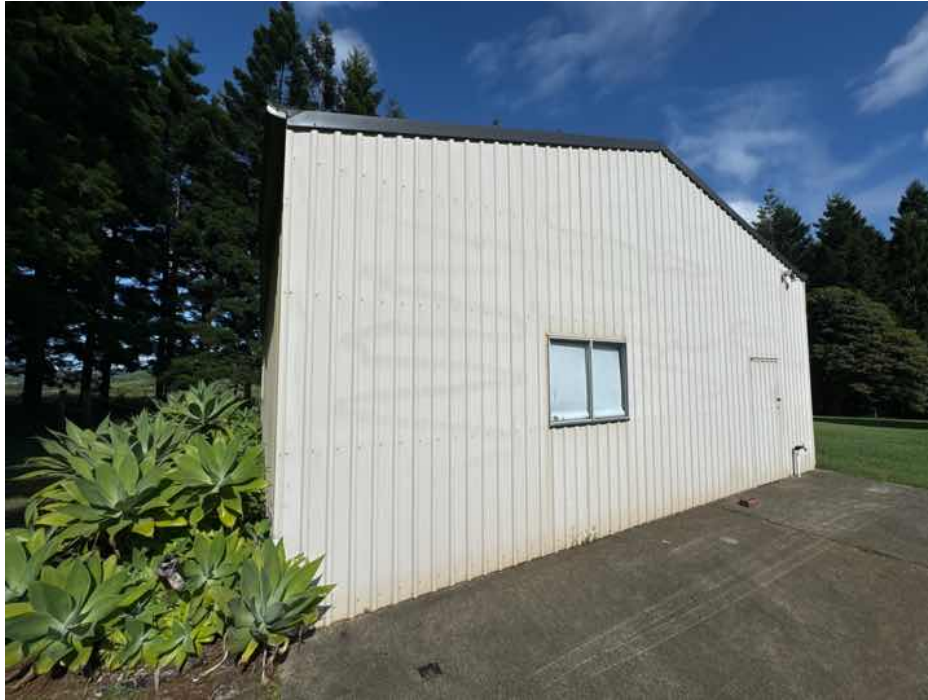
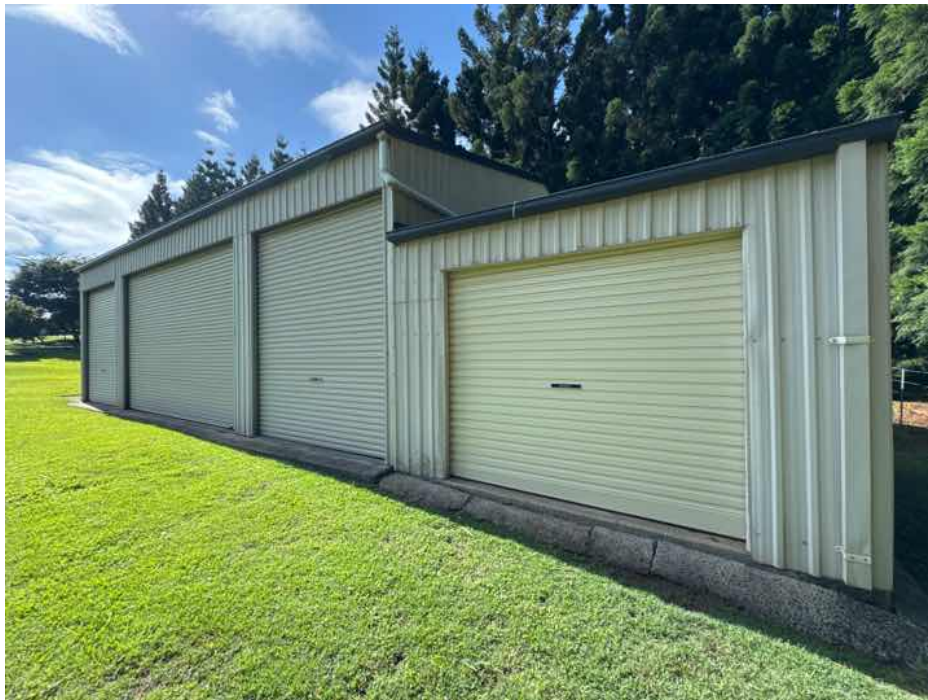
The shed is in fair usable condition.

Impact damage noted.

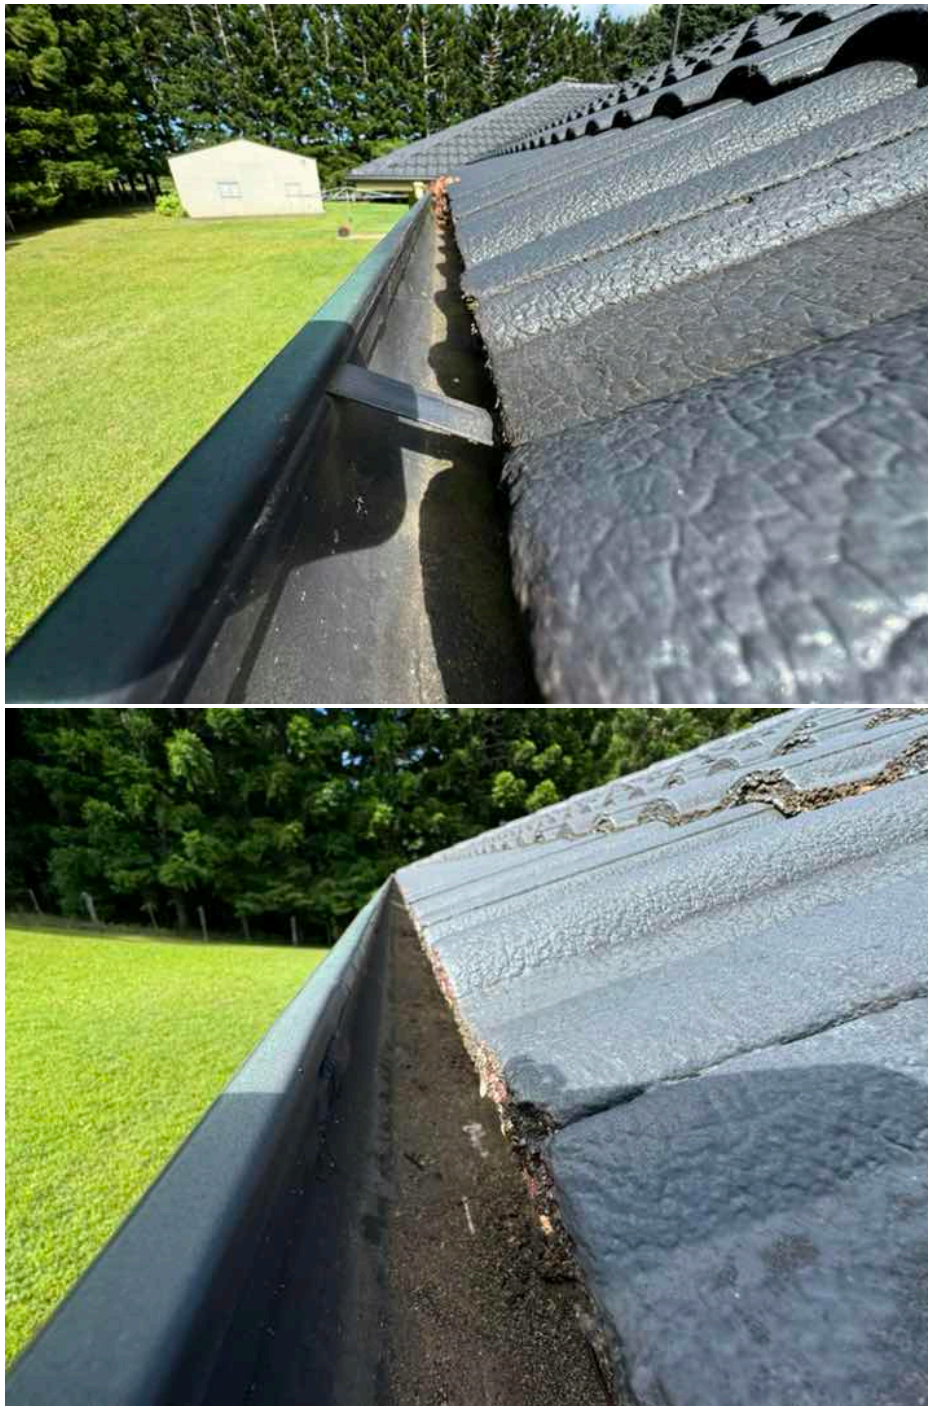
Debris in guttering areas- this requires cleaning out to prevent blocking of downpipes and leaking into eaves and fascia. Have gutters cleaned and assessed by a plumber for adequate fall. Regularly clean to prevent ponding. Ponding water will contribute to rust.

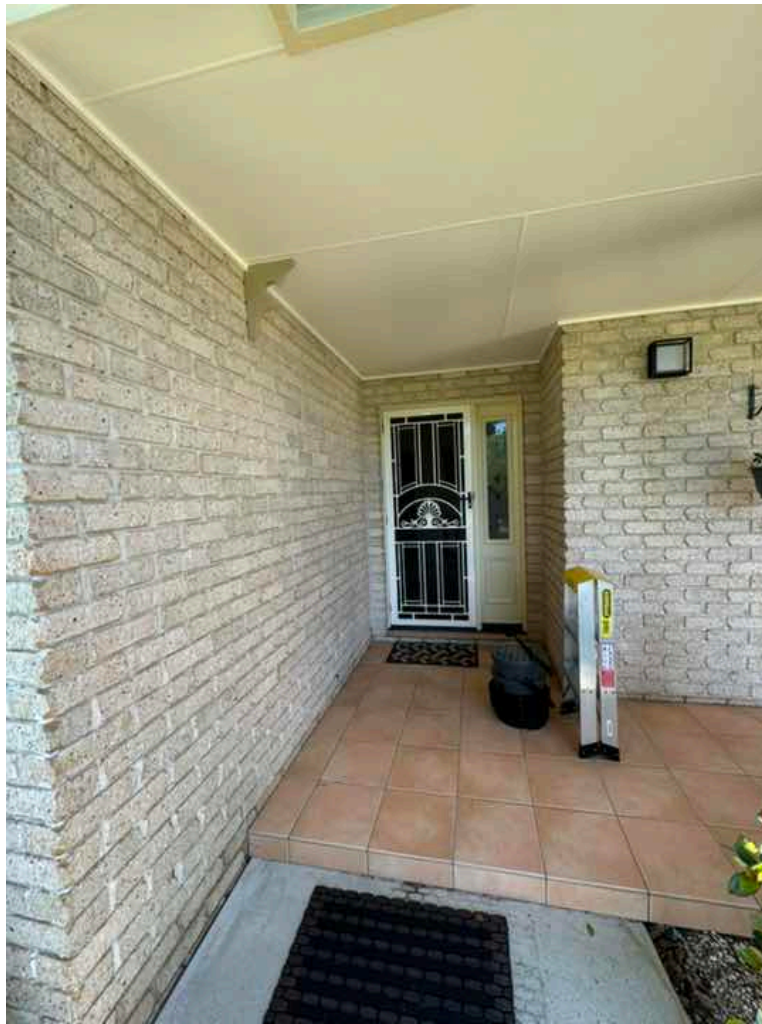
Tile cracks evident on entry patio/porch - Recommendations: Engage a qualified tiling contractor to repair.

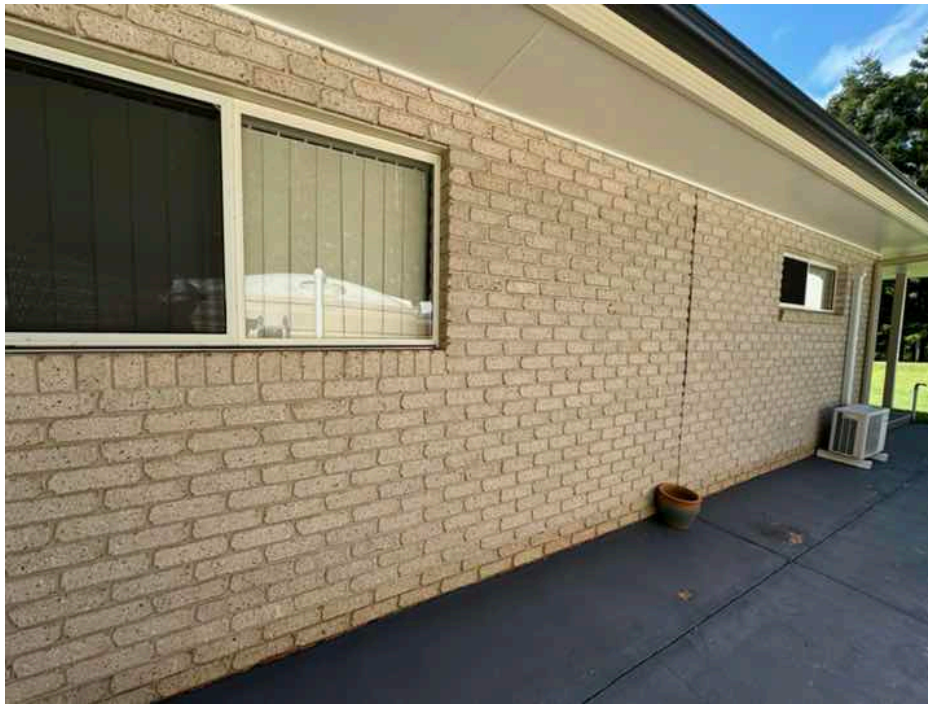
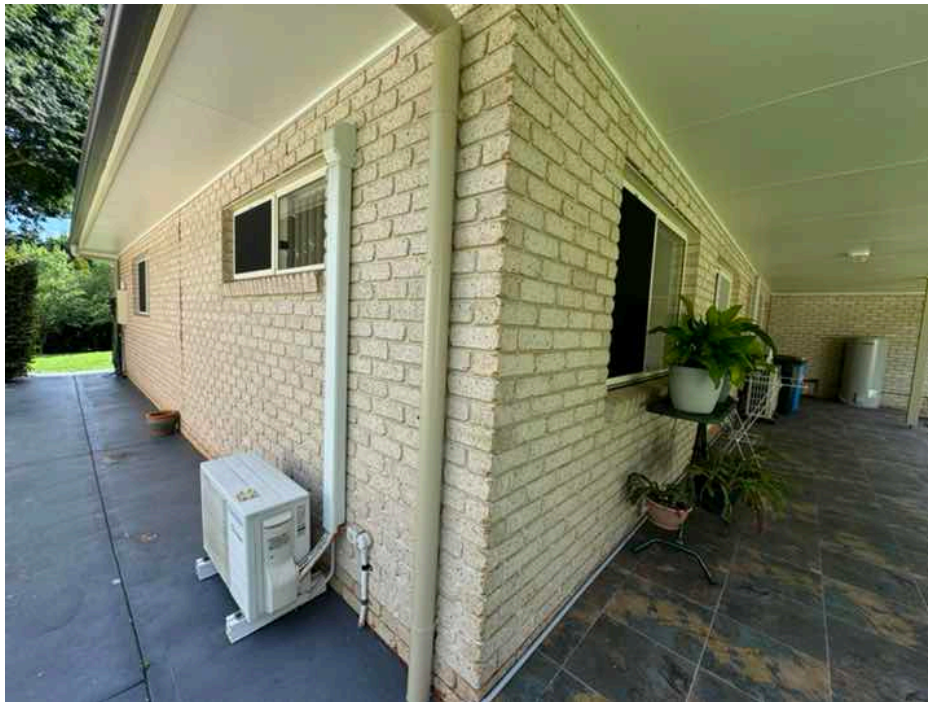
On visual inspection, the general condition of the exterior walls is serviceable for the age.

There appears to have been some settlement in the building which has caused some cracking to the walls. These cracks are categorized as 0 to 2. This can also cause some doors to bind or be out of square. In the inspector's opinion these cracks are due to settlement, usually due to ground movement and subsequent movement to building materials can be expected. Any cracks should be monitored and if cracks increase in size, further investigation should be carried out by a structural engineer.

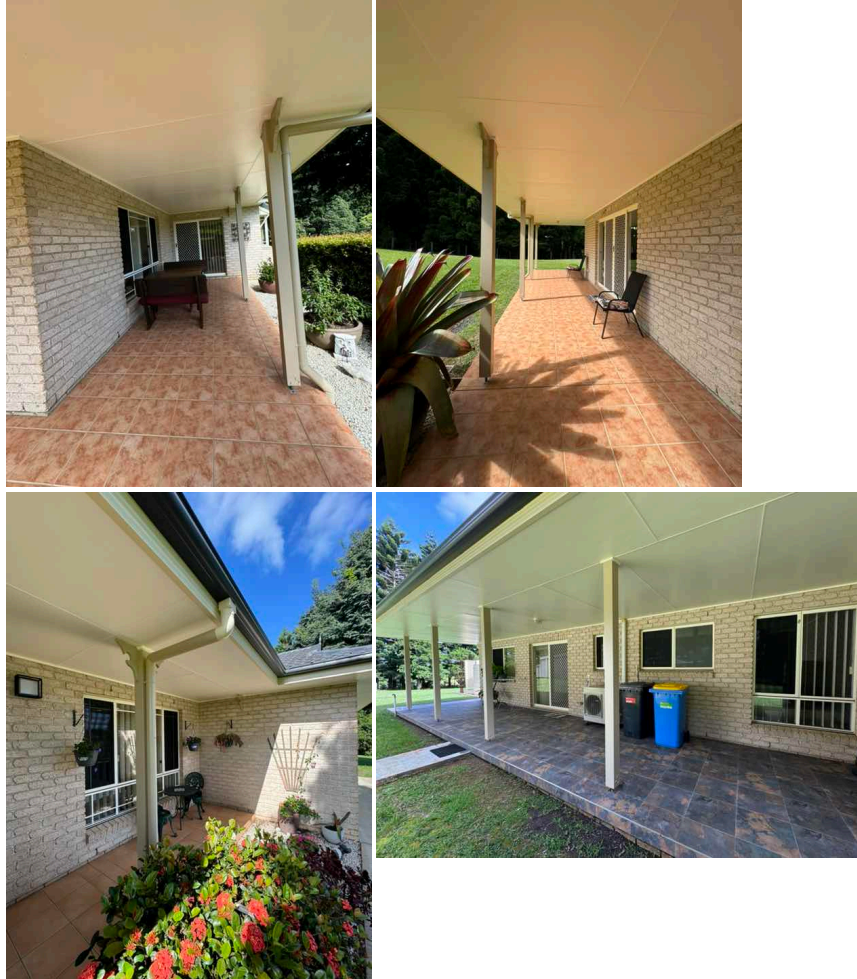
Tile cracking observed. A qualified tiler should be engaged for advice and recommendations. This may cause leaking and water penetration.

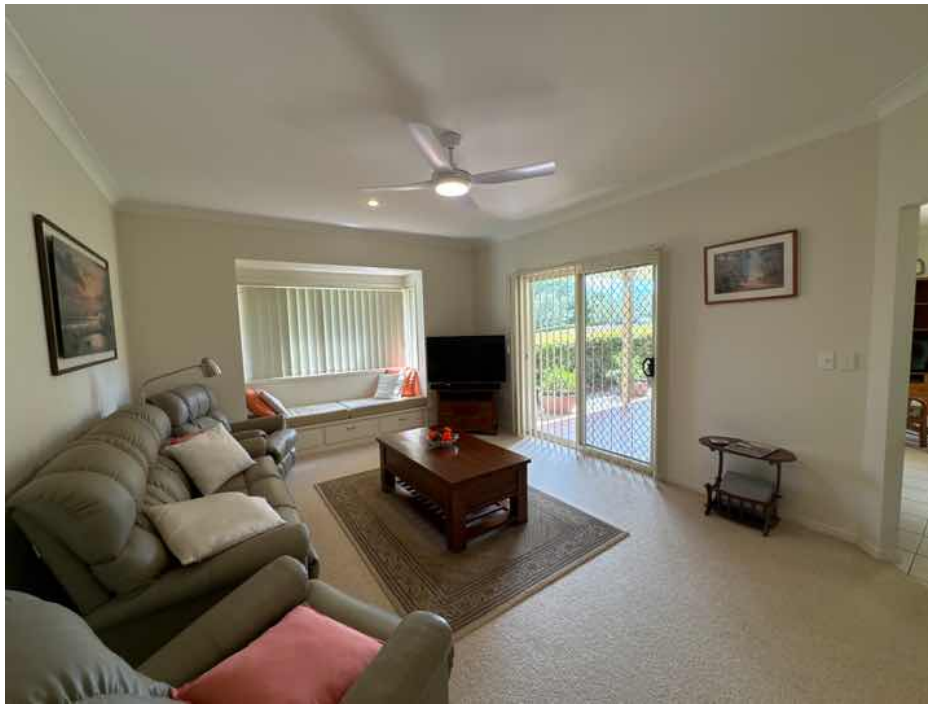
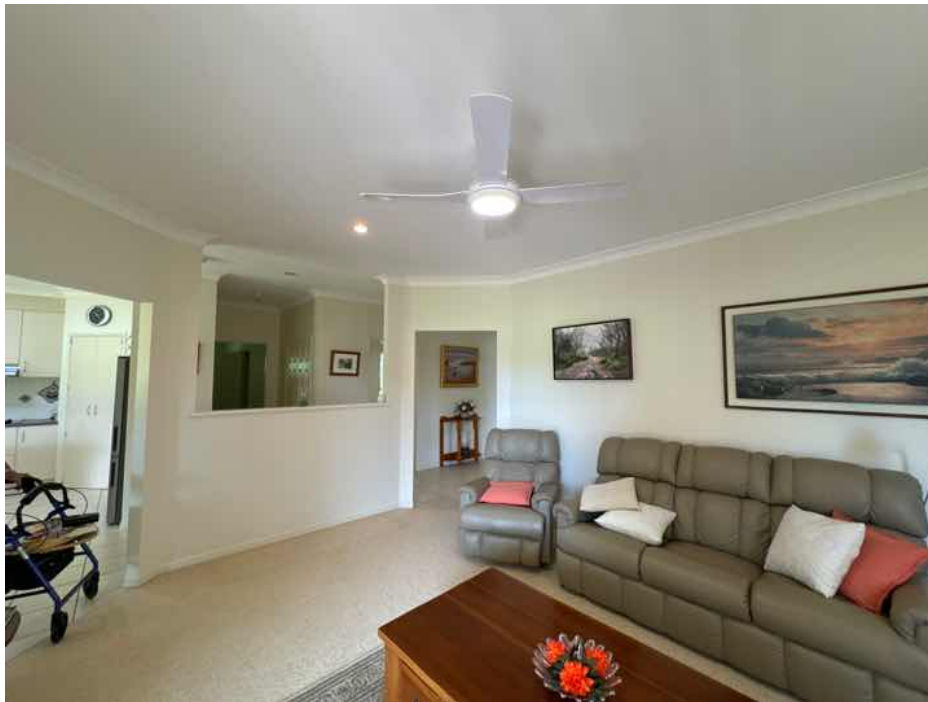
Typical cornice separation/detachment observed. I recommend you contact a qualified painter for repairs.

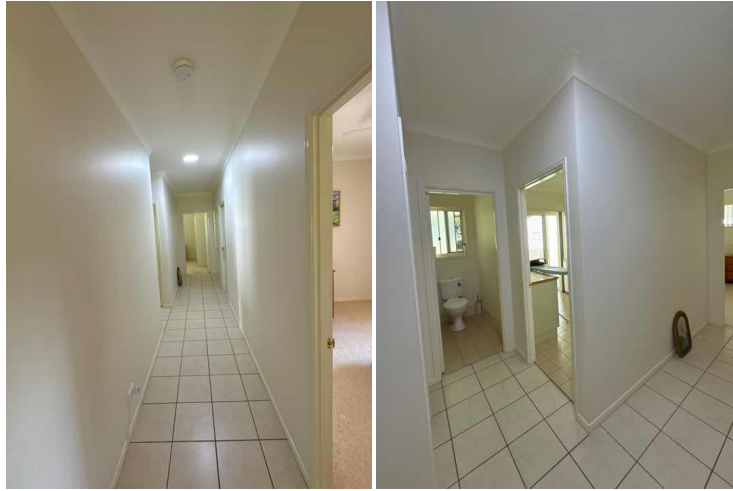
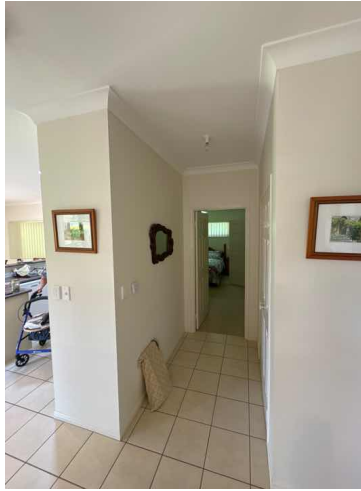
Settlement Cracks Noted. These are typical and generally patch and paint will suffice, however monitoring these cracks is advised for 12 months and if they become worse, further investigation by a suitably qualified professional is advised.

Typical cornice separation/detachment observed. I recommend you contact a qualified painter for repairs.

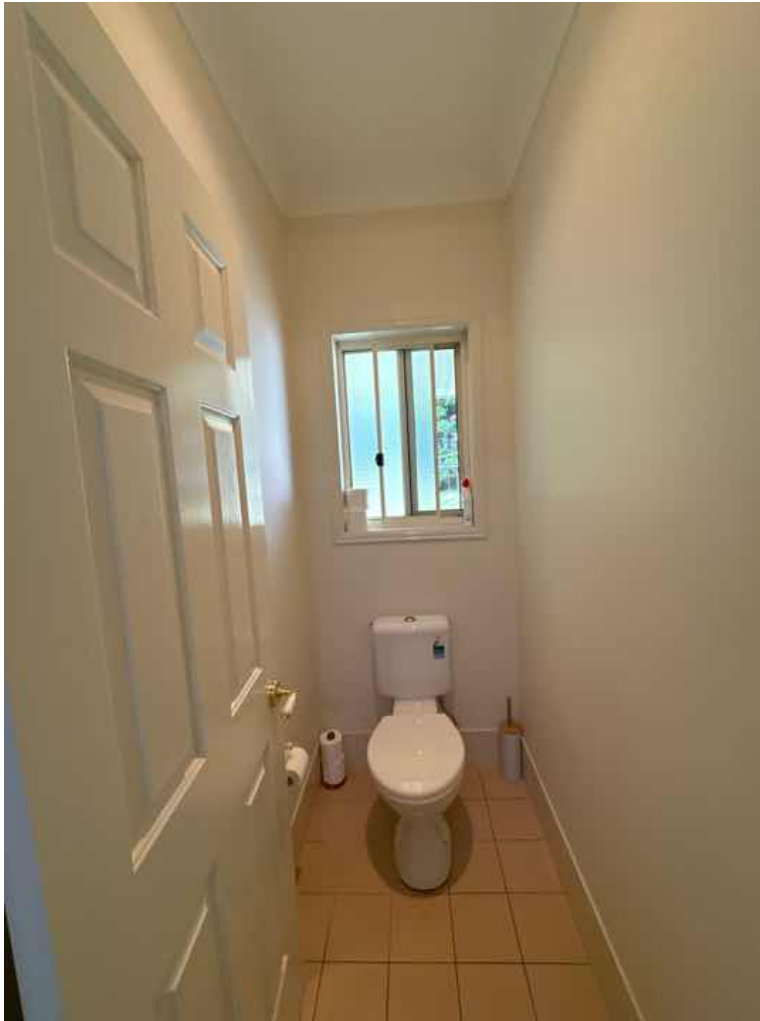
No exhaust fan is installed - Recommend having one installed.

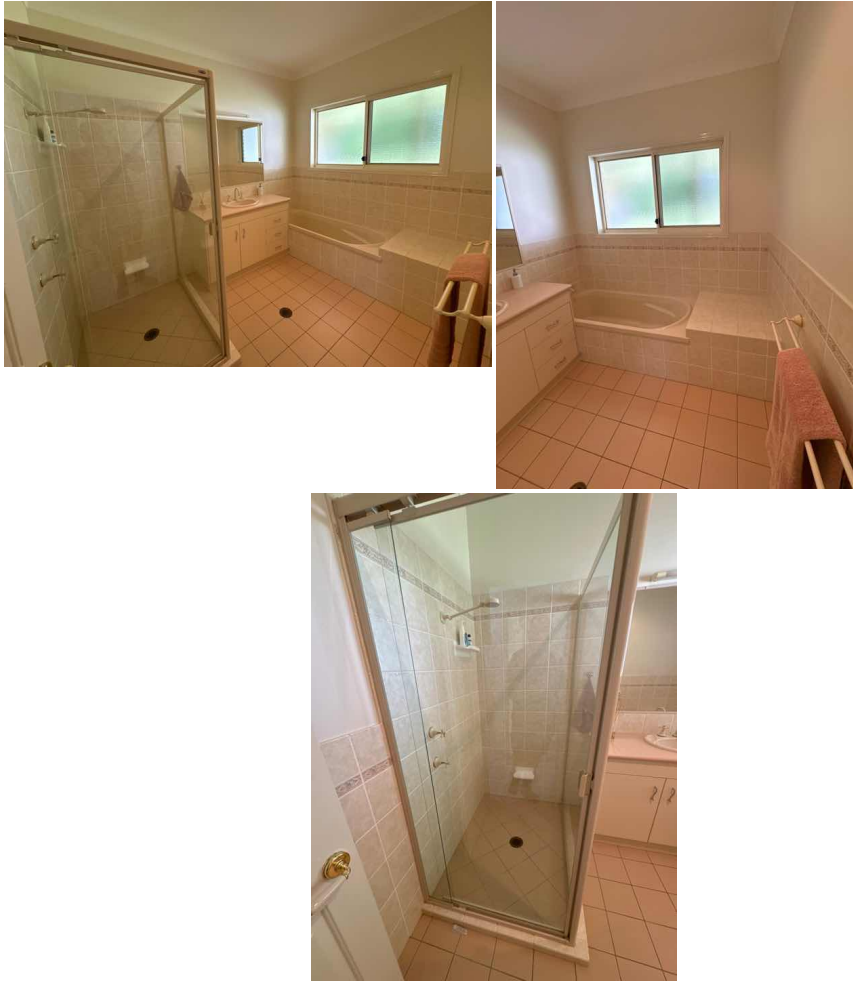
Cornice separation. I recommend you contact a licensed plasterer for repairs.

Deteriorated grout noted. This should be repaired as this will lead to water ingress under the tiles causing uplifting and possible water penetration.

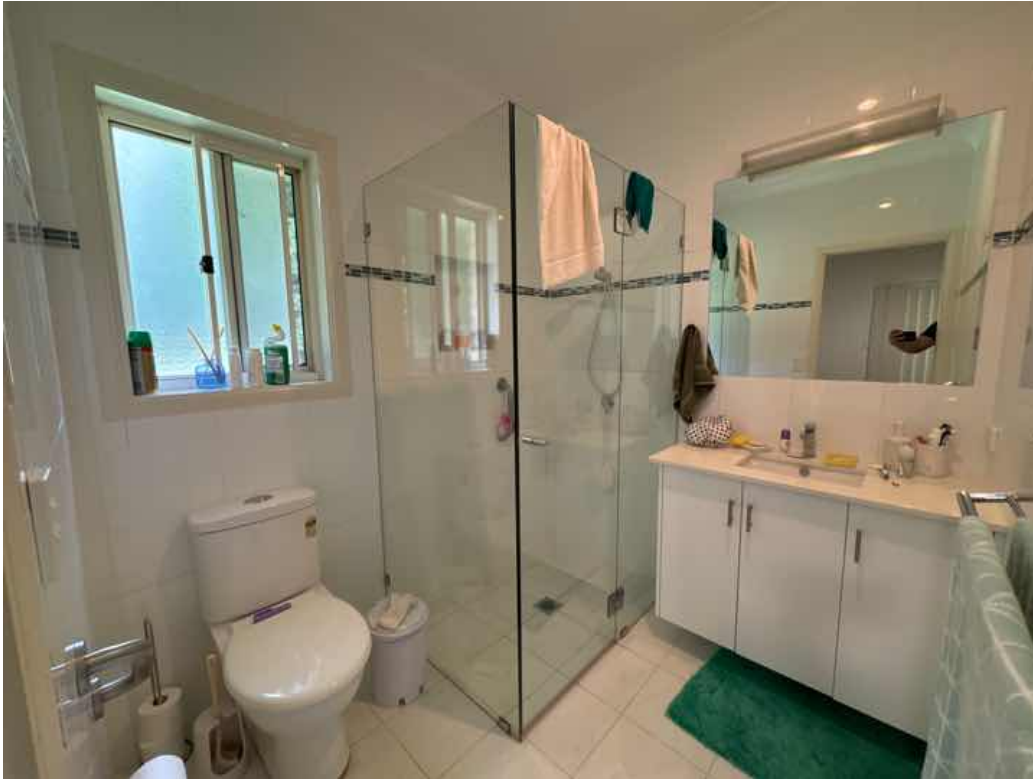
Drummy tiles noted. This needs to be repaired at the earliest as this has the potential to lead to many related issues such as damp, water ingress to other areas and cracked tiles. Contact a qualified tiler for repairs and recommendation

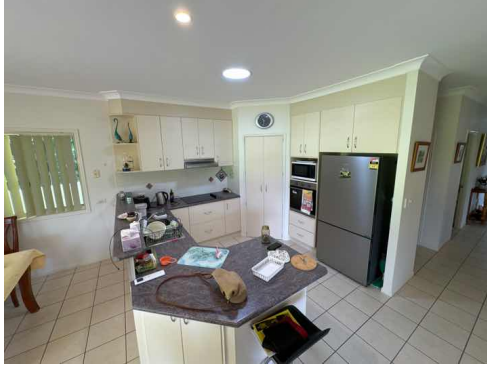
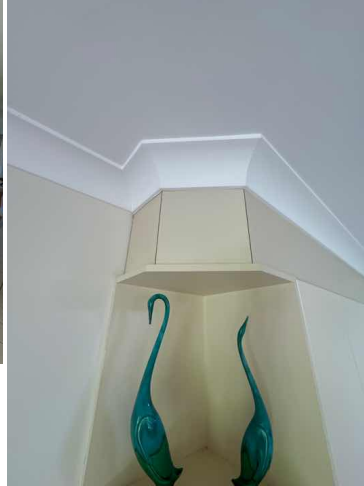
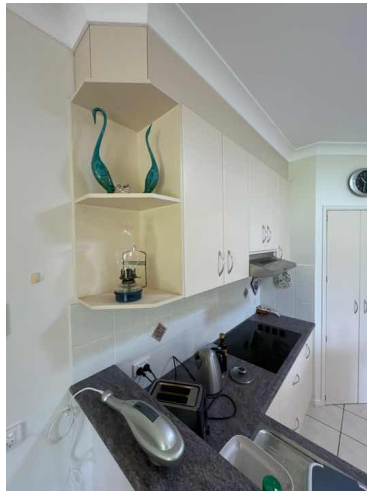
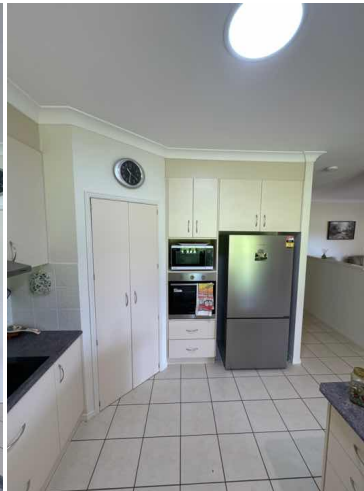
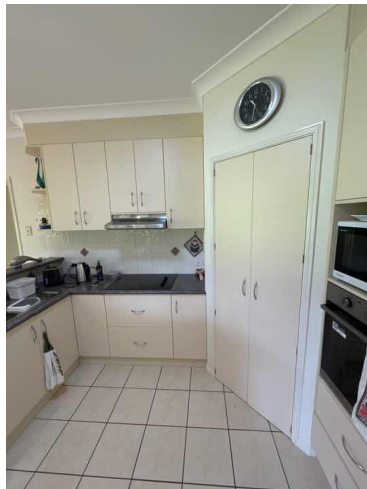
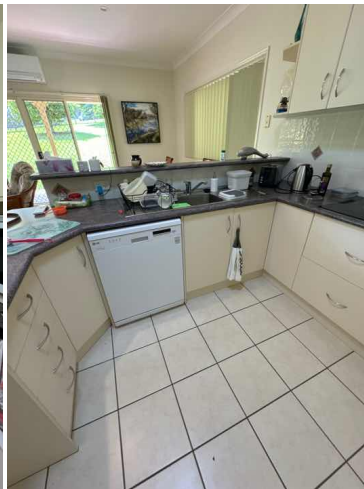
Cornice separation. I recommend you contact a licensed painter for repairs.

Adjustment to cabinet doors required, in some instance hinges may need to be replaced.

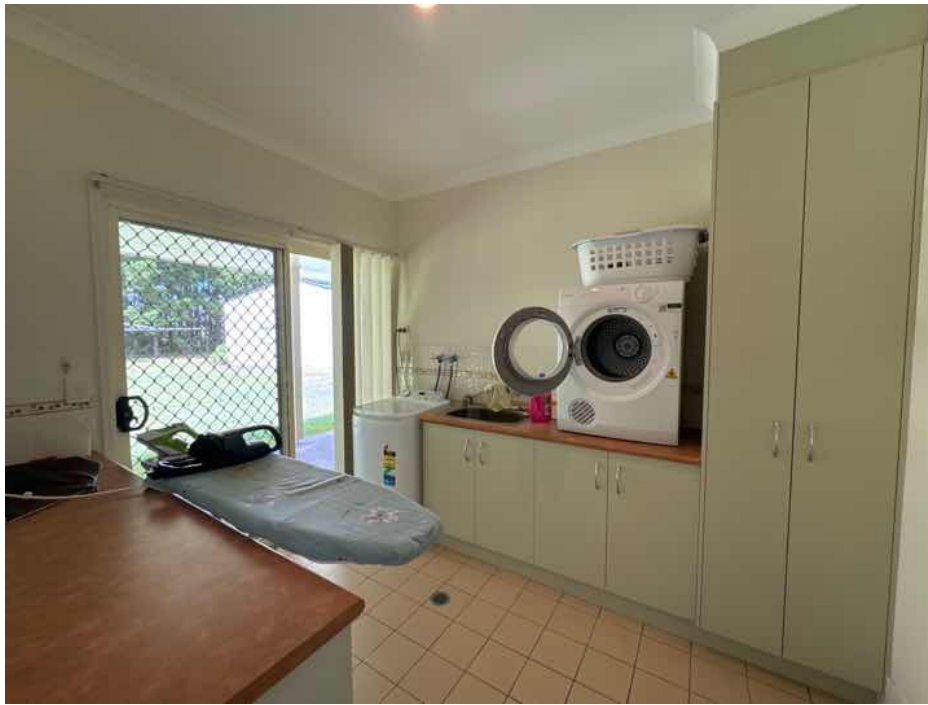
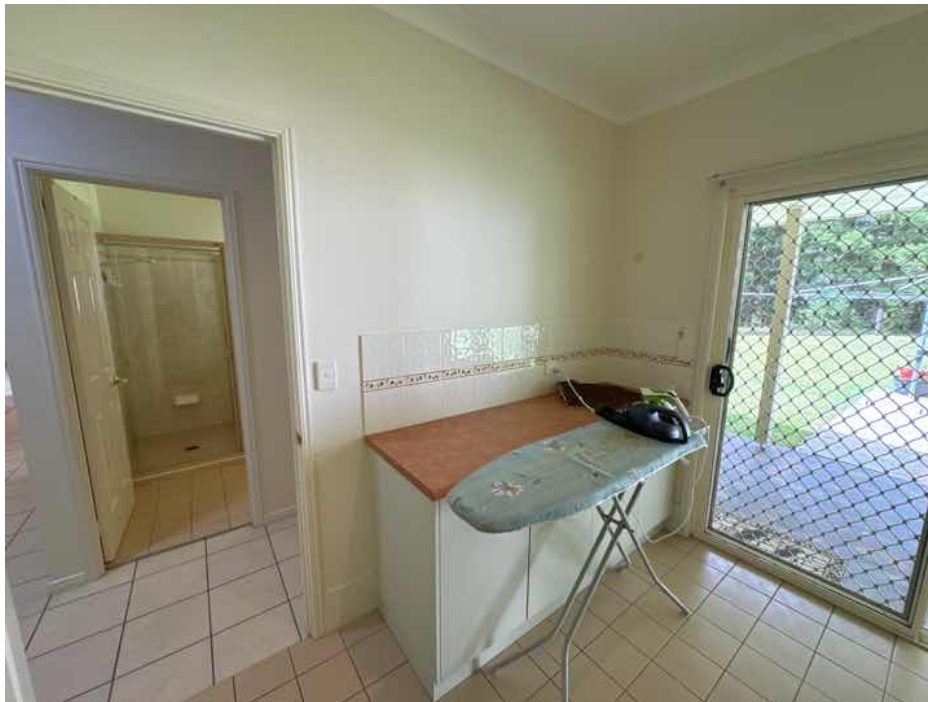
Cornice separation. I recommend you contact a licensed painter for repairs.

Minor cracks floor tiles. A qualified tiler should be engaged for repairs.
